**NATIONAL TRANSPORTATION SAFETY BOARD
OFFICE OF AVIATION SAFETY
WASHINGTON, D.C. 20594**

Airworthiness Group Chairman's Factual Report

ERA20MA001

Operator: Collings Foundation
Aircraft: B-17G, N93012
Location: Windsor Locks, CT
Date: October 2, 2019
Time: 0953 EST

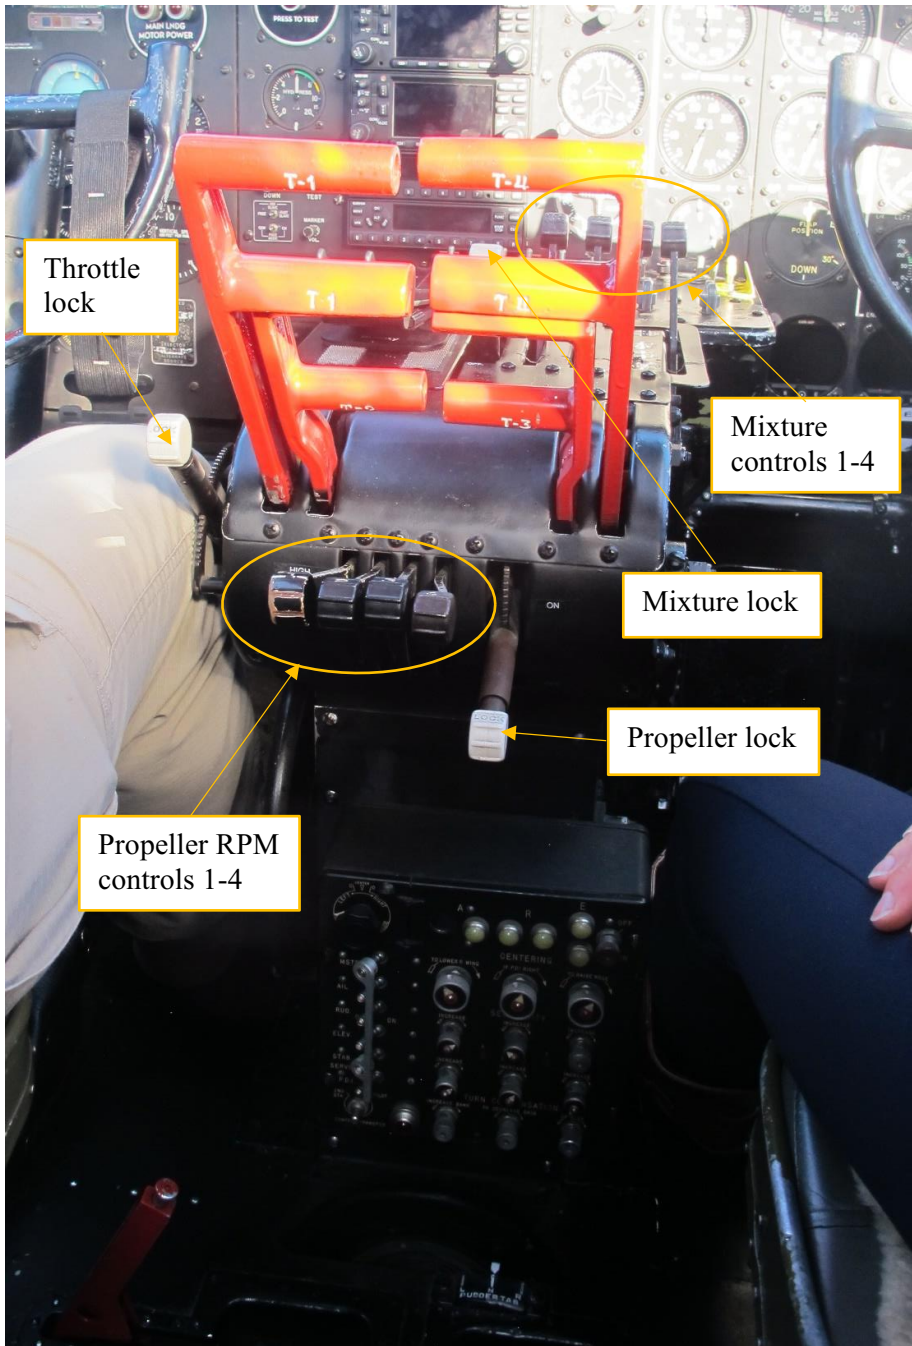
Figure 27 Throttle quadrant on exemplar airplane

Figure 27 shows the arrangement of the throttle and propeller controls. Each throttle lever has two handles, with the inboard engine levers nested between and below the outboards. The throttle quadrant was badly damaged by impact and fire (Figure 28). The upper portion of throttle lever 1 was missing both handles. Throttle 2 was intact but bent. Throttle 3 was intact. Throttle 4 had the upper handle missing. The propeller RPM levers for 1, 3, and 4 were near the high position, #2 was near low in this photo, but at the midpoint between high and low prior to being moved from glycol tank. The propeller lock lever was in the OFF position. The mixture lock lever was in the ON position (Figure 29). The position of the #1 lever was different before recovery from the top of the tank, it was slightly forward of the #2 lever instead of against the aft stop.

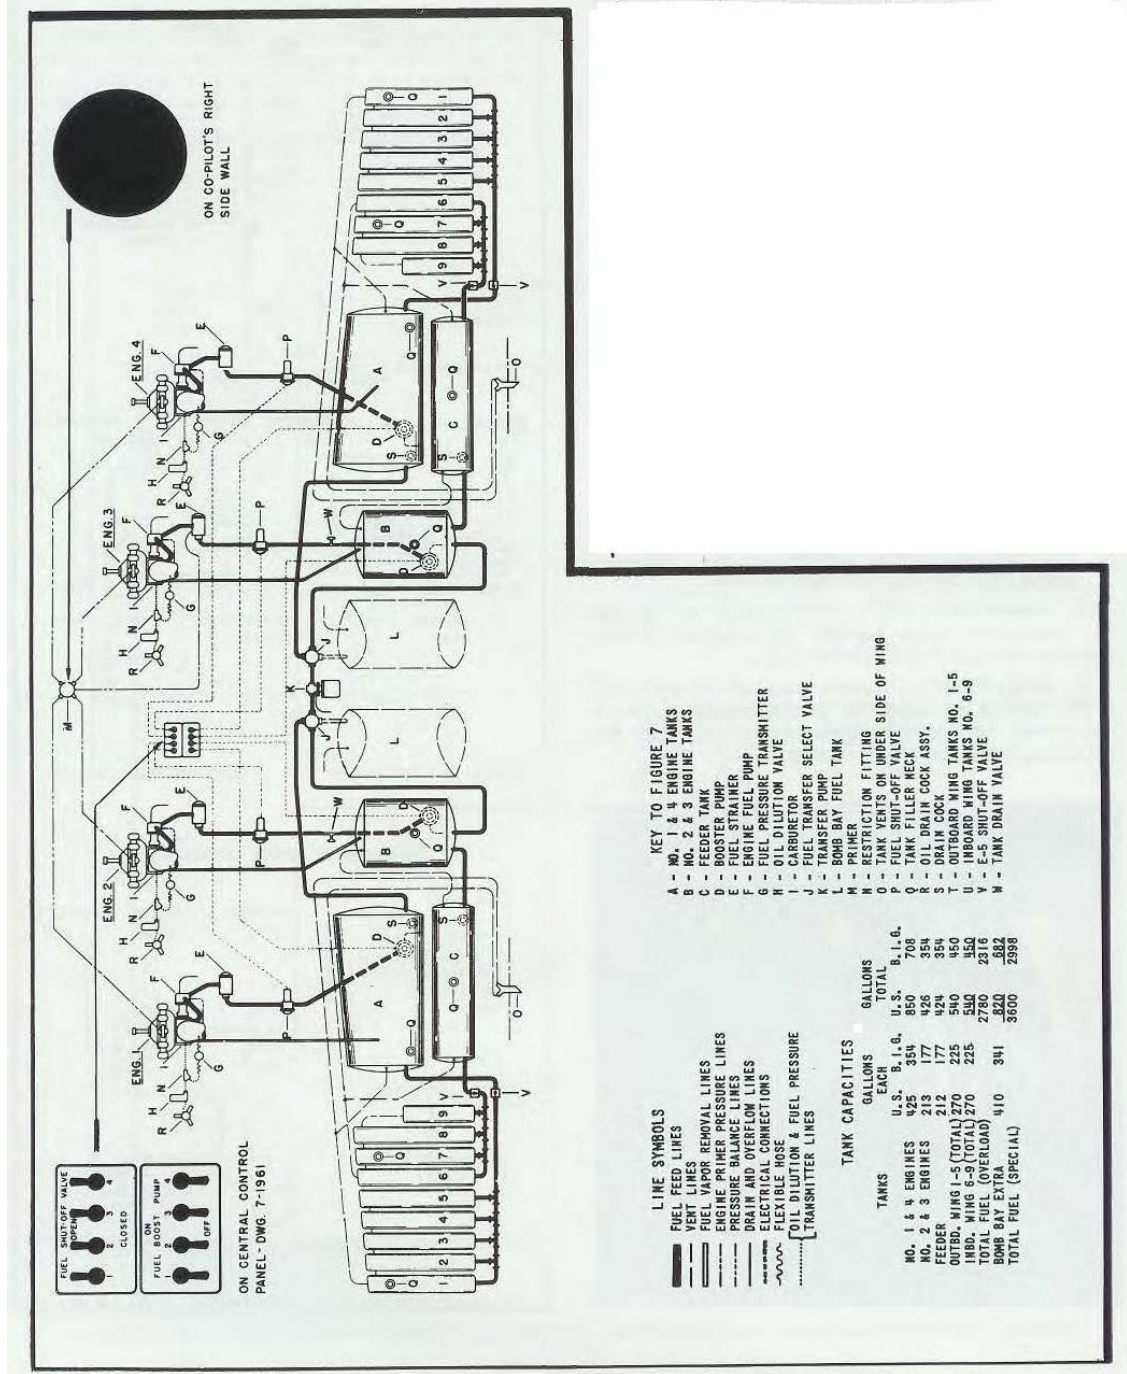
Figure 30 Fuel tank illustration

The airplane had one large (425 gallon) self-sealing rubber tank for the #1 engine, two smaller (213 gallon main, 212 gallon feeder) tanks for each inboard engine (#2 and #3), and one large (425 gallon) aluminum tank for the #4 engine (Figure 30). The airplane did not have the outboard “Tokyo” tanks or the bomb bay tanks installed. The bomb bay tanks were removable tanks only used on long range ferry flights. The tanks for #1 and #4 did not have a protective rubber covering and were consumed during the post impact fire (Figures 31-33). The tanks for #2 and #3 had a protective rubber covering and were still intact but heat damaged. A fuel sample was taken from the #3 tank (Figure 34).
