# National Transportation Safety Board

ERA21FA195

Aircraft Performance Study

Location: Eden, North Carolina  
Date: April 28, 2021  
Time: 13:24 EDT  
17:24 UTC  
Aircraft: Bell 429, N53DE

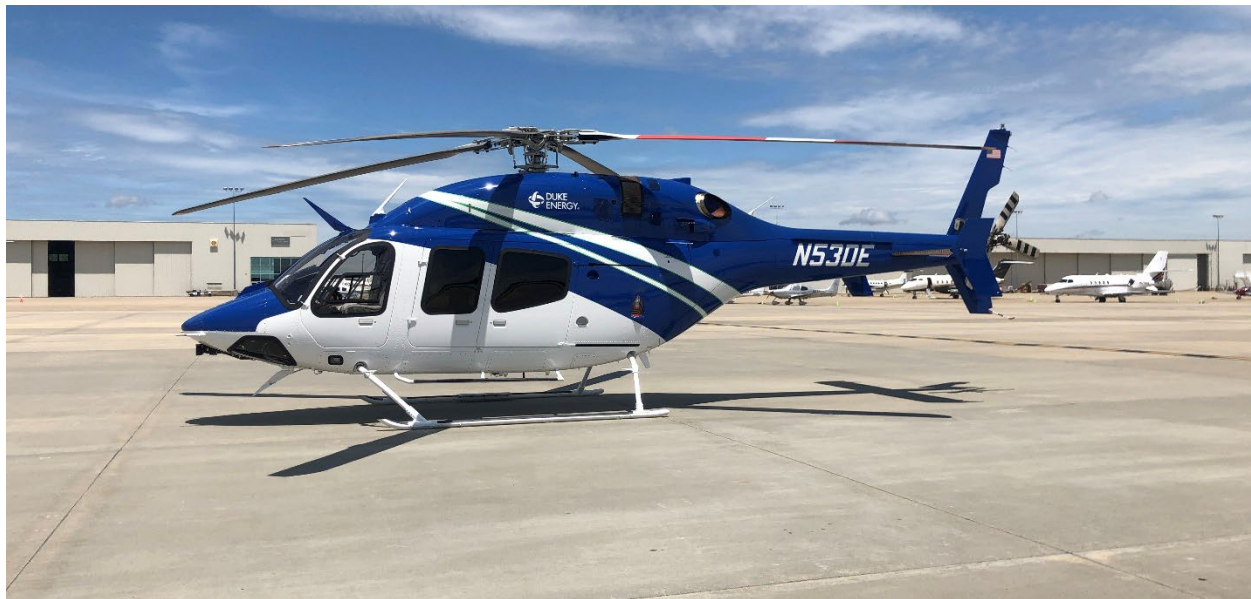
**Figure 1.** A photograph of the accident Bell 429, N53DE.

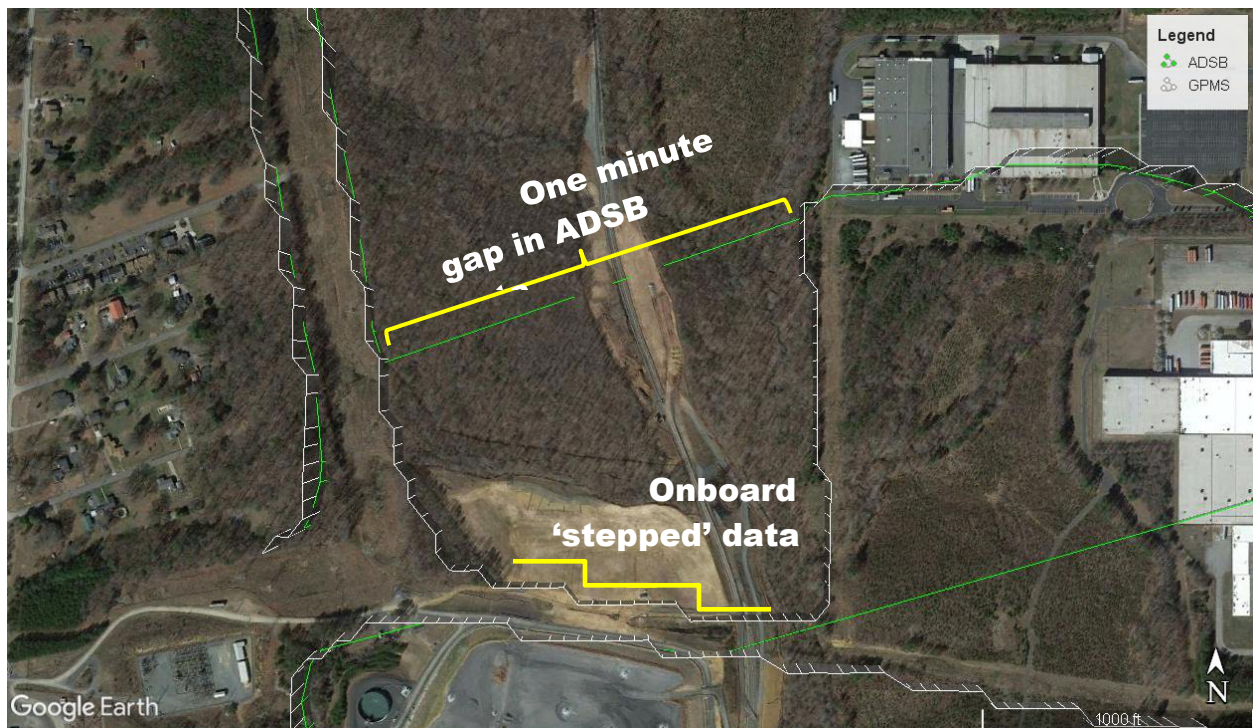
The latitude and longitude recorded by the onboard device exhibited a stepped characteristic (Figure 2) not seen in the smoother ADS-B data. It is likely that the stepped characteristic is reflective of how the position was recorded on the GPMS device. Additionally, the track angle, which is calculated, follows with the smoothed path. However, portions of the flight were missing from the ADS-B data but were recorded by the onboard recorder. Consequently, for calculations, the onboard position data was smoothed to a closer match of the ADS-B data for a more realistic flight path.

**Figure 2.** ADS-B flight path in green and onboard GPMS device data in white.

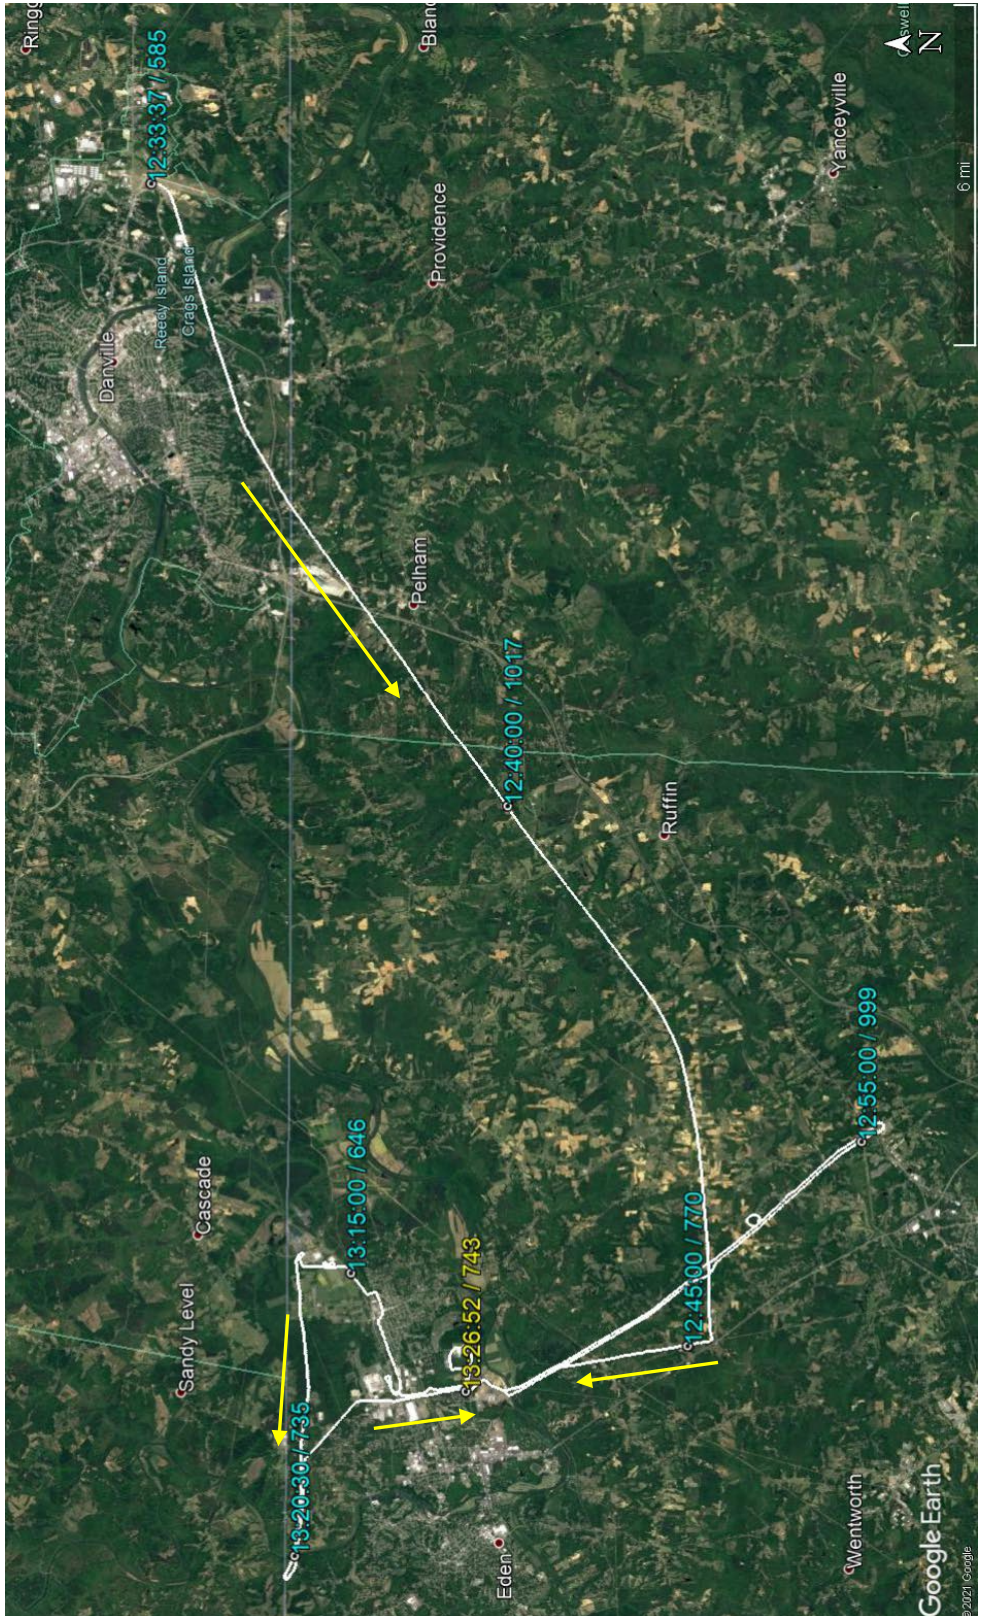
Figure 3 shows the accident flight path. Altitude above mean sea level (msl) and groundspeed are shown in Figure 4 and radar altitude, or recorded height above terrain, in Figure 5. The helicopter left Danville, Virginia about 12:33 and flew cross country south-west into North Carolina. By 12:45, the helicopter was flying powerline patrol around Eden, North Carolina. Line inspection was done at an altitude of about 100 ft above terrain with the helicopter gaining altitude during turns and when flying between line inspections.

**Figure 3.** Accident flight path from onboard data, with time and altitude (msl) annotated for select points. The final data point is shown in yellow.

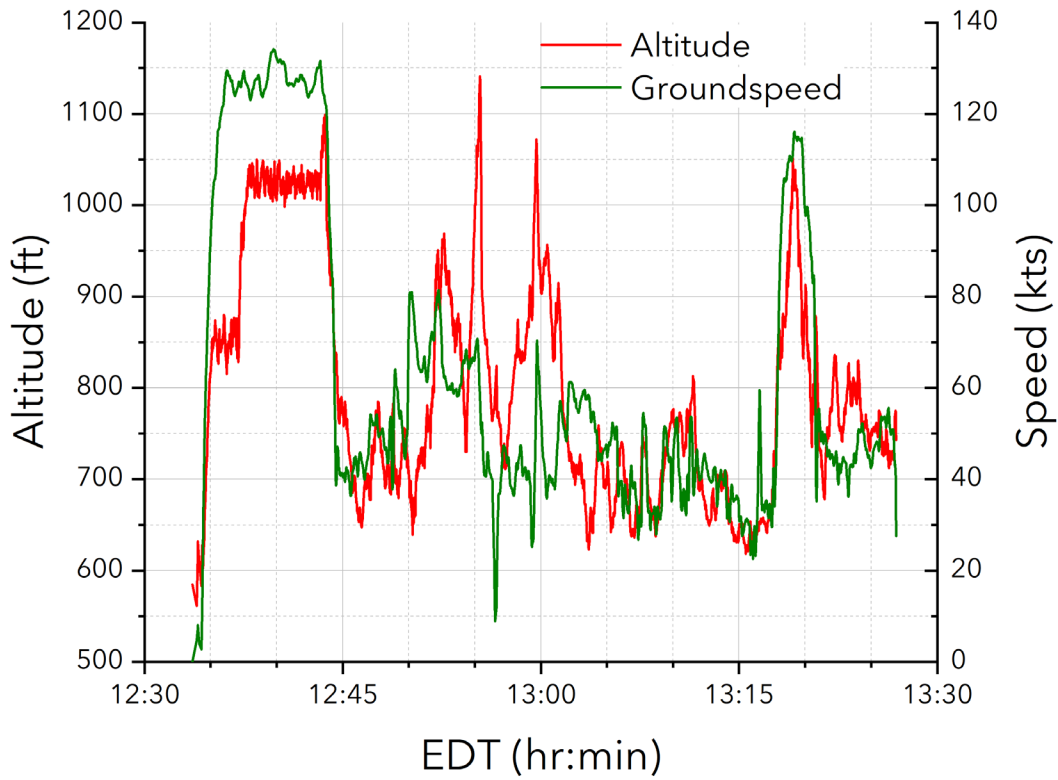
**Figure 4.** Accident flight altitude (msl) and groundspeed.

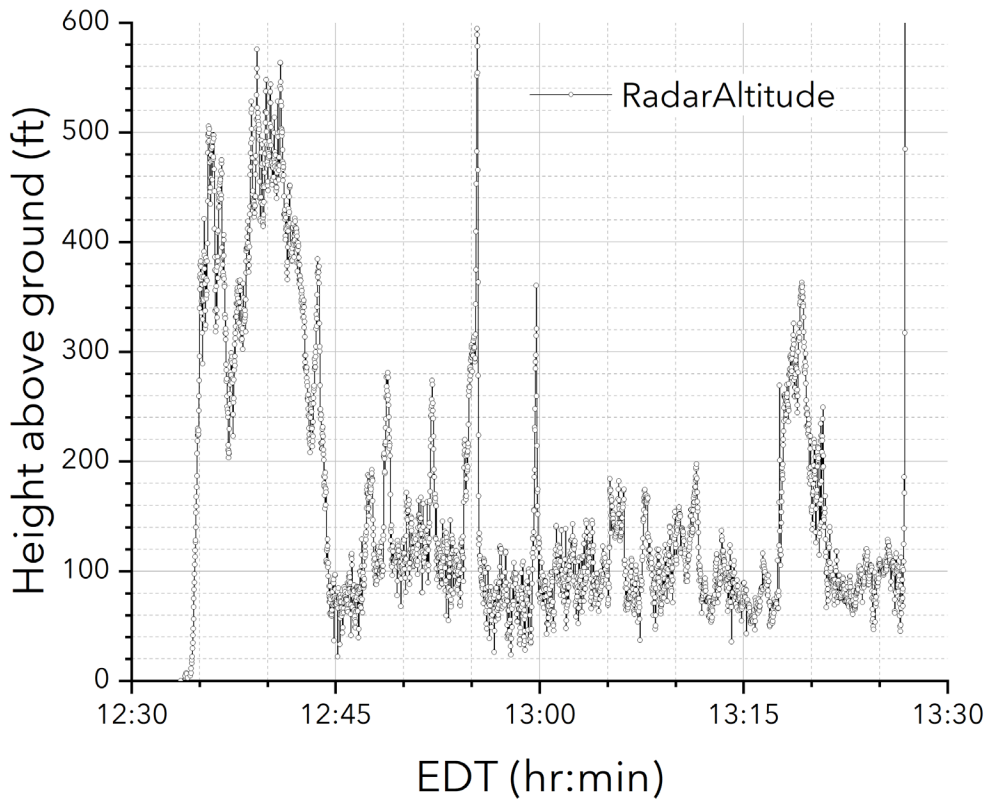
**Figure 5.** Accident radar altitude from onboard device.

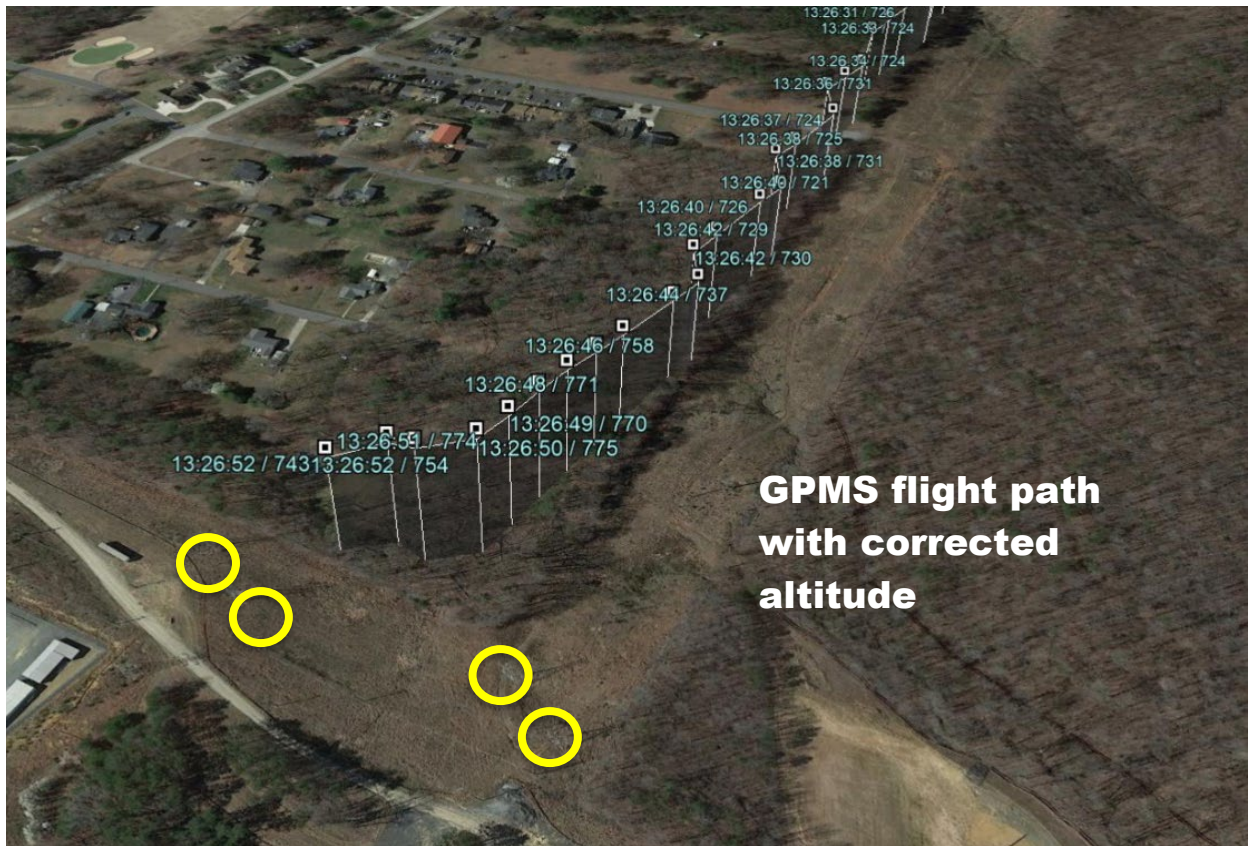
**Figure 9.** Google Earth satellite imagery corresponding to Figure 8. Yellow circles show the base of electrical towers.

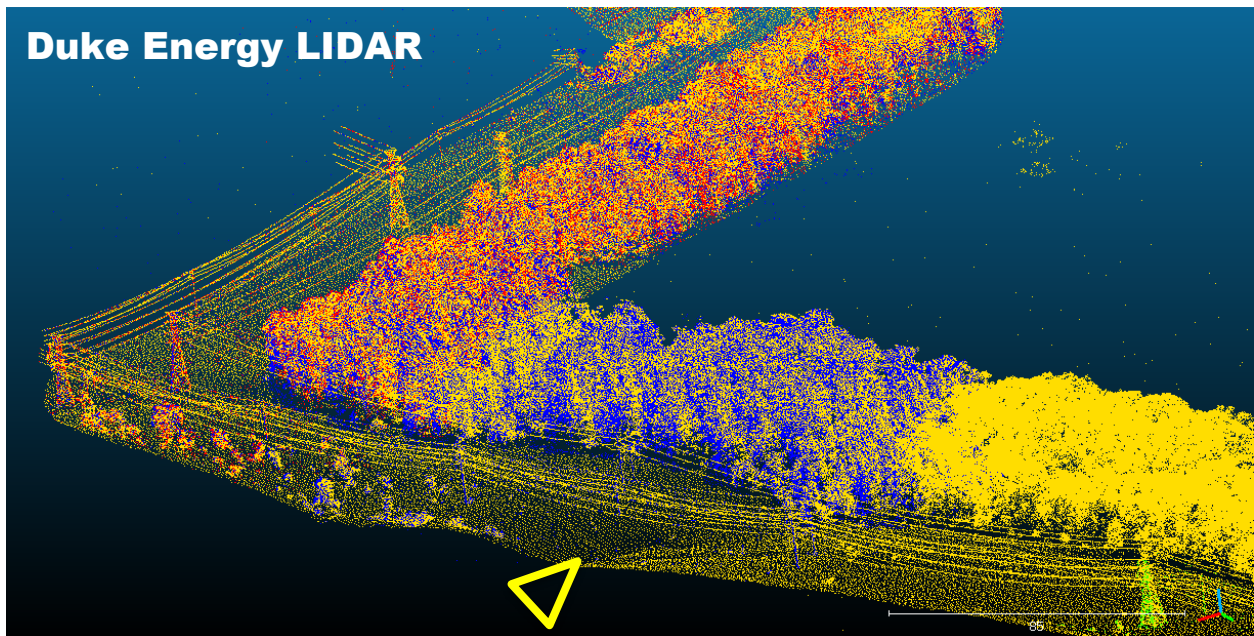
**Figure 10.** LIDAR data from Duke Energy corresponding to Figure 11. A yellow triangle indicates a small water course depression.

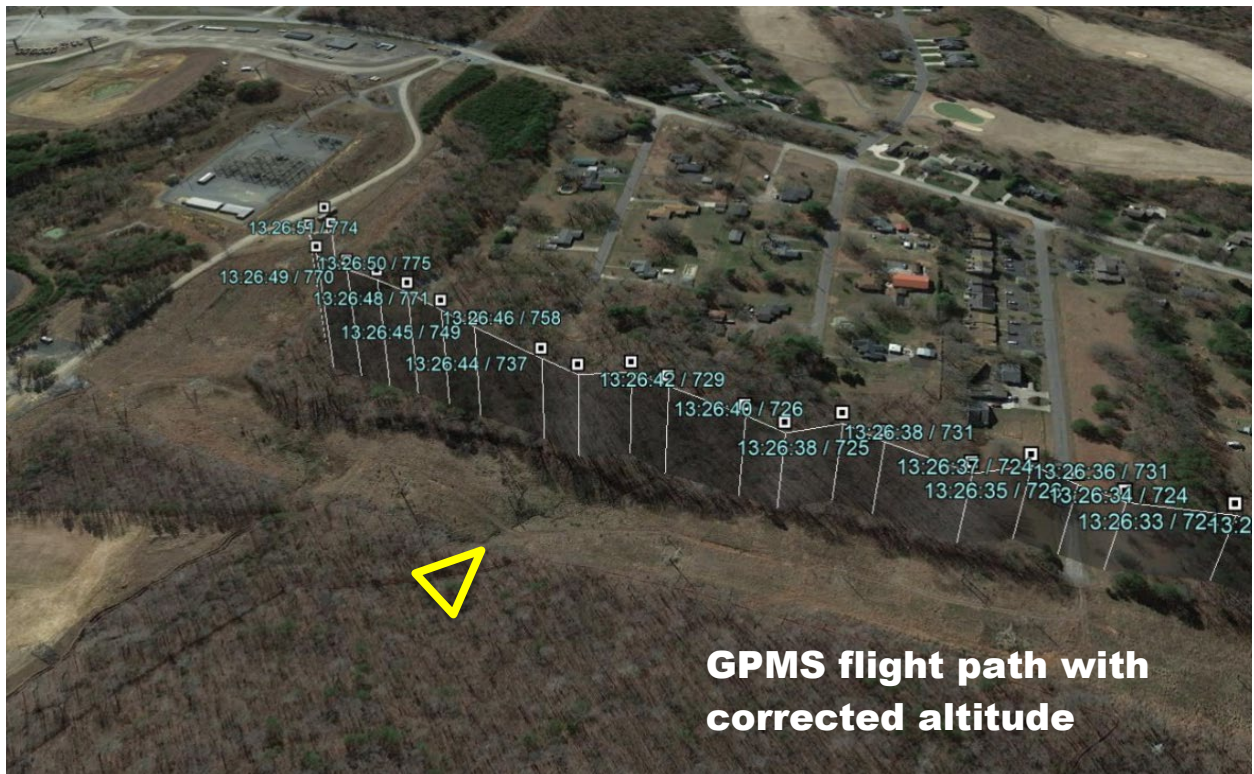
**Figure 11.** Google Earth satellite imagery corresponding to Figure 10. A yellow triangle indicates a small water course depression.

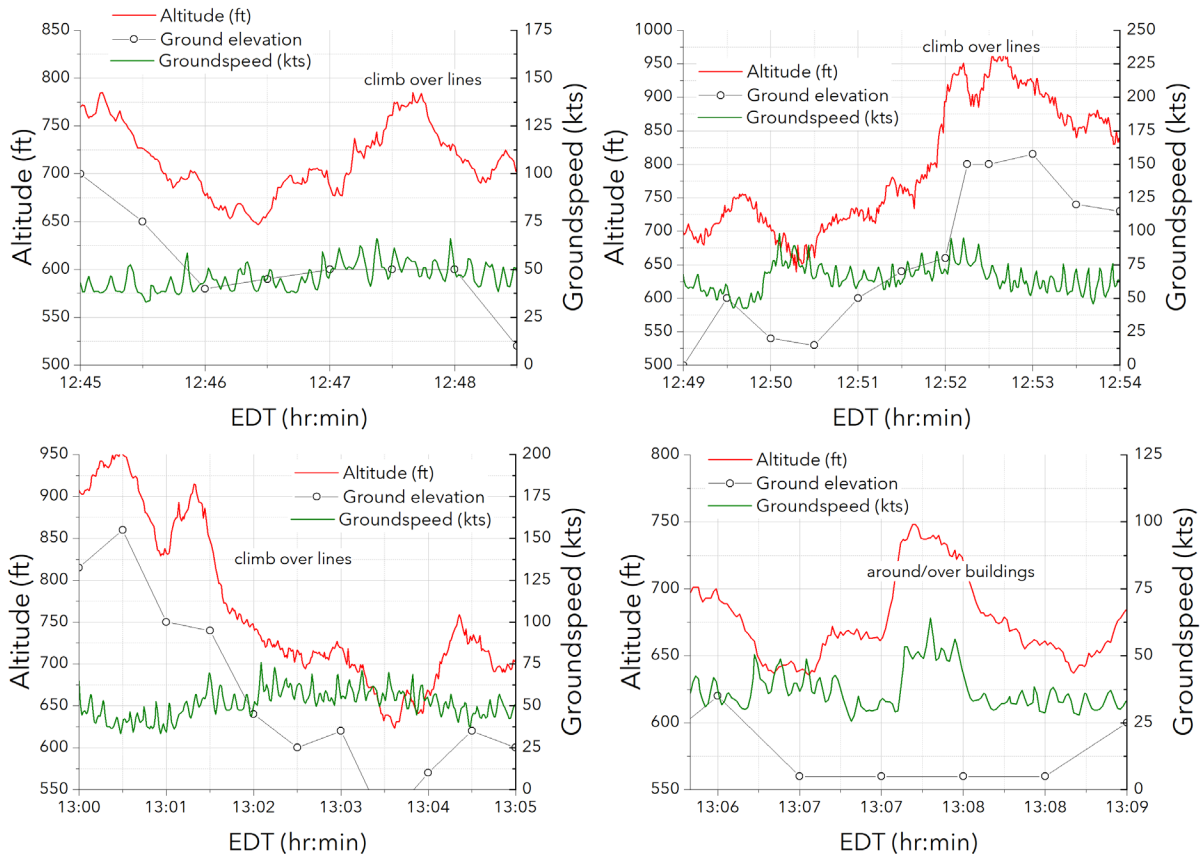
While flying along the lines, the helicopter was on average 100 ft above the ground. Figure 14 shows three times the helicopter climbed over powerlines and one time when it overflowed a building. When flying across power lines or over a building, the helicopter climbed to 150 ft or more above the ground. Groundspeed while flying along the wires was 50 to 75 kts with little noticeable change in speed while climbing to cross lines.

**Figure 14.** Altitude, ground elevation, and groundspeed for four earlier climbs over power lines or buildings.

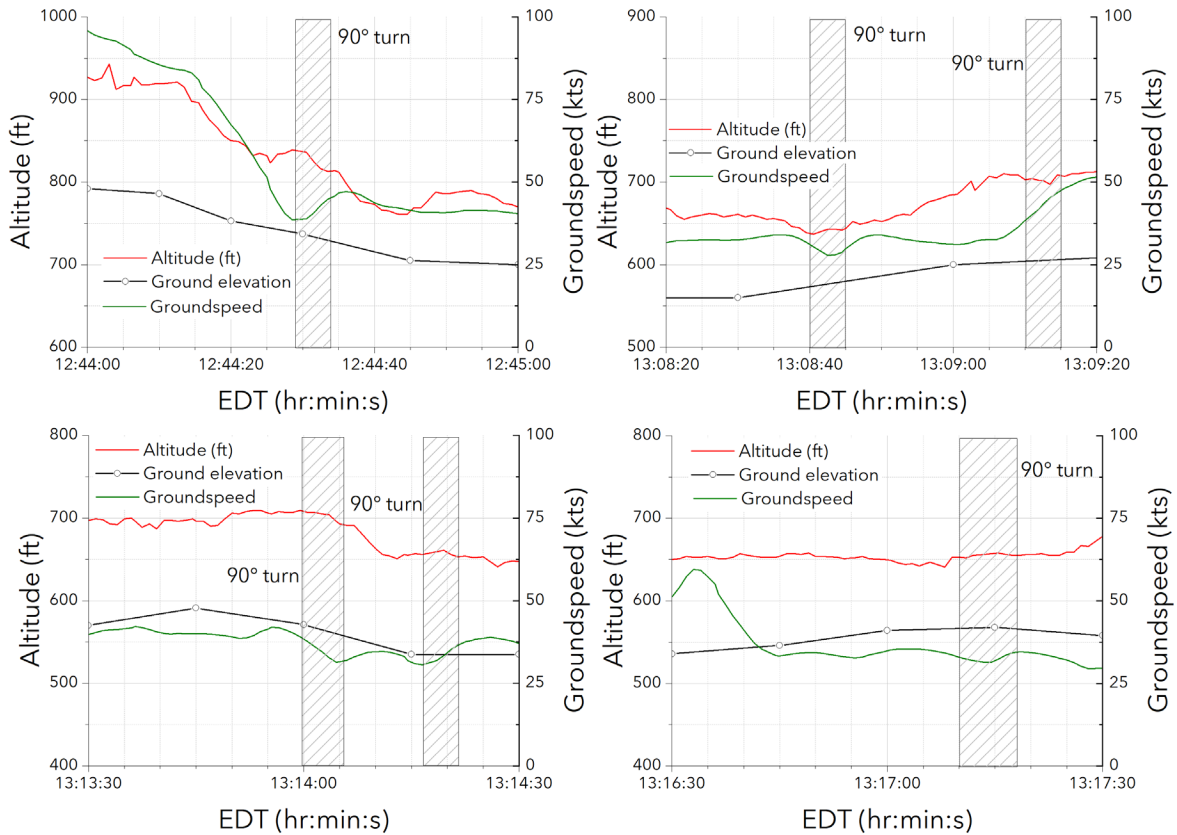
Figure 15 shows four prior 90° turns and Figure 16 shows four 180° turns the helicopter completed. 90° turns were completed in about 5 seconds at speeds between 30 and 40 kts and about 100 ft above the terrain. Altitude remained consistent

**Figure 15.** Altitude, ground elevation, and groundspeed for four earlier 90° turns.
