National Transportation Safety Board

ERA22FA058

VEHICLE PERFORMANCE

Location: Branchville, New Jersey
Date: November 11, 2021
Time: 1048 EST
1548 GMT
Airplane: Cessna 172S Skyhawk, N90559

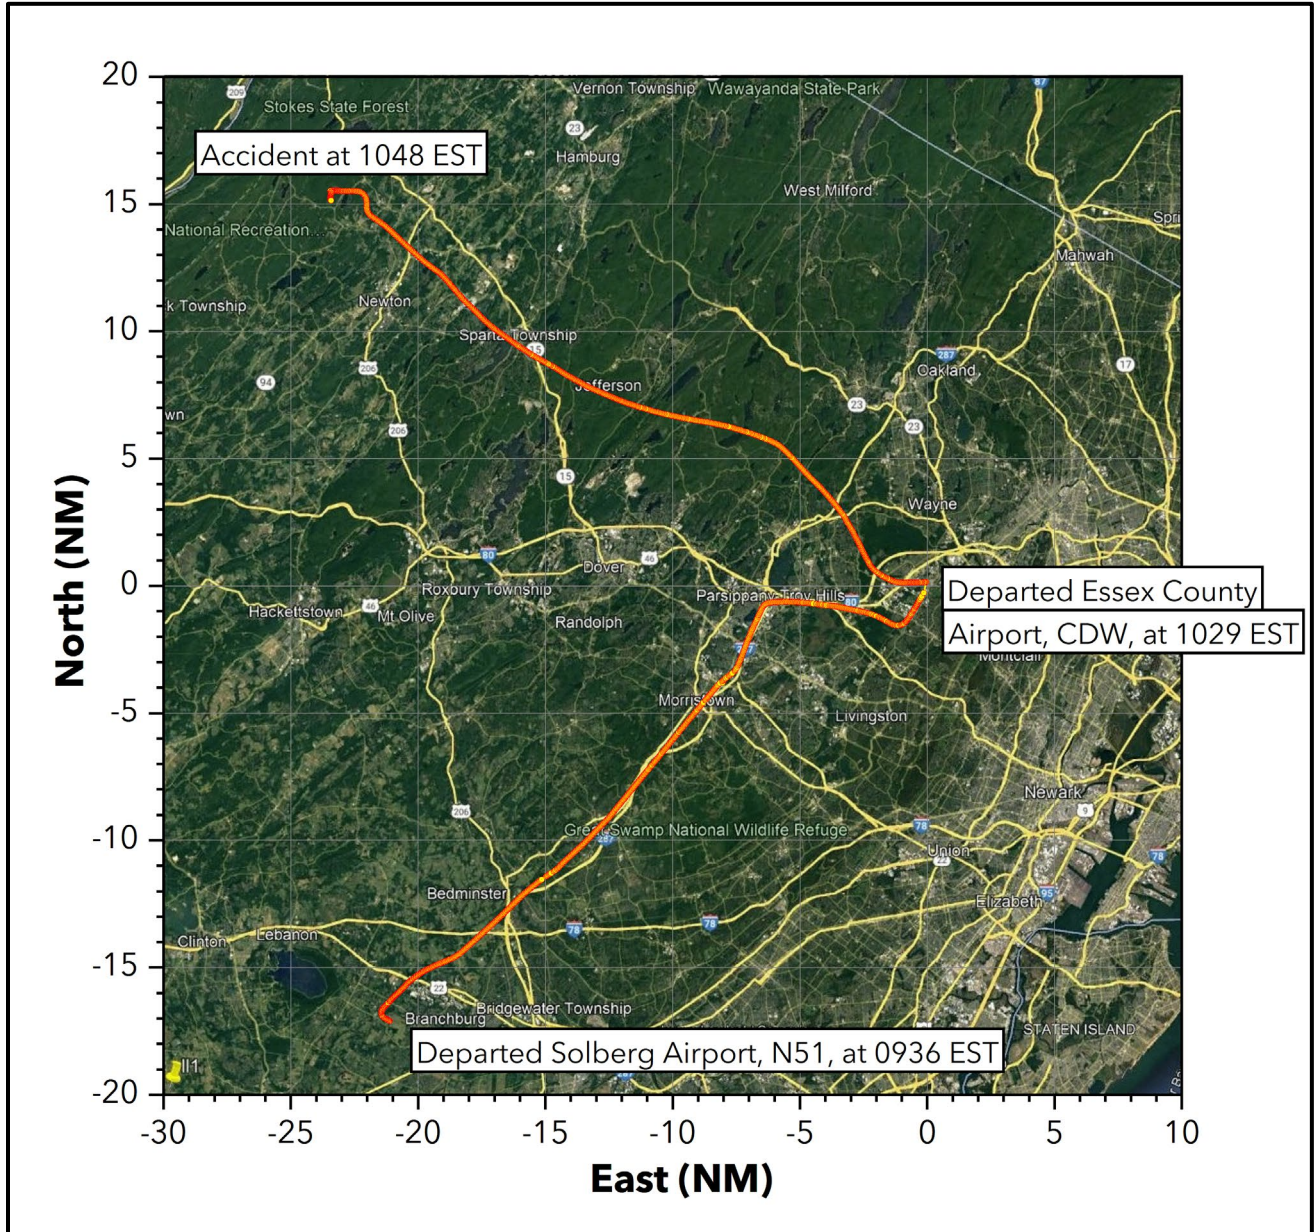
The airplane departed Essex County Airport (CDW), Caldwell, New Jersey, about 1029 and flew predominately in a northwesterly direction as it climbed. See Figure 1. The airplane reached an altitude of about 6,400 ft mean sea level (msl), before entering a steep descending left turn that continued until impact.

Figure 1: The Instructional Flight Departed Solberg Airport with a Stop at Essex County Airport. The Accident Happened After Leaving Essex County.
