# National Transportation Safety Board

ERA22FA399

## **VEHICLE PERFORMANCE**

Location: Bay City, Wisconsin  
Date: September 6, 2022  
Time: 1325 CDT  
1825 GMT  
Airplane: Experimental Glasair Super II SFT, N11HC

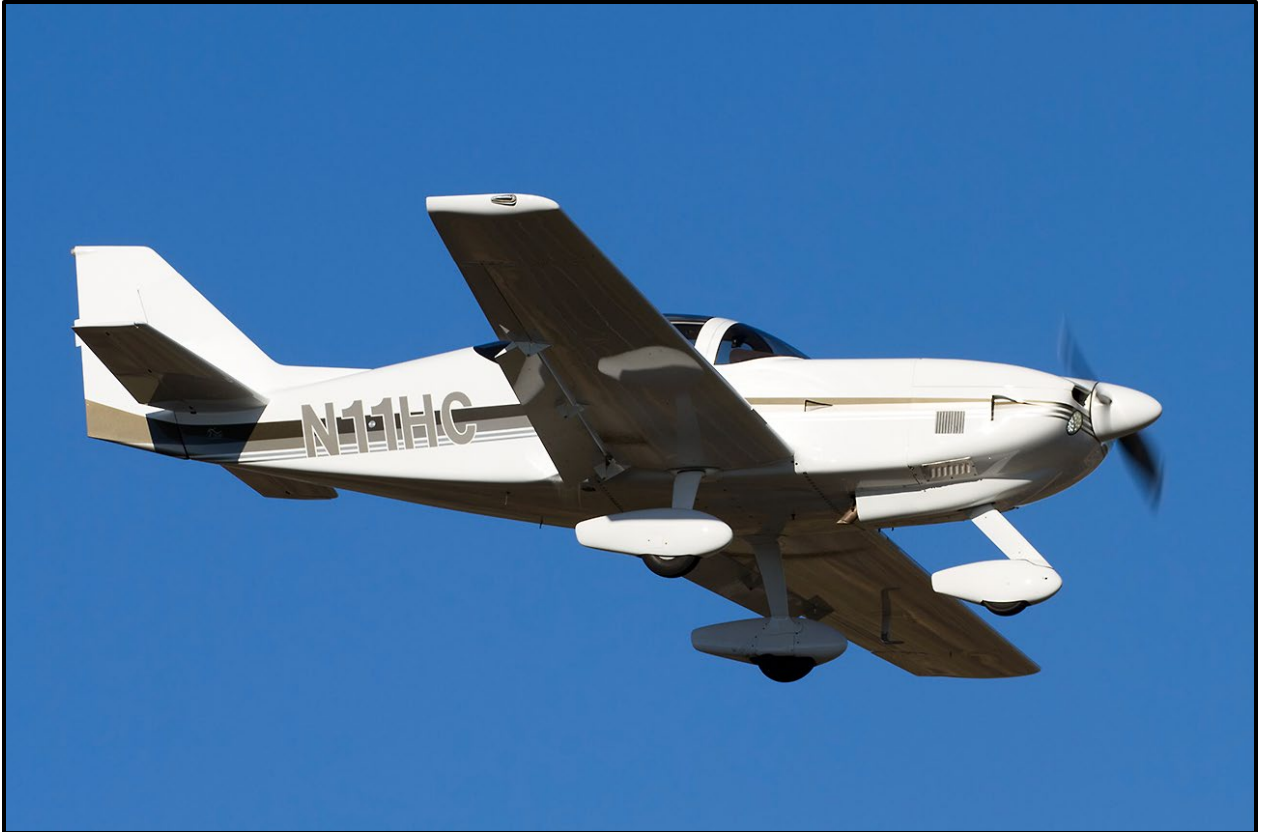
A picture of the accident airplane, an Experimental Glasair Super II SFT, is shown in Figure 2. The kit airplane was built in 2012 and is registered to Philip J. Conway.

**Figure 2: Accident Airplane, N11HC, an Experimental Glasair Super II SFT**
