Aircraft Accident/Incident Report No.: 221018

NTSB File No.: ERA23FA024

Aircraft: Beechcraft King Air E90

PROPELLER TEARDOWN EXAM – FACTUAL INFORMATION

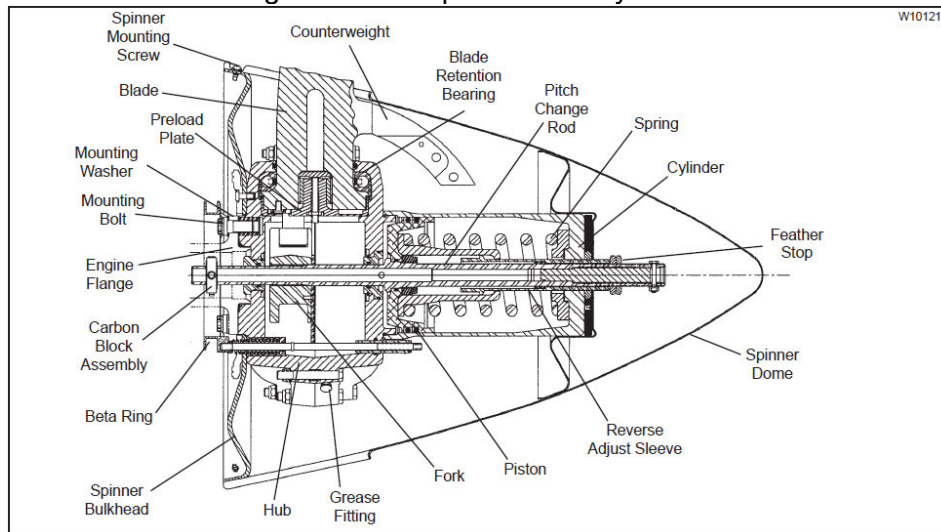
Figure #1 – Propeller cutaway sketch

General Comments: The propellers examined were 93” diameter, 4-blade, single-acting, hydraulically operated constant speed model with feathering and reverse pitch capability. Oil pressure from the propeller governor is used to move the blades to the low pitch (blade angle) direction. A feathering spring and blade counterweight forces are used to move the blades to the high pitch/feather direction in the absence of governor oil pressure. The propeller incorporates a Beta mechanism that actuates when blade angles are lower than the flight idle position. The propeller utilizes an aluminum hub with aluminum blades. Rotation is clockwise as viewed from the rear. A cutaway sketch is shown in Figure 1. The propellers were installed on the aircraft via Raisbeck Supplemental Type Certificate SA3593NM.

Reverse:	-9.0 ± 0.5	degrees
Beta Pick-up:	20.1 ± 0.1	degrees
Flight Idle:	See SA3593NM	
Feather:	84.5 ± 0.5	degrees
