ERA23FA024

## **AUTOMATIC DEPENDENT SURVEILLANCE- BROADCAST (ADS-B) STUDY**

Aircraft Performance Study

Location: Marietta, Ohio  
Date: October 18, 2022  
Time: 0709 eastern daylight time (EDT)  
1109 UTC  
Airplane: Beech E-90, N515GK

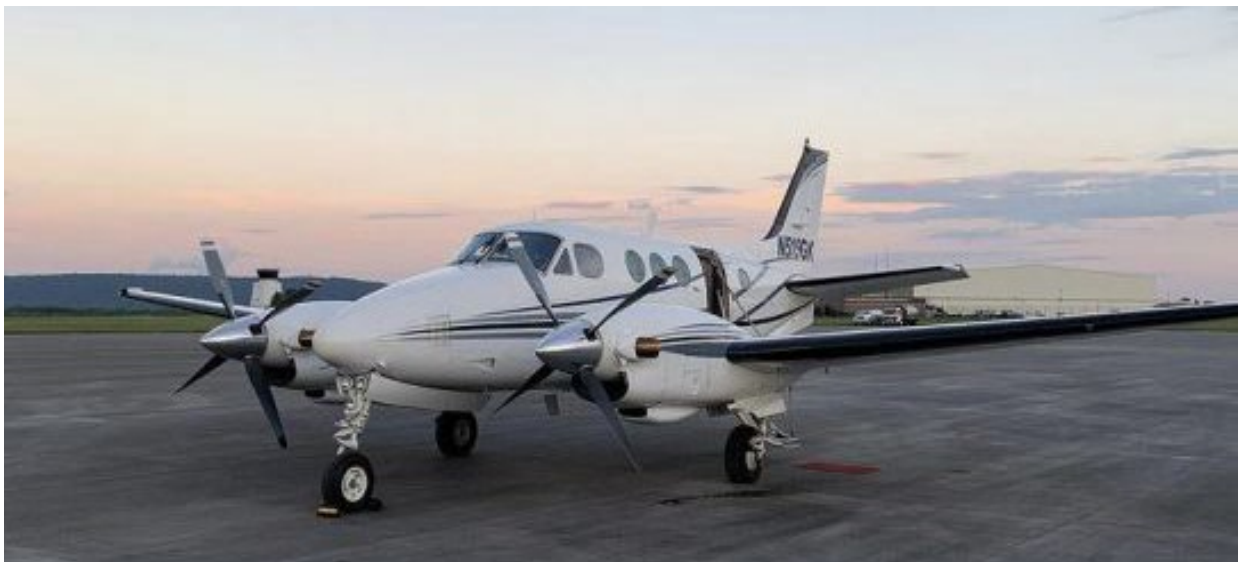
**Figure 1.** Accident airplane, N515GK.

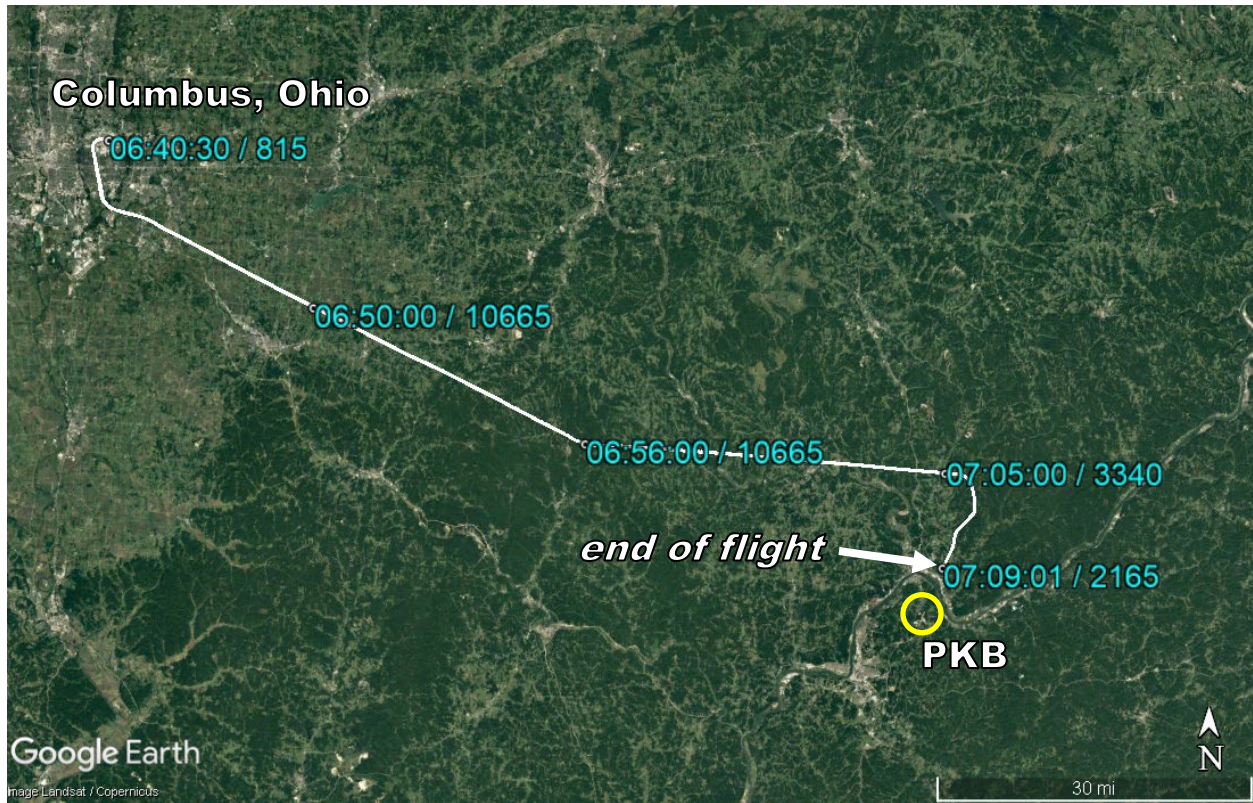
The flight took off from John Glenn Columbus International Airport (CMH), Columbus, Ohio about 06:40 and was enroute to Mid-Ohio Valley Regional Airport (PKB), Parkersburg, West Virginia (Figure 2). The airplane climbed to 10,600 ft msl (pressure altitude of 11,000 ft) by 06:50 (Figure 3). It continued at this altitude until 06:57 when it began to descend.

**Figure 2.** Airplane flight path with selected times and altitudes annotated. The destination airport is circled in yellow.
