Date: 15 June 2024

ERA23FA174 Tamarack Aerospace Party Submission

Cessna 525B Structural Departure Near KTPA

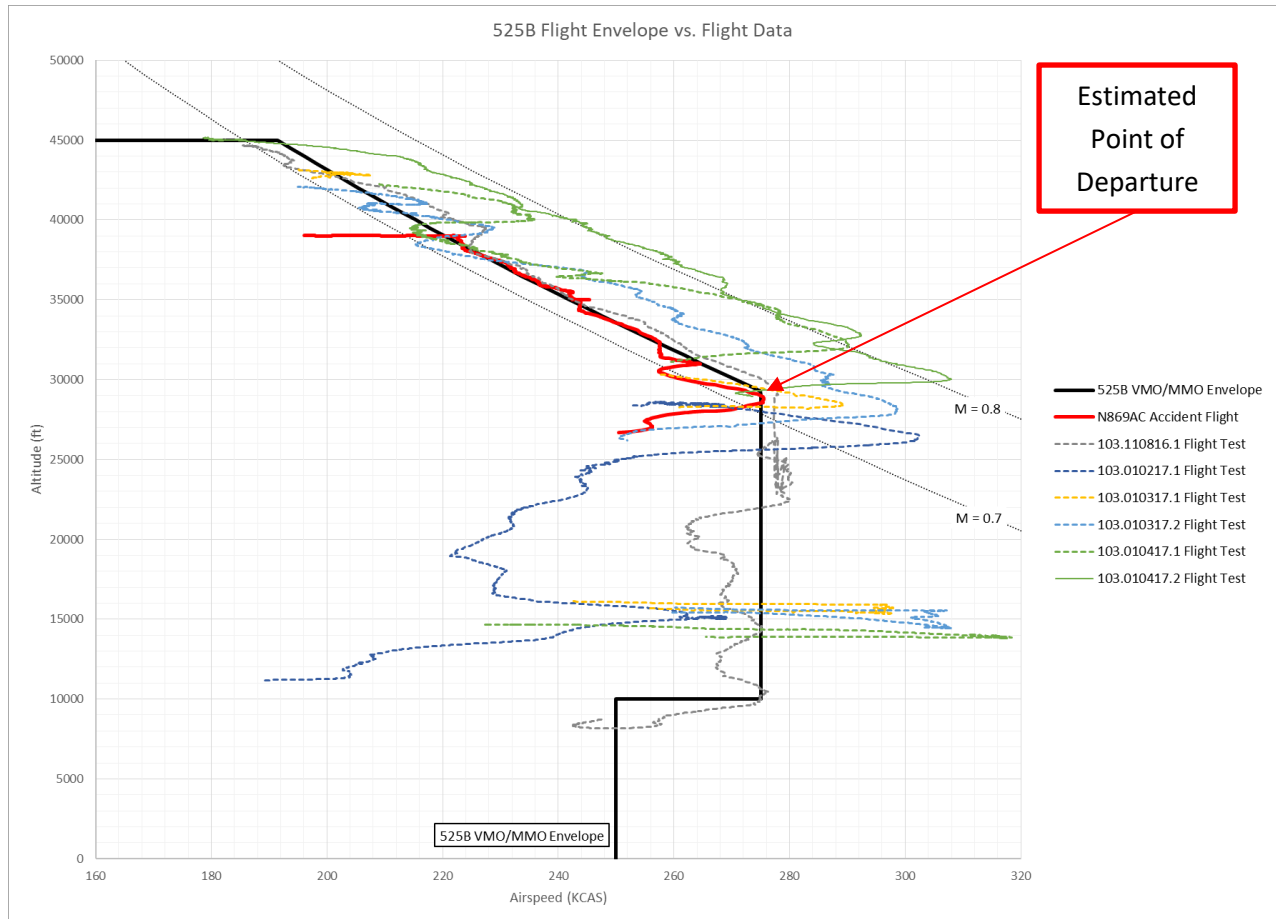
Figure 2-1 Accident flight and flight test comparison to flight envelope

A performance evaluation conducted by the NTSB found that the airplane was descending at approximately 5,300 feet per minute at the point of separation, between approximately 29,000 feet and 30,000 feet above sea level (between FL290 and FL300). The descent rate appeared to be related to altitude requirements at intersection OGGER, which is part of the TYNEE TWO arrival procedure for Fort Myers airport. The airspeed during the descent appeared to be close to VMO/MMO throughout, peaking

at approximately 276 KCAS at the estimated point of departure of the LH wing extension and winglet. A trace of the airplane’s airspeed at various altitudes is presented below. Note that the accident flight is in red. Other traces are visible in the figure below, corresponding to flight test data collected by Tamarack during the certification flight test program for ATLAS installations on the 525B.

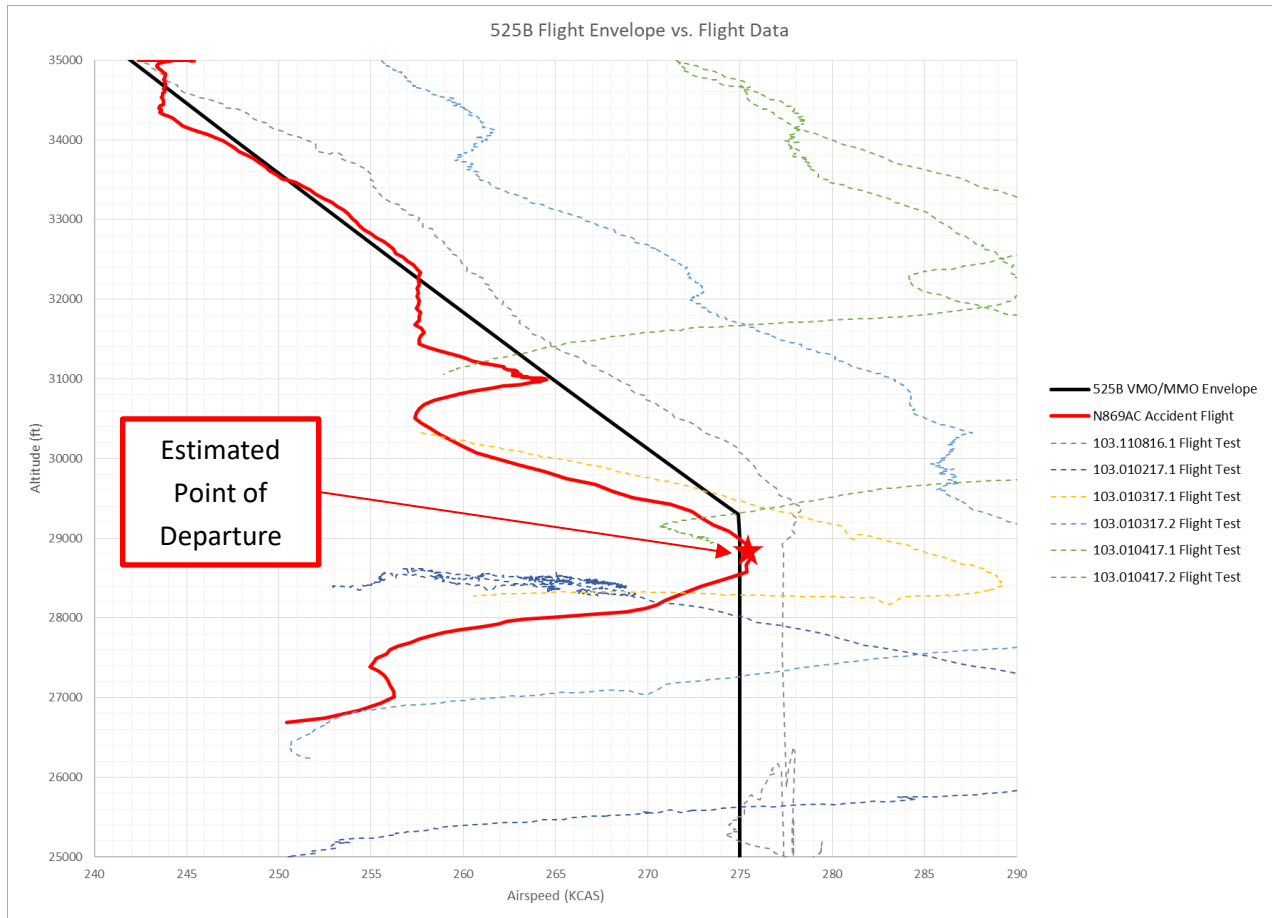
Figure 2-2 Accident flight and flight test comparison, detail at envelope knee

Tamarack notes that at approximately FL300, the flight envelope transitions from VMO (speed) to MMO (Mach number) as the speed limit for the airframe. This point is called the “knee” altitude, and represents the highest simultaneous Mach and dynamic pressure that the airframe can experience in flight. A detail view is presented below, showing the same flight data but scaled to focus on the knee region.

In the figure above, the accident flight is represented by a solid red line, while Tamarack flight test data is represented by dashed lines of different colors. Tamarack notes that VMO for the 525B is 275 KCAS, and the accident flight appears to have peaked at 276 KCAS. Tamarack also notes that certification authorities required flight testing at speeds well in excess of the VMO/MMO envelope as part of the approved flutter flight test program. Furthermore, structural analysis of the 525B ATLAS installation developed aerodynamic loads based in part on speeds above VMO/MMO at the knee altitude, ensuring that the analysis fully envelopes the most severe conditions encountered in service. While these high speeds are explicitly not permissible for flights in normal operation, the flight test data demonstrates that the airplane has been thoroughly tested in conditions more severe than the accident flight and that the flight condition alone was not a contributing factor in the separation of wing extension and winglet structure.
