National Transportation Safety Board

HWY24MH001

VEHICLE FACTORS

Group Chair's Factual Report

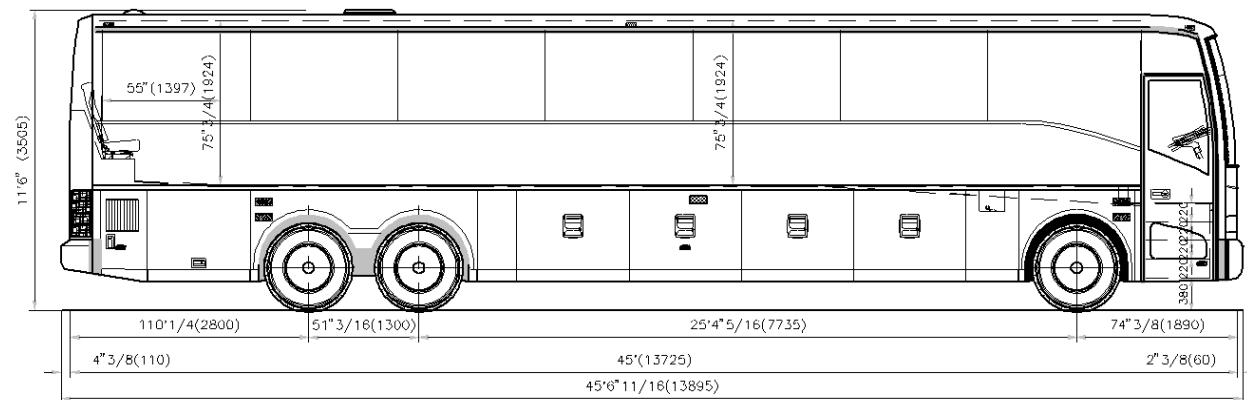
Figure 5 - Motorcoach Length, Width, and Height Measurements.

As shown in **Figure 5**, the length of the motorcoach was 45-feet 6-inches, and the height was 11-feet 6-inches. There were no axle or overall vehicle weights obtained. The vehicle was transporting 55 passengers and a driver.
