NATIONAL TRANSPORTATION SAFETY BOARD
Investigative Hearing

Norfolk Southern Railway general merchandise freight train 32N
derailment with subsequent hazardous material release and fires,
in East Palestine, Ohio, on February 3, 2023

GROUP	E
EXHIBIT	
3

MECHANISTIC ASPECTS OF BEARING BURN-OFF

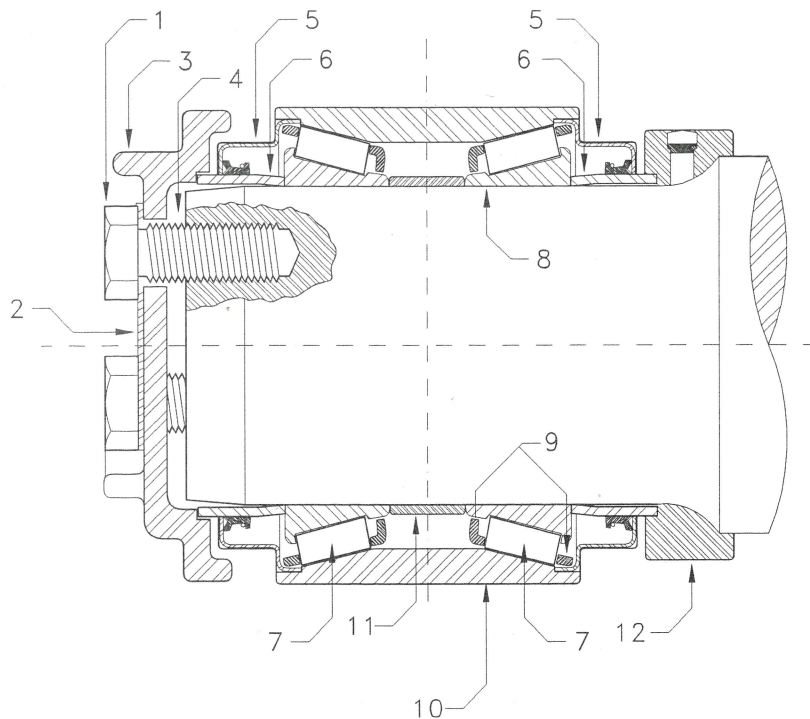
FIGURE 1 SECTION VIEW OF A TAPERED ROLLER BEARING SHOWING LOCATION AND ORIENTATION OF CRITICAL COMPONENTS.

1. Cap Screws
2. Locking Plate
3. End Cap
4. Cap Screw Seal Rings
5. Seal
6. Seal Wear Rings
7. Roller
8. Cone
9. Cage
10. Cup
11. Spacer
12. Backing Ring
