Survivability Notes

I. ACCIDENT INFORMATION:

NTSB ID: CEN19FA185
Location: Brainerd, MN
Aircraft: Agusta A109S
Tail number: N11NM
Accident date: June 28, 2019 0041 CDT
Injuries: 2 fatal (Pilot/ Passenger), 1 serious (Passenger)

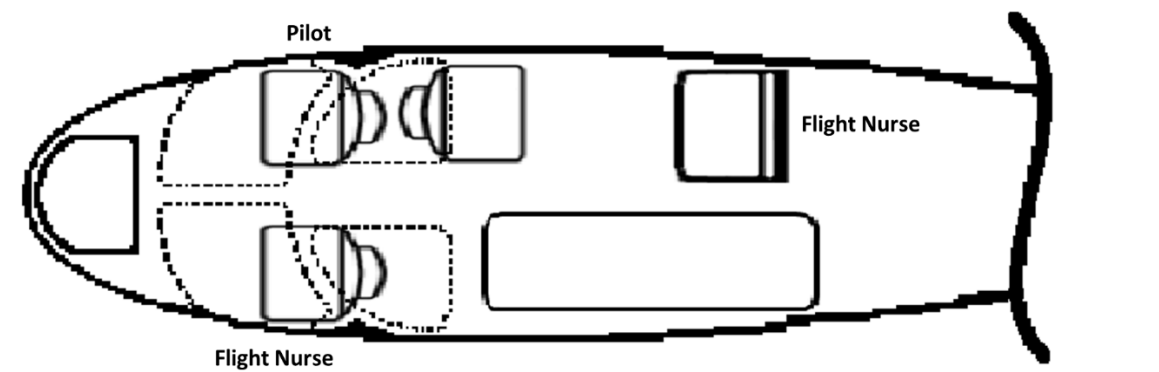
Figure 1 – Helicopter Seat Configuration

There were three occupants inside of the helicopter at the time of the accident. A pilot, located in the in the front right seat, passenger located in the front left seat, and a passenger in the aft right seat in the aircraft.

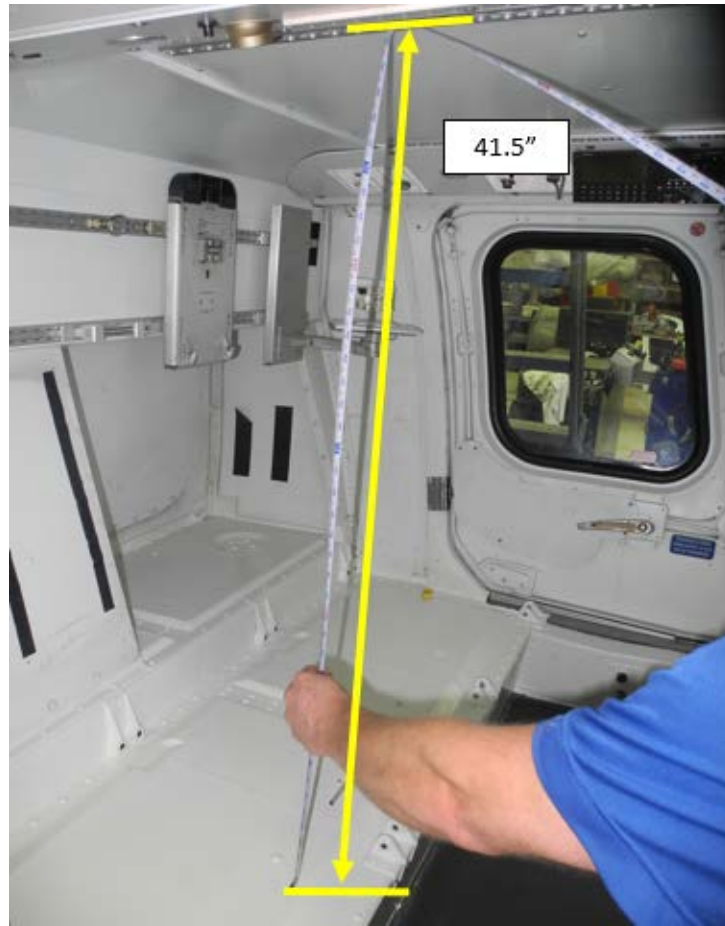
Photograph 9 - Distance From Top of Inegrated Boxed Structure to Ceiling

While at the scene the investigative team was able to take measurements of an exemplar with a similar configuration.
