2020-05-20, 0937L, N612R FLIPPED OVER ON TAKEOFF AFTER LAUNCHING FROM SURFSIDE SEA BASE, LINO LAKES, MN WX VFR, WINDS 120/09 PERHAPS UP TO 13KTS

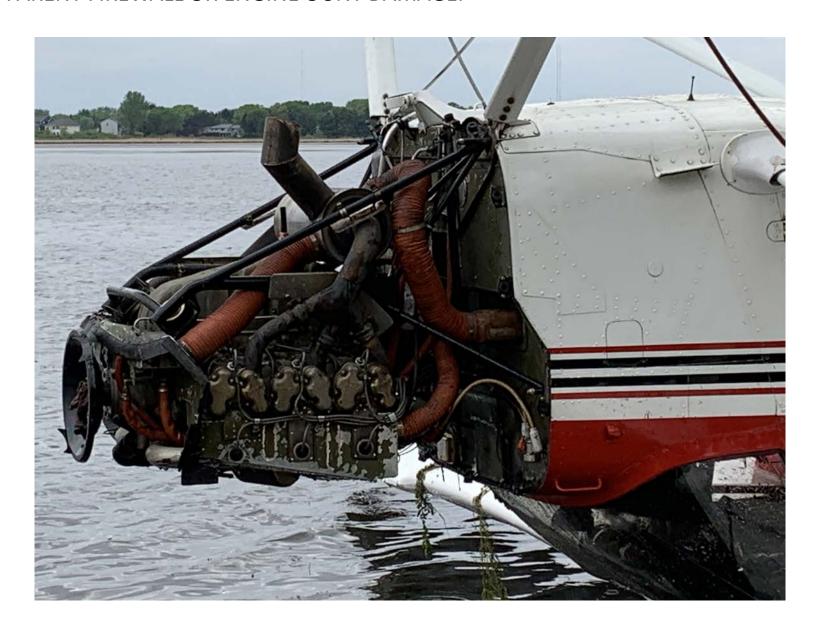
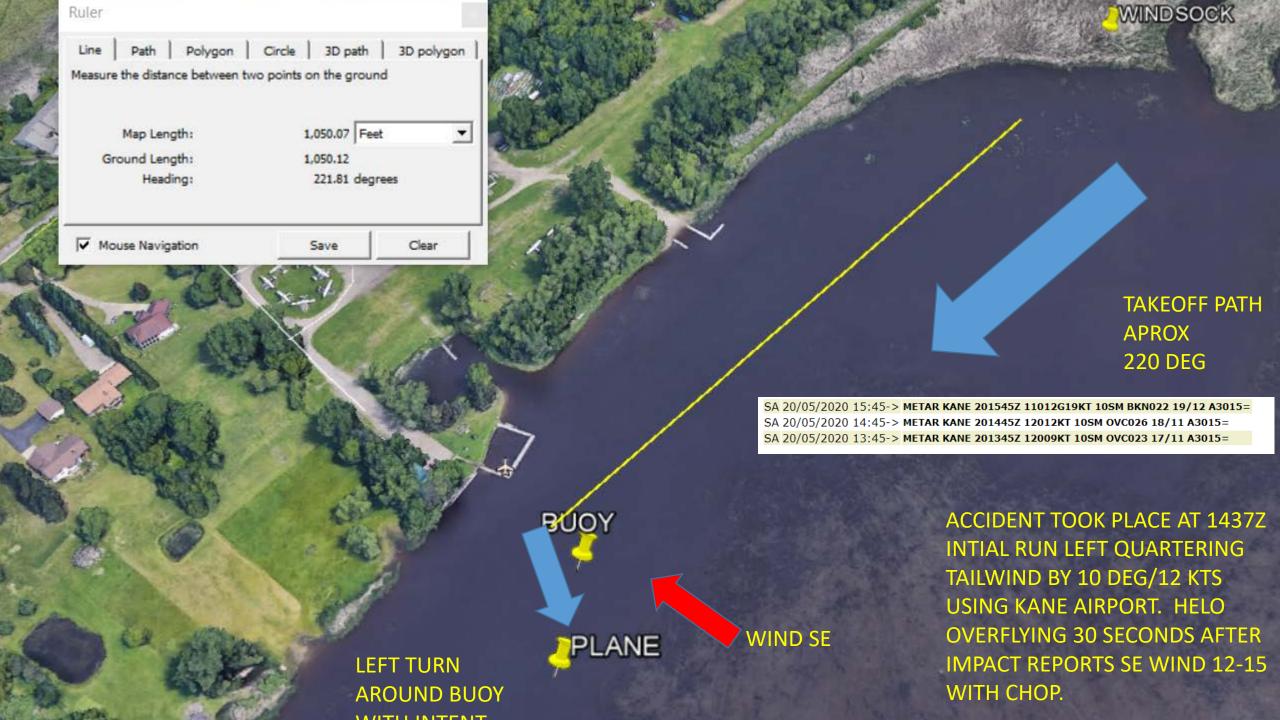
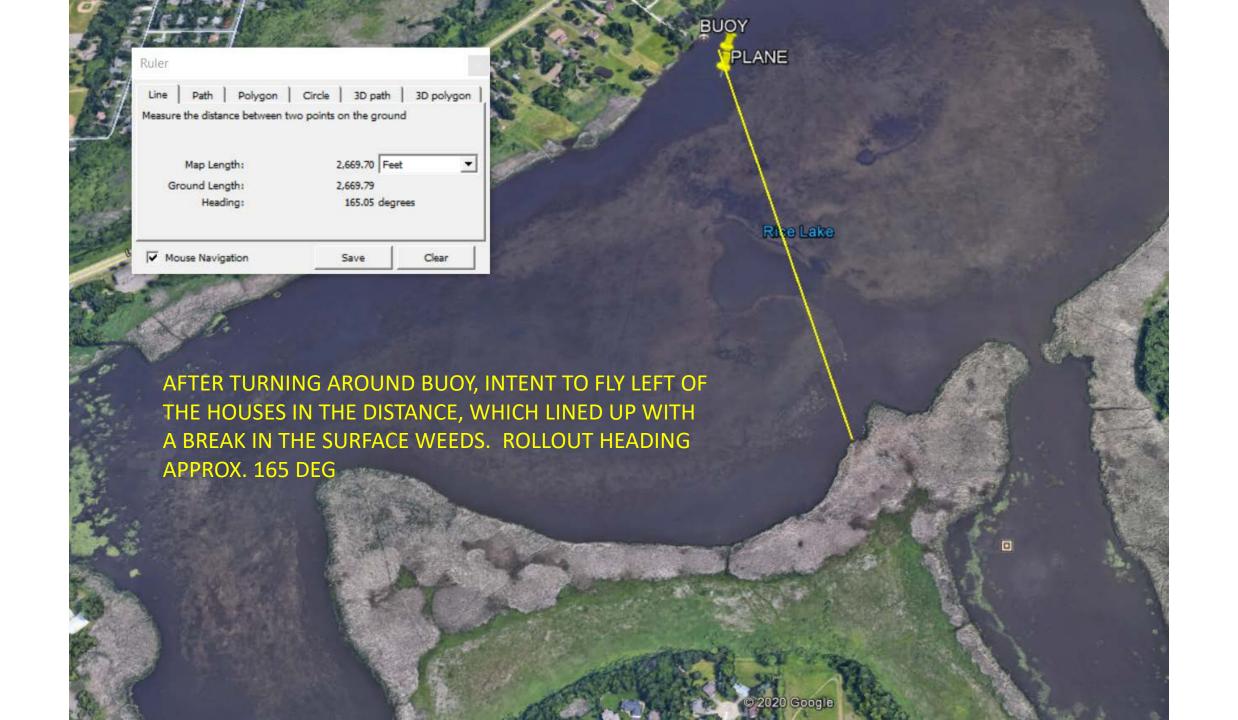
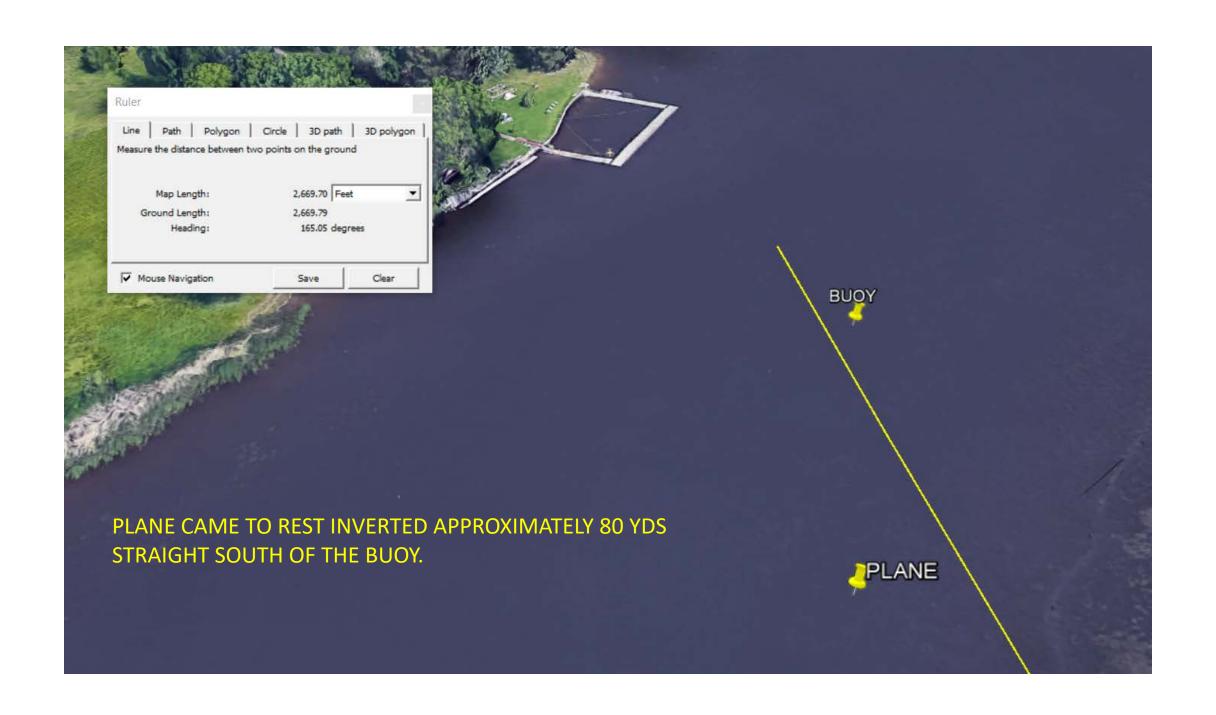
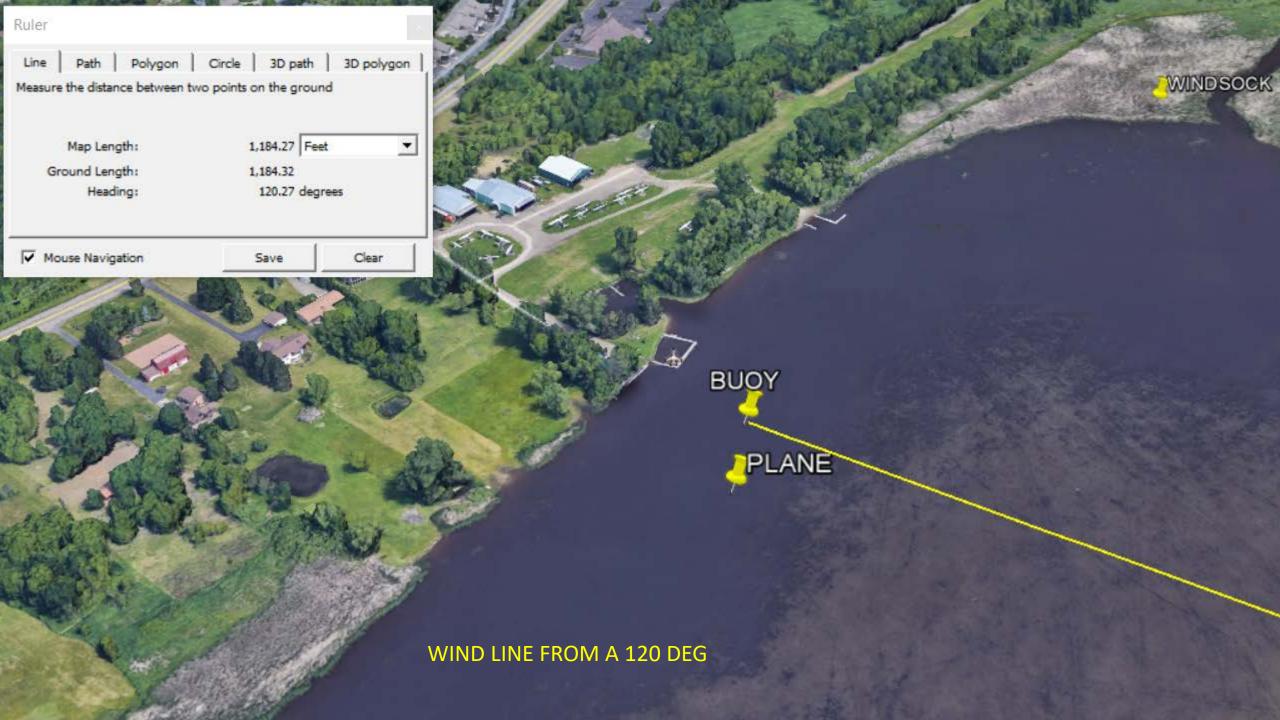
SUSPECT; WITH A SLIGHT QUARTERING TAILWIND FROM THE LEFT, WHILE MAKING A LEFT TURN THERE ARE CENTRIFIGUL FORCES ACTING TO THE OUTSIDE OF THE TURN (TO THE RIGHT), AND AT SOME POINT THE LEFT QUARTERING TAILWIND DOES BECOME A DIRECT LEFT CROSSWIND AMPLIFYING THE EFFECT OF A FORCE TO LIFT THE LEFT WING.

POTENTIALLY A GUST MAY HAVE BEEN PRESENT AS WELL.

PILOT AT CONTROLS REPORTS; A FORWARD RIGHT DIRECTION OF TRAVEL AS THE FRONT OF THE RIGHT FLOAT SINKS DOWN IN THE WATER.
