## **TEXAS EASTERN TRANSMISSION, LP**

### **MAY 4, 2020 FLEMING COUNTY INCIDENT GEOTECHNICAL CAUSATION REPORT**

PROJECT NO.: 1607024  
DOCUMENT NO.: Rev A

DATE: April 26, 2021

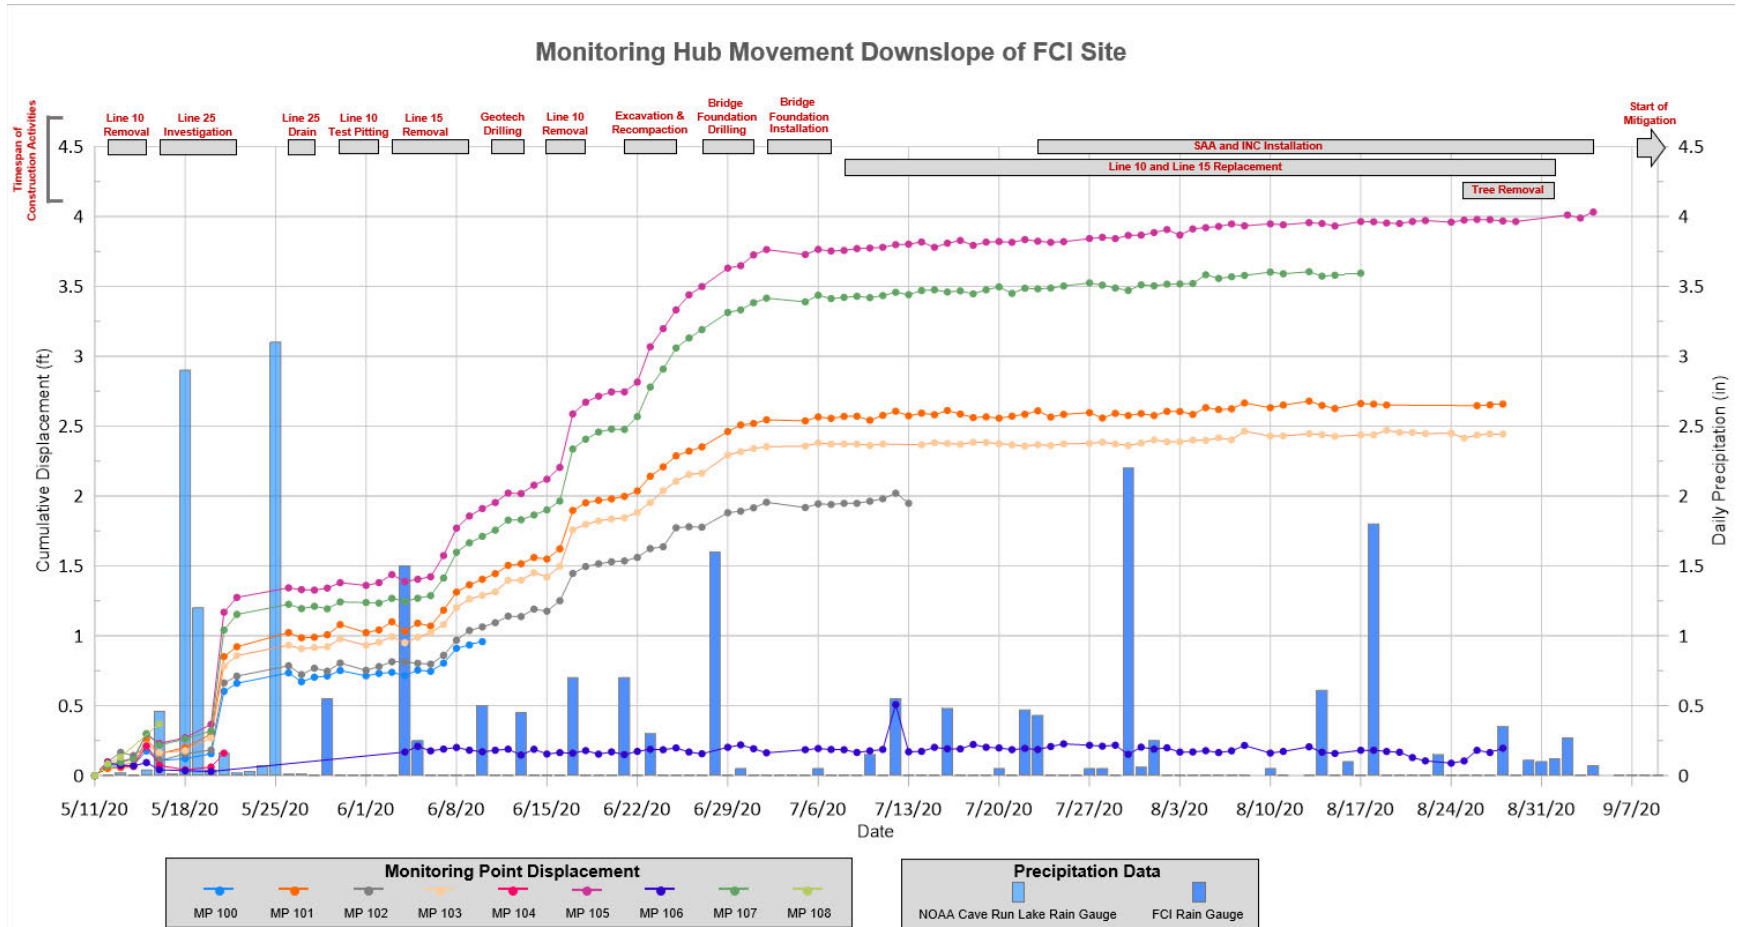
1.95 and 4.03 ft between May 12 and September 8, 2020. This movement occurred in distinct episodes, with the greatest movement of approximately 0.8 ft occurring within two days following a precipitation event when 4 inches of rain fell within a 48-hour period (see Figure 3-4).

**Figure 3-4. Cumulative displacement plot of downslope landslide monitoring hubs at FCI site between installation on May 11, 2020 and September 8, 2020. 24-hour period rainfall amounts and construction activities are also shown. Survey data provide by SGC. Rainfall data obtained from the Cave Run rain gauge (National Oceanic and Atmospheric Administration, 2020A) and FCI rain gauge data provided by WSP.**

number and size of cracks within the landslide mass. The influence of post-incident precipitation on ground movement rates at the Site is illustrated in the monitoring hub data shown in Figure 3-4.

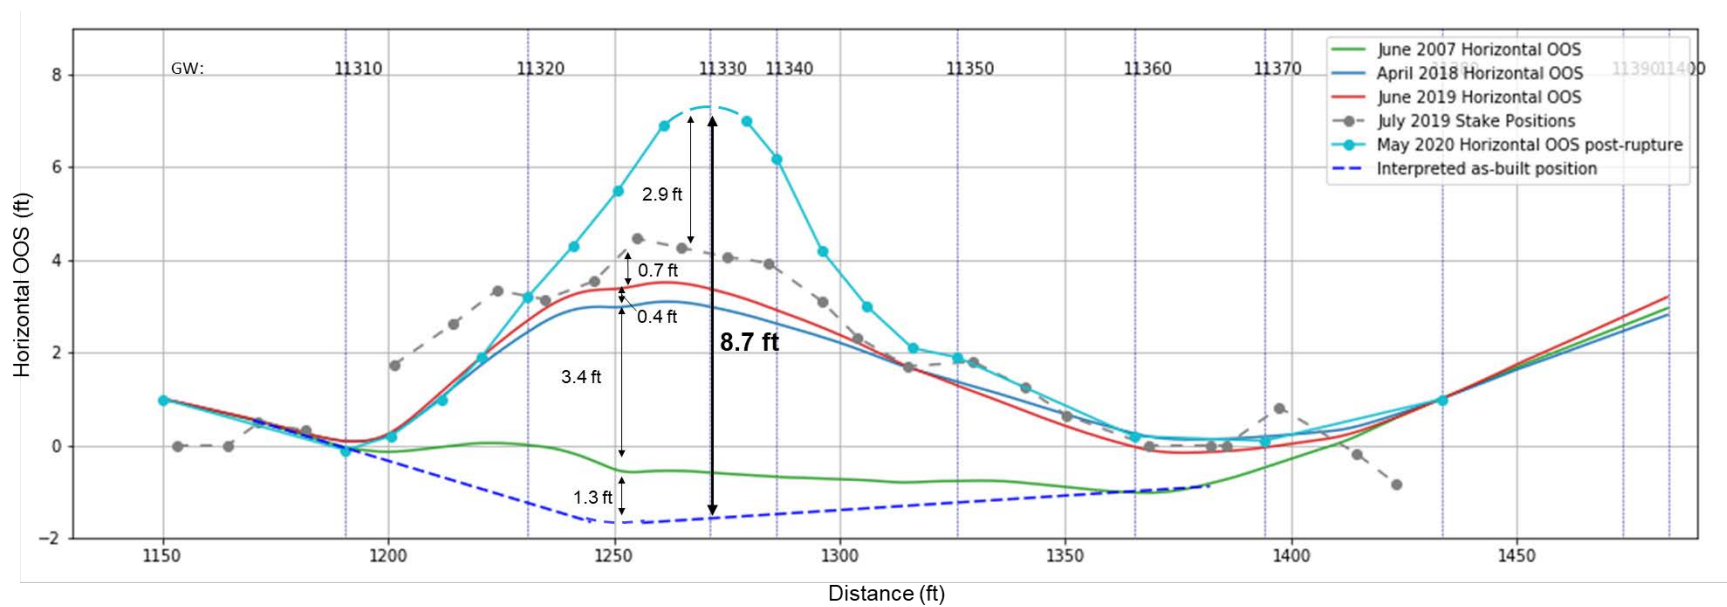
**Figure 3-7. Overlaid horizontal OOS datasets from IMU, focused to the affected length of Line 10. The as-built position was interpolated by considering the 2007 pipeline position and rolled bends. A total of 5.1 ft OOS is estimated as of June 2019.**

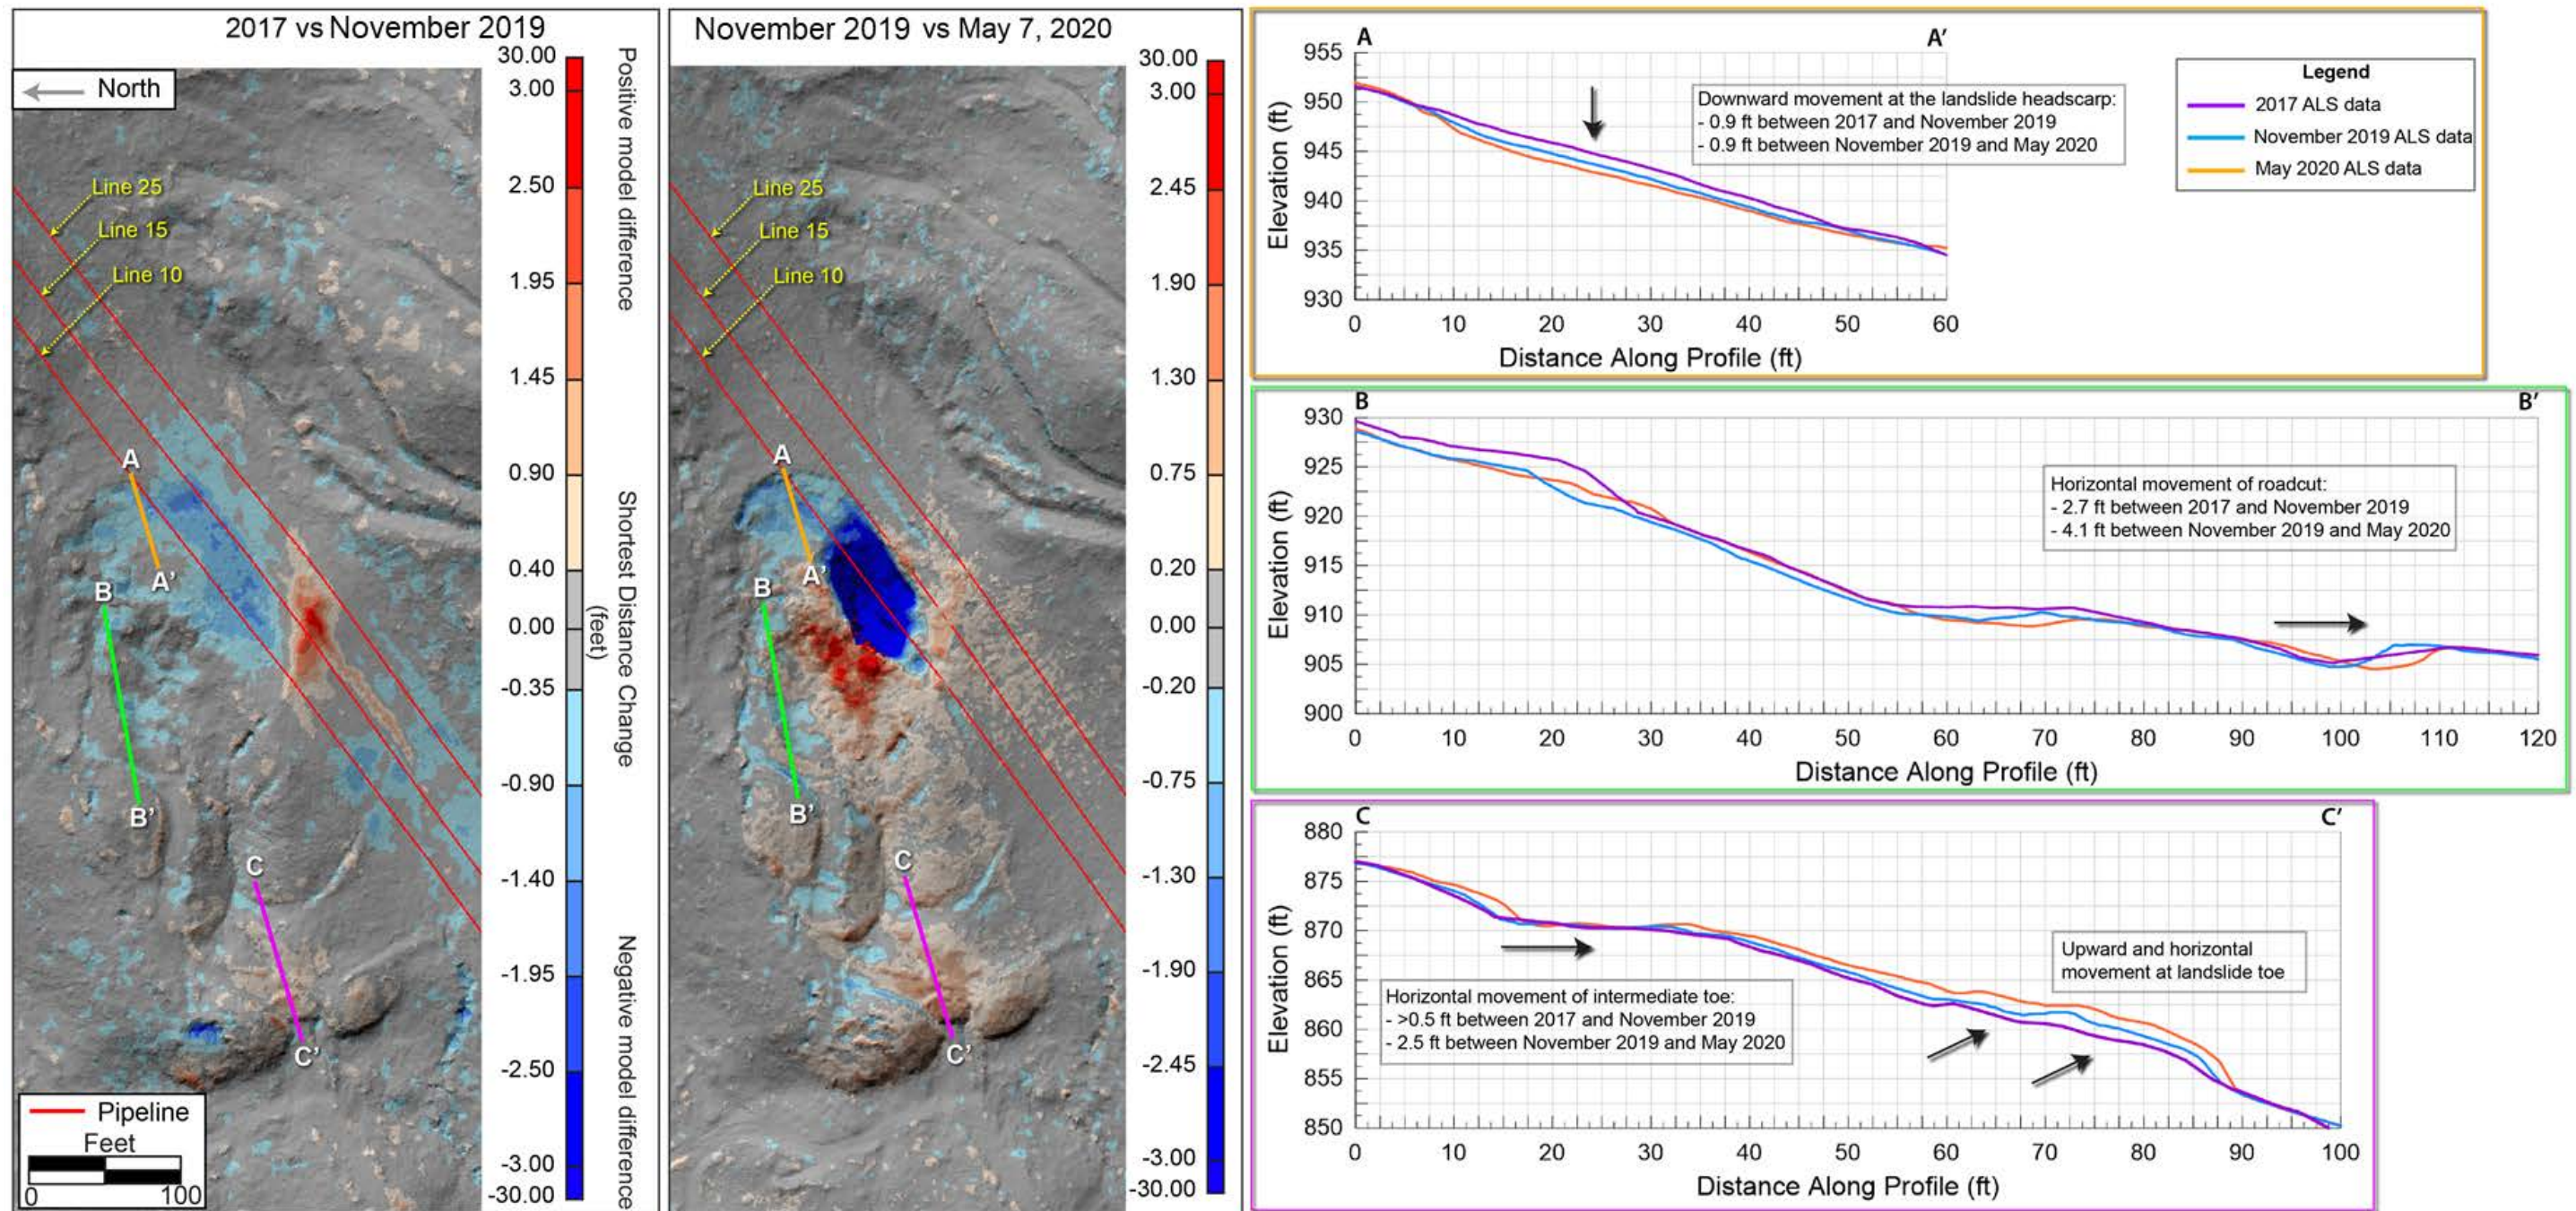
Figure 3-9. Assessment of LCD between 2017 vs November 2019 and November 2019 vs May 2020 in the vicinity of the blast crater. Profiles through key locations all indicate an acceleration in the velocity of the landslide movement between November 2019 and May 2020 compared to previous years at the Site.

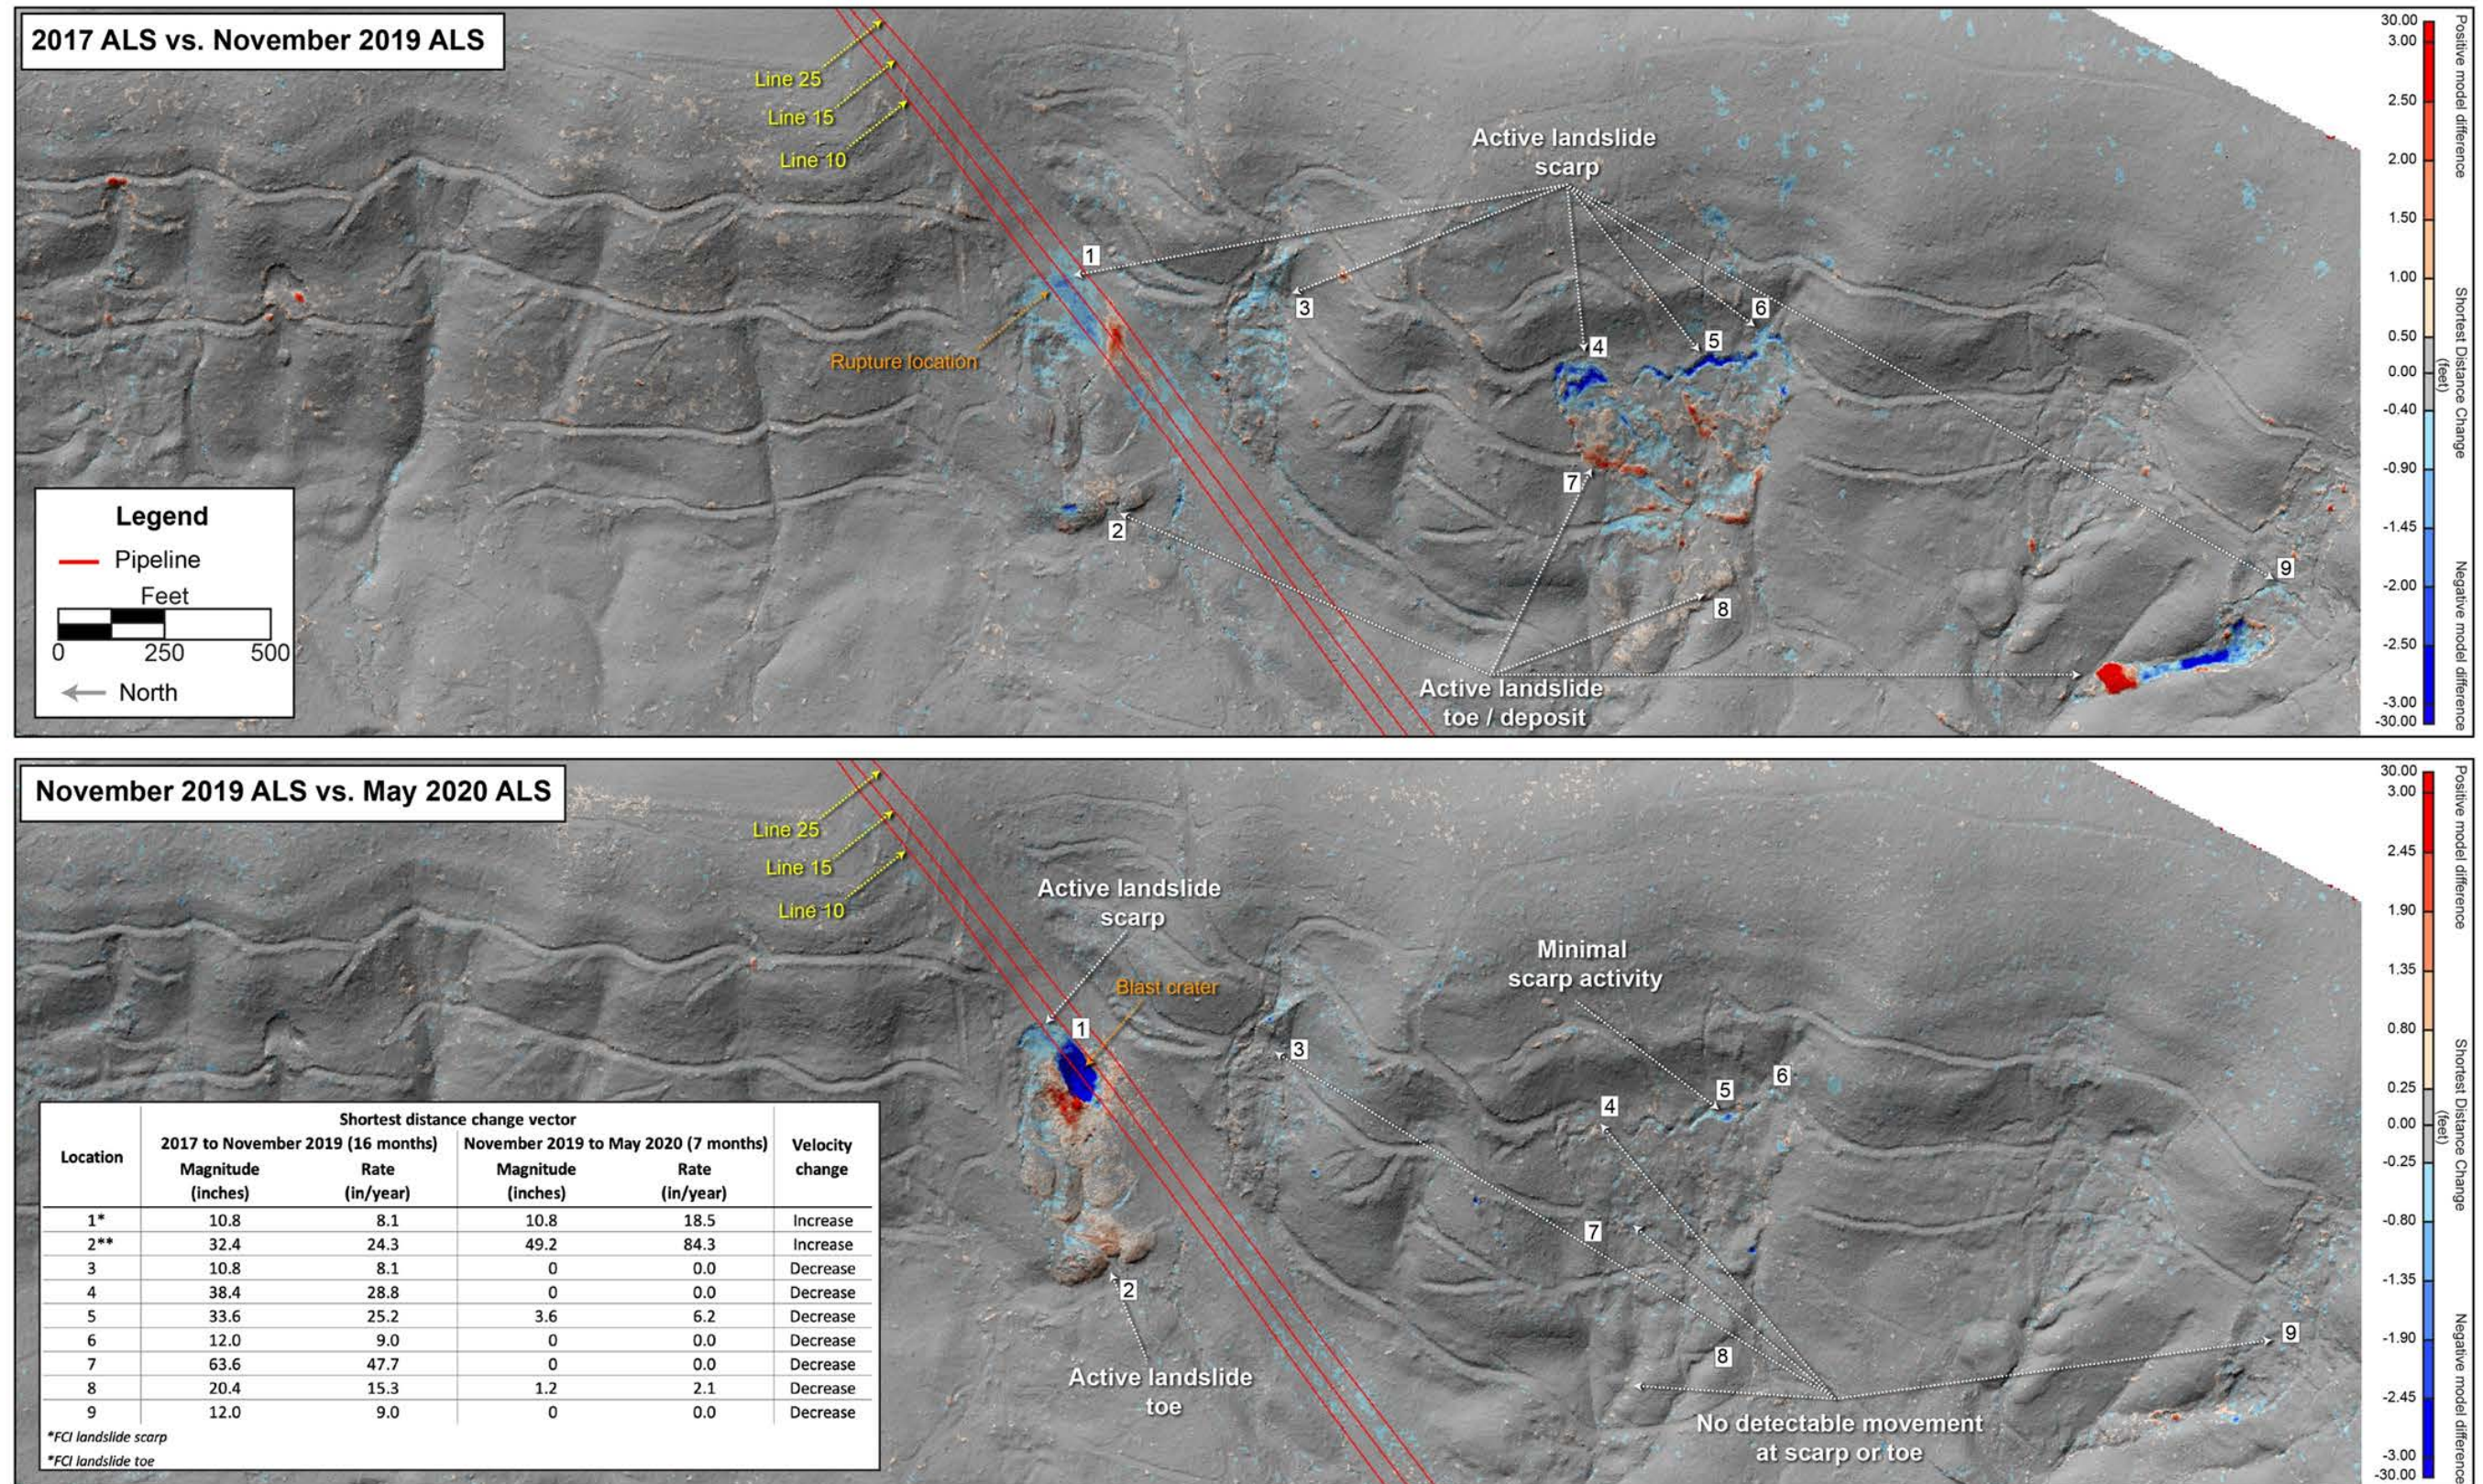
Figure 3-10. Assessment of landslide velocity between 2017 vs November 2019 (upper image) and November 2019 vs May 2020 (lower image) in the vicinity of the Site.

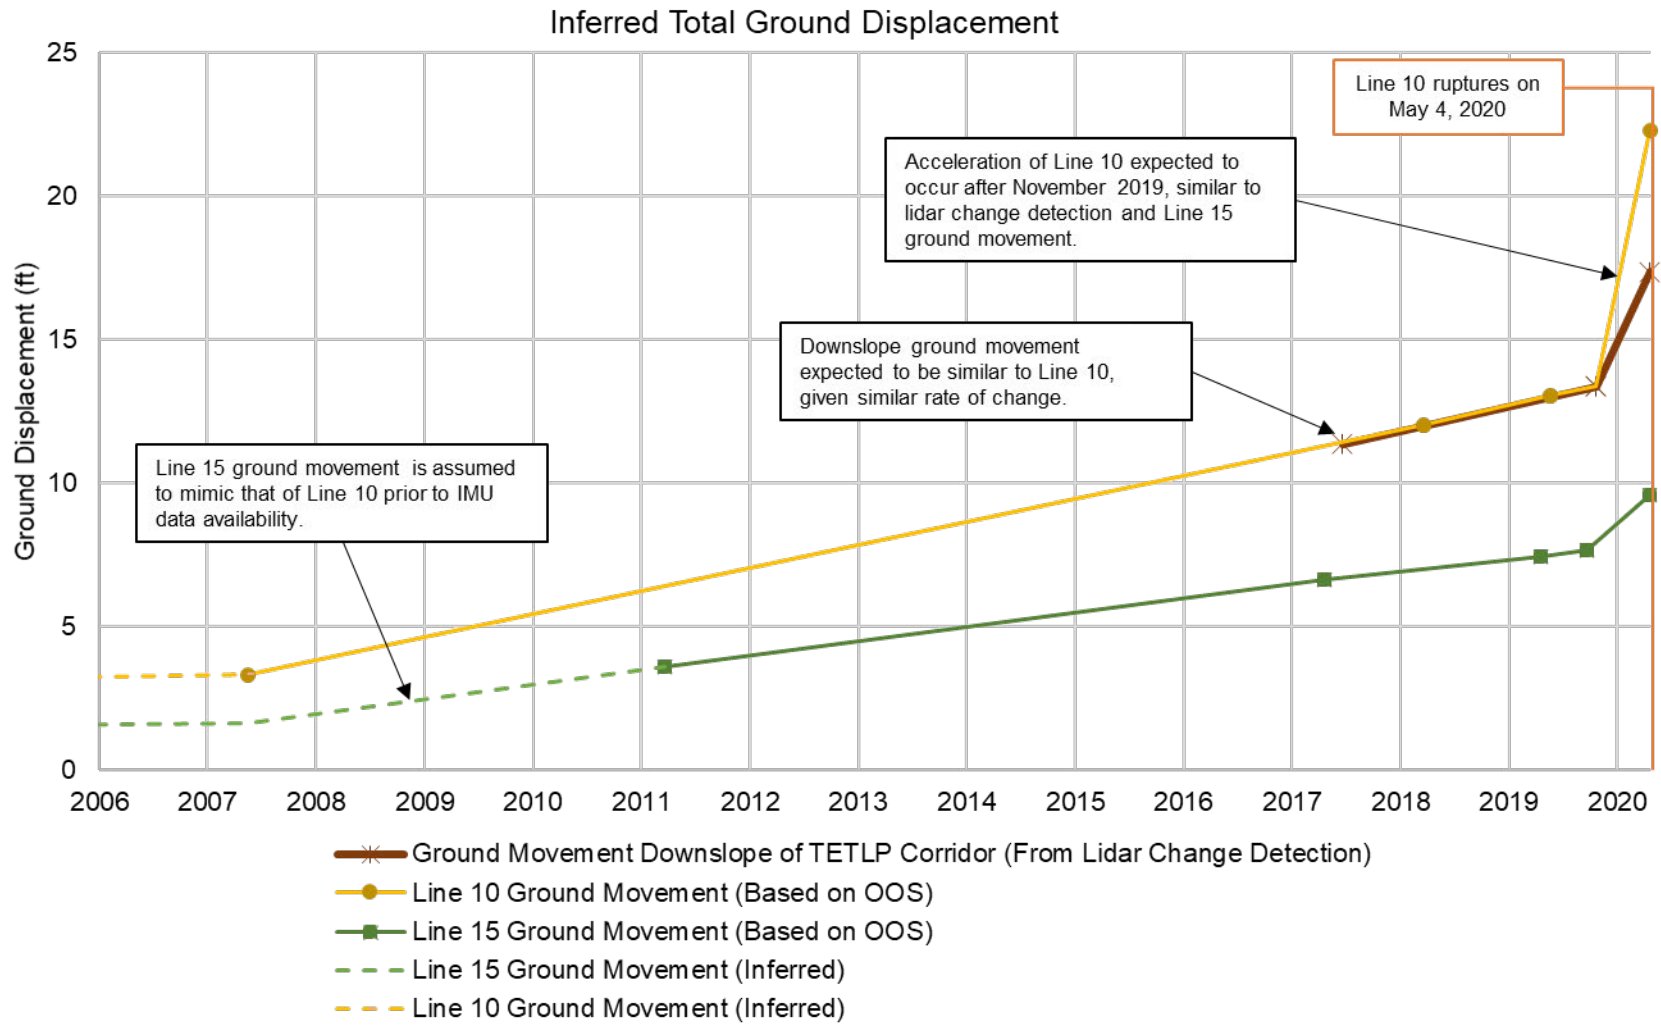
Lidar change detection, pipeline OOS measurements and detailed field mapping confirmed that the landslide had been active since the initial June 2007 Line 10 ILI tool run with some level of ground movement predating the tool run. Figure 4-1 shows the amount of ground movement before the FCI inferred from OOS measurements on Lines 10 and 15 as well as the lidar change detection while Figure 4-2 shows the calculated movement rates. From these plots, it is evident that prior to 2007, both Lines 10 and 15 had experienced some amount of slope movement. The plots show a movement rate that assumes an average rate of around 0.75 inches/yr on Line 10 and 0.36 inches/yr on Line 15 between June 2007 and the year the pipelines were originally installed (Line 10 in 1952 and Line 15 in 1957). Following 2007, the average ground movement rates increased and maintained a fairly consistent rate of movement up until November of 2019. In general, average movement rates for this period were between 10 and 11 inches/yr on Line 10 and in the slide mass downslope of the TETLP corridor and between 3.6 and 7 inches/yr on Line 15. As evident in the Line 10 OOS (June 2019 and May 2020), the Line 15 OOS (October 2019 and May 2020) and lidar change detection data (November 2019 and May 2020), ground movement rates increased sometime between June 2019 and the May 2020 FCI. The Line 15 OOS and lidar change detection results indicate this acceleration occurred sometime between November 2019 and May 2020. Assuming ground movement rates accelerated in November 2019, the movement rate between November 2019 and May 2020 was 17.9 ft/yr on Line 10 and 2.1 ft/yr on Line 15.

As can be seen in Figures 4-1 through 4-3, the total ground movement inferred from the OOS measurements on Lines 10 and 15 and the lidar change detection are not the same. One component of this is differing ground movement rates within the slide mass, as discussed above. While Line 15 was within the landslide mass, inferred ground movement rates were much less than in the location of Line 10, based on the OOS data, which is also supported by the lidar change detection results. The lidar change detection shows increased downslope movement along both Lines 10 and 15 between 2017 and November 2019, but the movement along Line 15 is less than along Line 10. This is likely due to Line 15 being further upslope than Line 10, in an area closer to the edge of the landslide mass, where the landslide was less active and less movement was occurring. Similarly, the difference in ground movement rates between Line 10 and the lidar change detection results may be due to different movement rates at Line 10 and the slide mass downslope off the TETLP corridor. This could have been due to the presence of additional seepage near Line 10 or differing thicknesses of colluvium beneath Line 10 and downslope of the TETLP corridor. Assuming that the overall volume of soil moving past any single point within the more active part of the landslide was the same, ground movement would be greater in areas where the landslide mass was thinner. Based on test pitting and drilling, the depth of the slide mass increased downslope of Line 10. This means that, assuming a similar volume of soil was moving along Line 10 and in the downslope landslide mass, slope movement rates along Line 10 would have been higher.

**Figure 4-1. Plot showing inferred ground movement at the FCI site based on IMU and field-based OOS measurements and lidar change detection.**

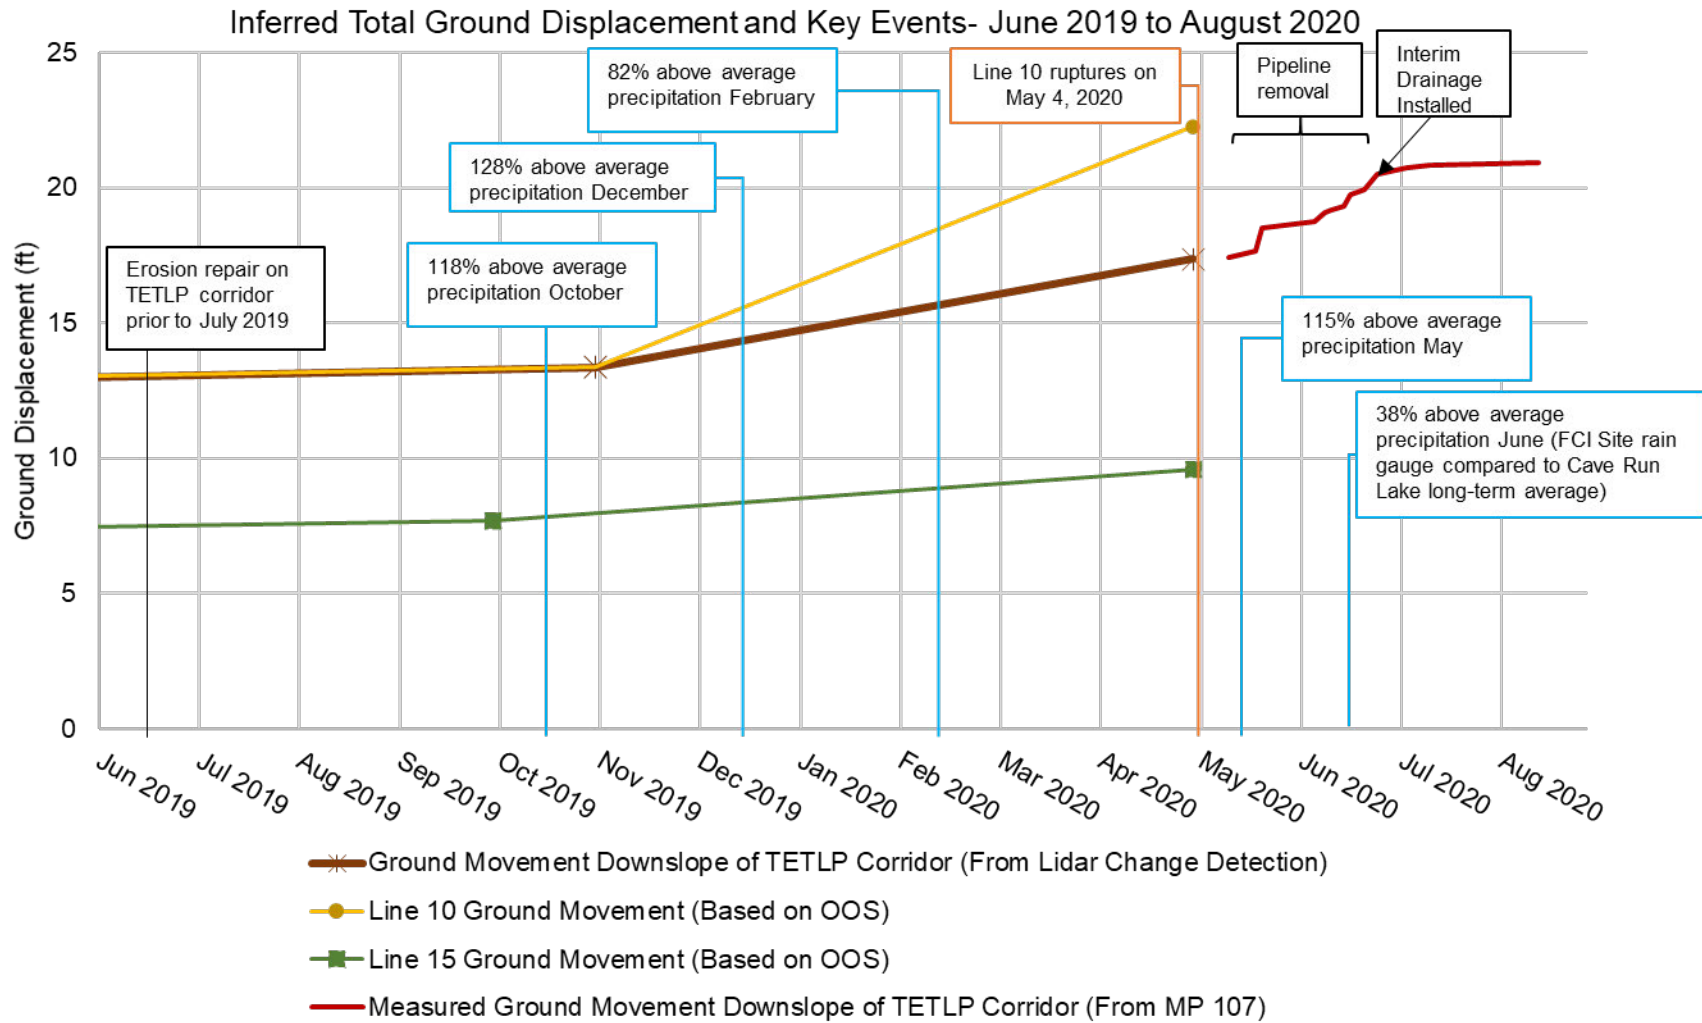
Between November 2019 and the May 4, 2020 FCI, the average ground movement rate increased over 20 times. Figure 4-5 provides a timeline of events and the inferred total ground displacement on Line 10 and 15 between June 2019 and the May 2020 FCI as well as ground displacement downslope of the TETLP corridor from survey monitoring hub data. Over this time period, two major factors likely contributed to the dramatic increase in ground displacement. The first, would be the high levels of precipitation over the fall and winter of 2019-2020. Starting in October 2019 above average precipitation fell on the Site. In the months of October 2019, December 2019, and February 2020, 118%, 128% and 82% above average rainfall fell in each month, respectively. This was greater than the amount of precipitation over similar time periods than in the previous two years (including 2018). The impact of this high level of precipitation on slope stability is greater than at other times of the year due to lower evaporation from less sunlight and minimal evapotranspiration allowing more surface runoff to infiltrate the soil. However, similar ground movement rates were not observed in lidar change detection at neighboring landslides on similar aspects. This indicates that the landslide movement and rapid acceleration that occurred during this time was driven by conditions unique to the Site.

**Figure 4-5. Plot showing notable TETLP corridor activities (black boxes) and precipitation anomalies (blue boxes) with the inferred ground movement on Lines 10 and 15 between as well as downslope of the TETLP corridor between June 2019 and August 14, 2020. Ground movement from monitoring hub MP 107 is shown to illustrate ground movement at the Site following the FCI.**

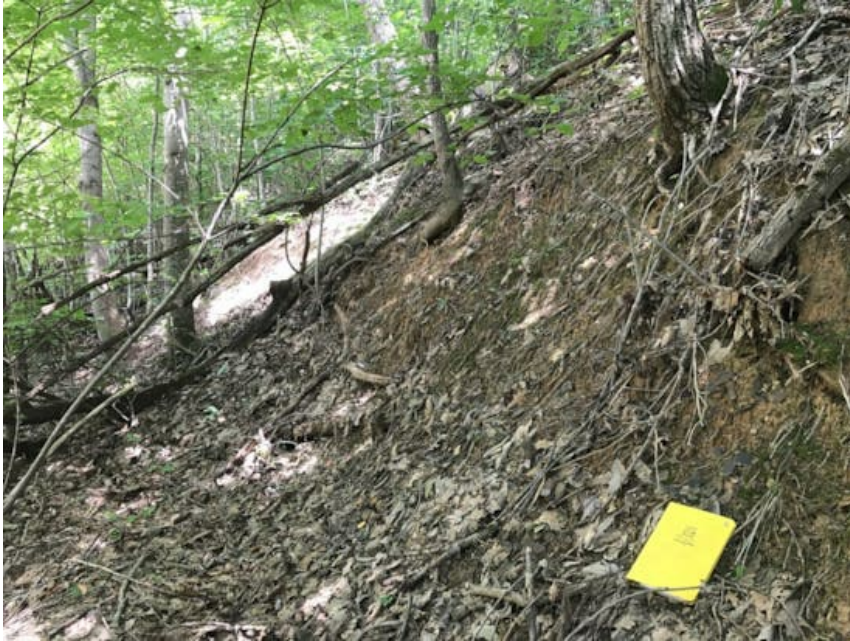
Looking north at head scarp east of ROW (Feature D). Note some fresh soil and pistol-butted trees.

Assess the strain demand on Lines 10 and 15 using the to-scale maps produced during the ground inspection. Consider a strain relief and drainage at the site to improve site conditions.

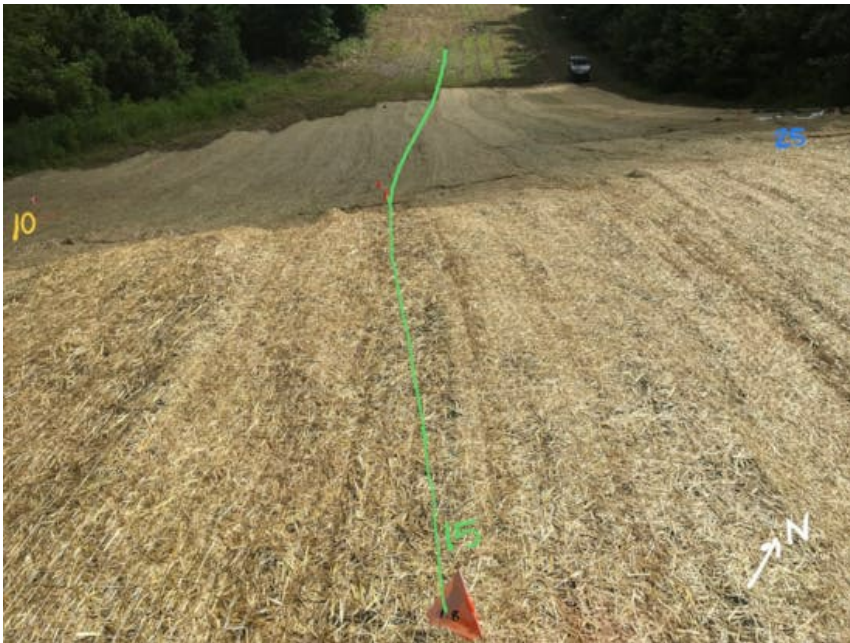
Standing on Line 15 at the lower slope break, looking upslope at the bench and deflections on Line 15

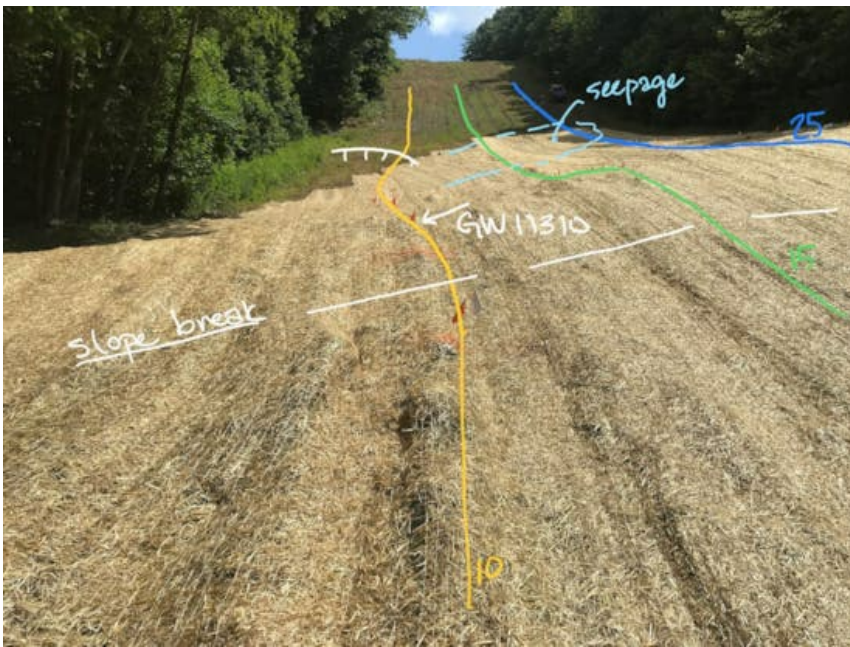
Standing at lower slope break on line 10, looking upslope at bench and lateral deflections.

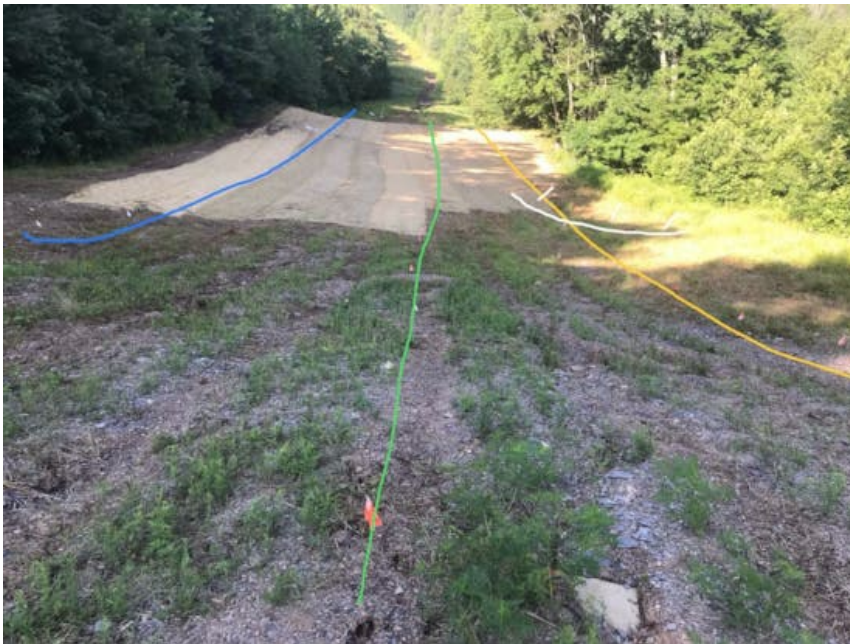
Standing on Line 15, looking downslope. Note defelction in flag lines for Line 10 (yellow) and Line 15 (green). Possible scarp noted in white. Evidence of weathered siltstone from Feature A is present in foreground.

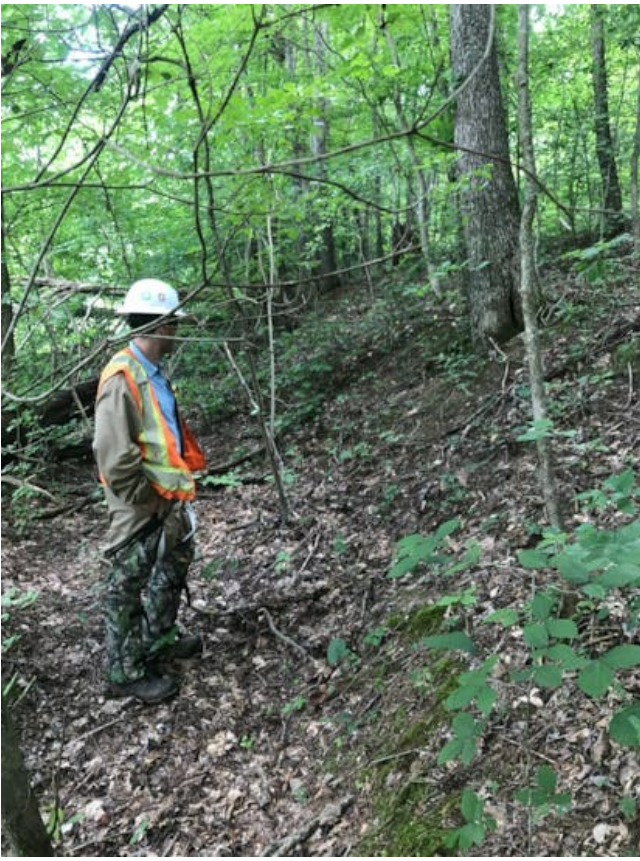
East of ROW near Line 25 strain 23, looking at possible overgrown scarp. Area on ROW very swampy, with ponded water and thick grasses.

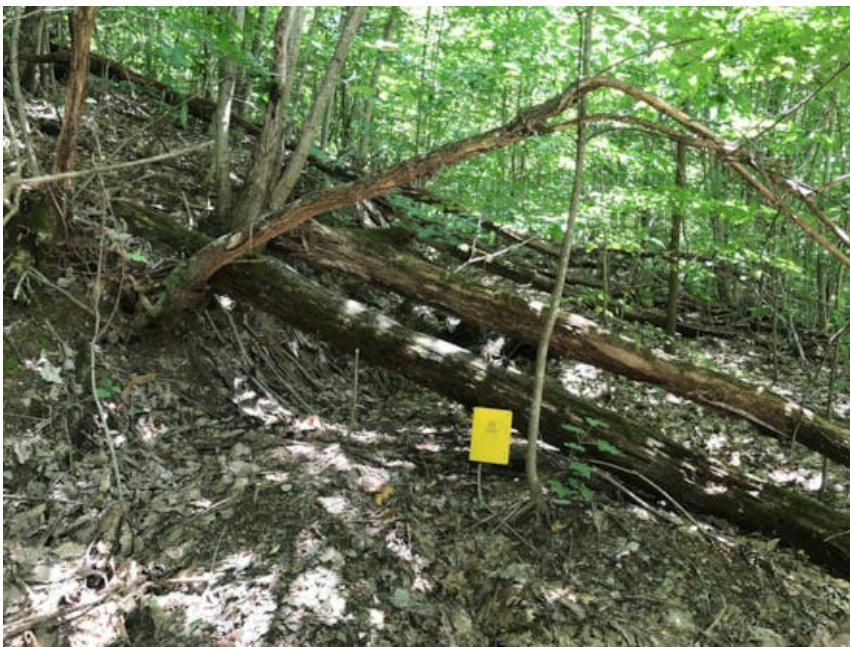
Looking south at scarp east of ROW (Feature D).

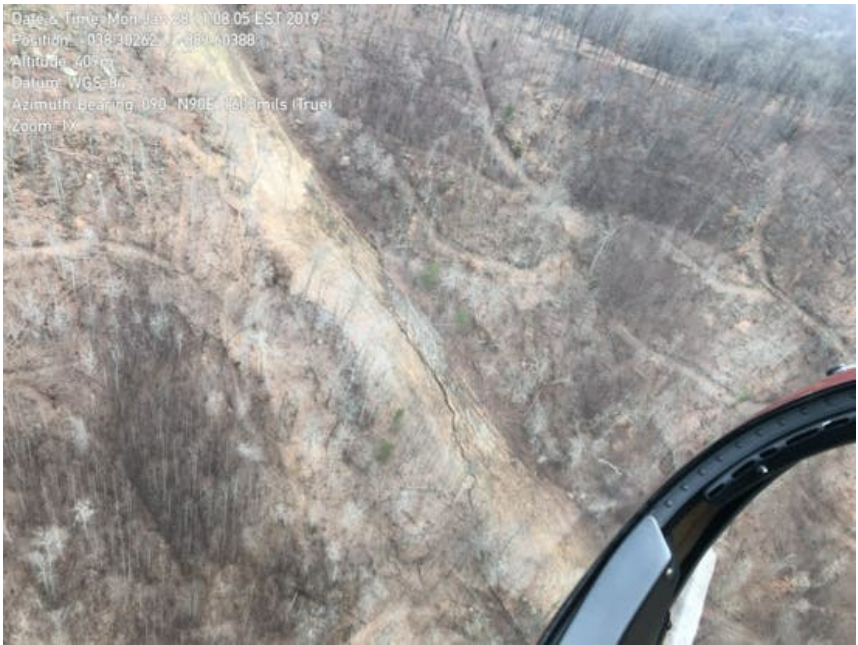
Looking approximately northeast at ROW. Note apparent erosion feature crossing ROW.

Oct 9, 2018 - Geotechnical Screening Inspection

Complete a ground inspection to assess features observed in lidar.

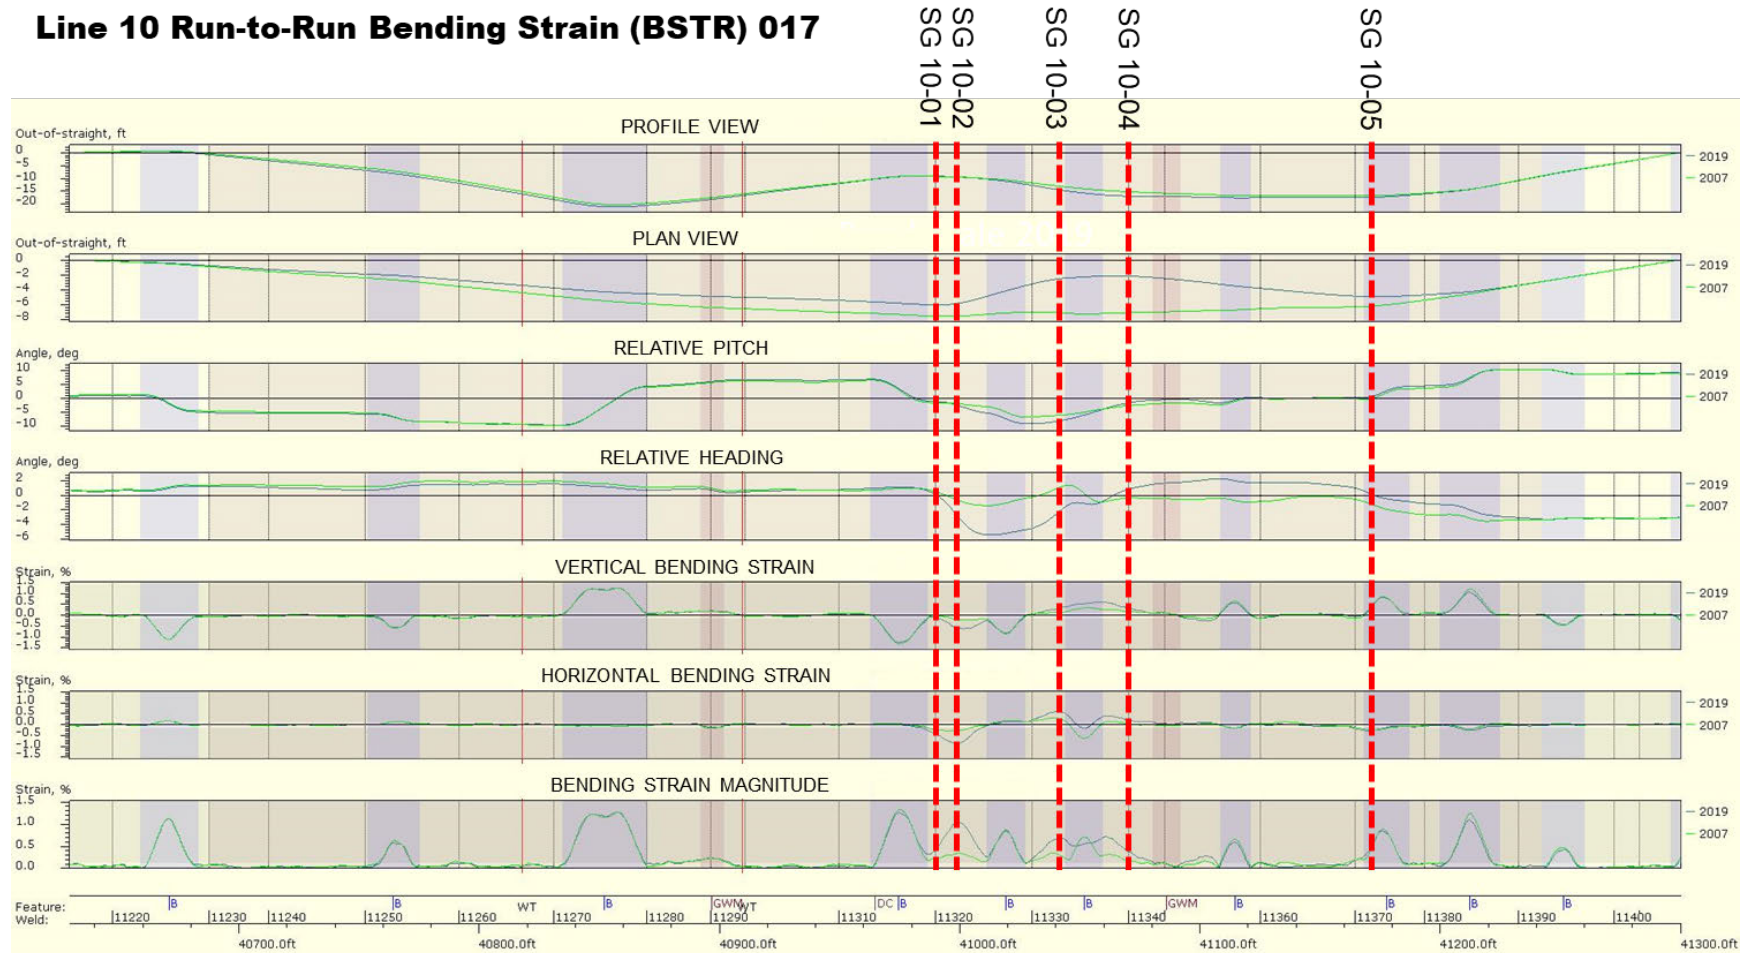
**Line 10 Run-to-Run Bending Strain (BSTR) 017**

**Figure 2-1. Strain plot for Line 10 2019-2007 run-to-run bending strain 017 showing proposed strain gauge set locations (red dashed lines). Plots provided by Baker Hughes (2019a).**

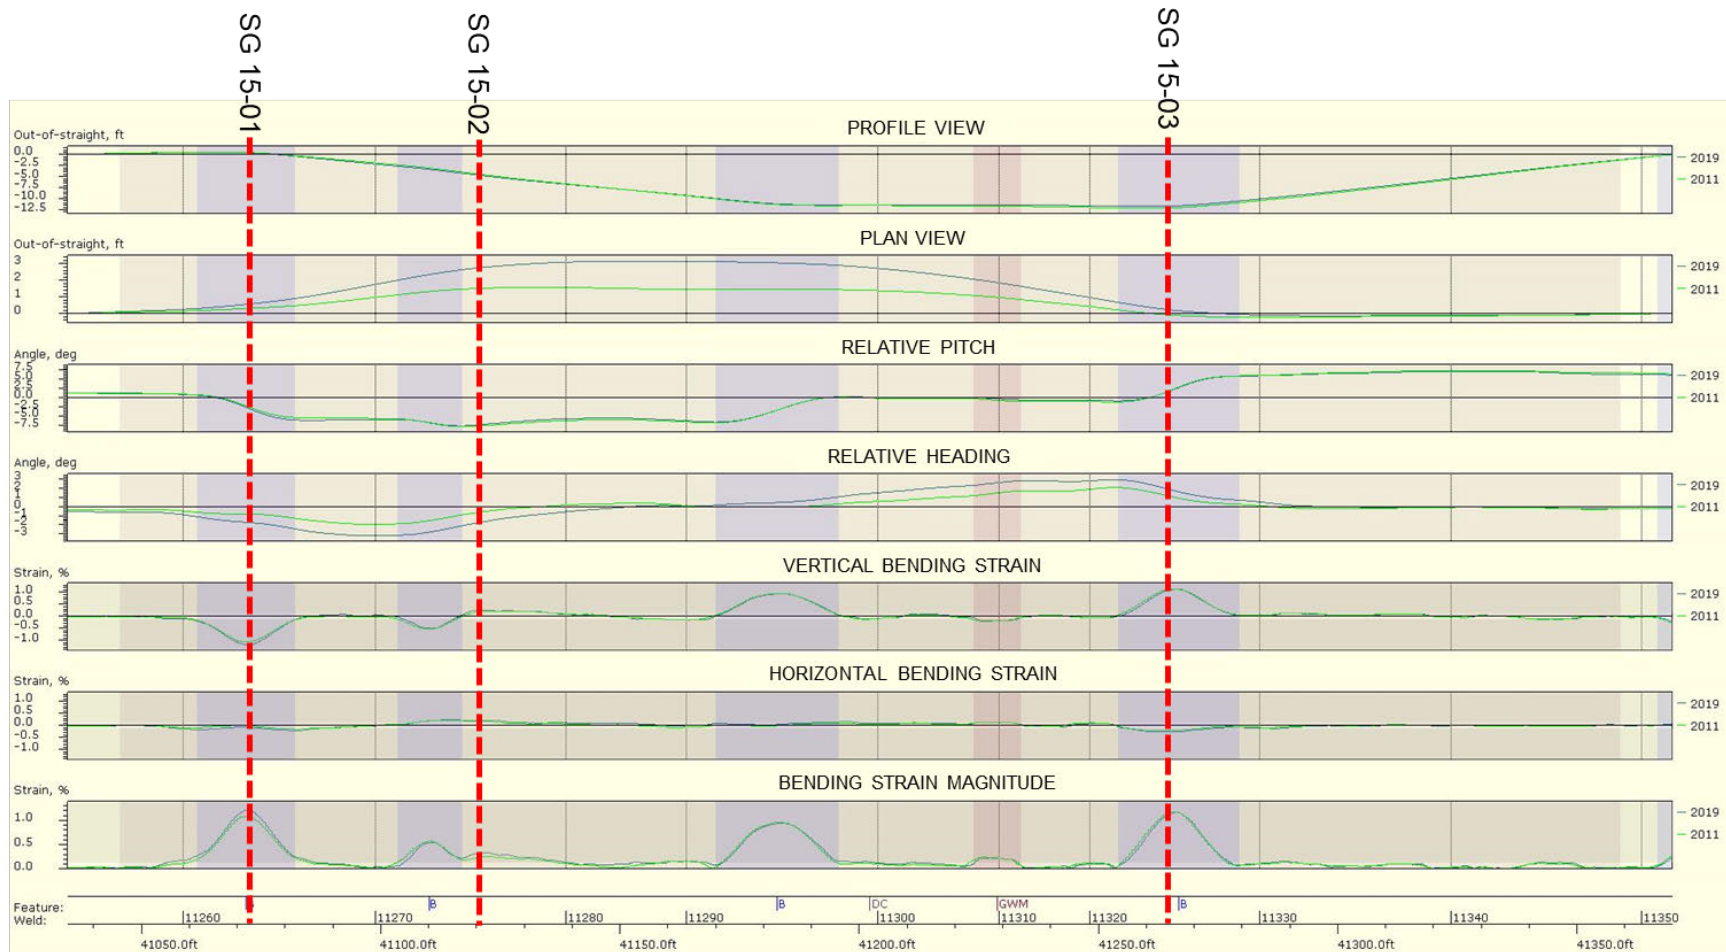
### Line 15 Run-to-Run Bending Strain (BSTR) 029

Figure 2-2. Strain plot for Line 15 2019-2011 run-to-run bending strain 029 showing proposed strain gauge set locations (red dashed lines). Plots provided by Baker Hughes (2019b).
