## **TEXAS EASTERN TRANSMISSION, LP**

### **MAY 4, 2020 FLEMING COUNTY INCIDENT GEOTECHNICAL CAUSATION REPORT**

PROJECT NO.: 1607024  
DOCUMENT NO.: Rev A

DATE: April 26, 2021

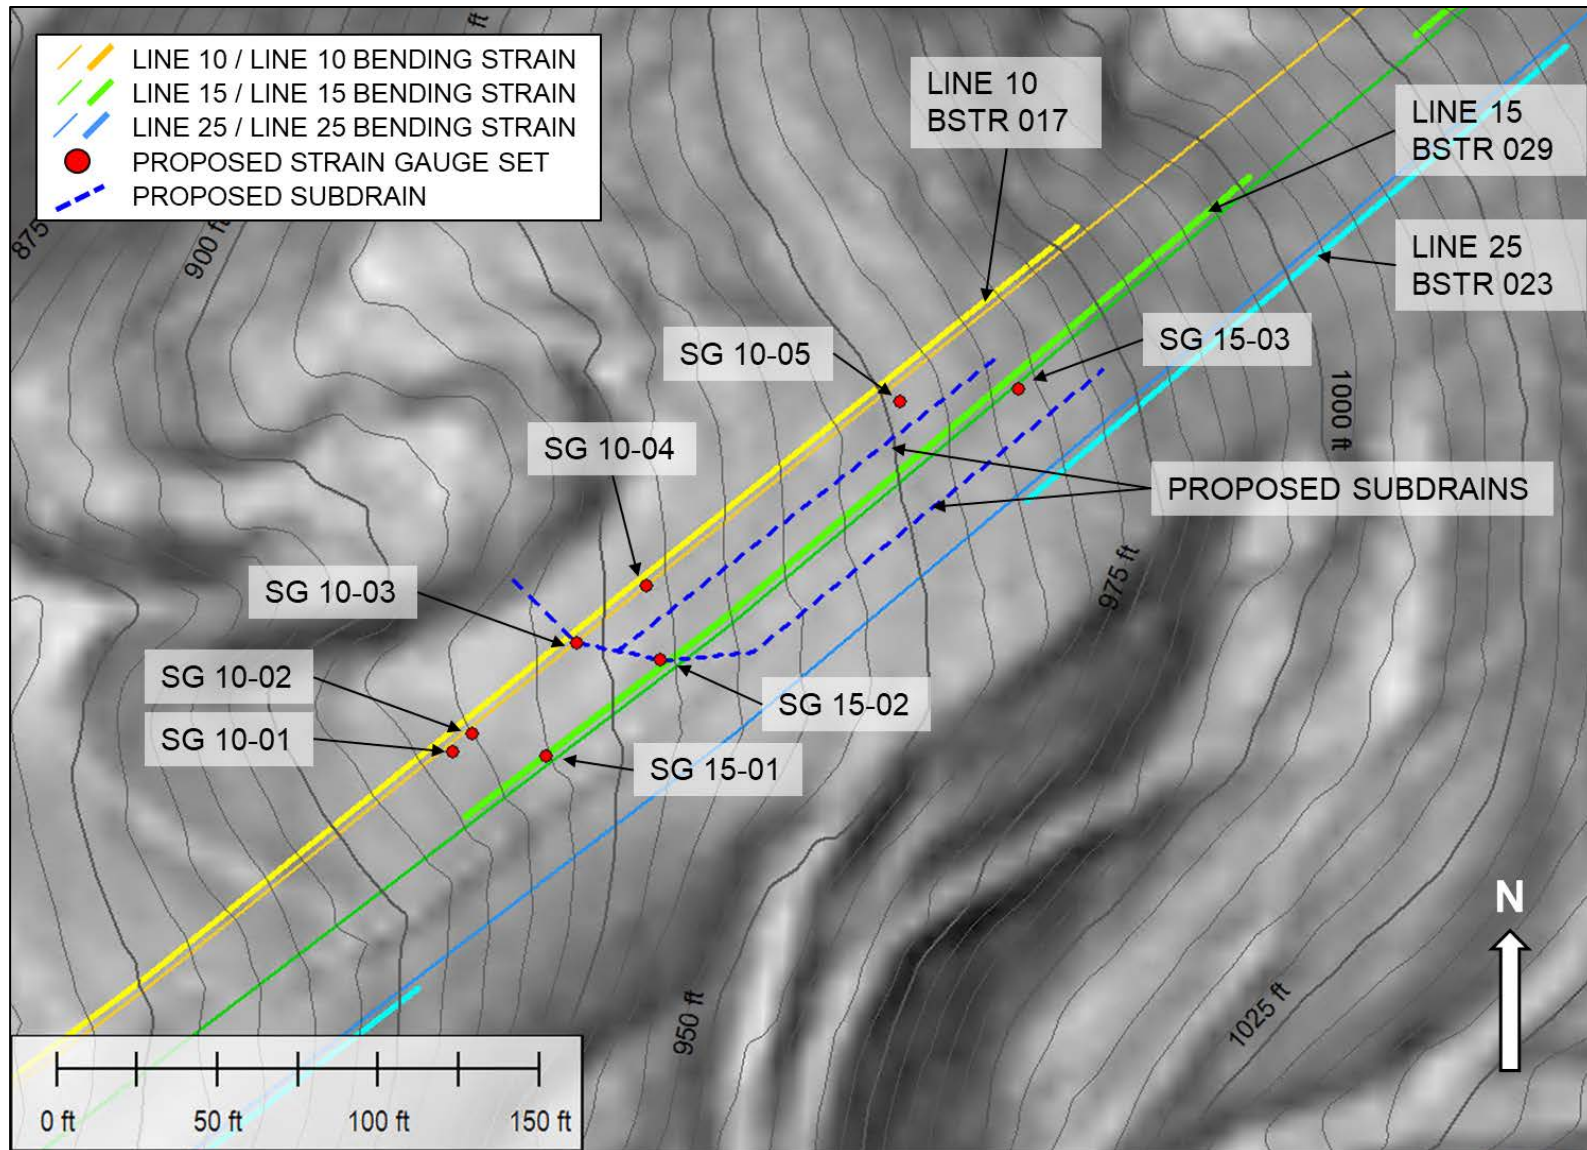
**Figure 2-4. Lidar plan-view of the proposed strain gauge sets and subdrain locations. Note that pipe linework may vary from actual: strain gauge locations are to be based on relation to girth welds as shown in the IMU plots.**

BGC will also provide guidance on the installation of subsurface drains to improve stability conditions at the site. The proposed locations of the subdrains are shown in Figure 2-4. Drainage will be targeted to intercept seepage observed during the July 2019 ground inspection and transport the intercepted water to the north side of the RoW. The final locations of the drains will be field-fit based on observations made during construction. Drainage construction is expected to occur concurrently with the strain gauge installation so bell hole excavations can be utilized for routing drains beneath Lines 10 and 15.

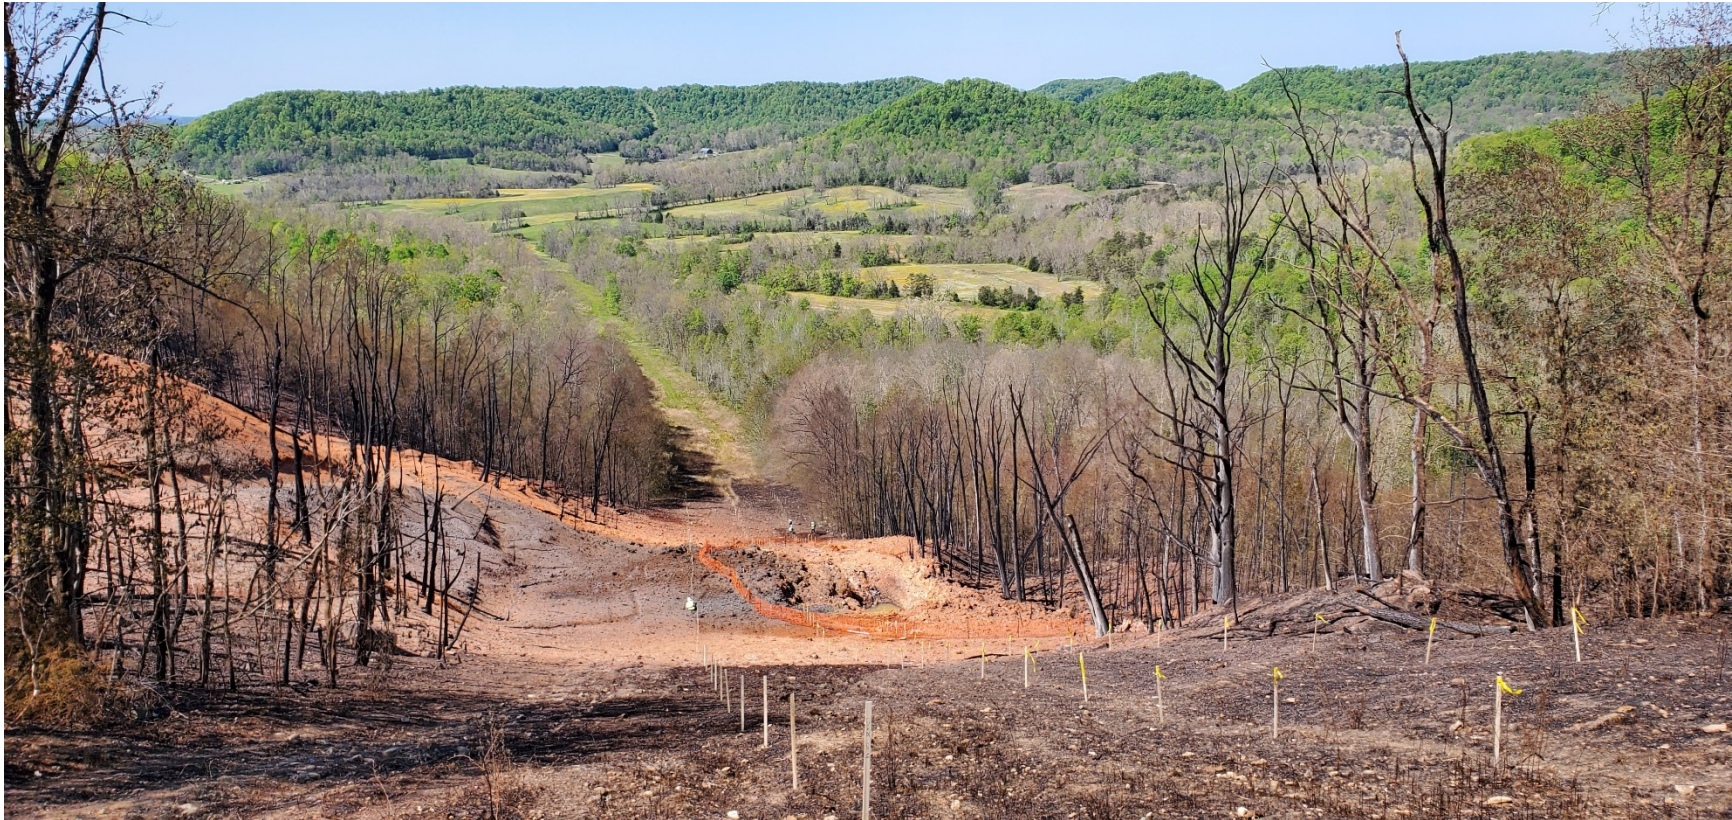
**Photo C-1. Looking southwest at the FCI site. The blast crater from the FCI is within the orange safety fence in the middle portion of the photo. BGC photo taken May 7, 2020.**

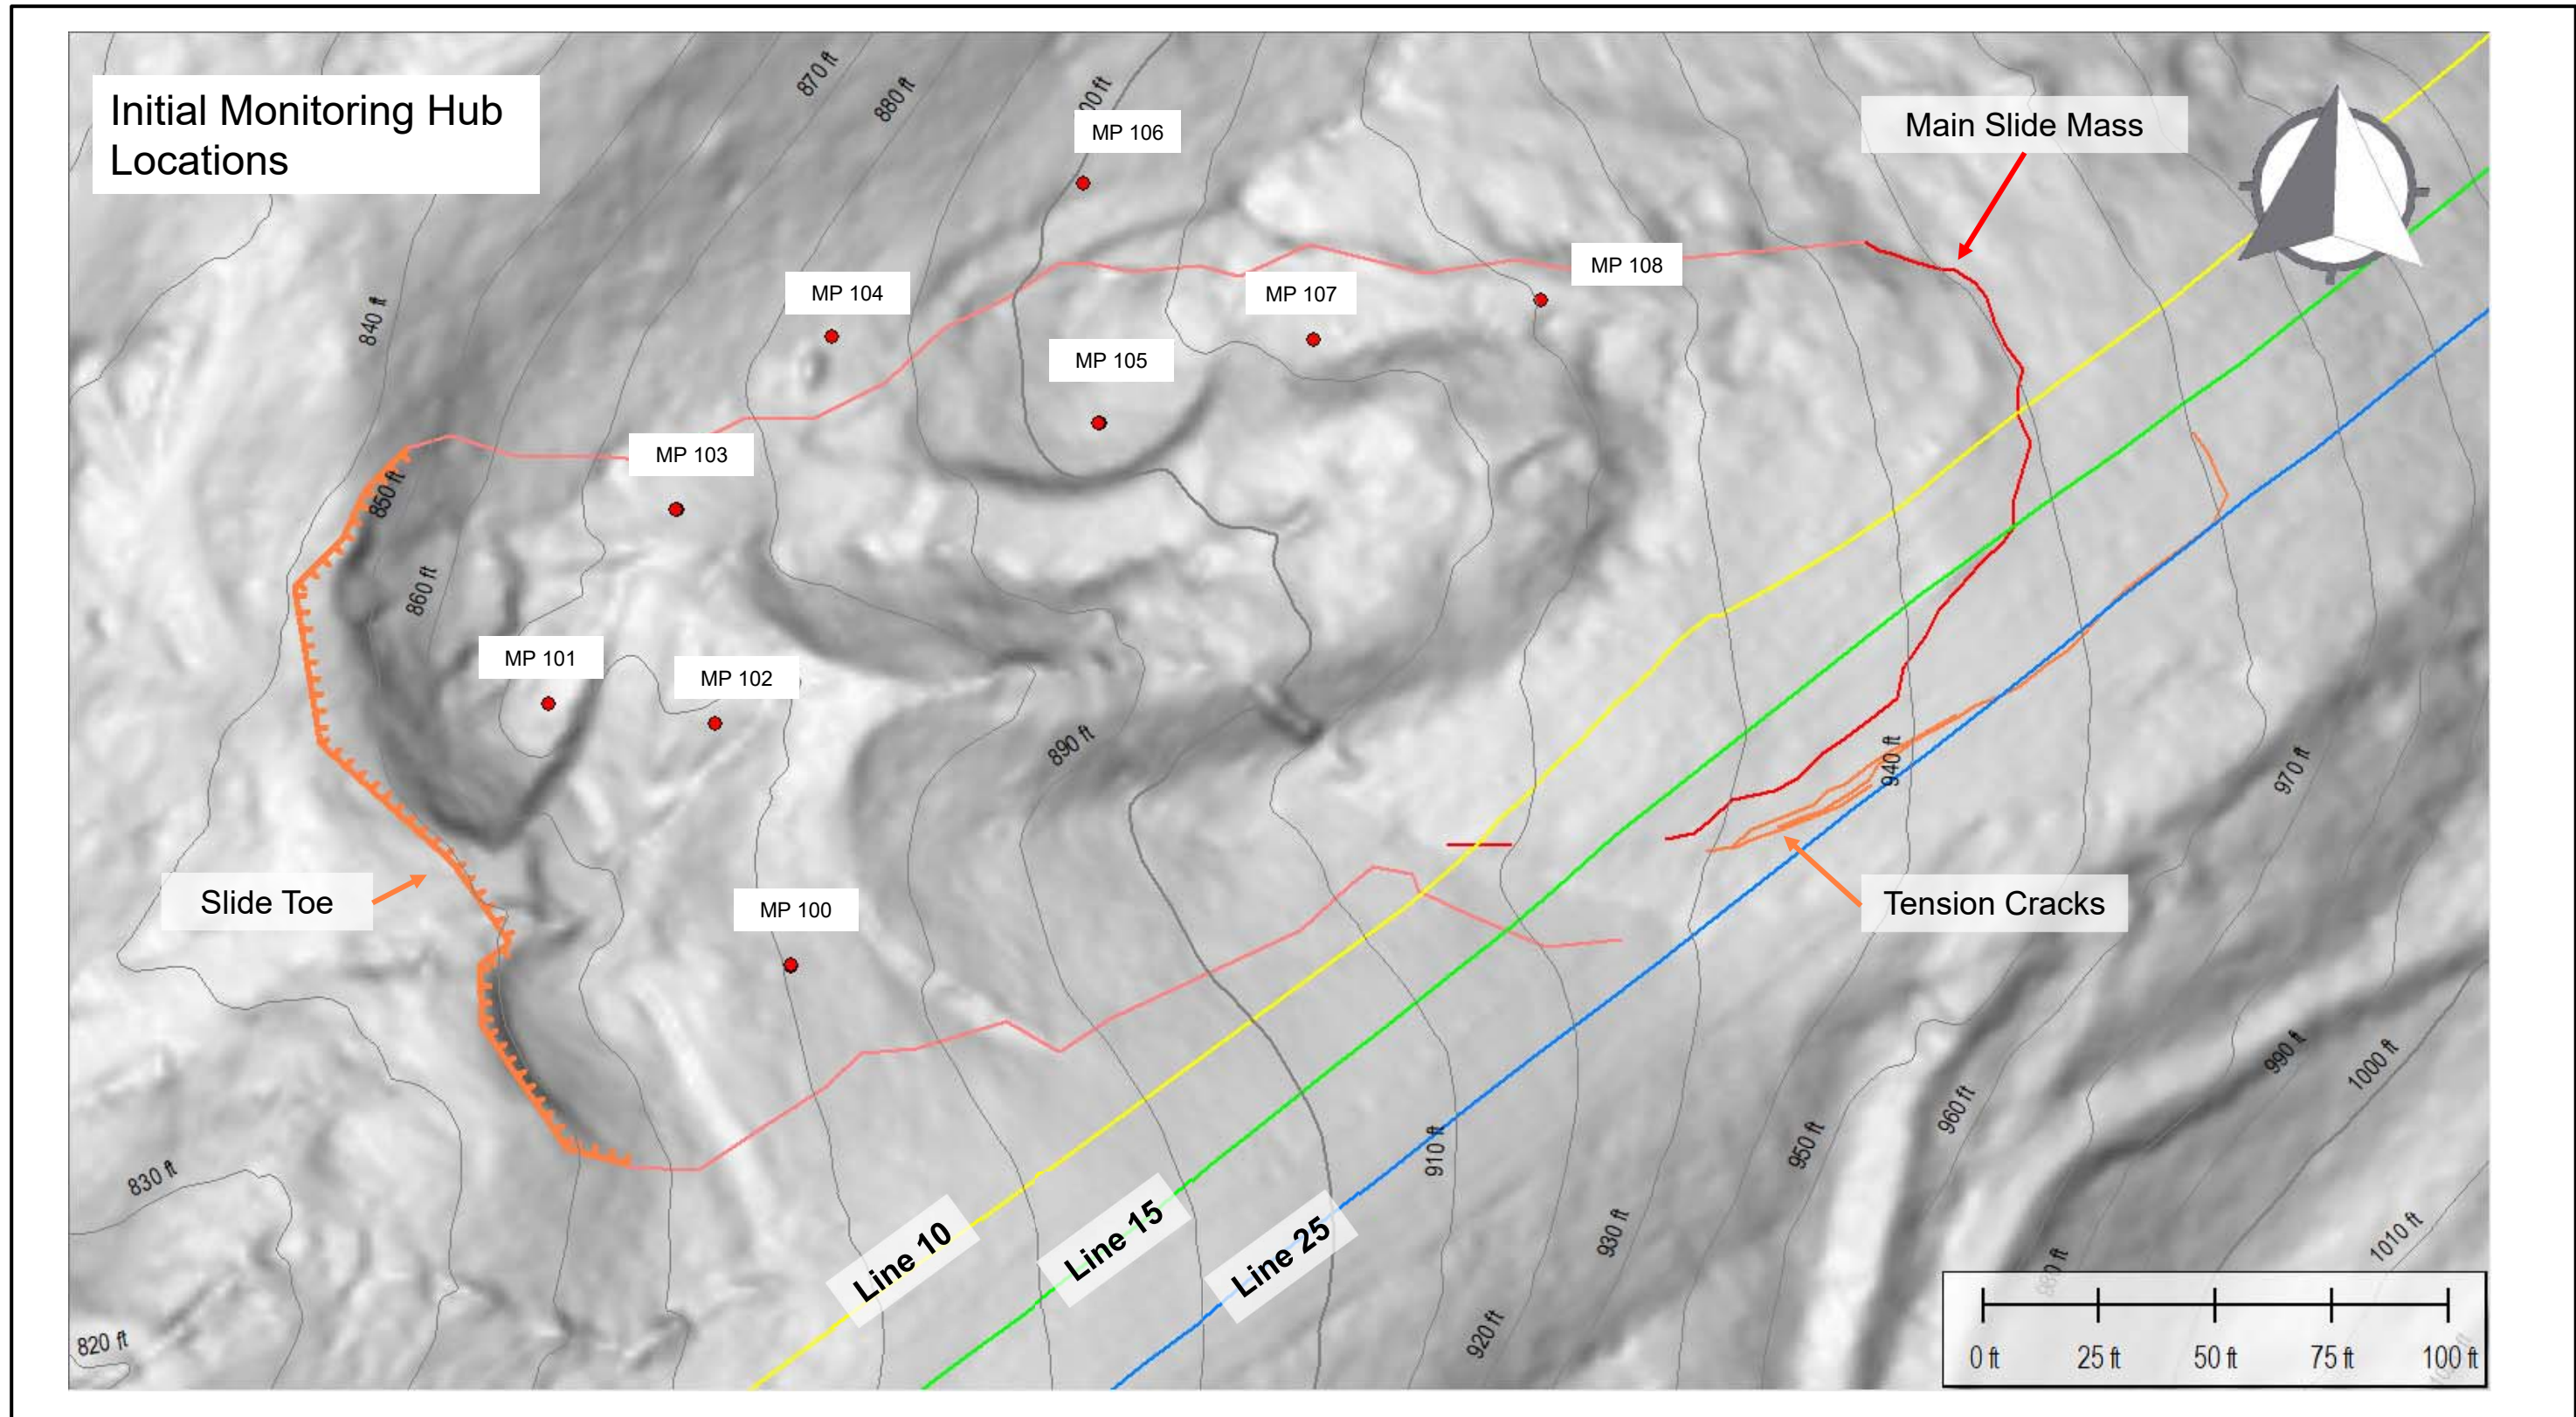
4. Map shows the initial monitoring point locations (red dots) in relation to the main slide mass (outlined in red), tension cracks (orange lines), and Lines 10, 15 and 25.

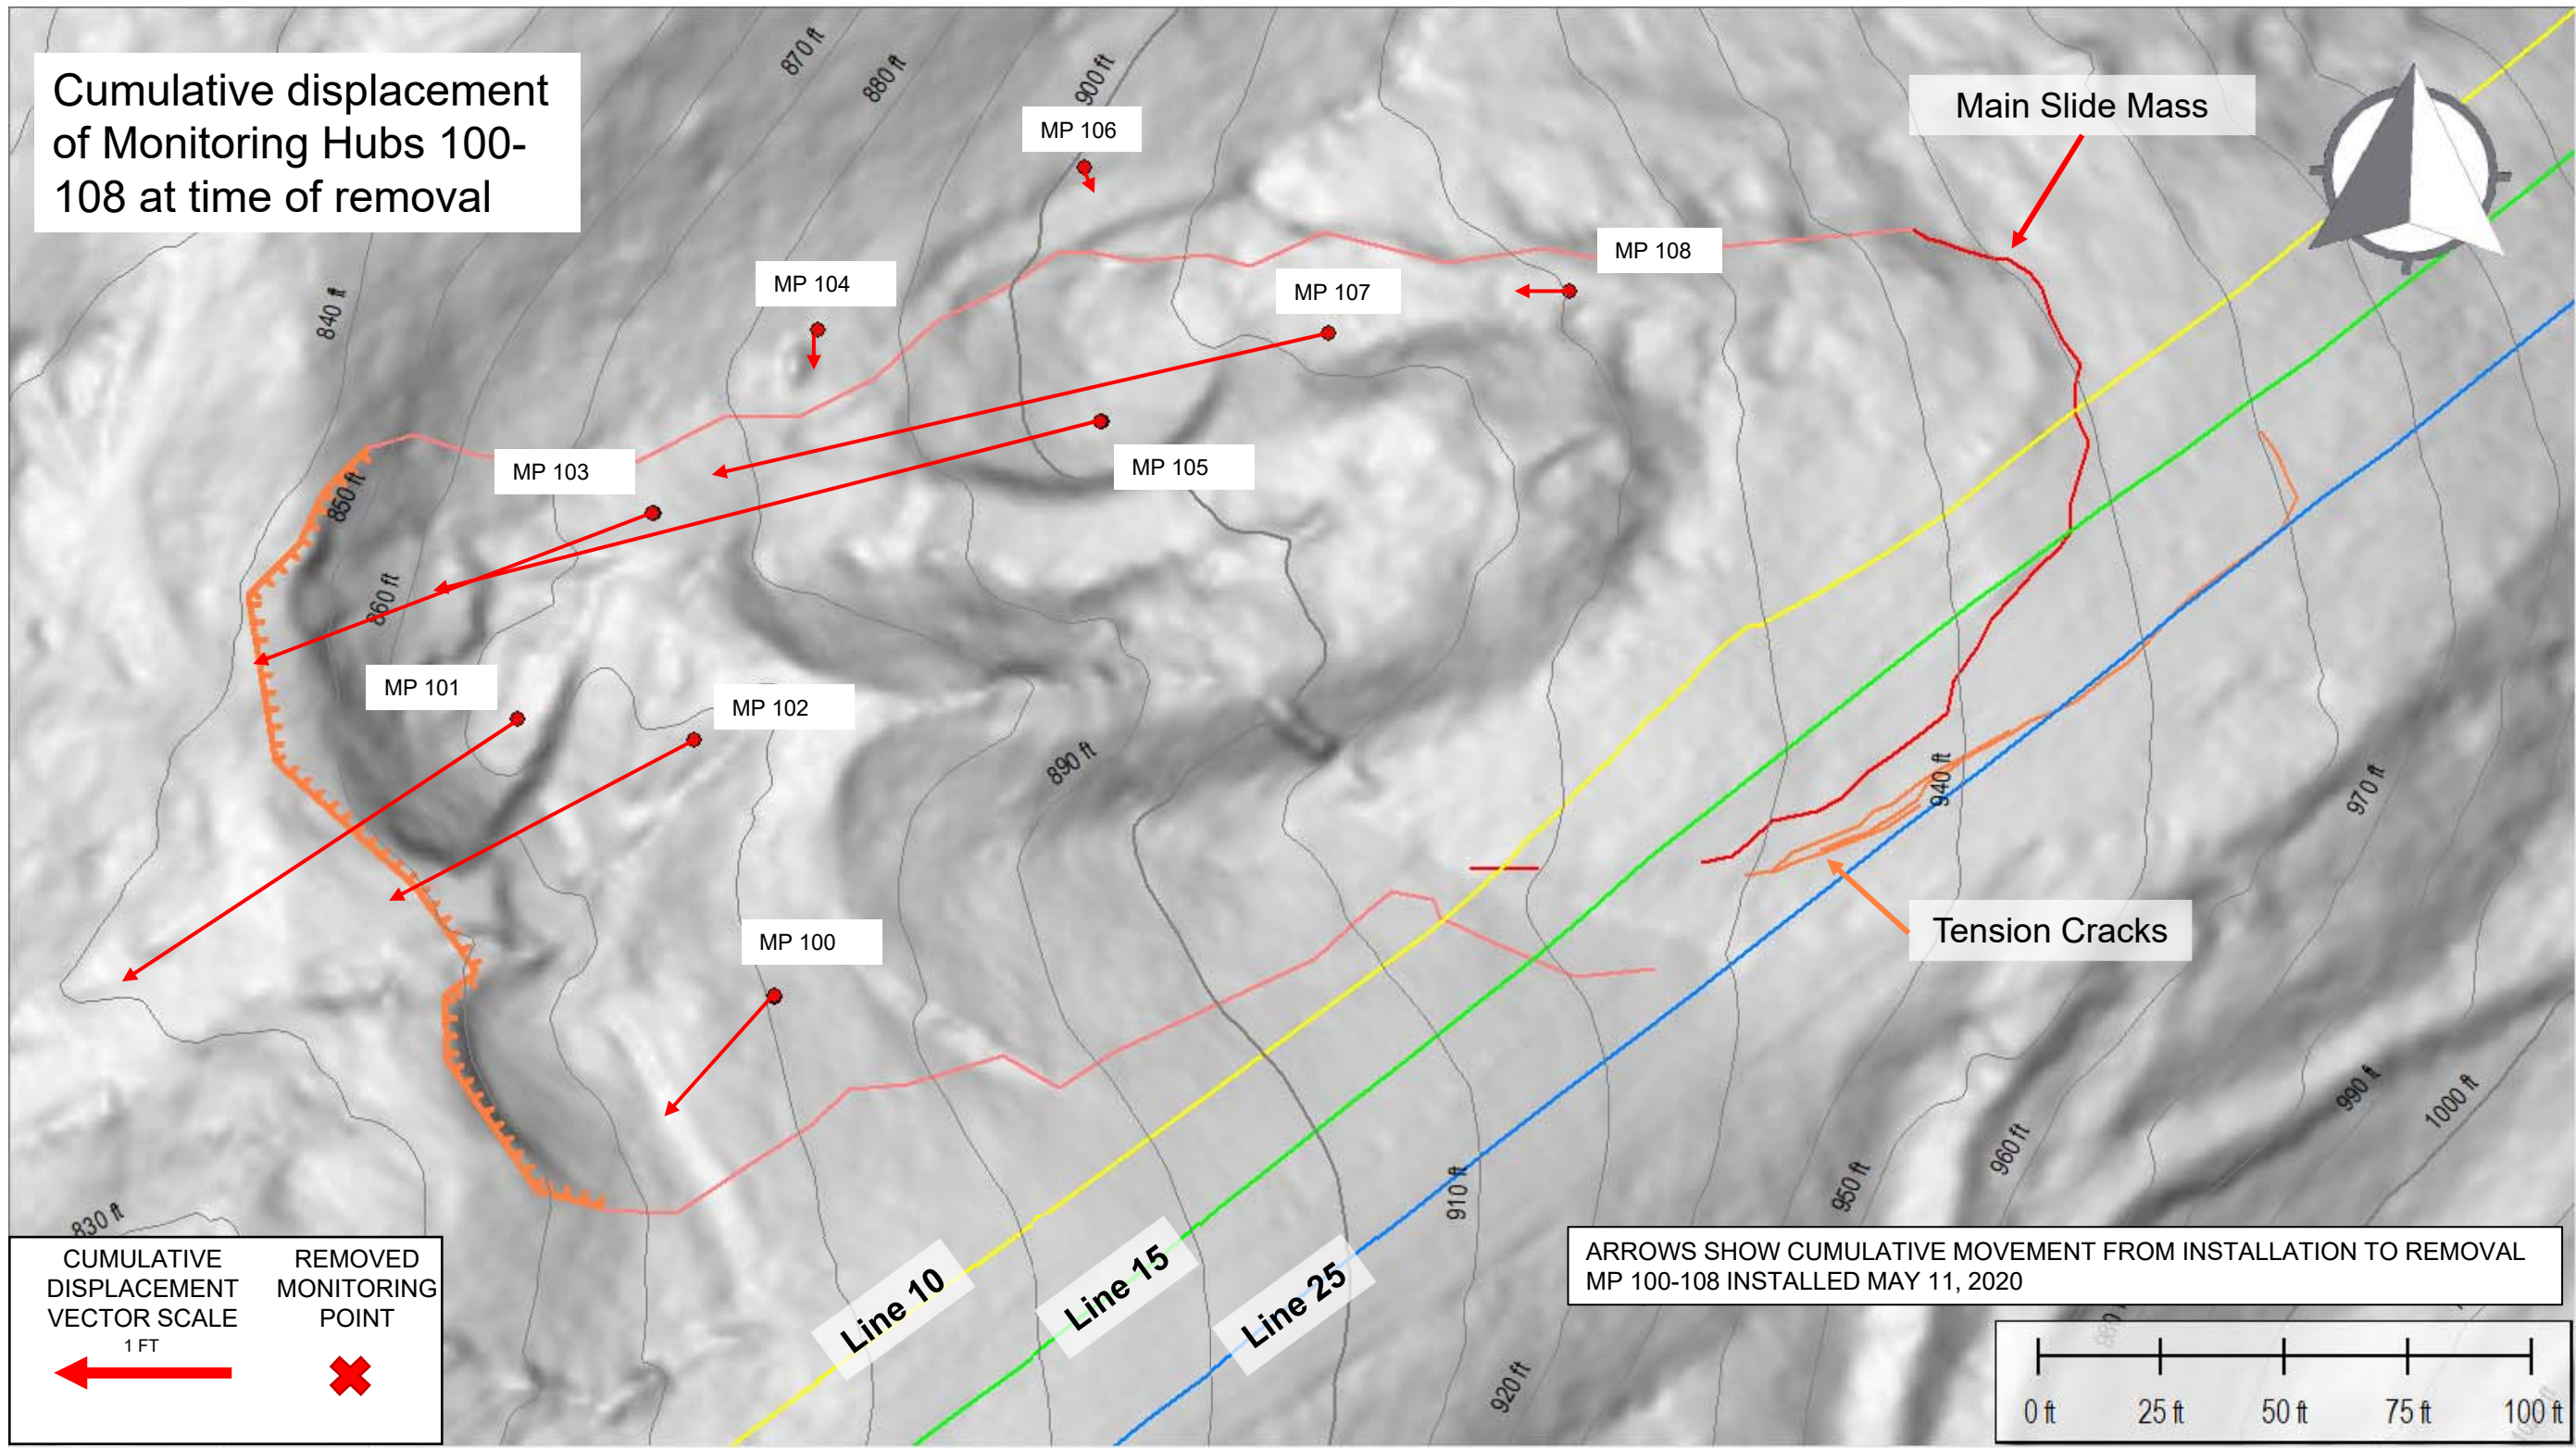
Cumulative displacement of Monitoring Hubs 100-108 at time of removal

ARROWS SHOW CUMULATIVE MOVEMENT FROM INSTALLATION TO REMOVAL  
MP 100-108 INSTALLED MAY 11, 2020

4. Map shows the initial monitoring point locations (red dots) and movement vectors (red arrows) in relation to the main slide mass (outlined in red), tension cracks (orange lines), and Lines 10, 15 and 25.

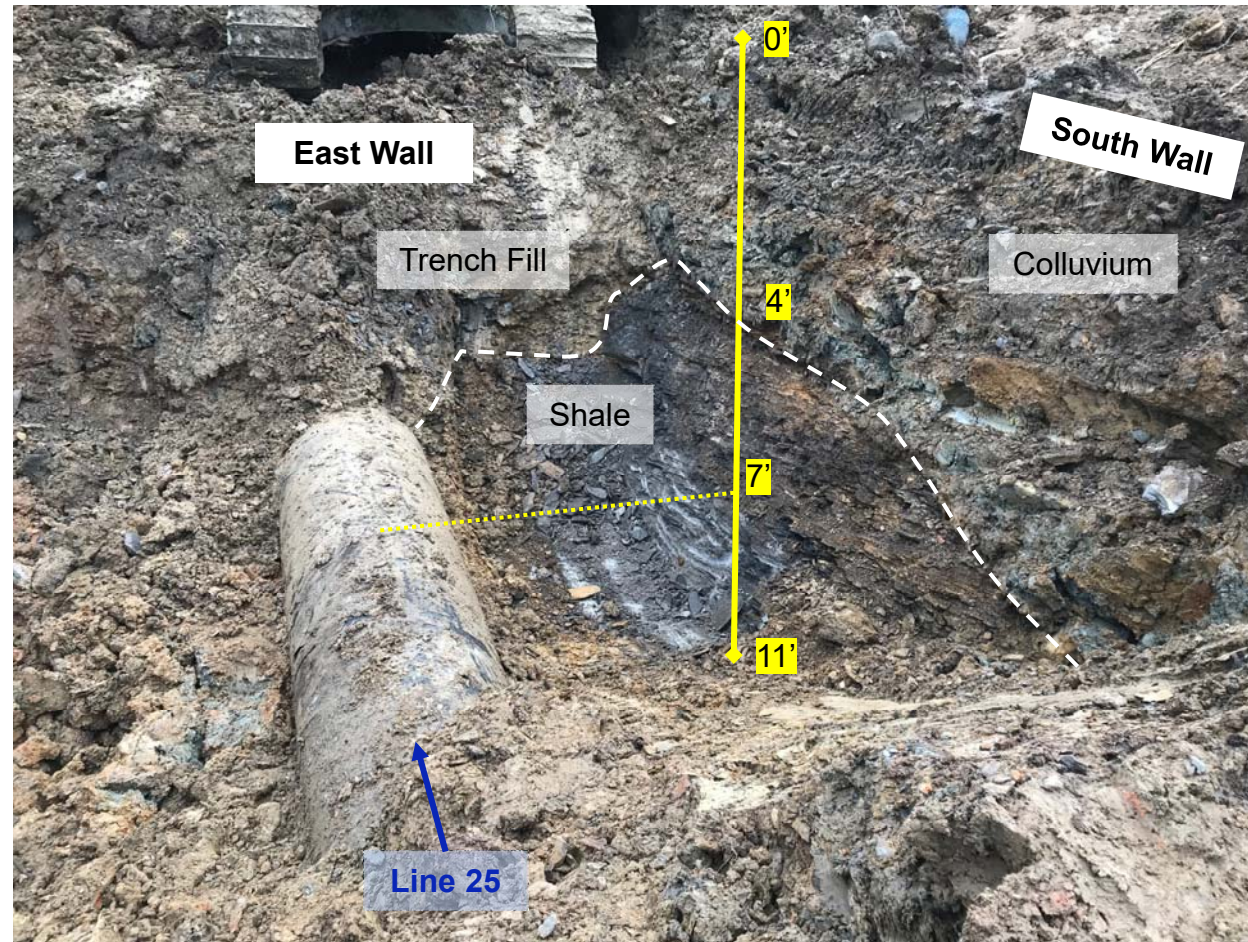
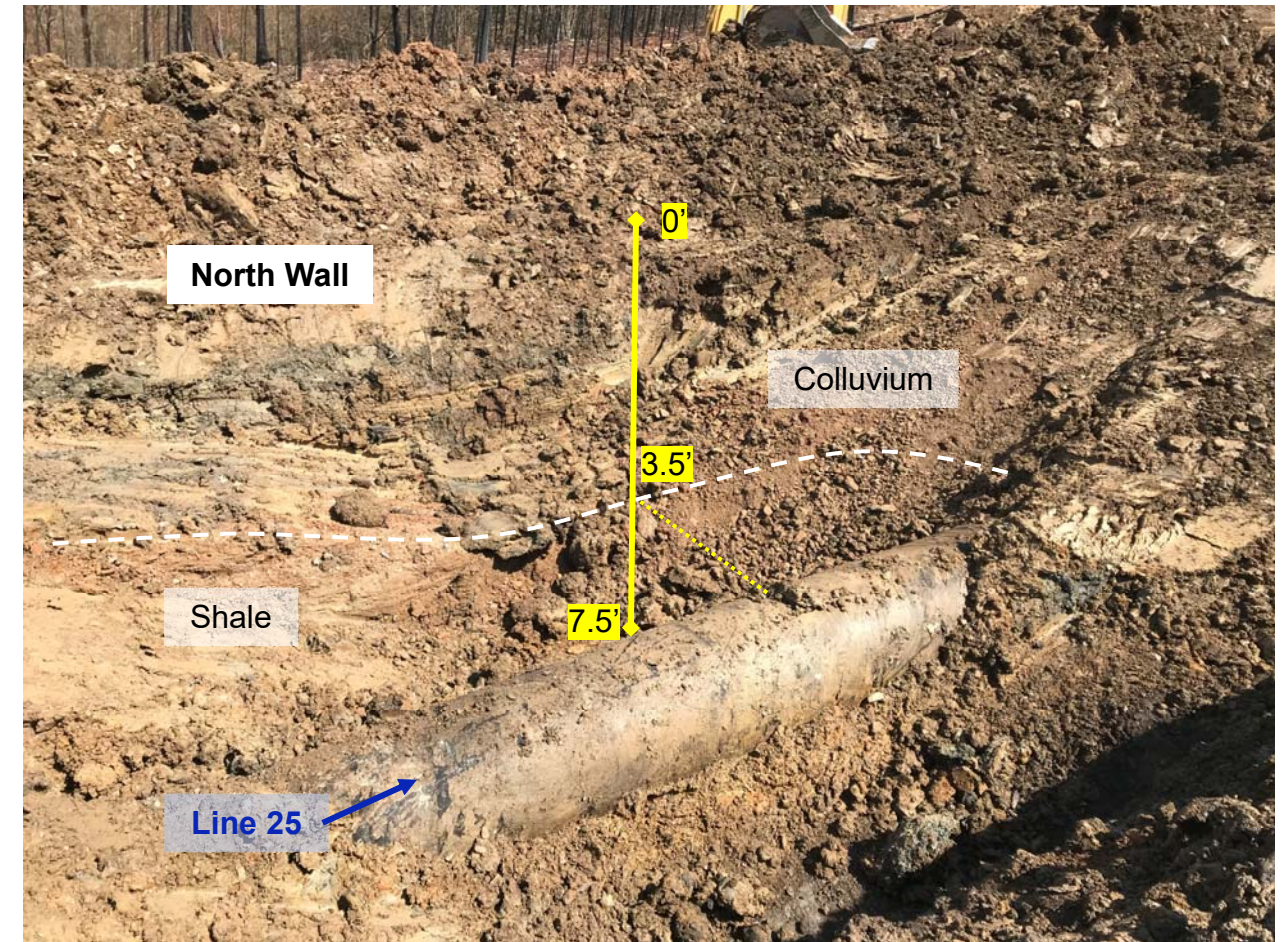
Test Pit 01: Excavated along Line 25. Excavation shows that Line 25 is trenched in shale bedrock.

Feature	Depth (ft)
Bedrock contact	4
Top of Pipe	7
Bottom of excavation	11

Feature	Depth (ft)
Bedrock contact/top of pipe	3.5
Bottom of excavation	7.5

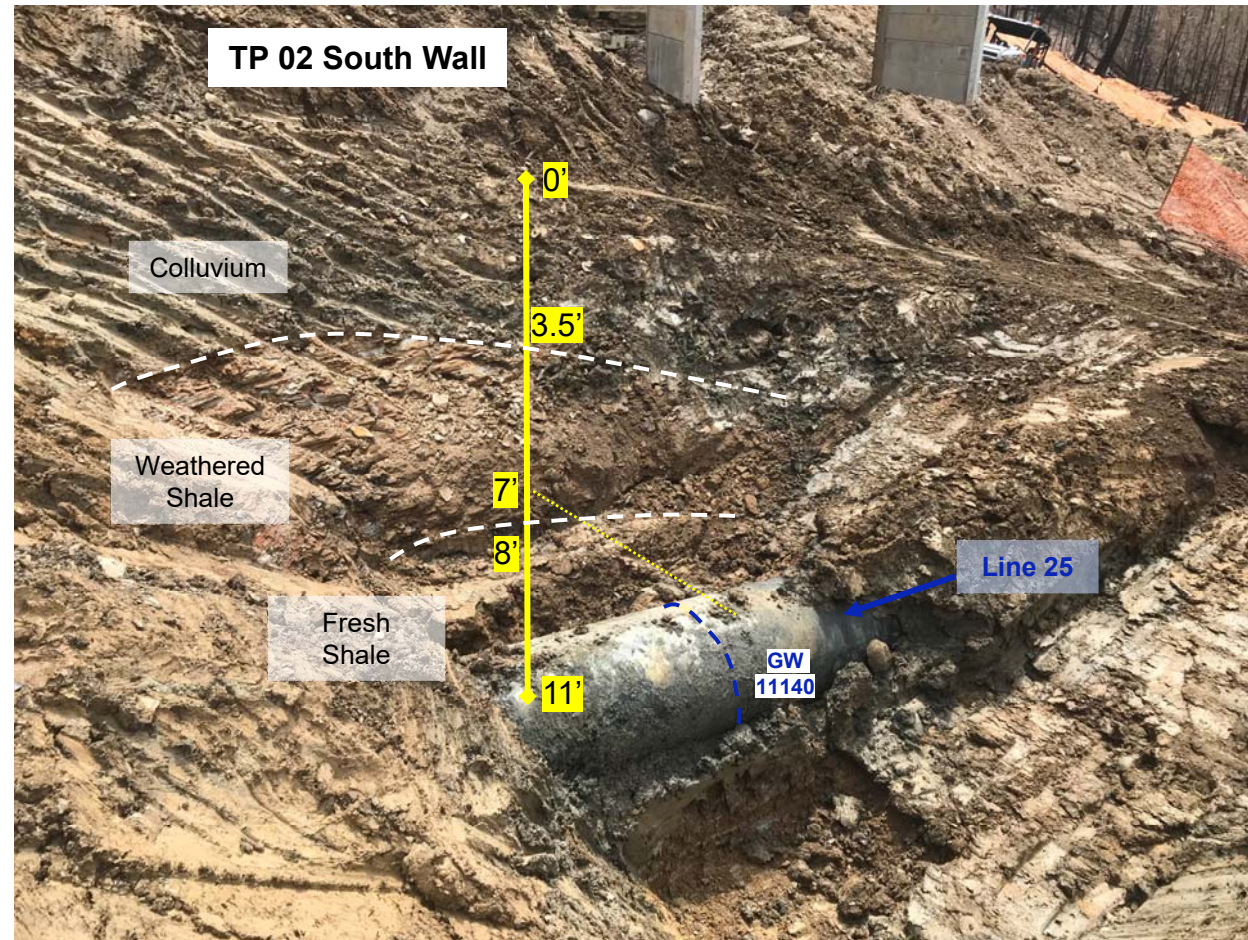
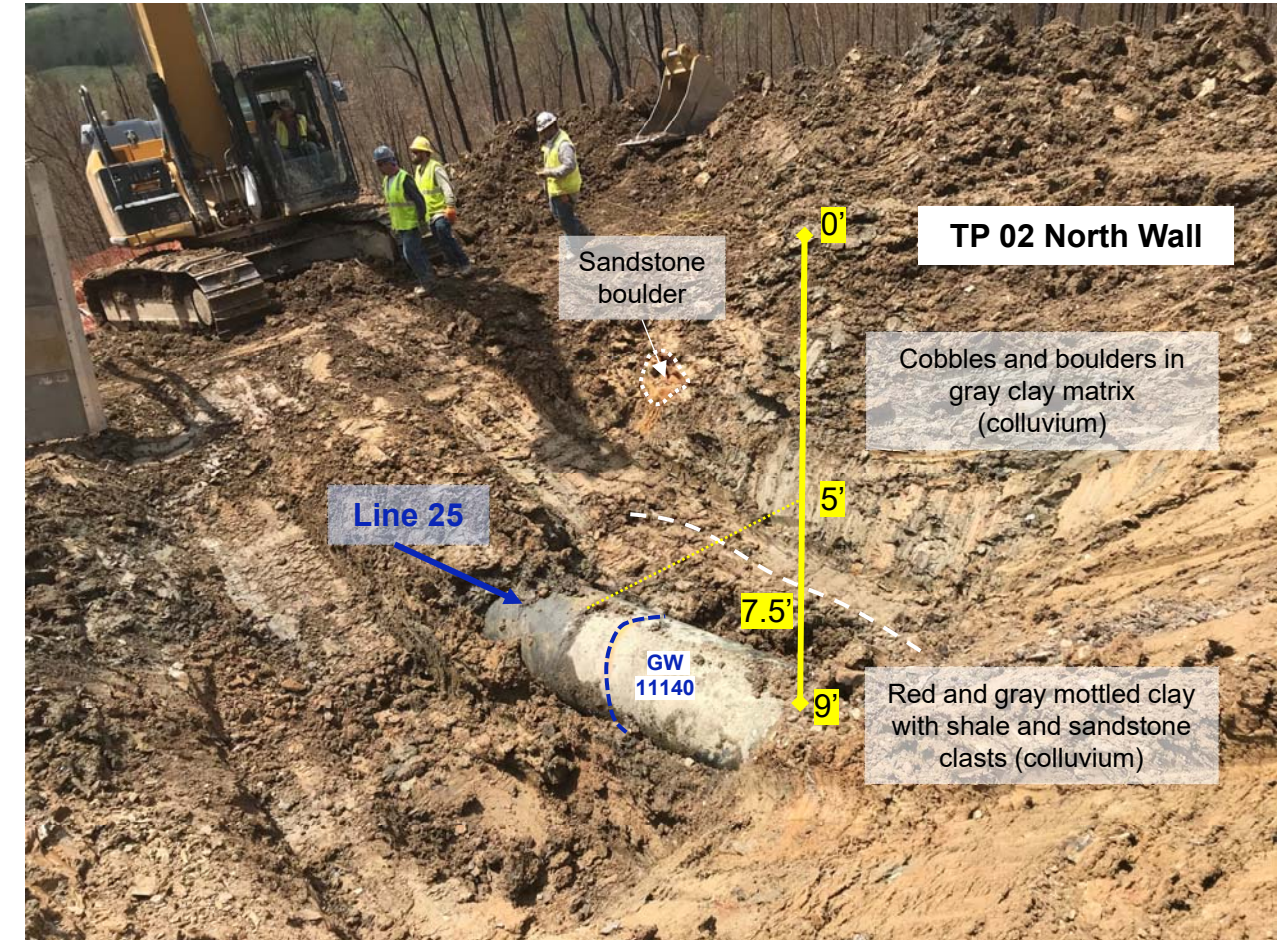
Test Pit 02: Photo logs of the south wall (left) and north wall (right) of a bell hole around GW 11140 of Line 25. The excavation shows shale bedrock above the elevation of Line 25 on the south wall, but not on the north wall.

Feature	Depth (ft)
Colluvium-Weathered Shale Contact	3.5
Top of Pipe	7
Weathered-Fresh Shale Contact	8
Bottom of Excavation	11

Feature	Depth (ft)
Top of Pipe	5
Mottled colluvium contact	7.5
Bottom of Excavation	9

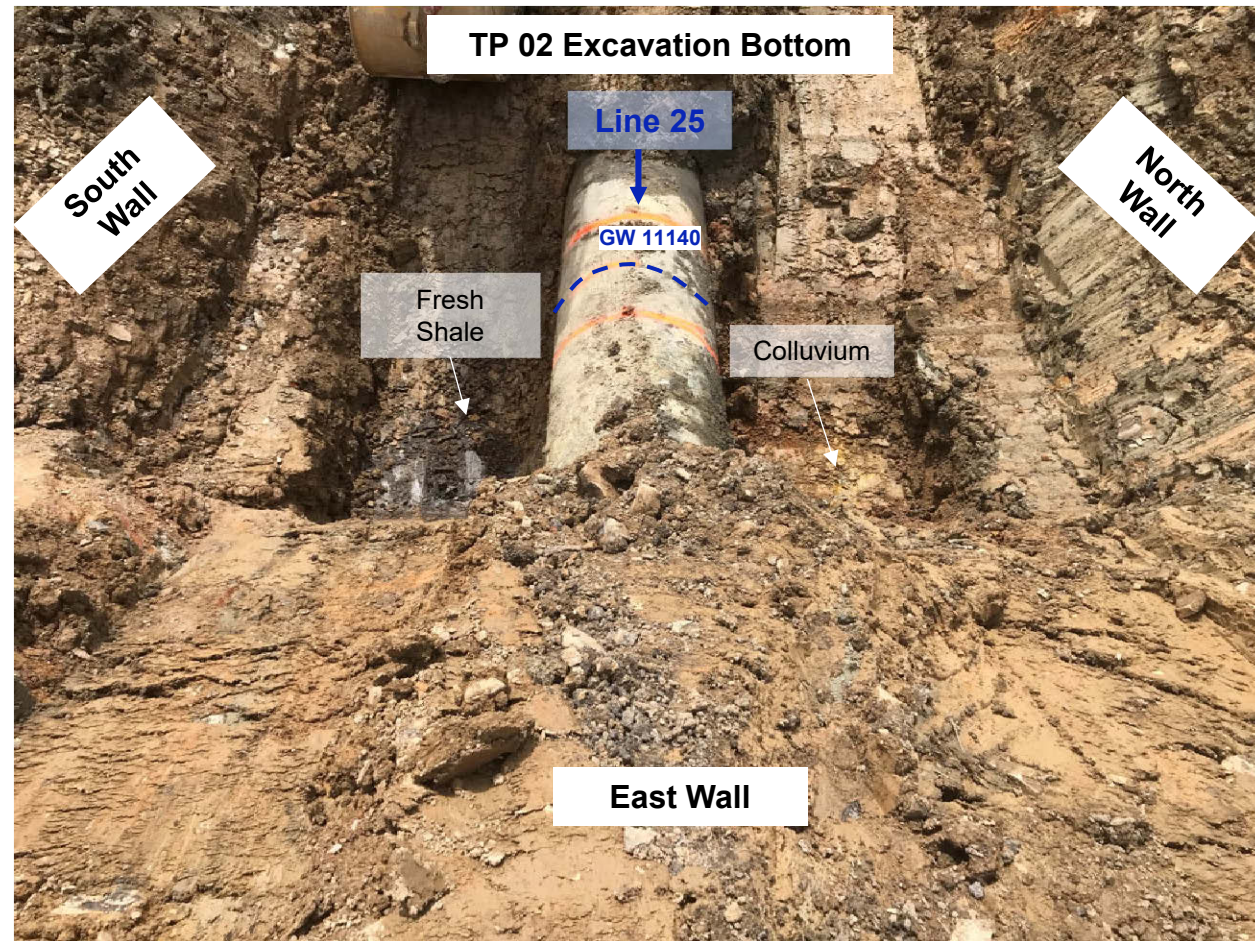
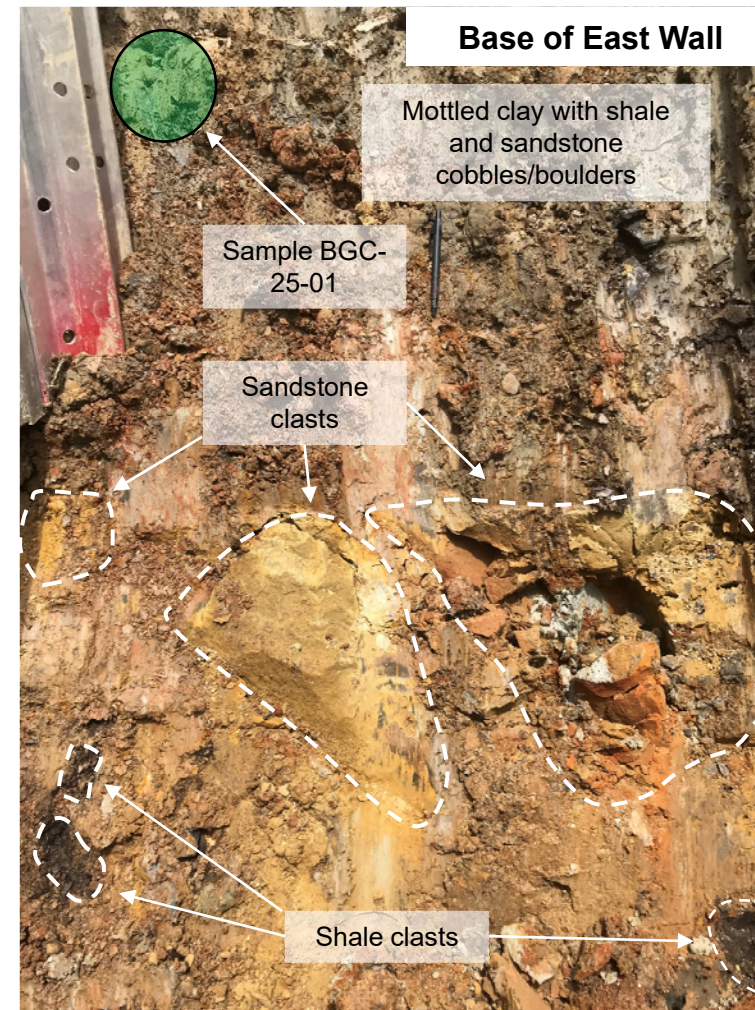
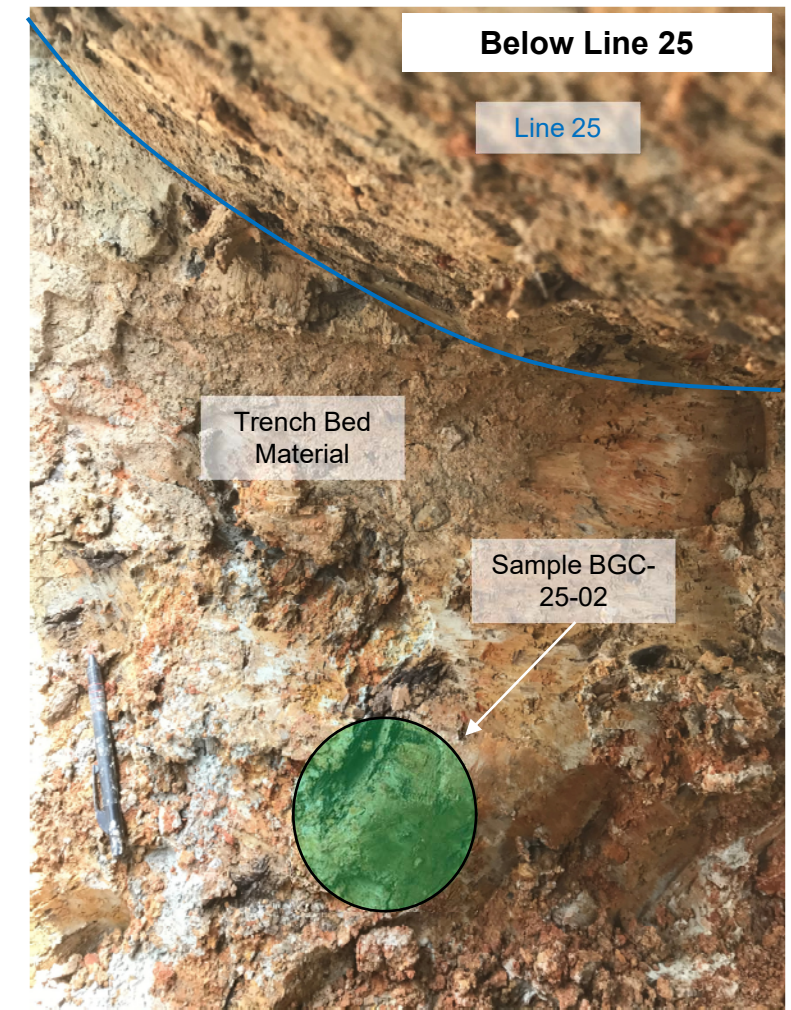
Test Pit 02 (continued): Photo logs showing the stratigraphy at the base of the TP 02 bell hole. Left photo shows fresh shale bedrock on the south side of the pipeline, but not on the north side. The middle and right photos show the location of samples collected in TP 02.

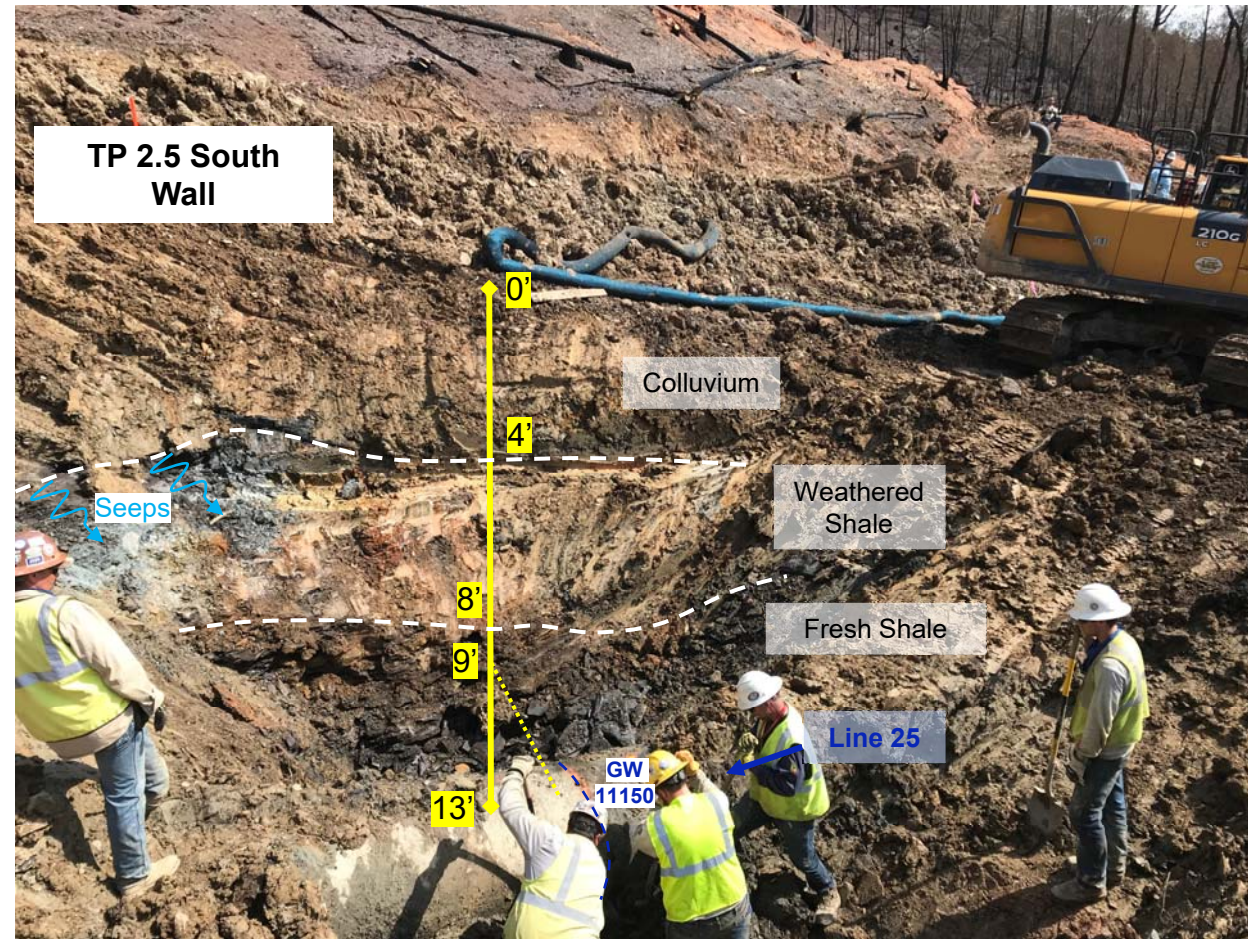
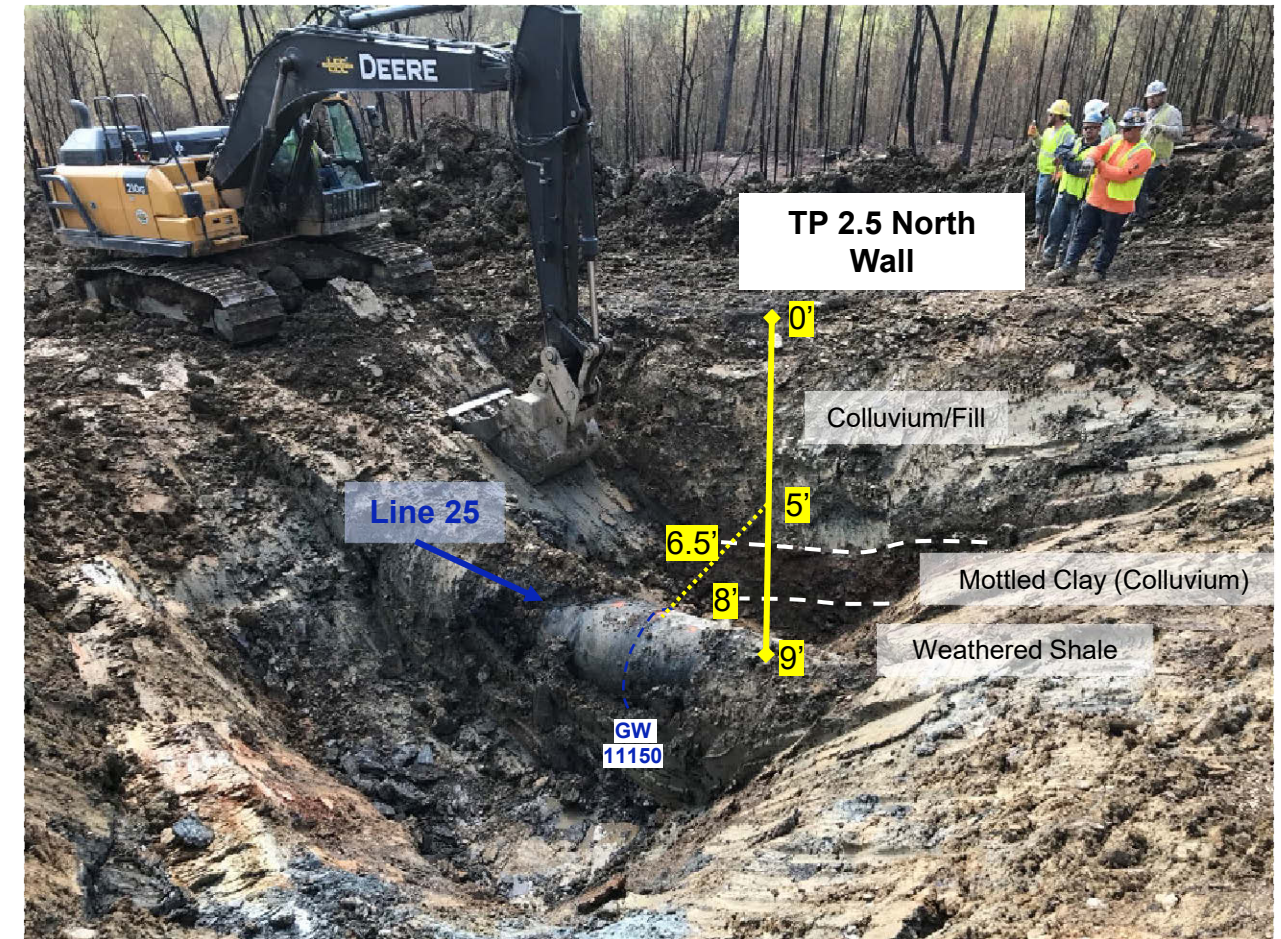
Test Pit 2.5: Photo logs of the south wall (left) and north wall (right) of a bell hole around GW11150 of Line 25. The excavation shows that Line 25 is trenched in shale bedrock.

Feature	Depth (ft)
Colluvium-Weathered Shale Contact	4
Weathered-Fresh Shale Contact	8
Top Of Pipe	9
Bottom of Excavation	13

Feature	Depth (ft)
Top Of Pipe	5
Colluvium/Fill-Mottled Clay (Colluvium) Contact	6.5
Mottled Clay (Colluvium)-Weathered Shale Contact	8
Bottom of Excavation	9
