## **TEXAS EASTERN TRANSMISSION, LP**

### **MAY 4, 2020 FLEMING COUNTY INCIDENT GEOTECHNICAL CAUSATION REPORT**

PROJECT NO.: 1607024  
DOCUMENT NO.: Rev A

DATE: April 26, 2021

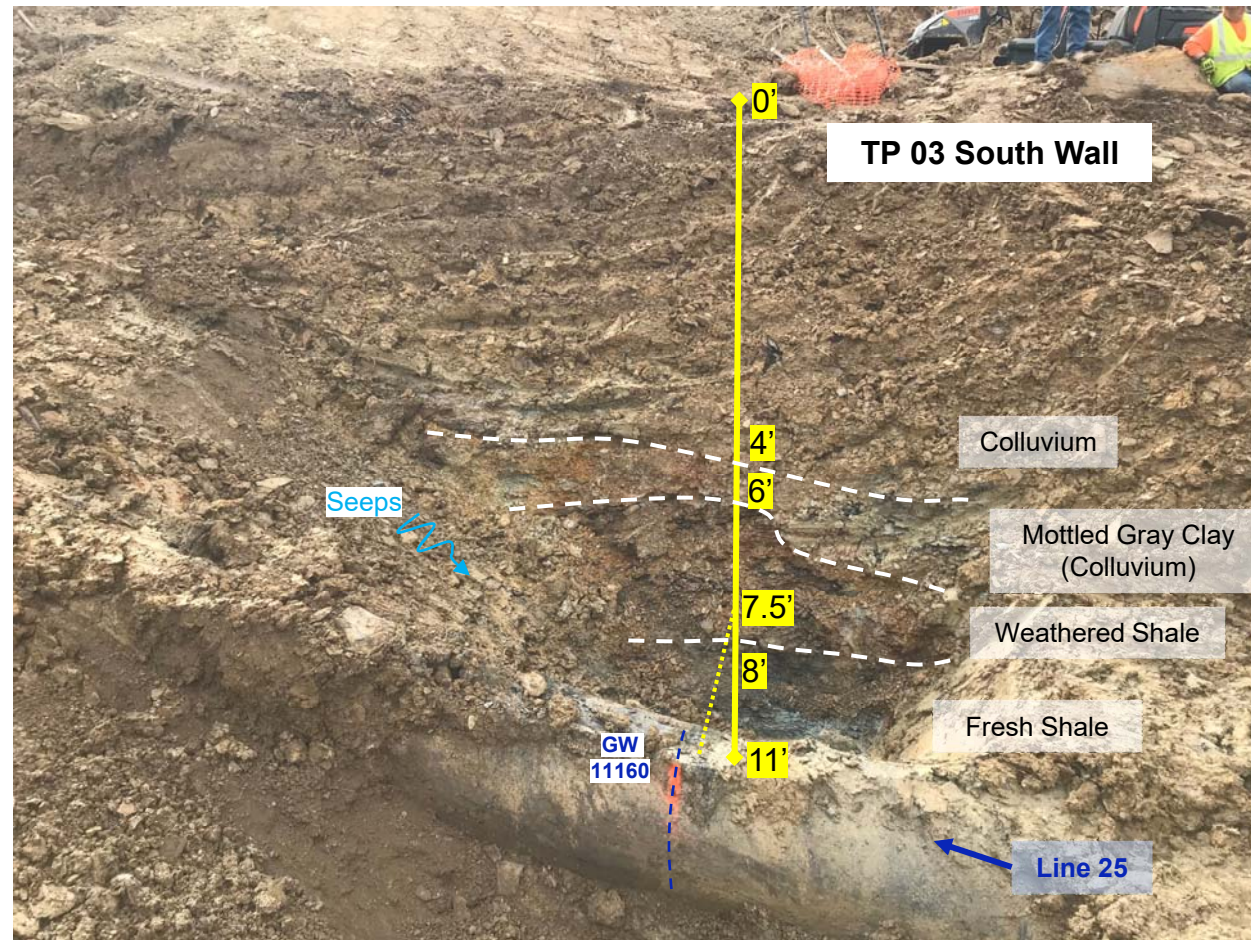
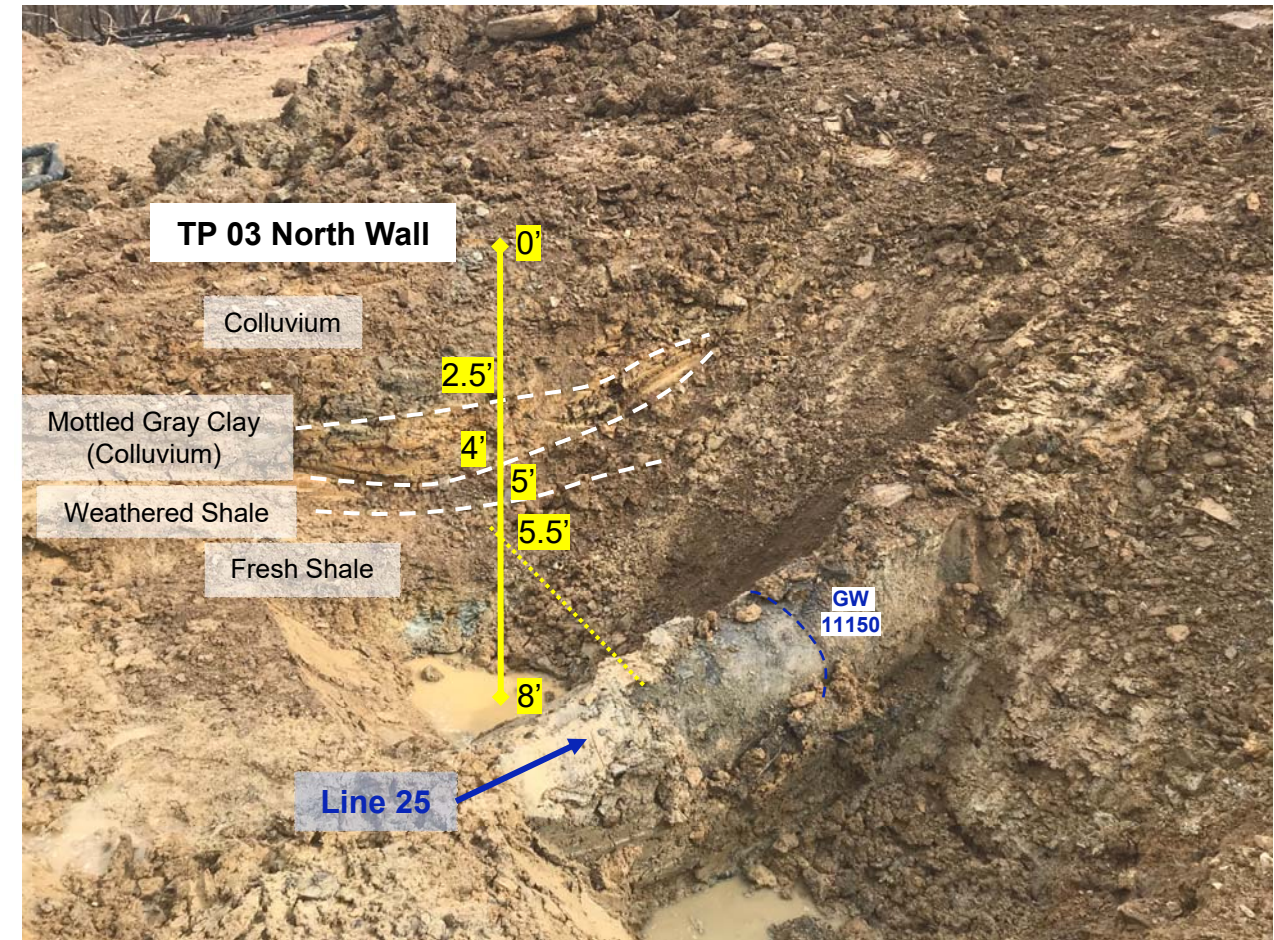
Test Pit 03: Photo logs of the south wall (left) and north wall (right) of a bell hole around GW 11160 of Line 25. The excavation shows that Line 25 is trenched in shale bedrock.

Feature	Depth (ft)
Colluvium-Mottled Gray Clay Contact	4
Mottled Gray Clay- Weathered Shale Contact	6
Top Of Pipe	7.5
Weathered Shale-Fresh Shale Contact	8
Bottom of Excavation	11

Feature	Depth (ft)
Colluvium-Mottled Gray Clay Contact	2.5
Mottled Gray Clay- Weathered Shale Contact	4
Weathered Shale-Fresh Shale Contact	5
Top of Pipe	5.5
Bottom of Excavation	8

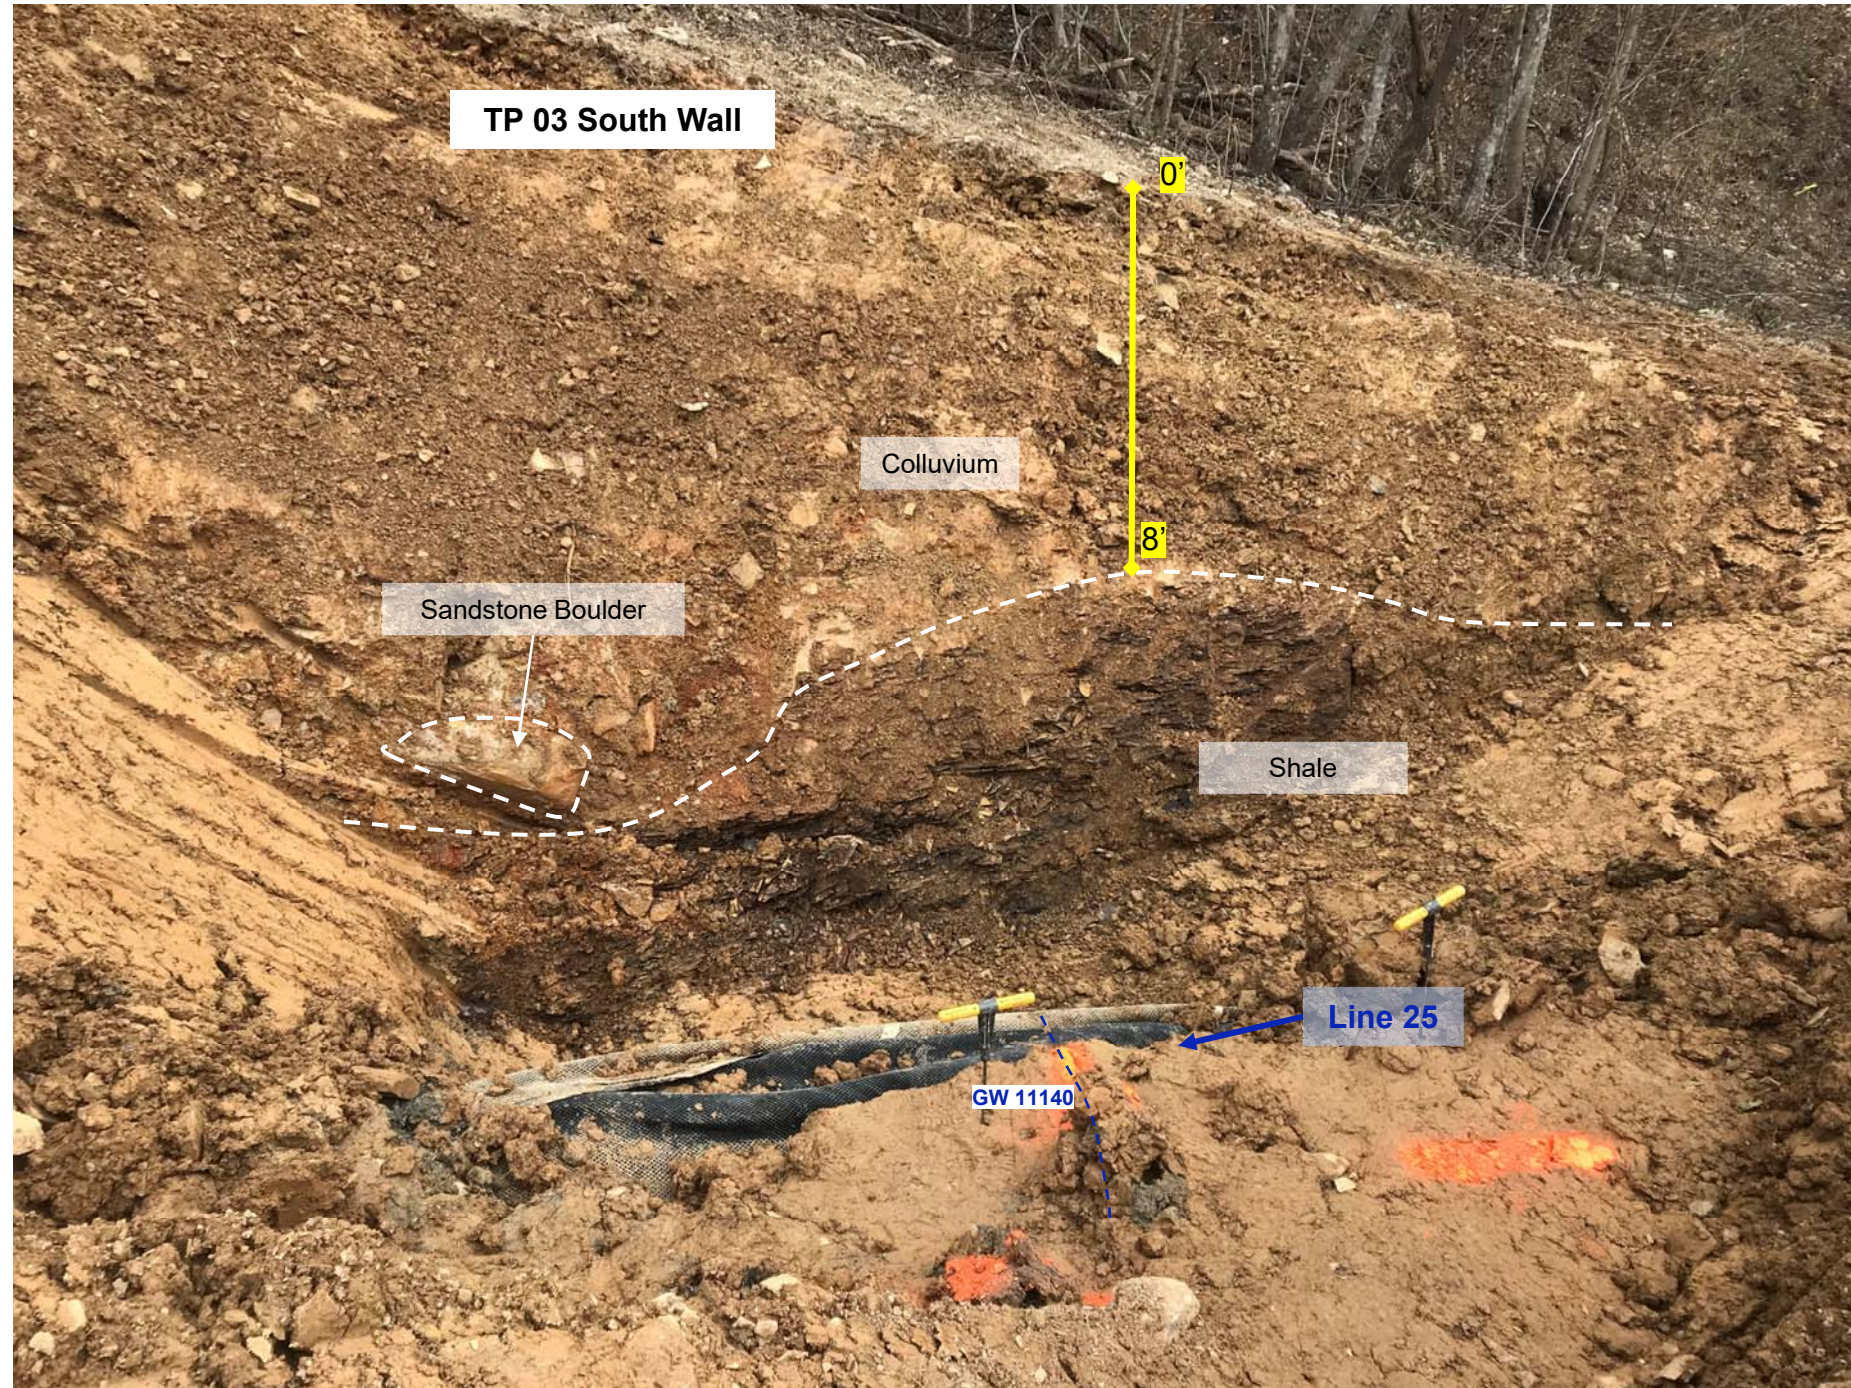
Test Pit 04: Photo log showing fresh shale exposed above the elevation of Line 25.

Feature	Depth (ft)
Bedrock contact	8

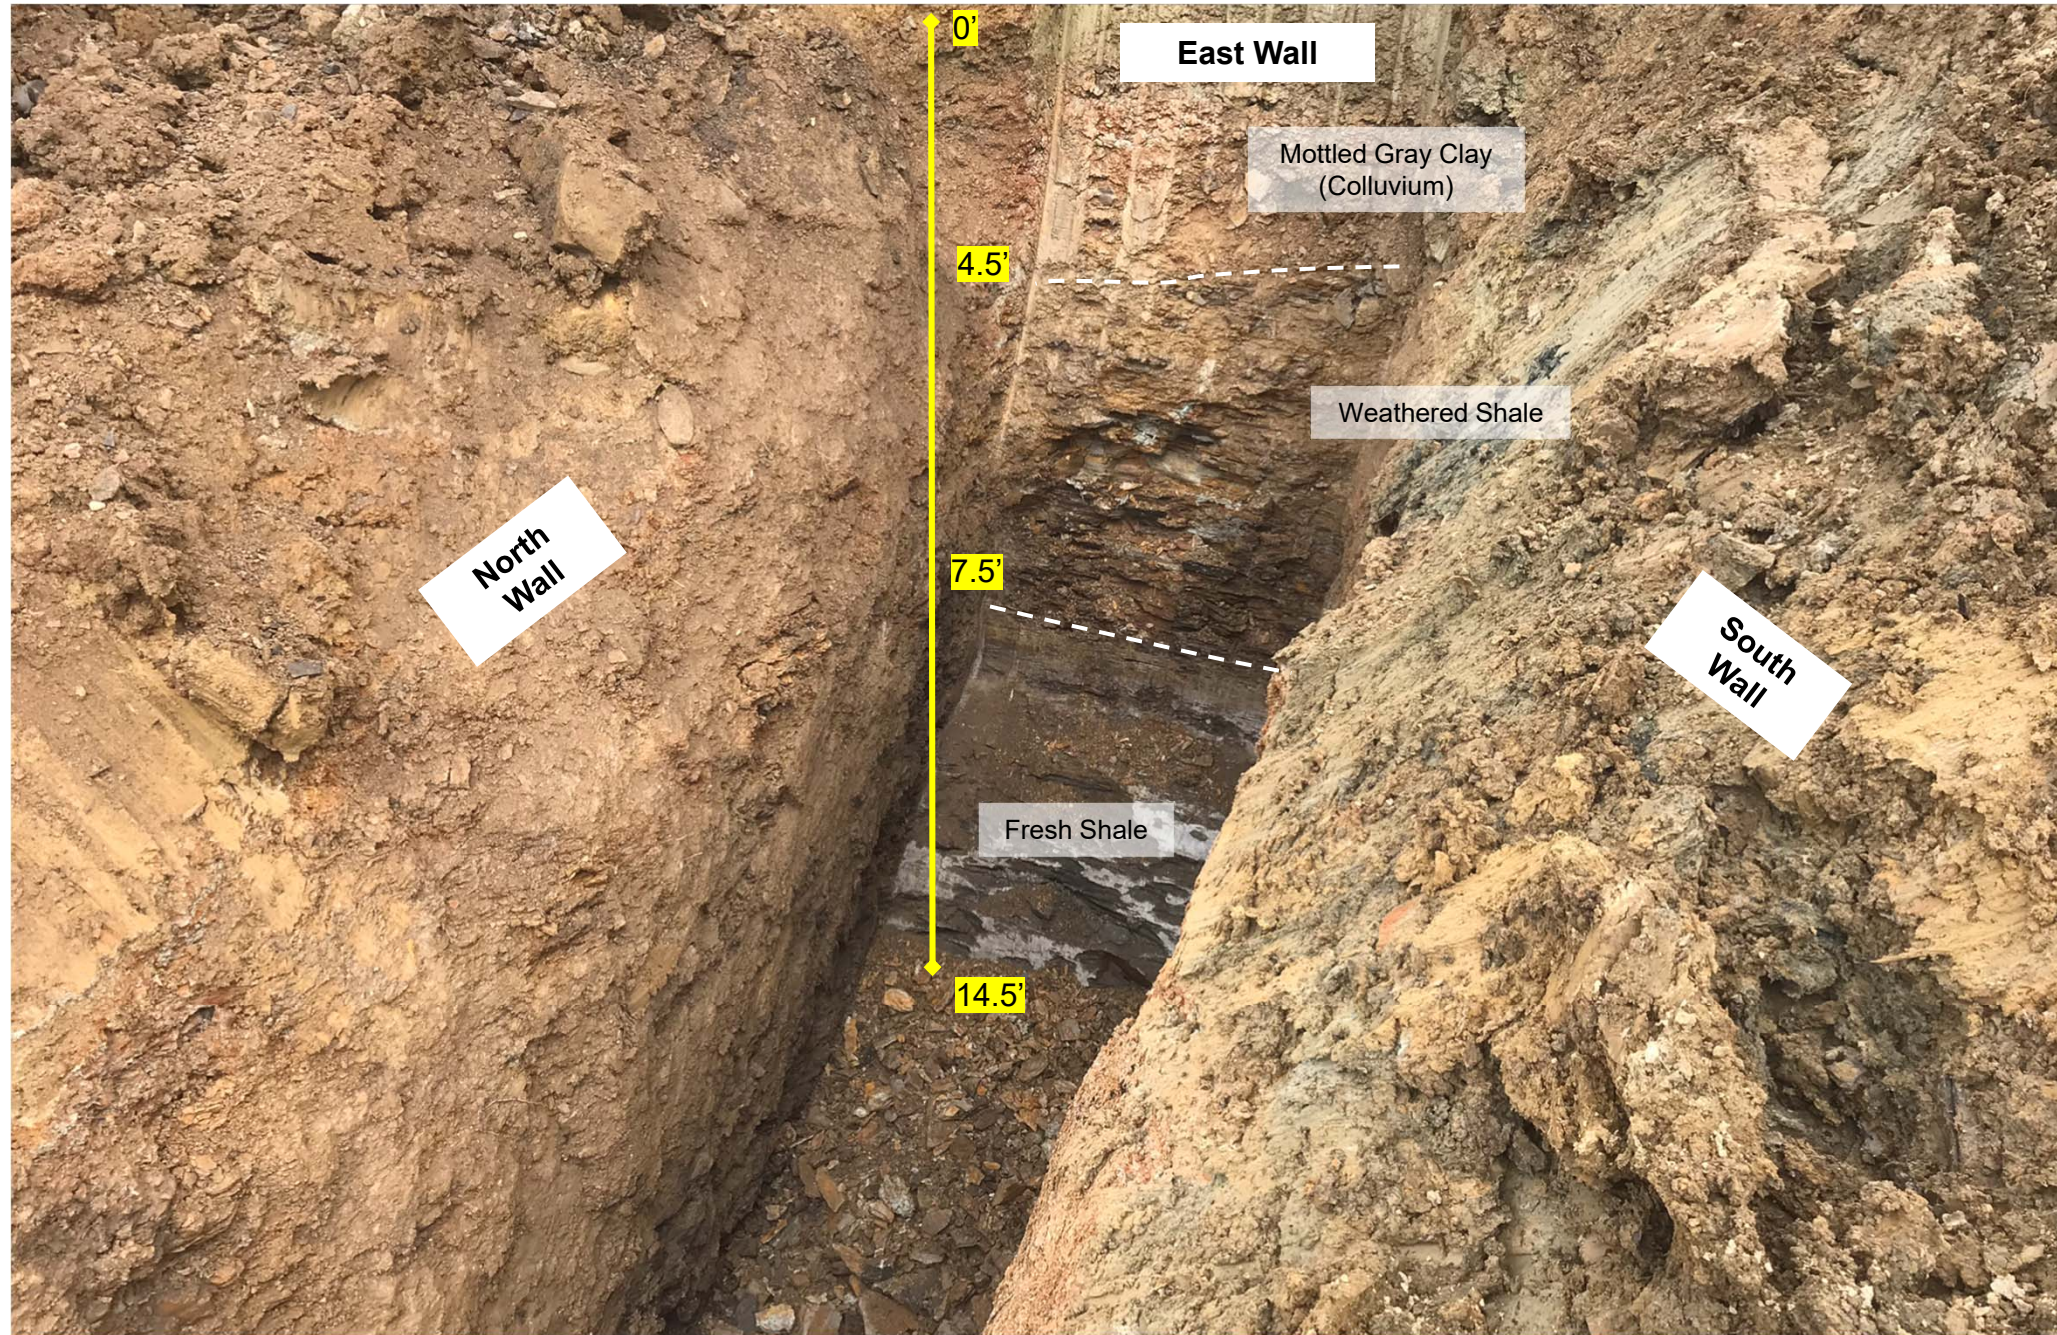
Feature	Depth (ft)
Mottled Gray Clay- Weathered Shale Contact	4.5
Weathered Shale-Fresh Shale Contact	7.5
Bottom of Excavation	14.5

Test Pit 05: Photo log showing fresh shale exposed at the base of the excavation.

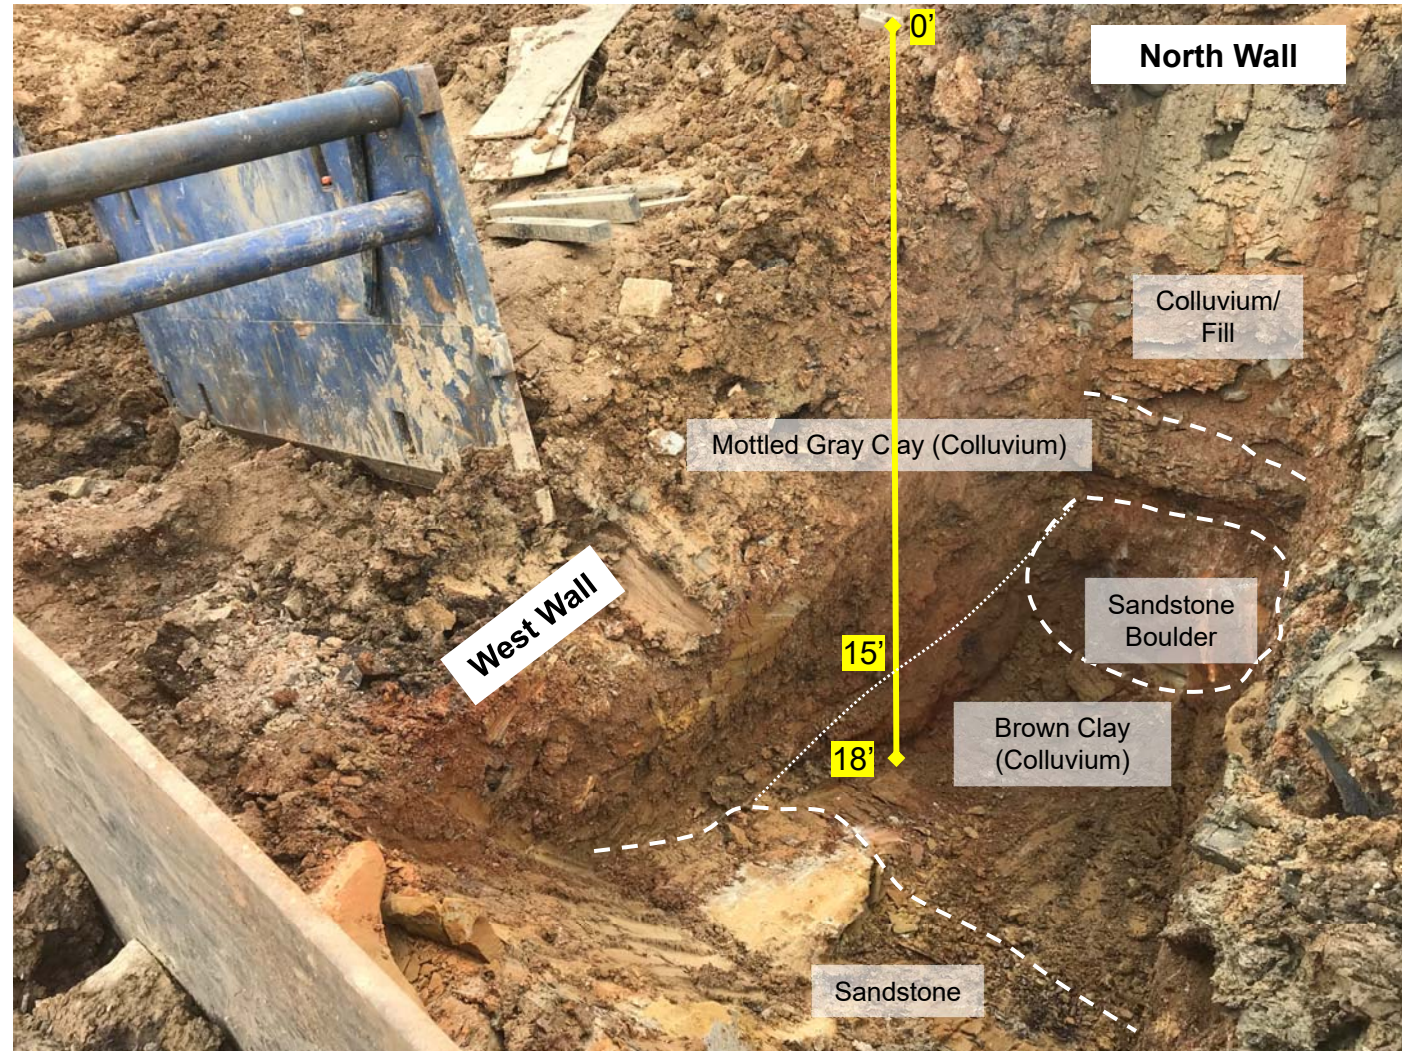
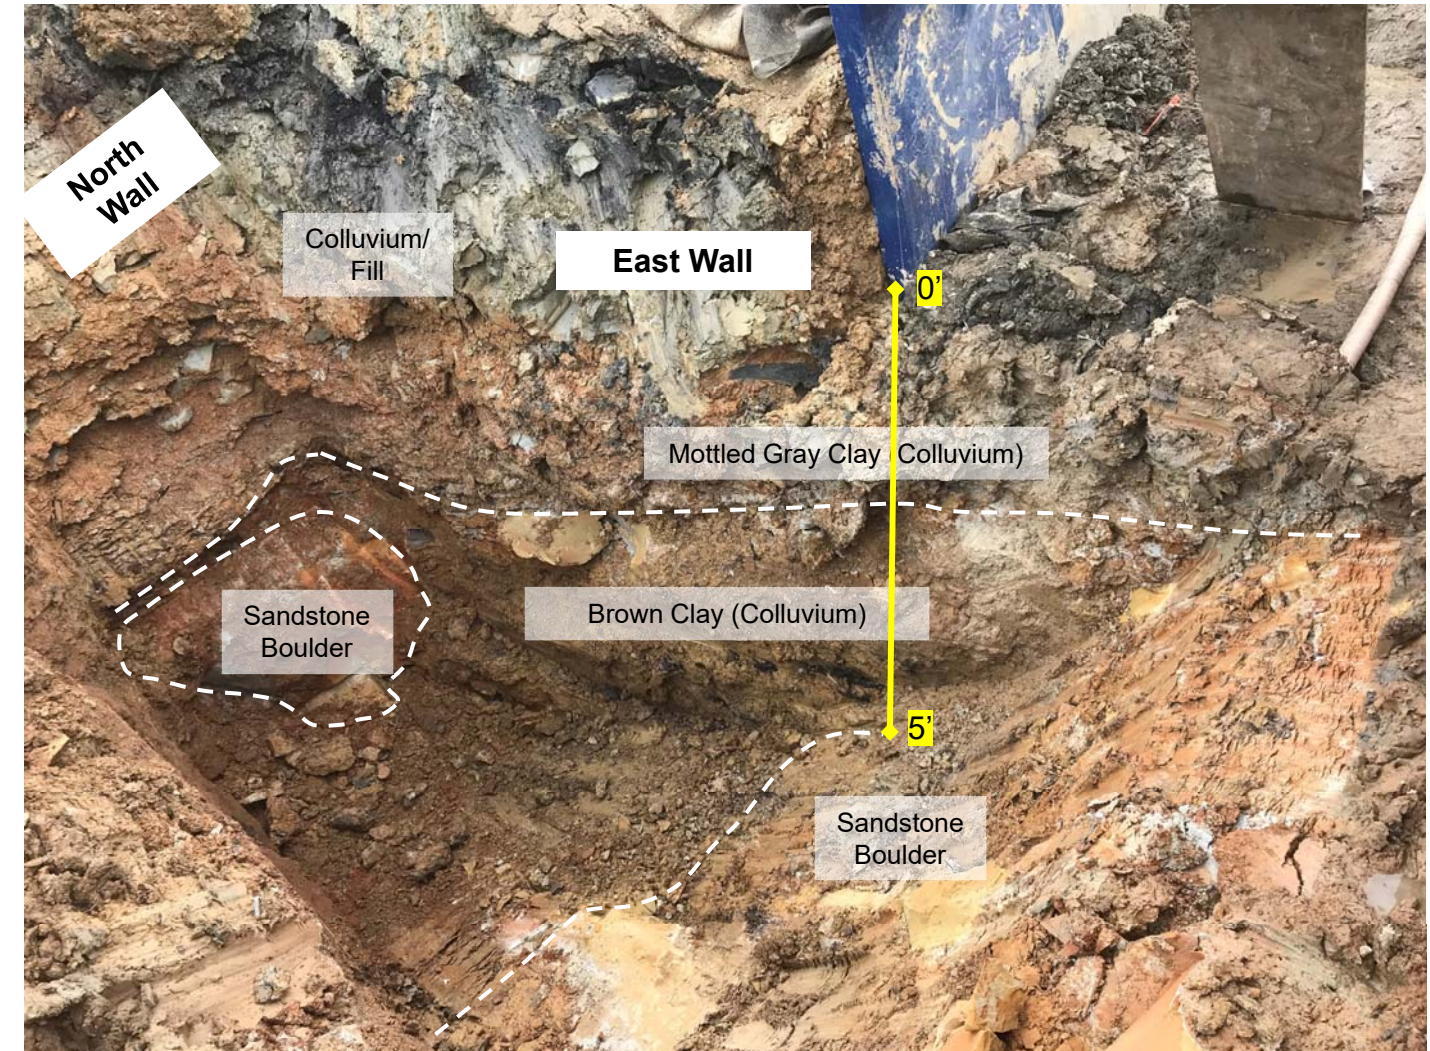
Test Pit 06: Photo logs of the west wall (left) and east wall (right) showing sandstone (interpreted as boulders) exposed at the base of the excavation.

Feature	Depth (ft)
Top of Sandstone Boulder	15
Bottom of Excavation	18

Feature	Depth (ft)
Top of Sandstone Boulder	5 (from trench bottom)

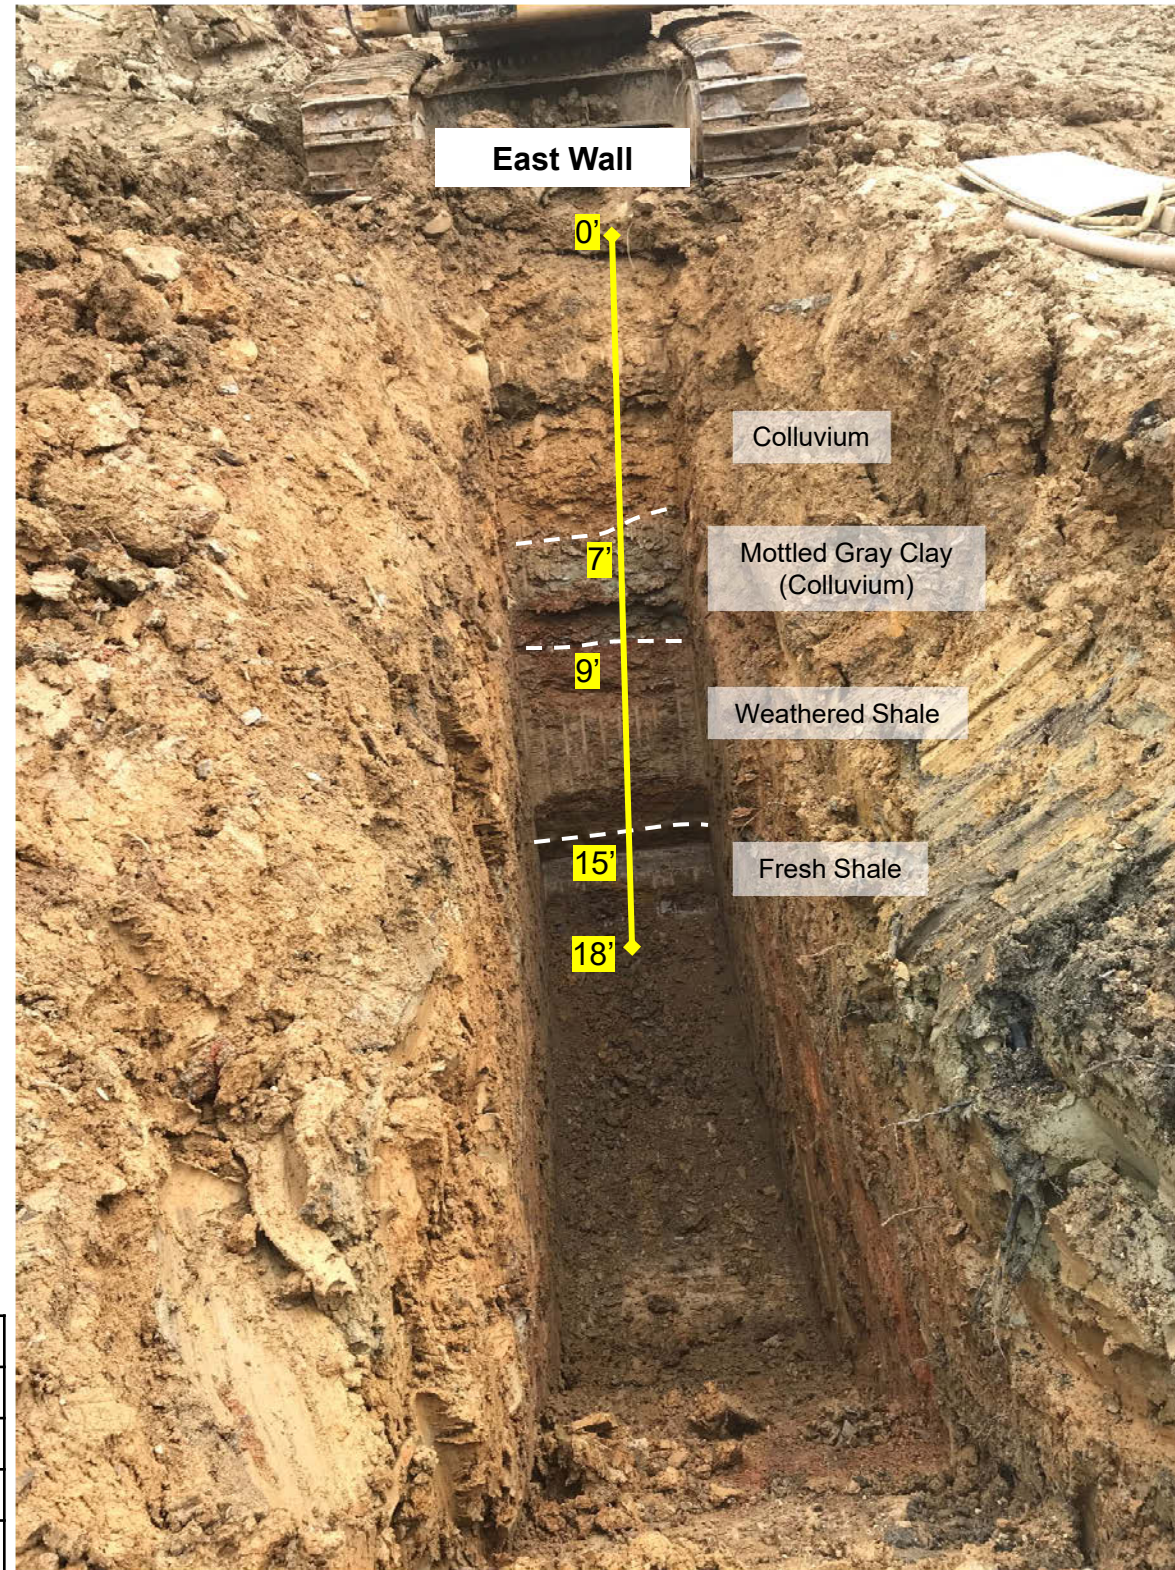
Test Pit 6A: Photo log showing fresh shale exposed at the base of the excavation.

Feature	Depth (ft)
Top of Mottled Gray Clay	7
Mottled Gray Clay- Weathered Shale Contact	9
Weathered Shale-Fresh Shale Contact	15
Bottom of Excavation	18

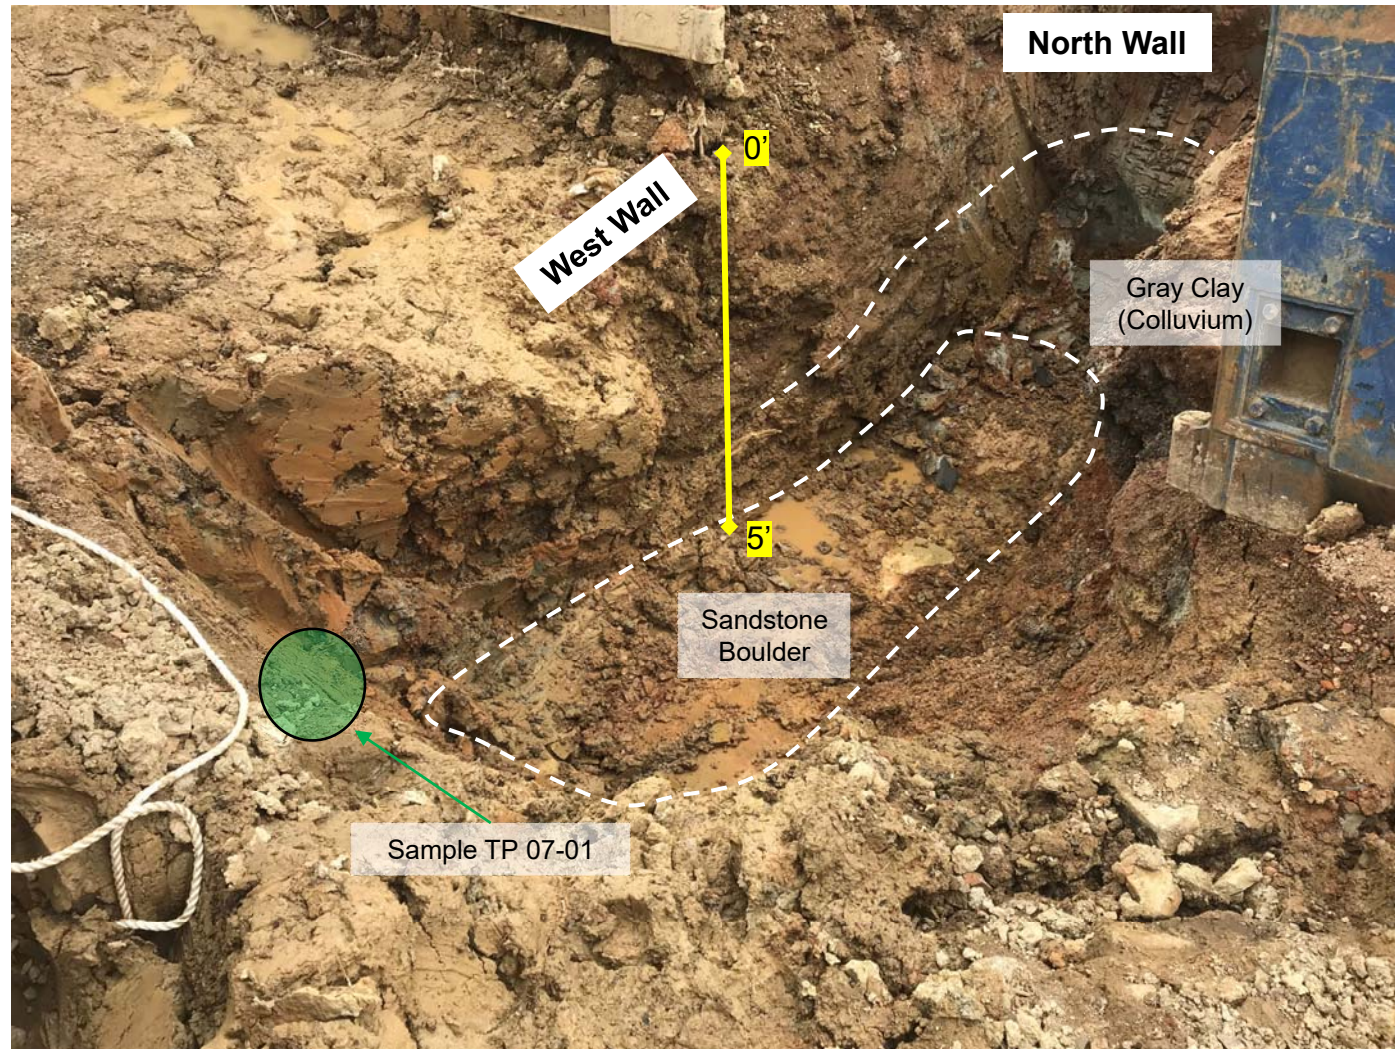
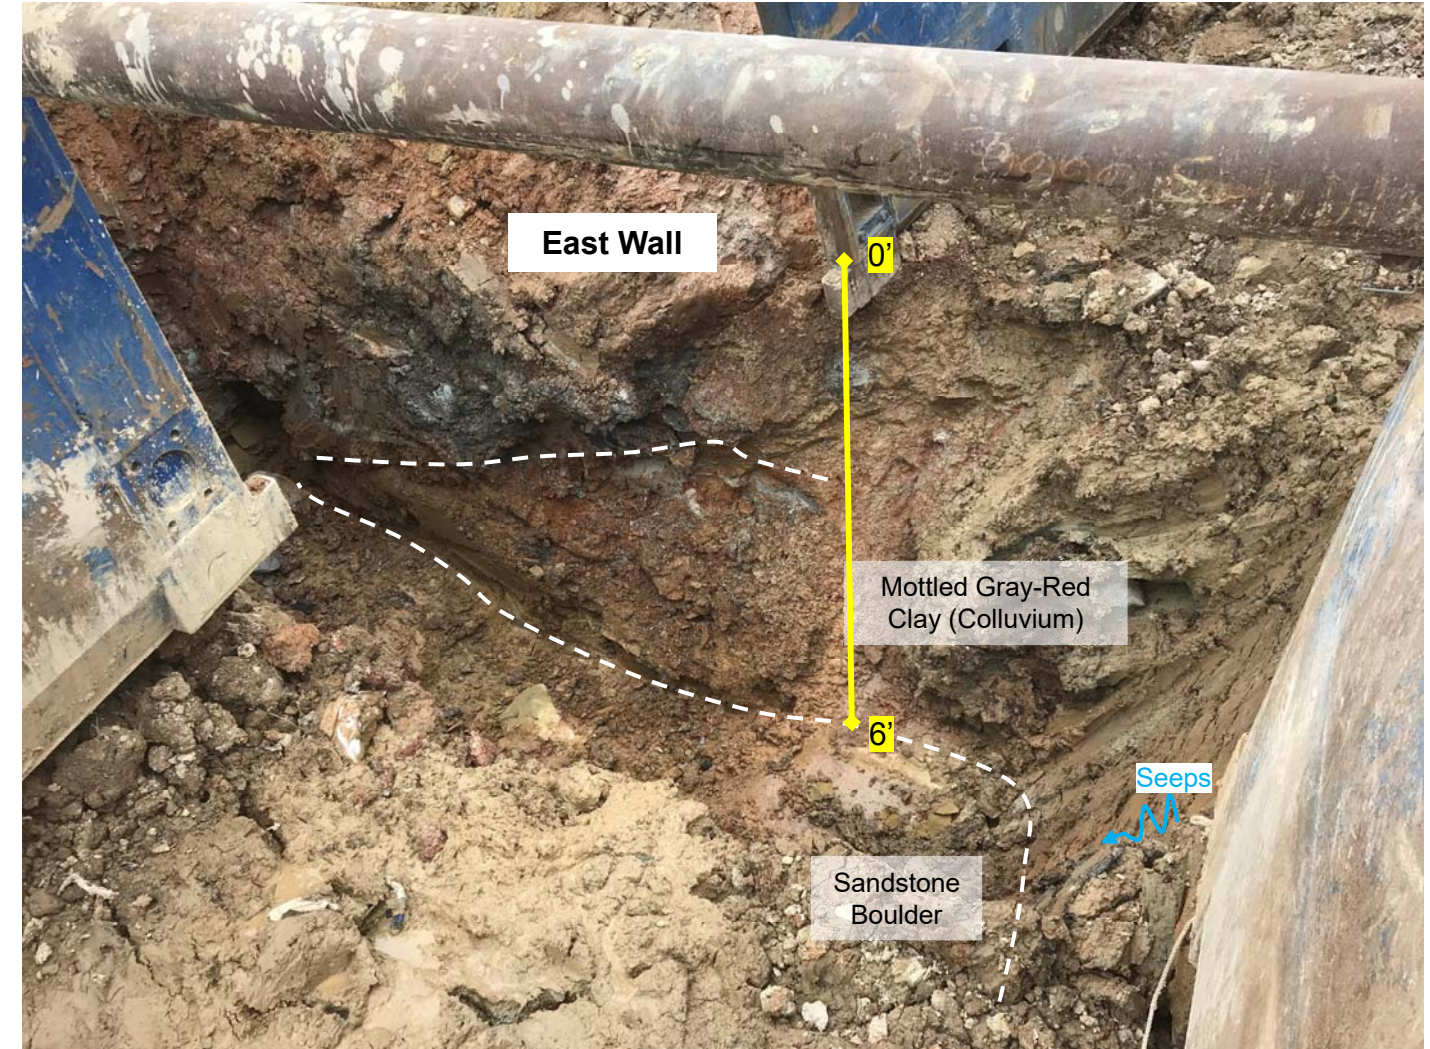
Tet Pit 07: Photo logs of west wall (left) and east wall (right) showing sandstone (interpreted as boulders) exposed at the base of the excavation. The test pit was dug perpendicular to the excavation of Line 10.

Feature	Depth (ft)
Top of Sandstone Boulder	5 (from trench bottom)

Feature	Depth (ft)
Top of Sandstone Boulder	6 (from trench bottom)

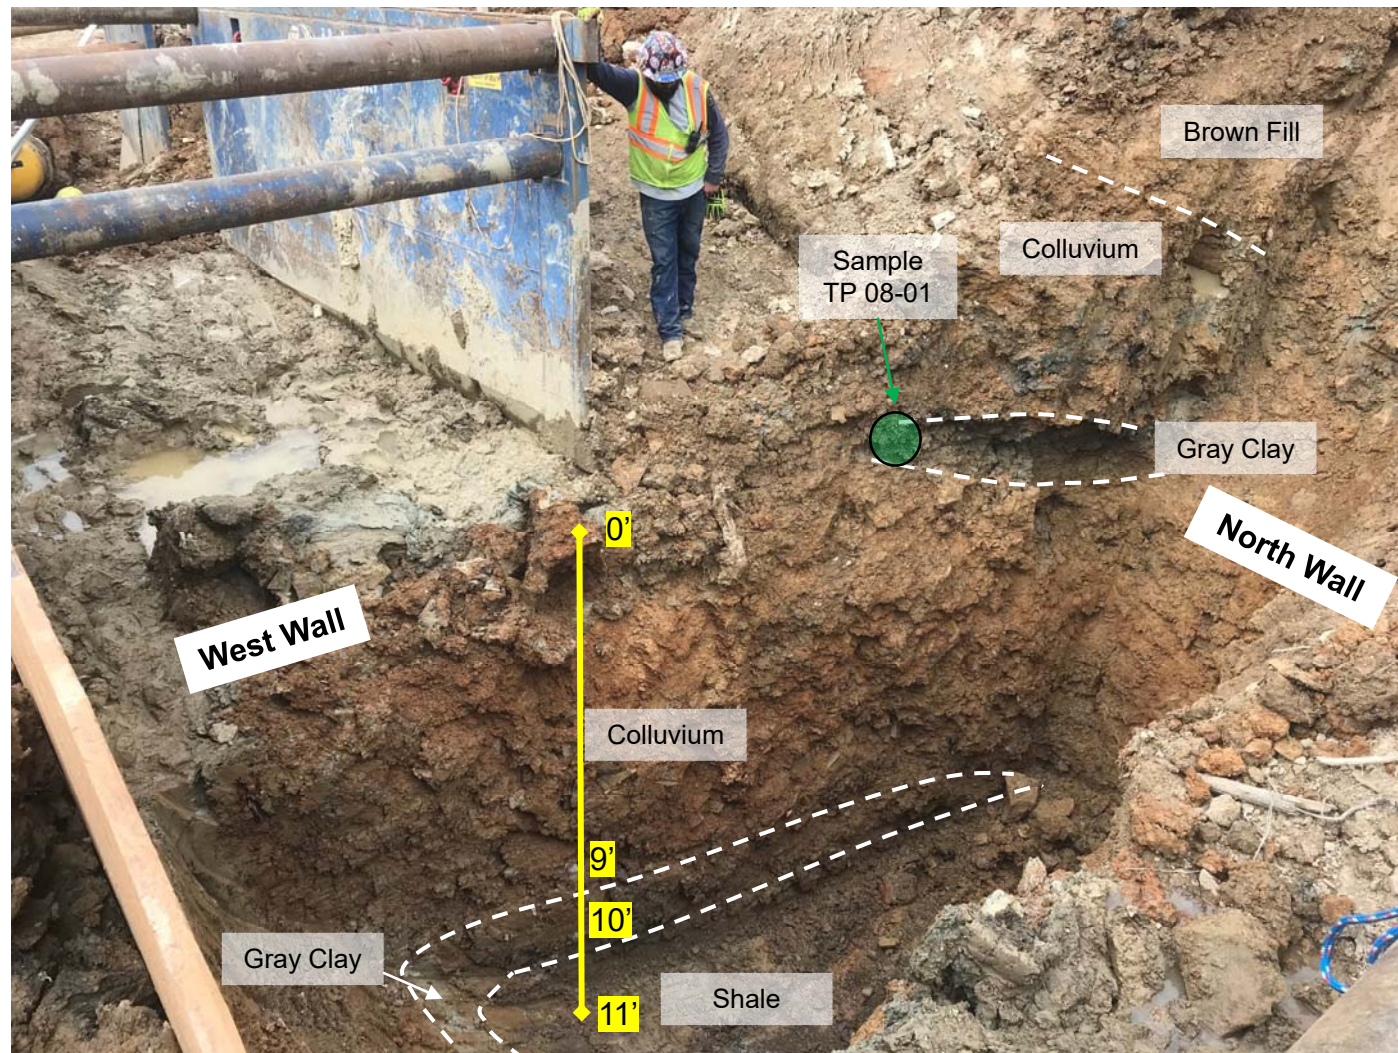
Test Pit 08: Photo logs of the west wall (left) and east wall (right) showing fresh shale exposed at the base of the excavation. The test pit was dug perpendicular to the excavation of Line 10.

Feature	Depth from trench bottom (ft)
Top of Gray Clay	9
Shale (Bedrock) Contact	10
Bottom of Excavation	11

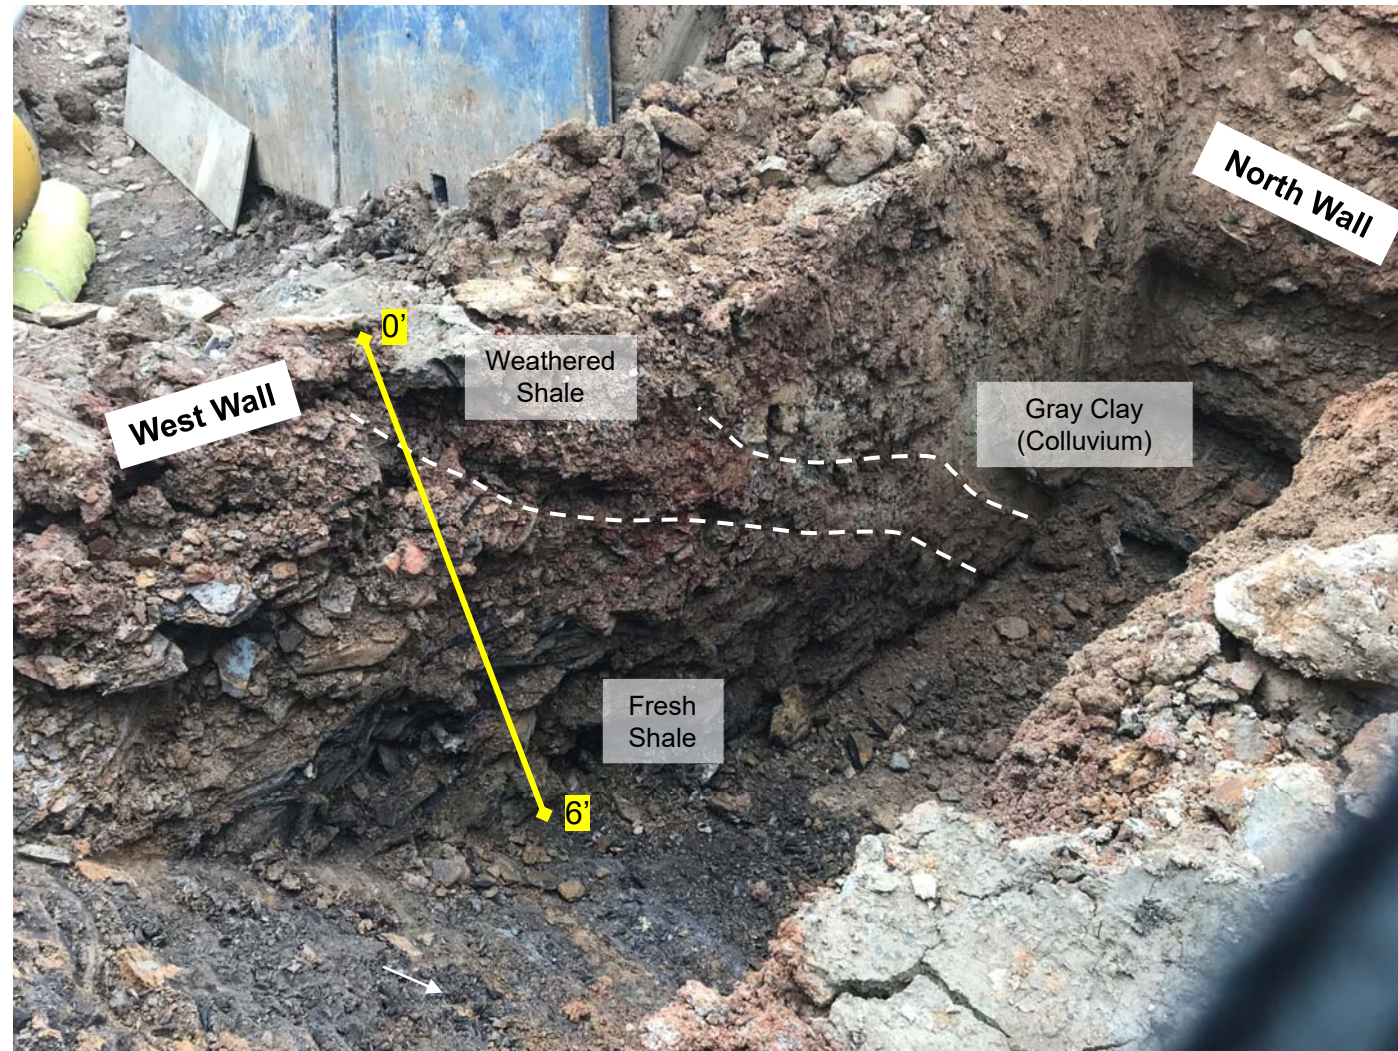
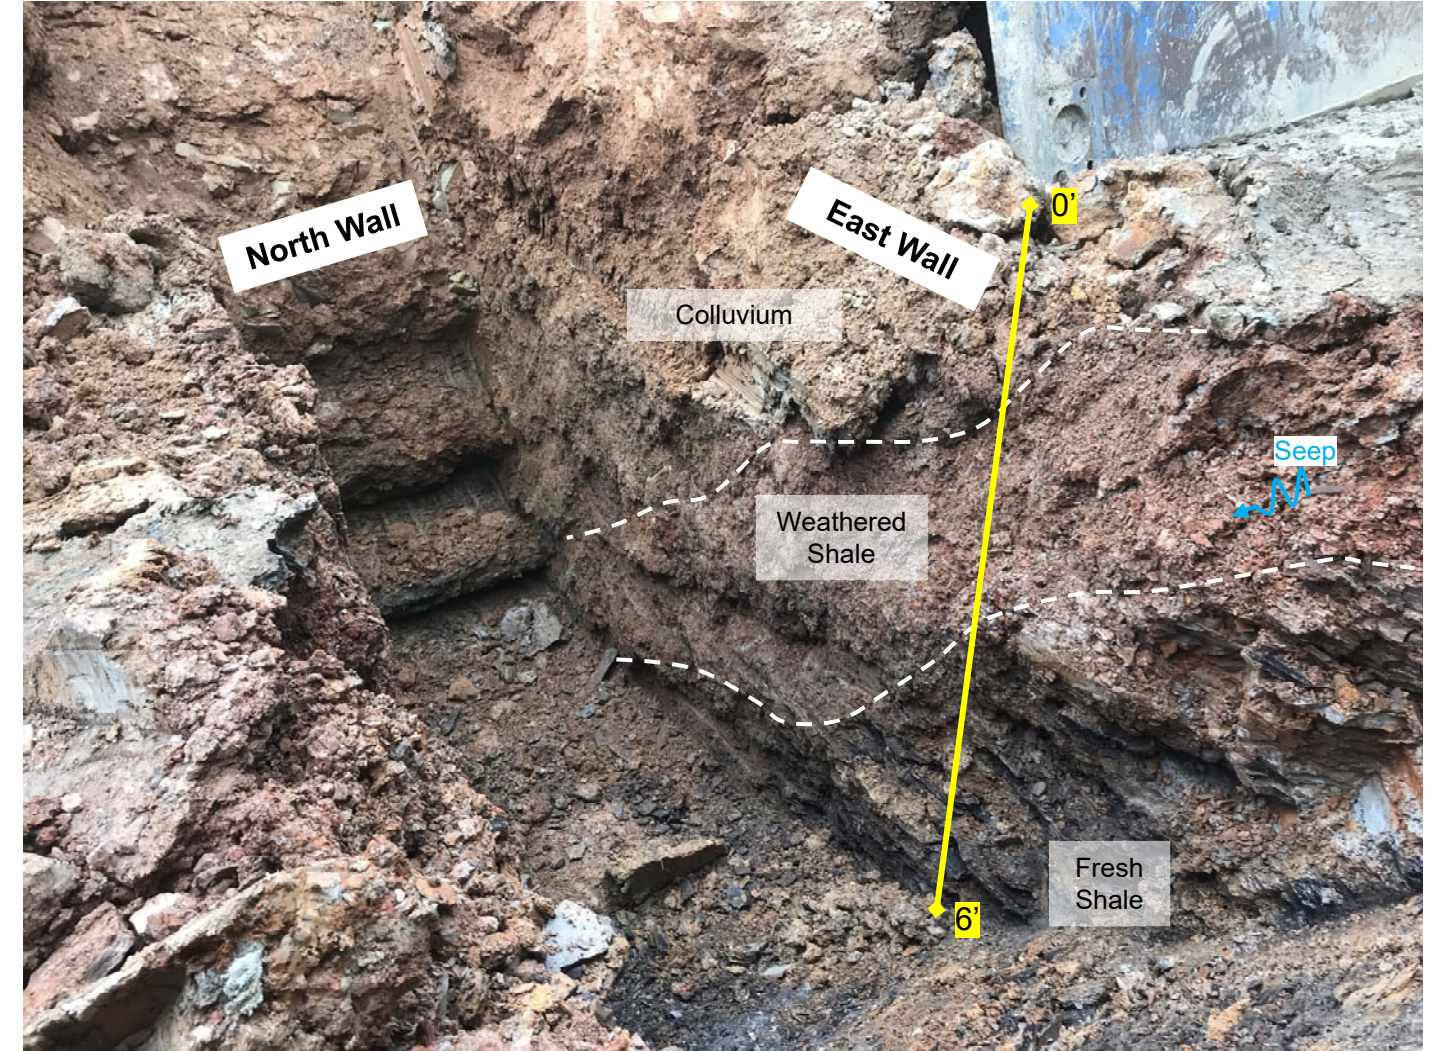
PREPARED BY: WCD	FIGURE TITLE TP 09 PHOTO LOG		
CHECKED BY: TM	CLIENT: TEXAS EASTERN TRANSMISSION, LP		
APPROVED BY: CAD	SCALE: AS SHOWN	PROJECT NO: 1607024	FIGURE NO: E-13

Test Pit 09: Photo logs of the test pit's west wall (left) and east wall (right) showing fresh shale exposed at the base of the excavation. The depth of shale bedrock dives steeply to the north. The test pit was dug perpendicular to the excavation of Line 10.

Feature	Depth from trench bottom (ft)
Bottom of Excavation	6

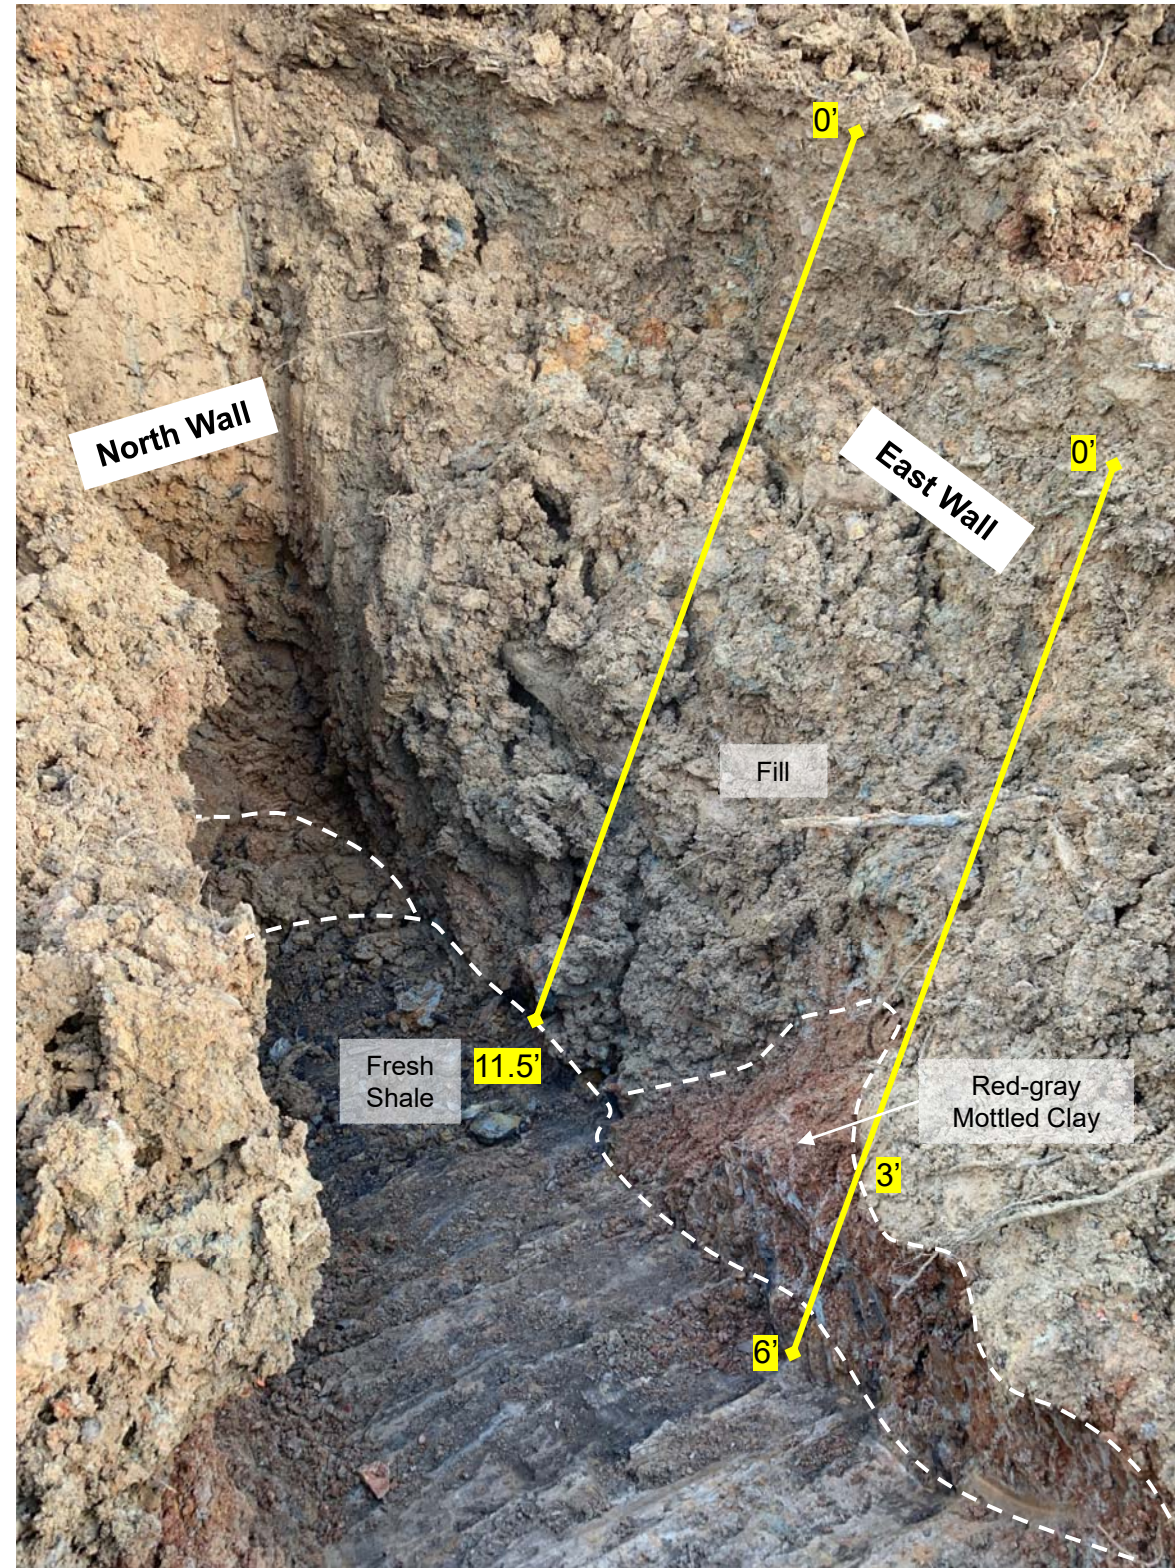
PREPARED BY: WCD	FIGURE TITLE TP 10 PHOTO LOG		
CHECKED BY: TM	CLIENT: TEXAS EASTERN TRANSMISSION, LP		
APPROVED BY: CAD	SCALE: AS SHOWN	PROJECT NO: 1607024	FIGURE NO: E-15

Test Pit 10: Photo log showing fresh shale exposed at the base of the excavation. The depth of the shale bedrock is measured at two locations along the east wall of the test pit.

Feature	Depth (ft)
Top of Red-Gray Mottled Clay	3
Bottom of Excavation/Shale (Bedrock) Contact	6 (to south) 11.5 (to north)
