## **TEXAS EASTERN TRANSMISSION, LP**

### **MAY 4, 2020 FLEMING COUNTY INCIDENT GEOTECHNICAL CAUSATION REPORT**

PROJECT NO.: 1607024  
DOCUMENT NO.: Rev A

DATE: April 26, 2021

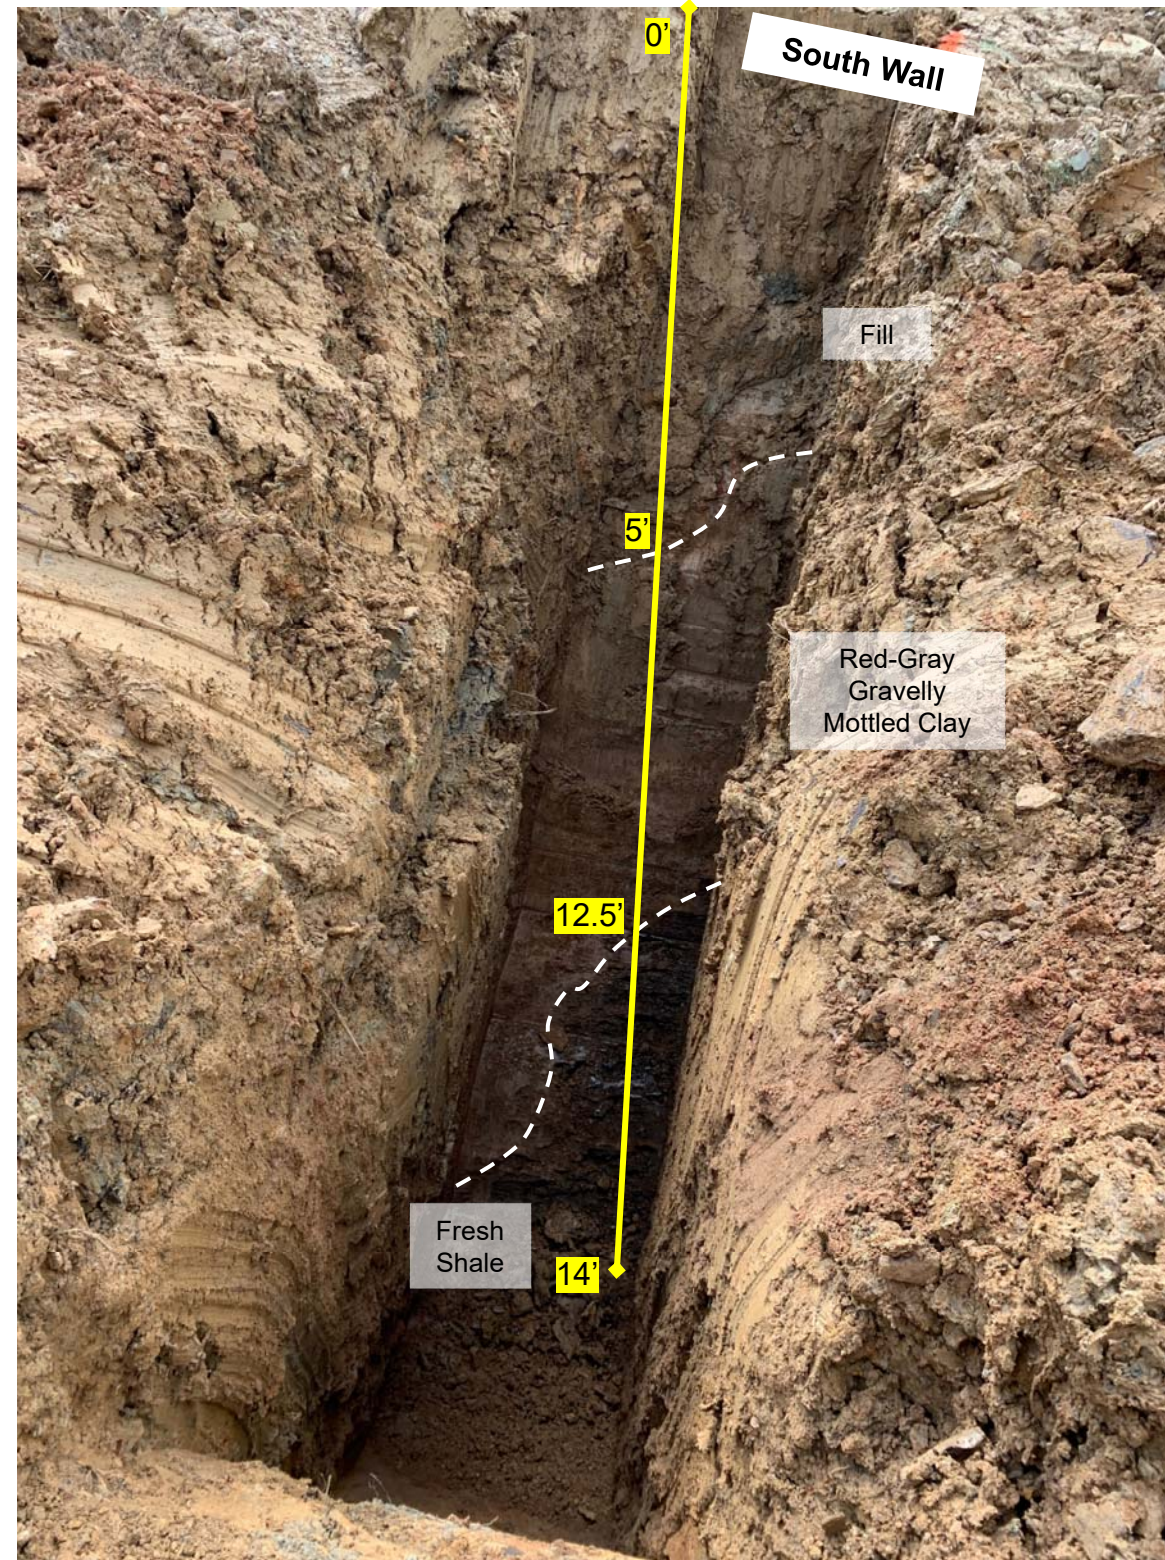
PREPARED BY: WCD	FIGURE TITLE TP 11 PHOTO LOG		
CHECKED BY: TM	CLIENT: TEXAS EASTERN TRANSMISSION, LP		
APPROVED BY: CAD	SCALE: AS SHOWN	PROJECT NO: 1607024	FIGURE NO: E-16

Test Pit 11: Photo log showing fresh shale exposed at the base of the excavation. The top of shale bedrock dives steeply to the east.

Feature	Depth (ft)
Top of Red-Gray Mottled Clay	5
Shale (Bedrock) Contact	12.5
Bottom of Excavation	14

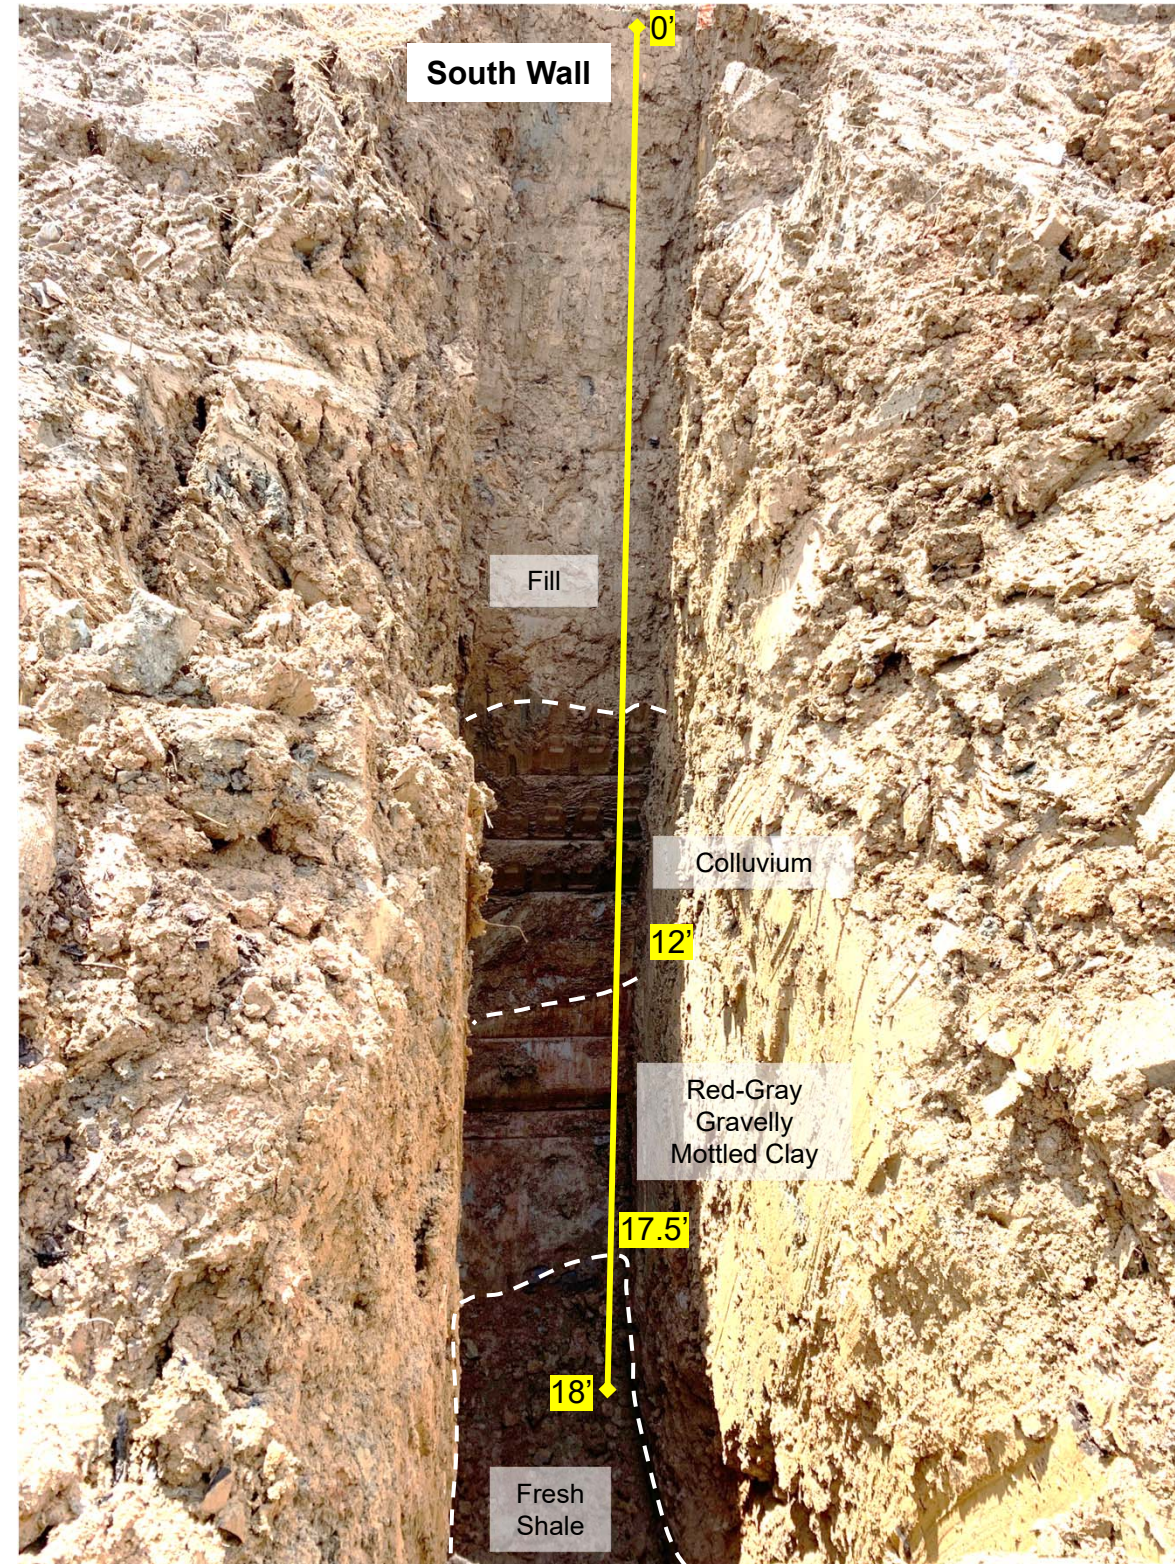
PREPARED BY: WCD	FIGURE TITLE TP 12 PHOTO LOG		
CHECKED BY: TM	CLIENT: TEXAS EASTERN TRANSMISSION, LP		
APPROVED BY: CAD	SCALE: AS SHOWN	PROJECT NO: 1607024	FIGURE NO: E-17

Test Pit 12: Photo log showing fresh shale exposed at the base of the excavation.

Feature	Depth (ft)
Top of Red-Gray Mottled Clay	12
Shale (Bedrock) Contact	17.5
Bottom of Excavation	18

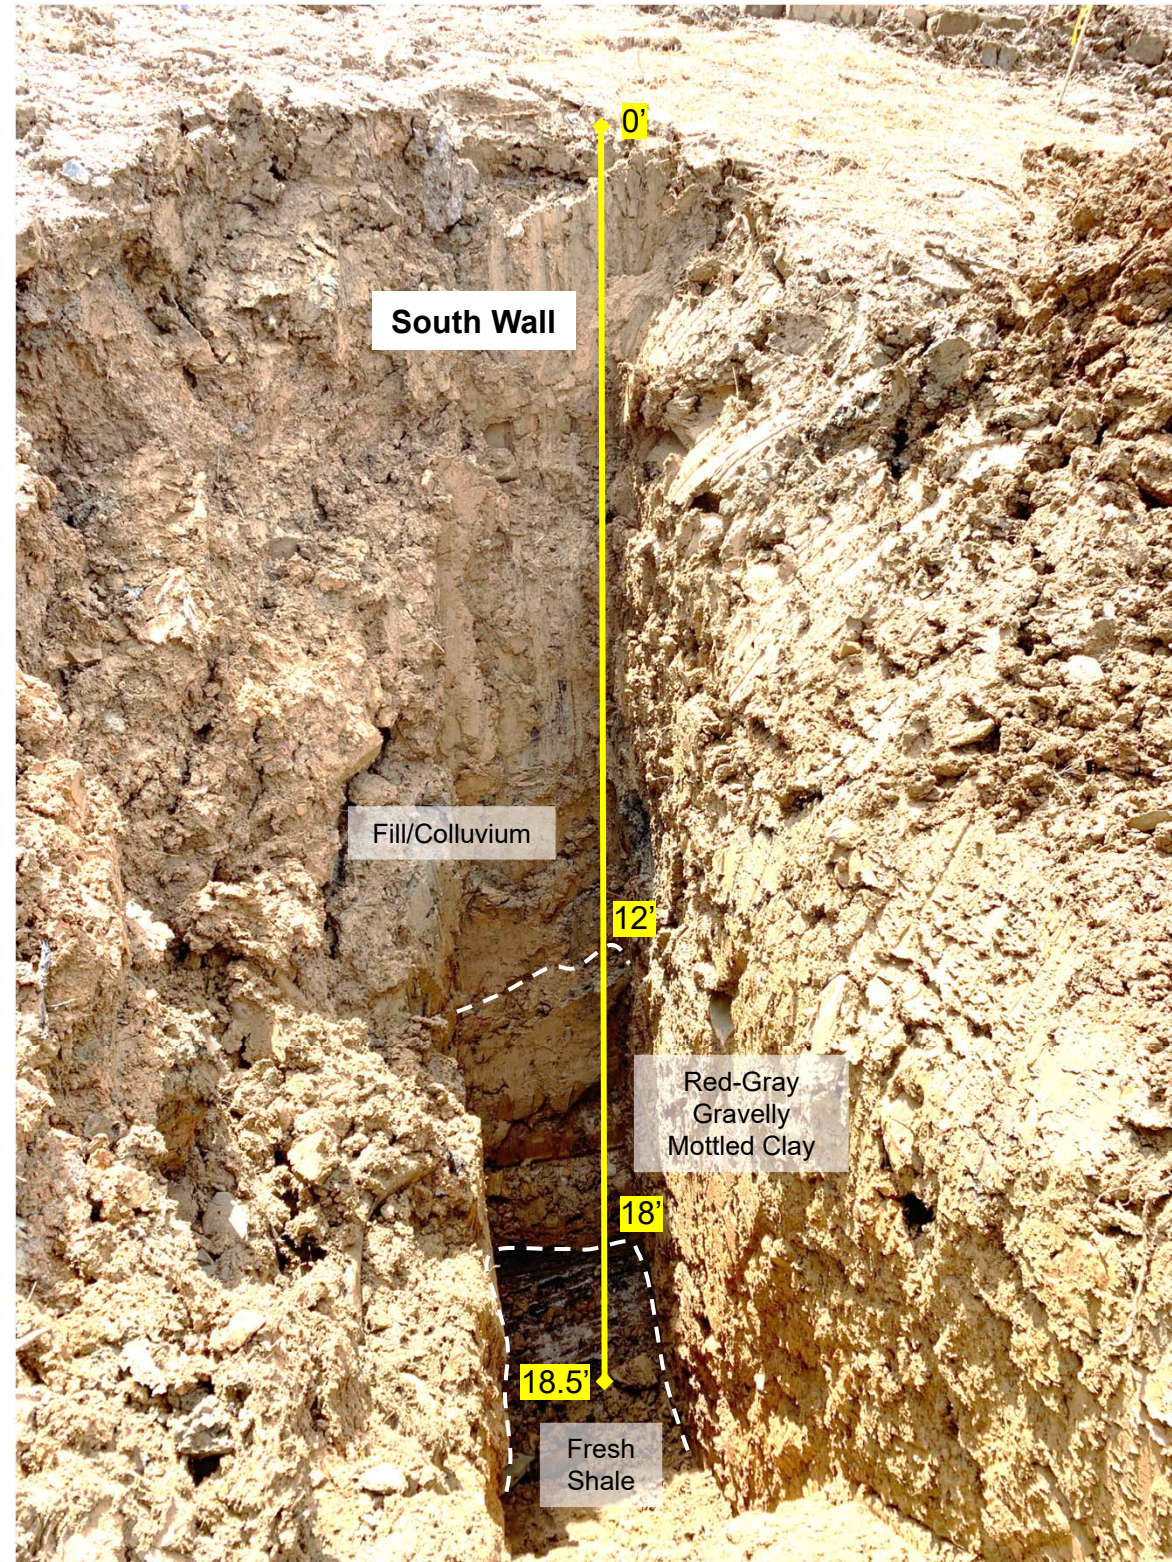
PREPARED BY: WCD	FIGURE TITLE TP 13 PHOTO LOG		
CHECKED BY: TM	CLIENT: TEXAS EASTERN TRANSMISSION, LP		
APPROVED BY: CAD	SCALE: AS SHOWN	PROJECT NO: 1607024	FIGURE NO: E-18

Test Pit 13: Photo log showing fresh shale exposed at the base of the excavation. Depths were estimated due to unsafe conditions around the excavation.

Feature	Depth (ft)
Top of Red-Gray Mottled Clay	12
Shale (Bedrock) Contact	18
Bottom of Excavation	18.5

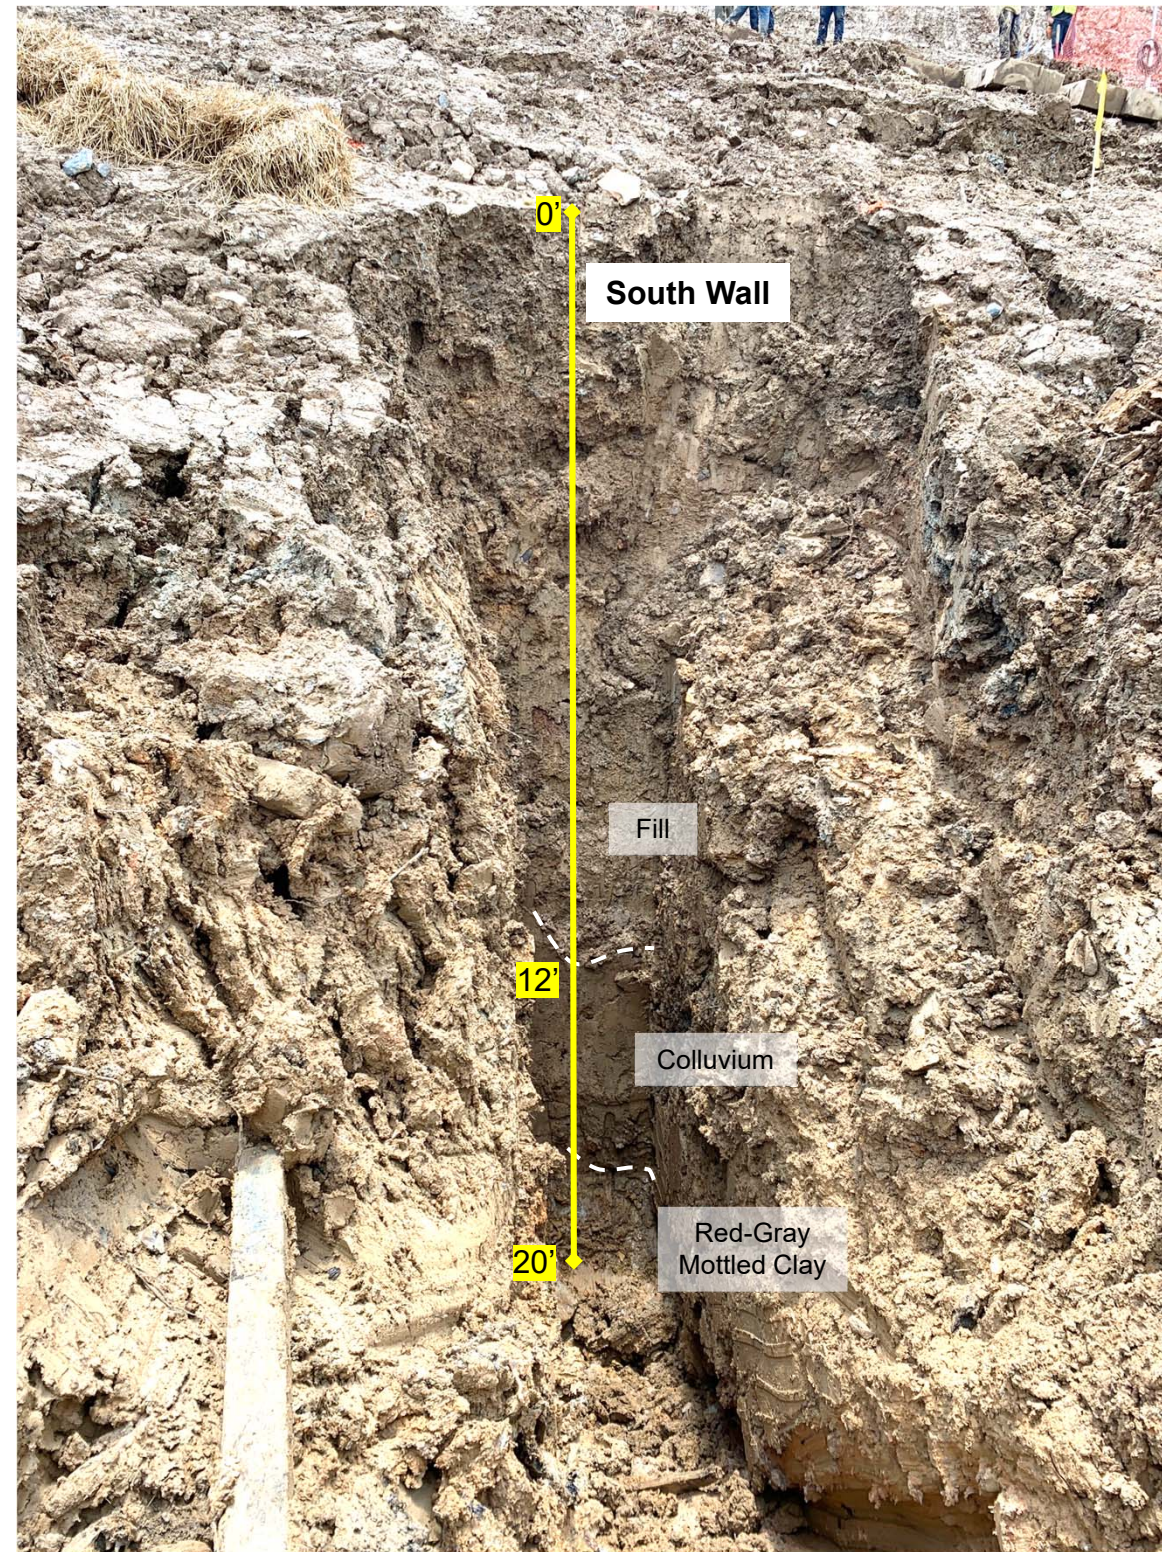
PREPARED BY: WCD	FIGURE TITLE TP 14 PHOTO LOG		
CHECKED BY: TM	CLIENT: TEXAS EASTERN TRANSMISSION, LP		
APPROVED BY: CAD	SCALE: AS SHOWN	PROJECT NO: 1607024	FIGURE NO: E-19

Test Pit 14: Photo log showing red-gray mottled clay exposed at the base of the excavation. Depths were estimated due to unsafe conditions around the excavation.

Feature	Depth (ft)
Fill-Colluvium Contact	12
Bottom of Excavation	20

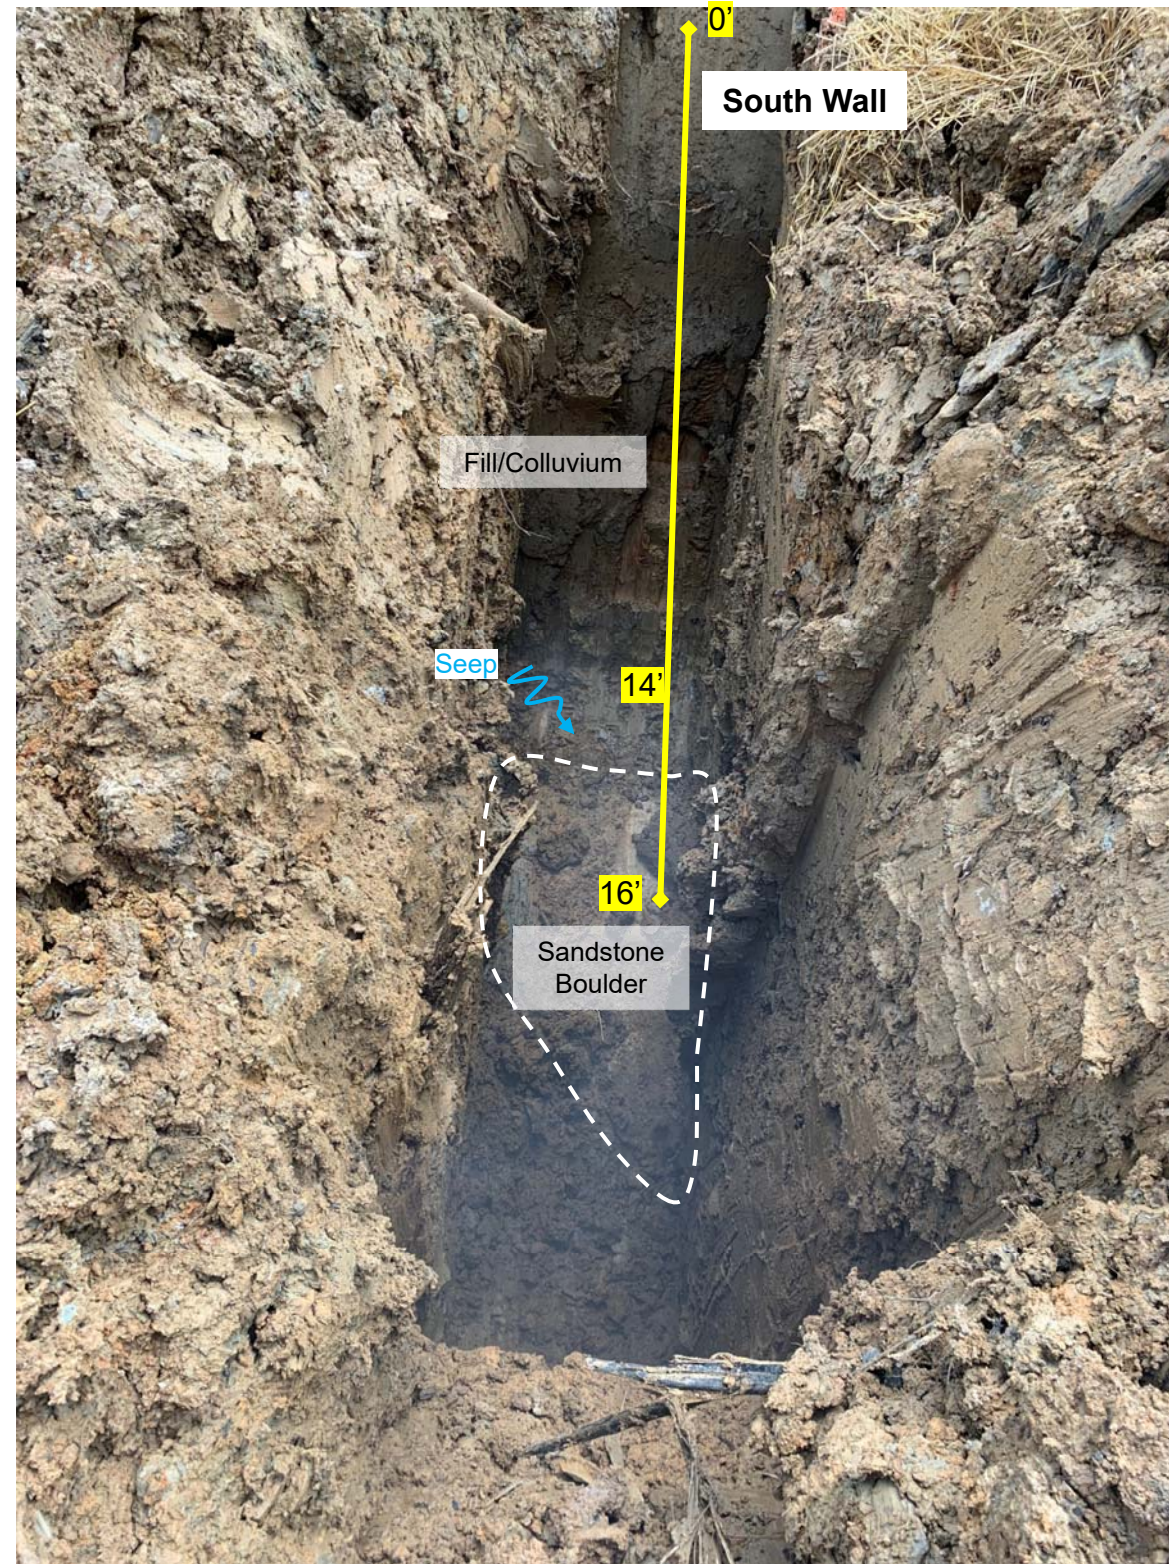
PREPARED BY: WCD	FIGURE TITLE TP 15 PHOTO LOG		
CHECKED BY: TM	CLIENT: TEXAS EASTERN TRANSMISSION, LP		
APPROVED BY: CAD	SCALE: AS SHOWN	PROJECT NO: 1607024	FIGURE NO: E-20

Test Pit 15: Sandstone floors the bottom of excavation (interpreted as boulders). Test pit concluded upon refusal at the sandstone.

Feature	Depth (ft)
Seep	14
Bottom of Excavation/Top of Sandstone Boulder	16

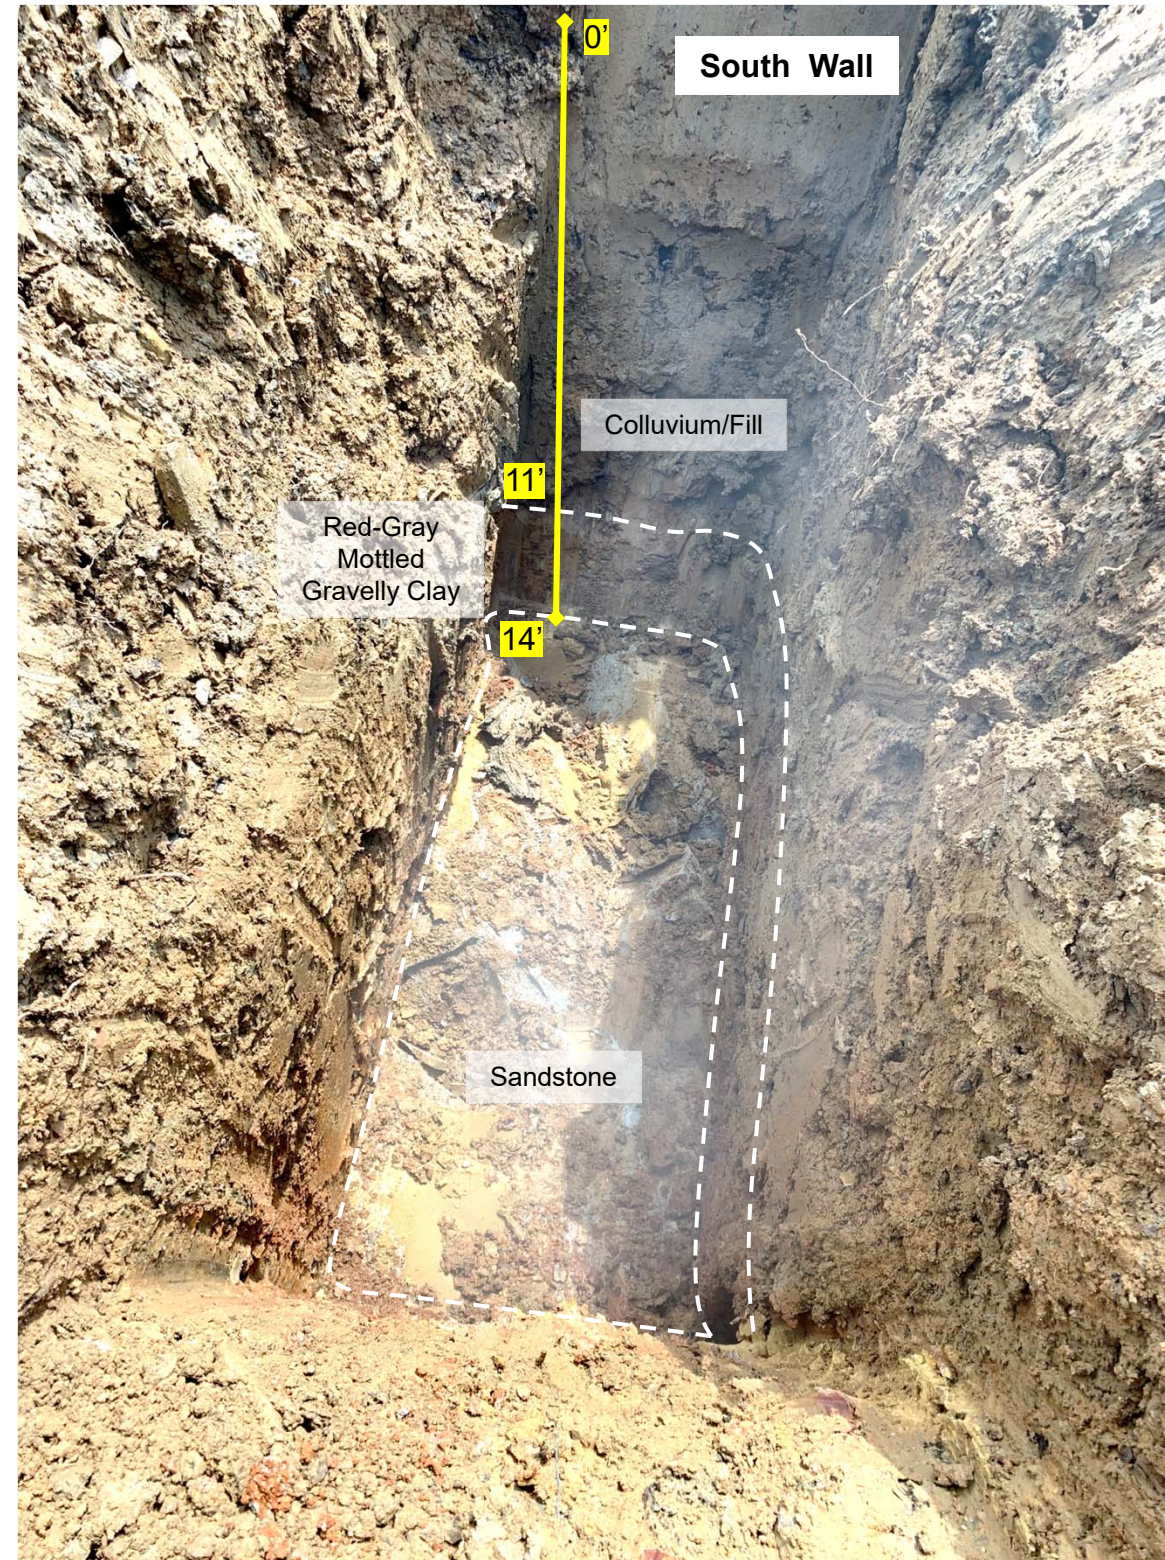
PREPARED BY: WCD	FIGURE TITLE TP 16 PHOTO LOG		
CHECKED BY: TM	CLIENT: TEXAS EASTERN TRANSMISSION, LP		
APPROVED BY: CAD	SCALE: AS SHOWN	PROJECT NO: 1607024	FIGURE NO: E-21

Test Pit 16: Test pit concluded upon refusal at the sandstone (interpreted as boulders).

Feature	Depth (ft)
Top of Red-Gray Gravelly Clay	11
Bottom of Excavation/Top of Sandstone	14

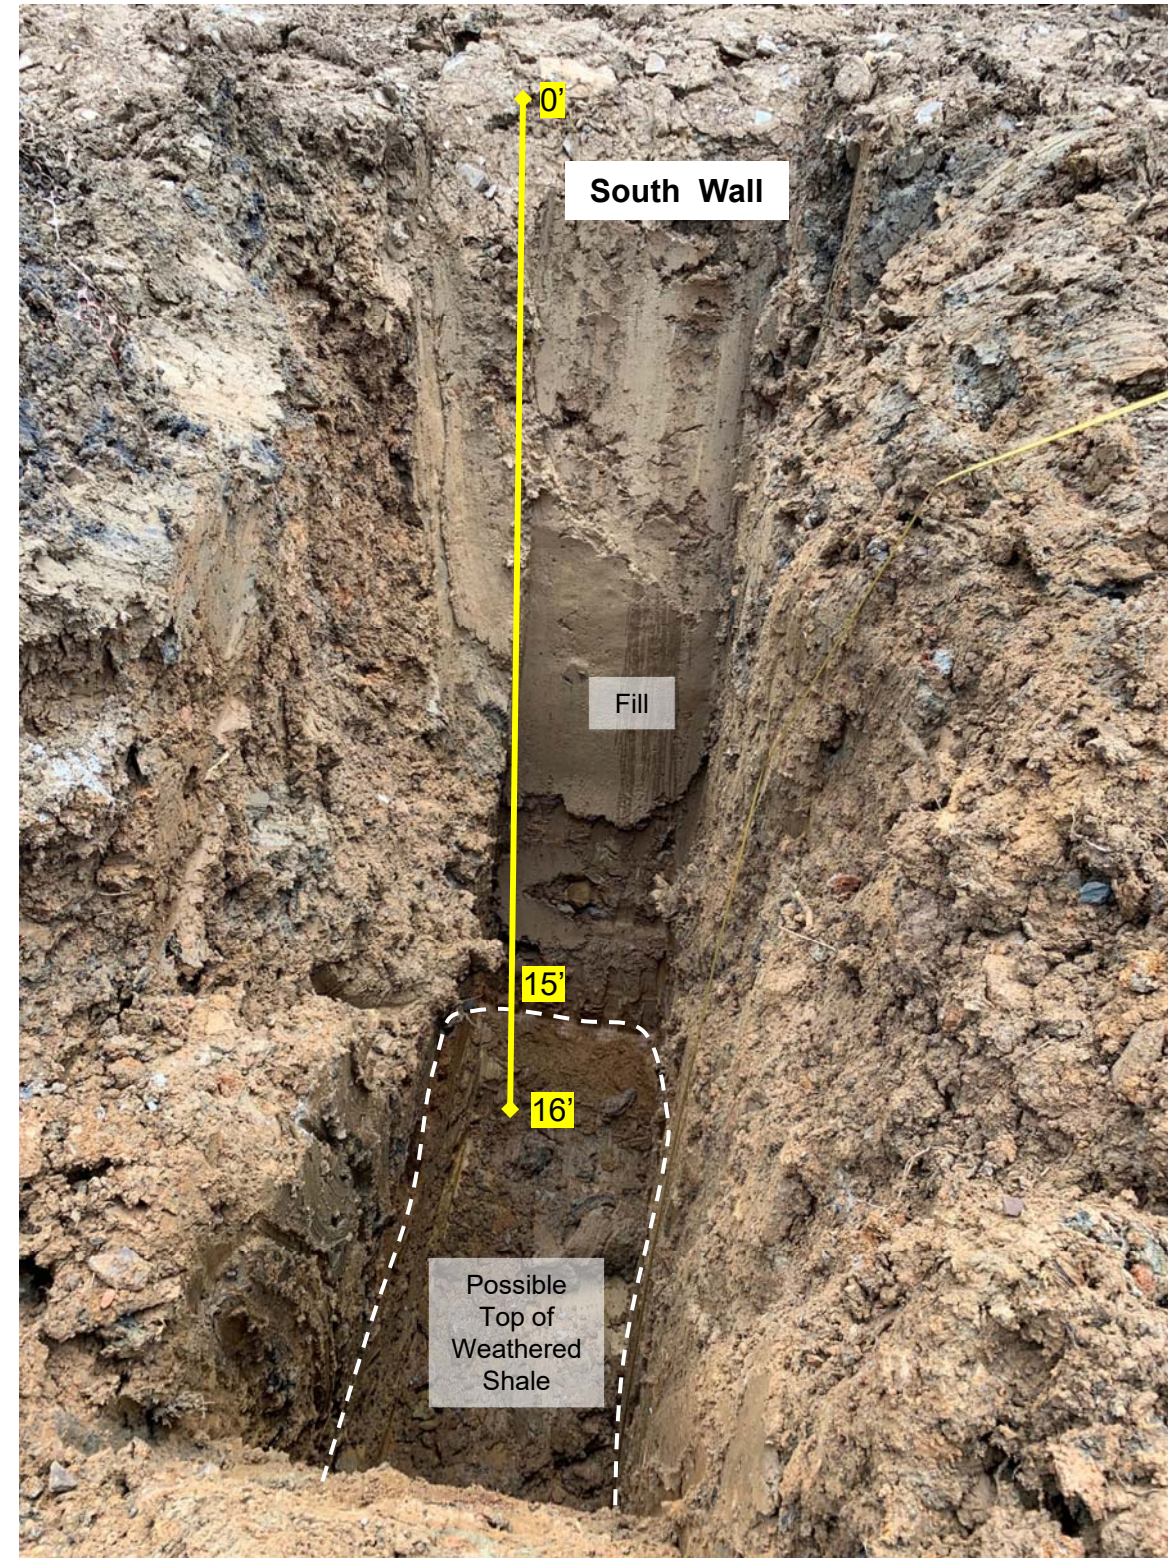
PREPARED BY: WCD	FIGURE TITLE TP 17 PHOTO LOG		
CHECKED BY: TM	CLIENT: TEXAS EASTERN TRANSMISSION, LP		
APPROVED BY: CAD	SCALE: AS SHOWN	PROJECT NO: 1607024	FIGURE NO: E-22

Test Pit 17: The test pit was concluded at the total reach of the excavator. Due to collapsing side walls, the depth of the weathered shale was not able to be confirmed.

Feature	Depth (ft)
Possible Shale (Bedrock) Contact	15
Bottom of Excavation	16

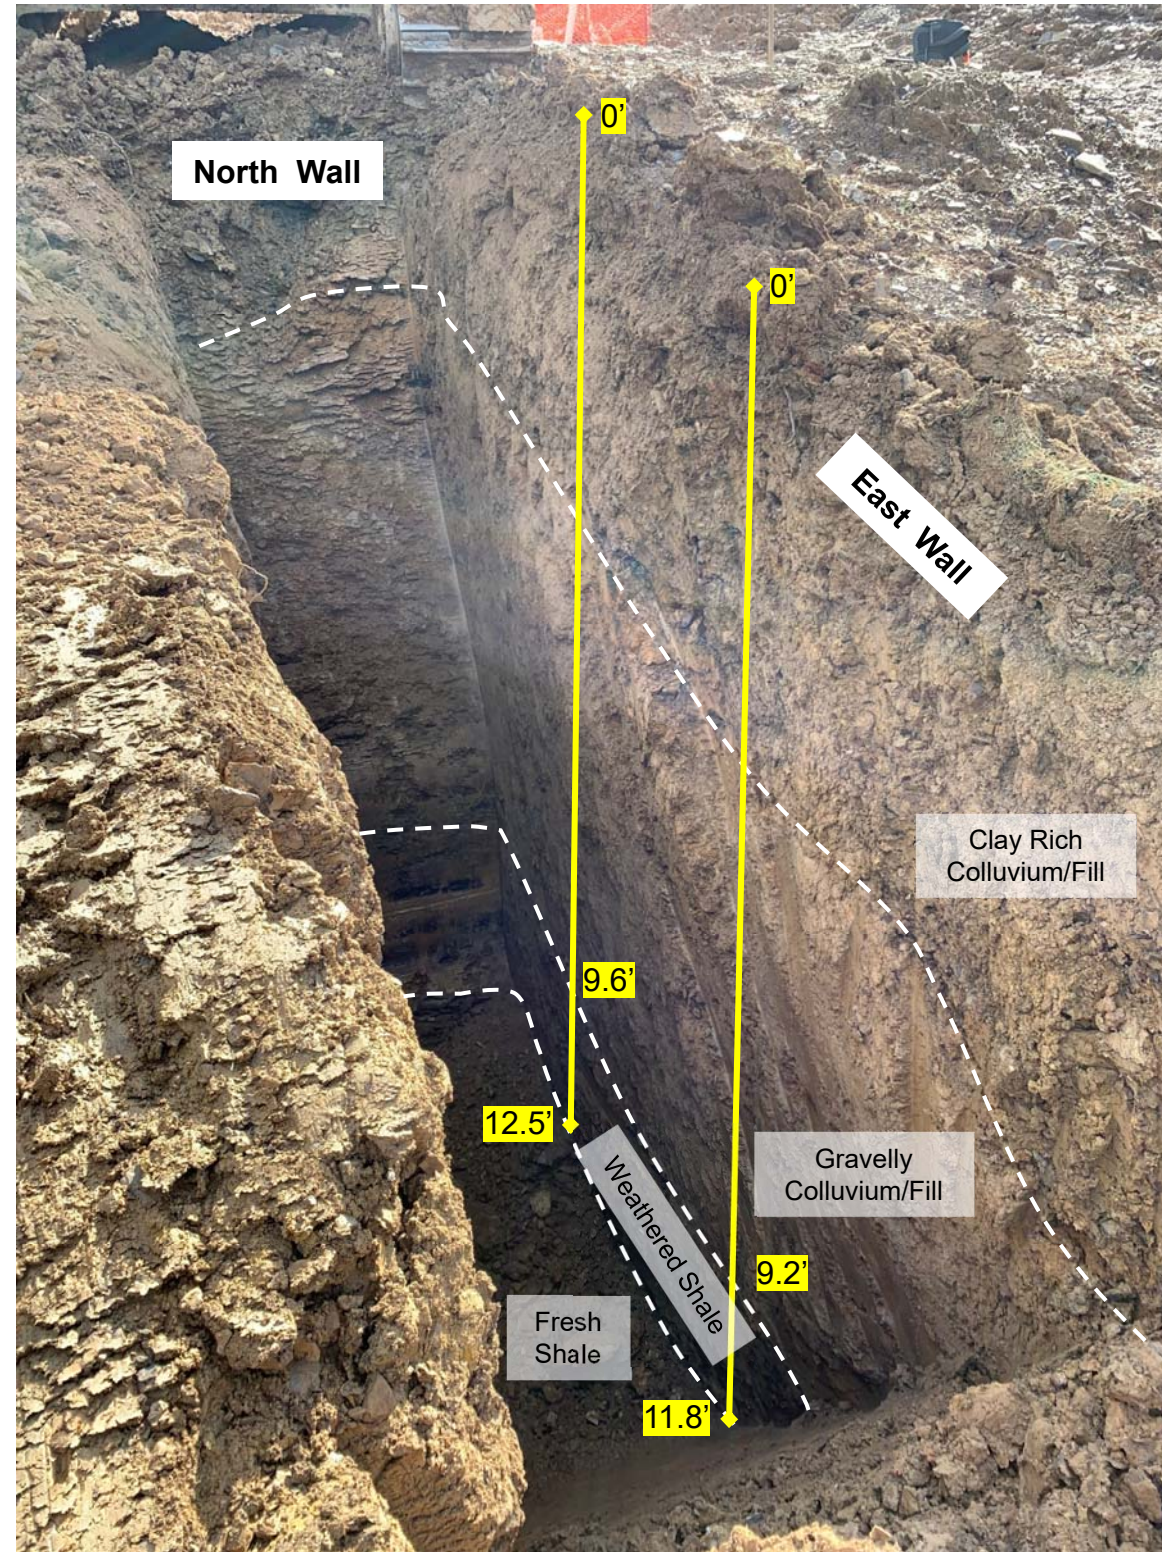
PREPARED BY: WCD	FIGURE TITLE TP 18 PHOTO LOG		
CHECKED BY: TM	CLIENT: TEXAS EASTERN TRANSMISSION, LP		
APPROVED BY: CAD	SCALE: AS SHOWN	PROJECT NO: 1607024	FIGURE NO: E-23

Test Pit 18: Photo log showing fresh shale exposed at the base of the excavation.

Feature	Depth (ft)
Top of Weathered Shale	9.2 – 9.6
Bottom of Excavation/ Top of Fresh Shale	11.8 – 12.5

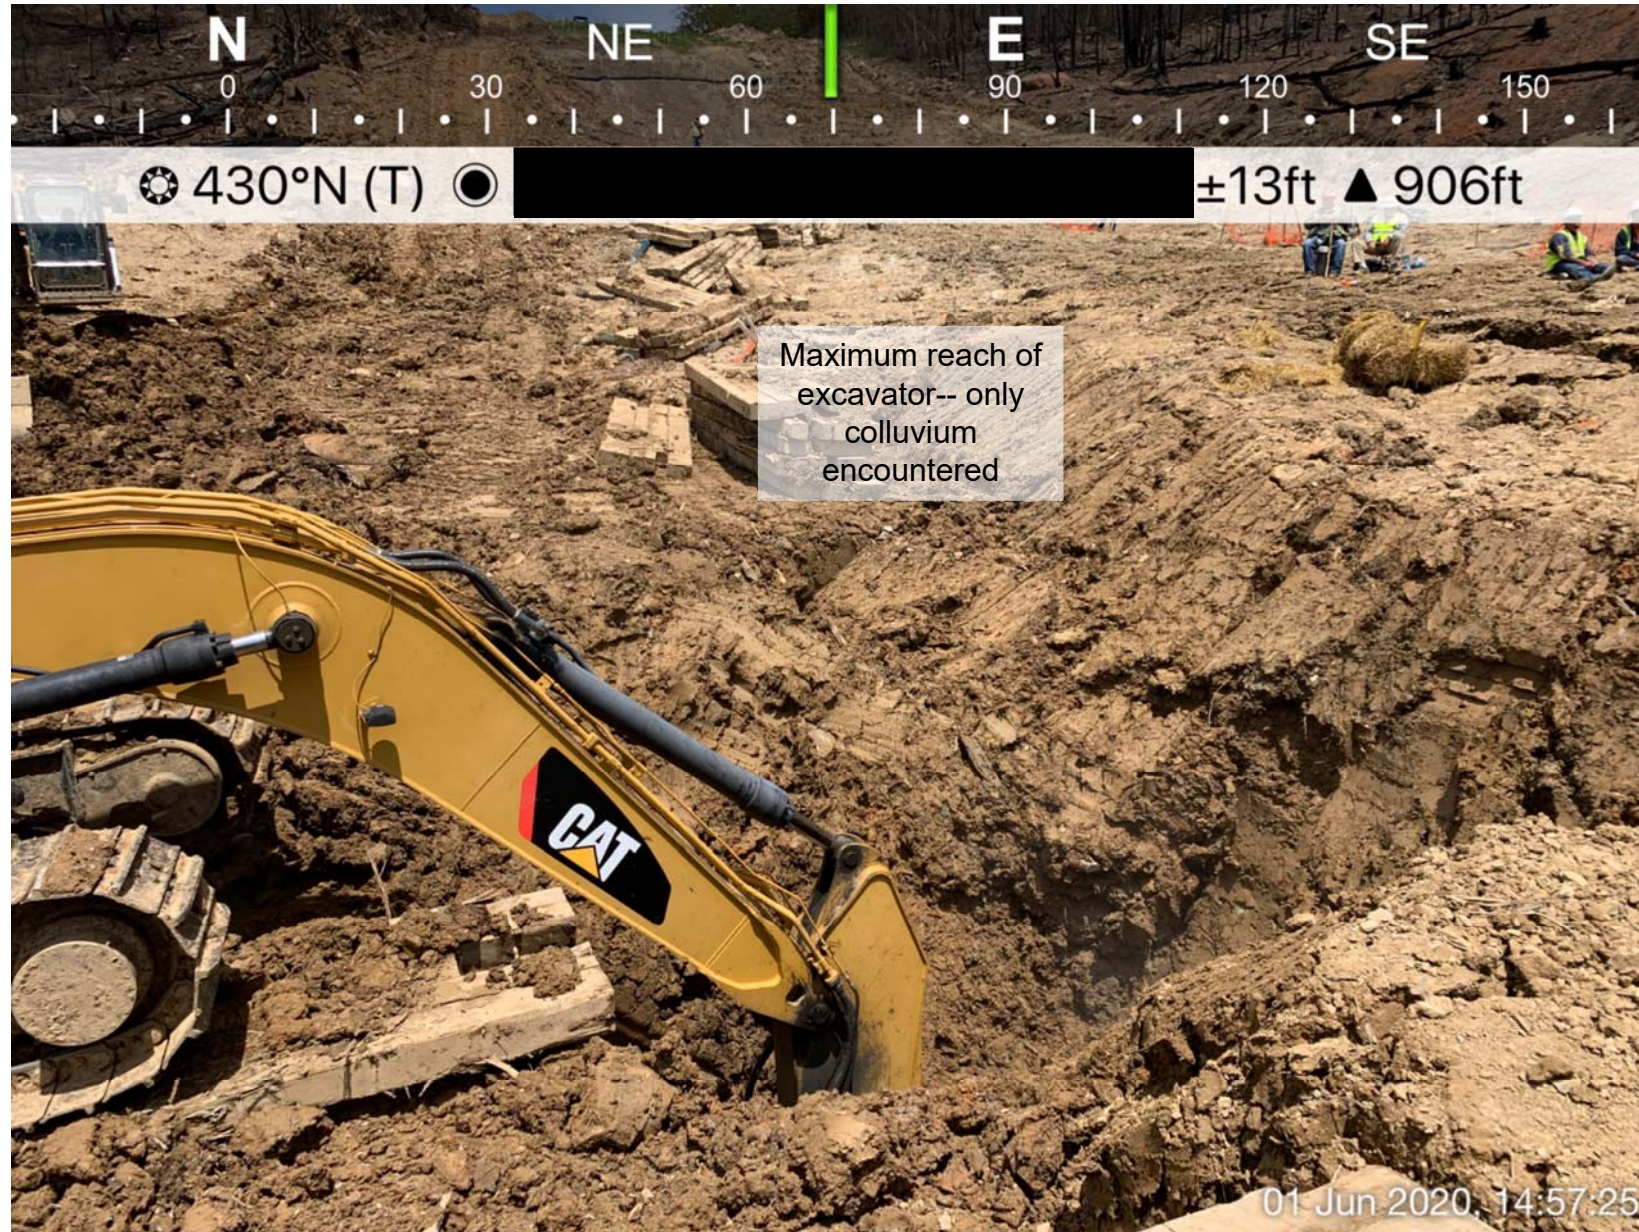
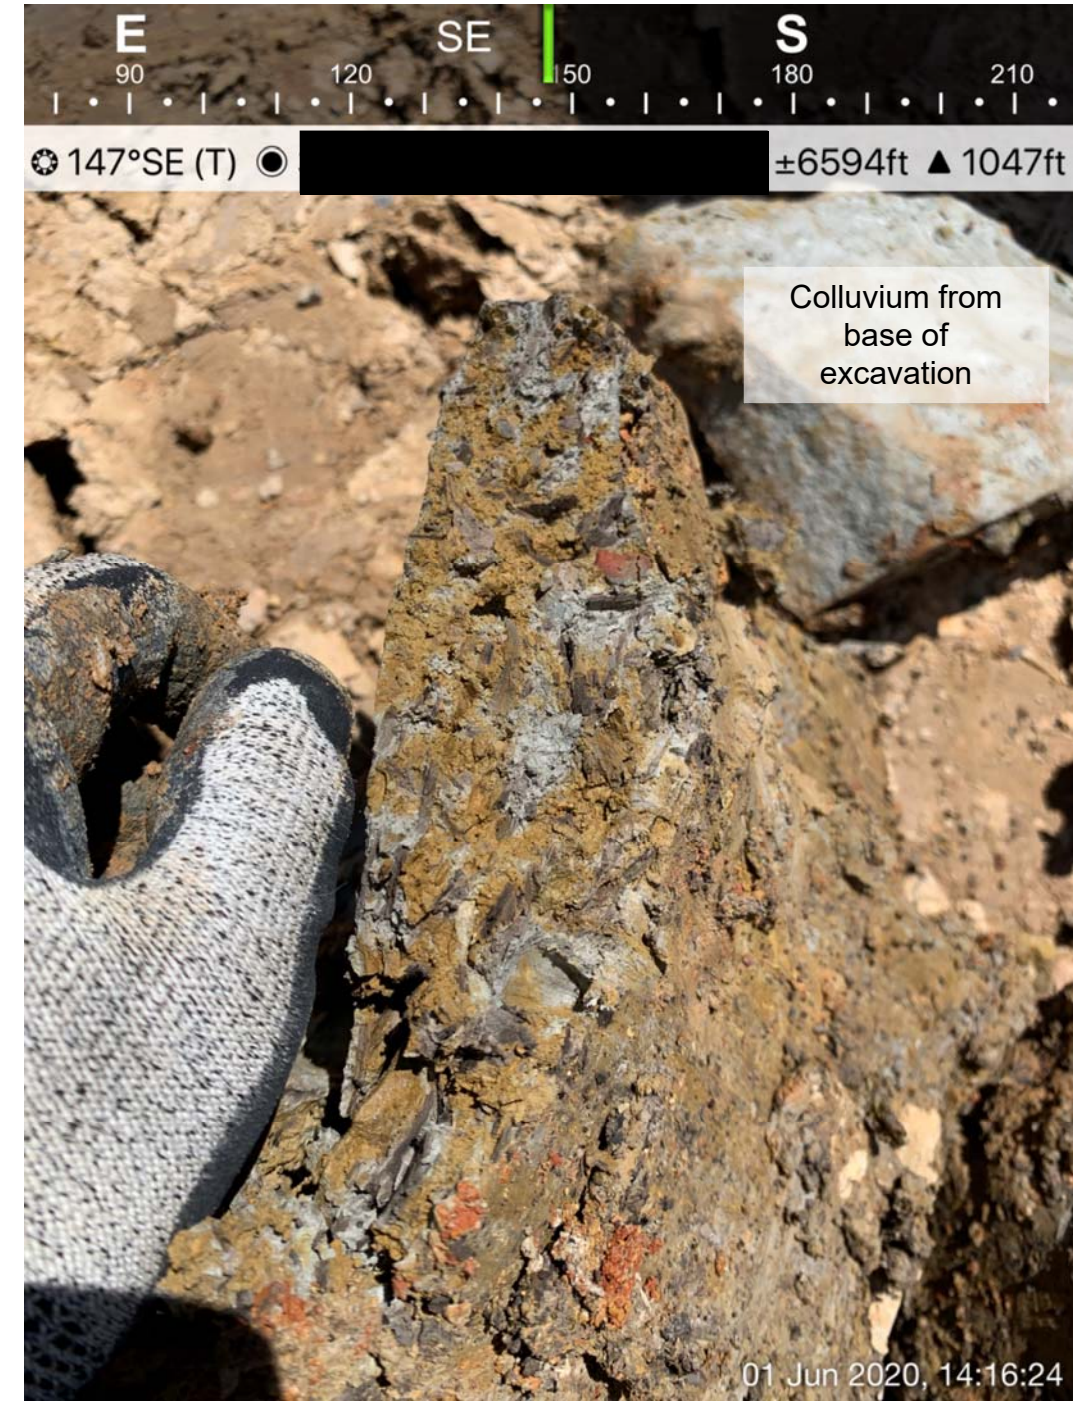
PREPARED BY: WCD	FIGURE TITLE TP 19 PHOTO LOG		
CHECKED BY: TM	CLIENT: TEXAS EASTERN TRANSMISSION, LP		
APPROVED BY: CAD	SCALE: AS SHOWN	PROJECT NO: 1607024	FIGURE NO: E-24

Test Pit 19: Colluvium (right image) was exposed throughout the entire depth (33 ft) of the excavation. Left image shows the maximum reach of the excavator.

Feature	Depth (ft)
Bottom of Excavation	33

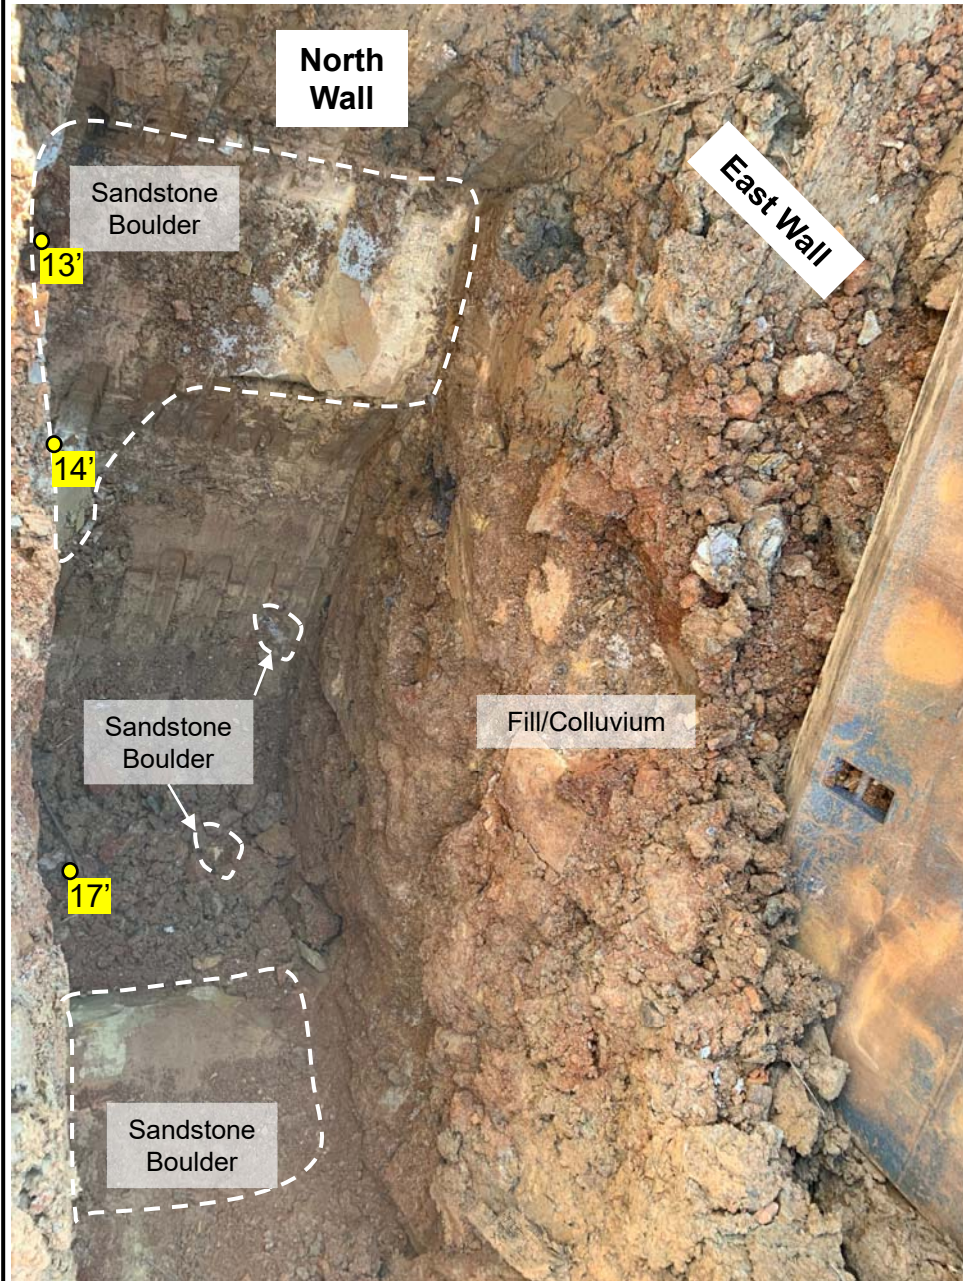
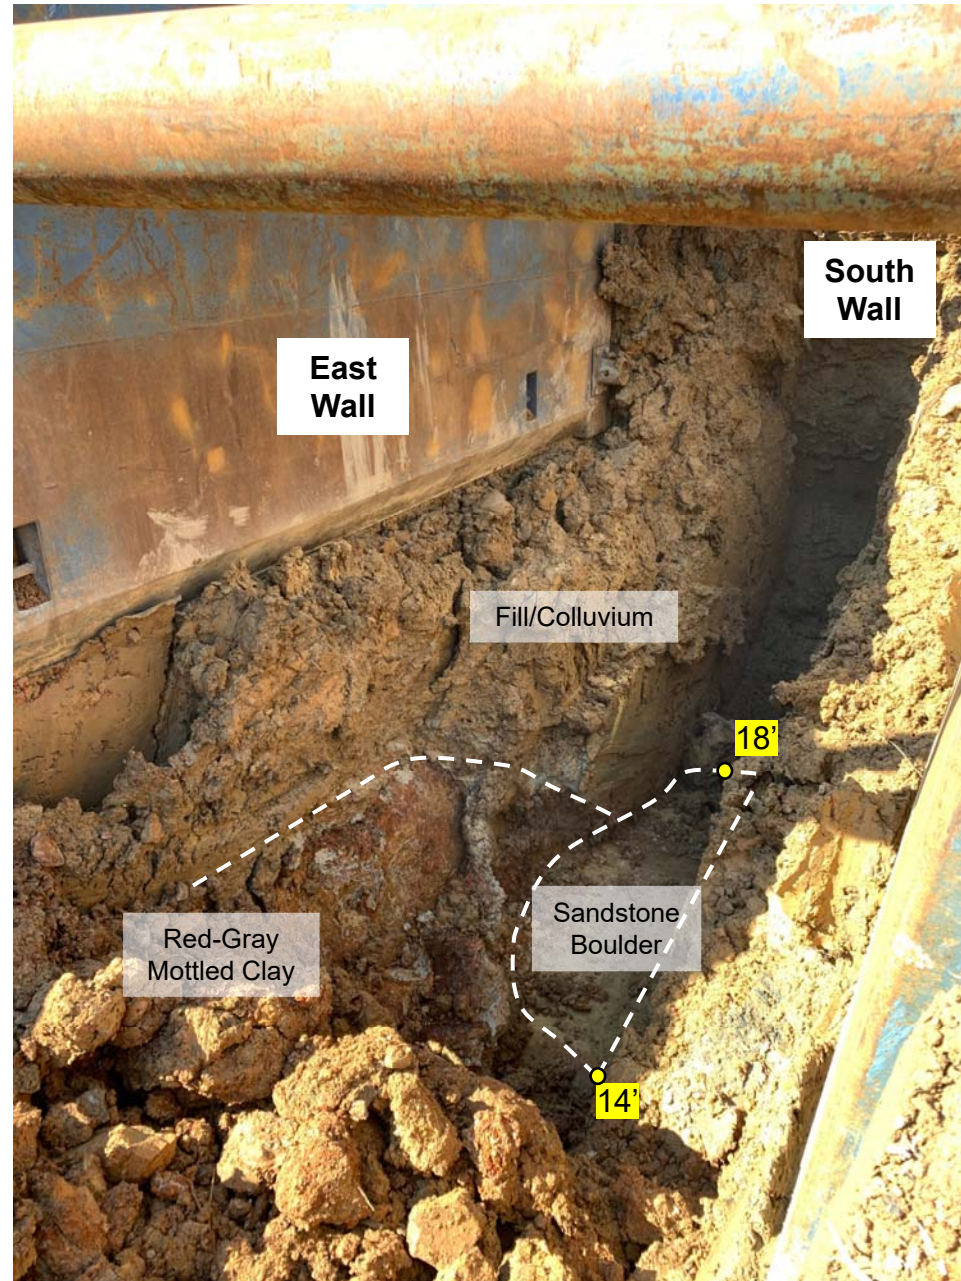
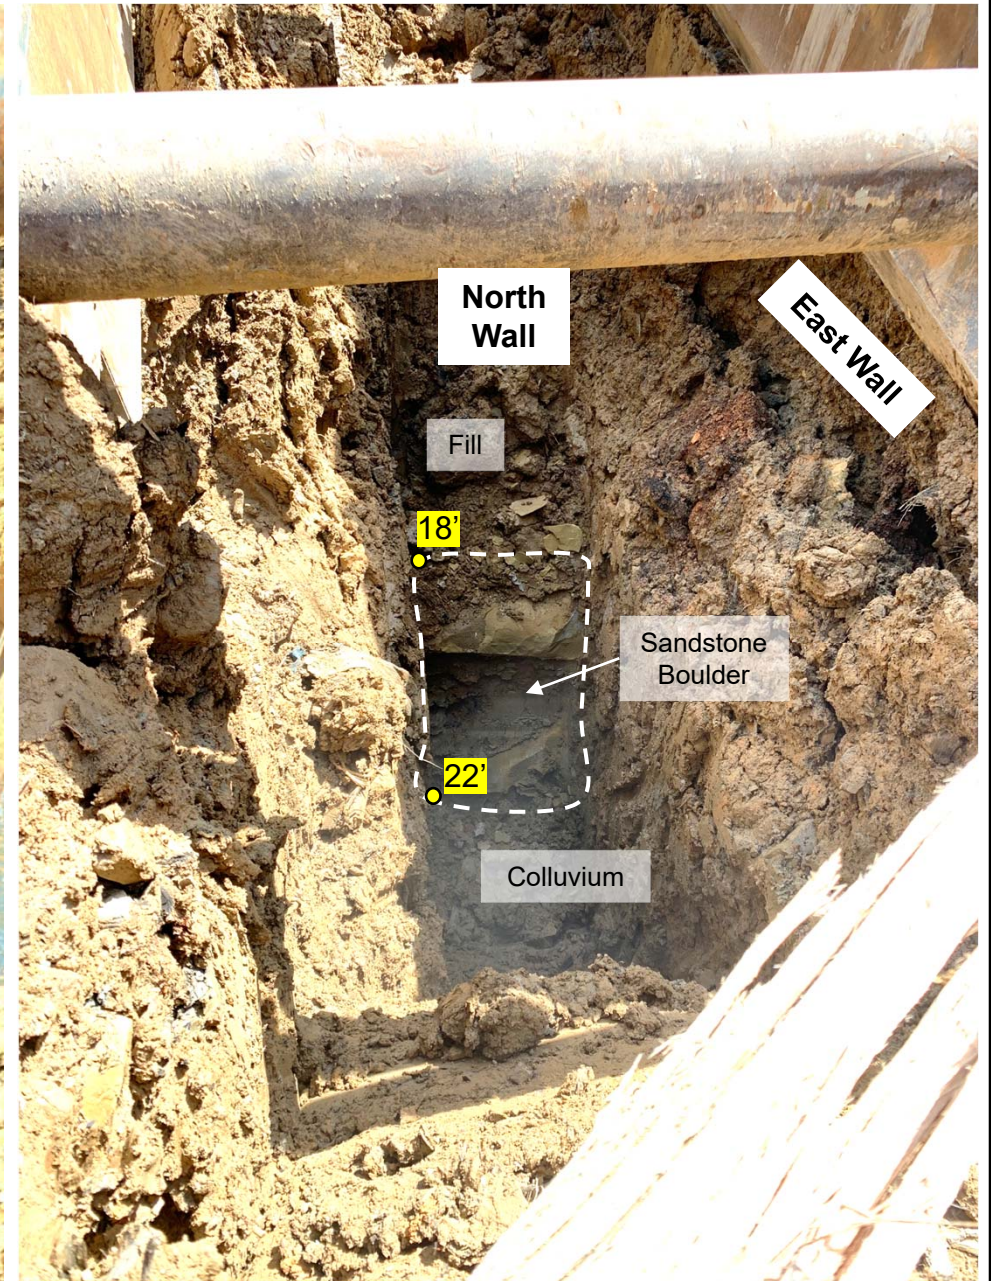
PREPARED BY: WCD	FIGURE TITLE TP 20 PHOTO LOG		
CHECKED BY: TM	CLIENT: TEXAS EASTERN TRANSMISSION, LP		
APPROVED BY: CAD	SCALE: AS SHOWN	PROJECT NO: 1607024	FIGURE NO: E-25

Test Pit 20: Sandstone boulders within colluvium exposed throughout excavation. The progression of the excavation is shown from left (shallower) to right (deeper).

Feature	Depth (ft)
Top of Sandstone Boulder	18
Bottom of Excavation/Bottom of Sandstone Boulder	22
