## **TEXAS EASTERN TRANSMISSION, LP**

### **MAY 4, 2020 FLEMING COUNTY INCIDENT GEOTECHNICAL CAUSATION REPORT**

PROJECT NO.: 1607024  
DOCUMENT NO.: Rev A

DATE: April 26, 2021

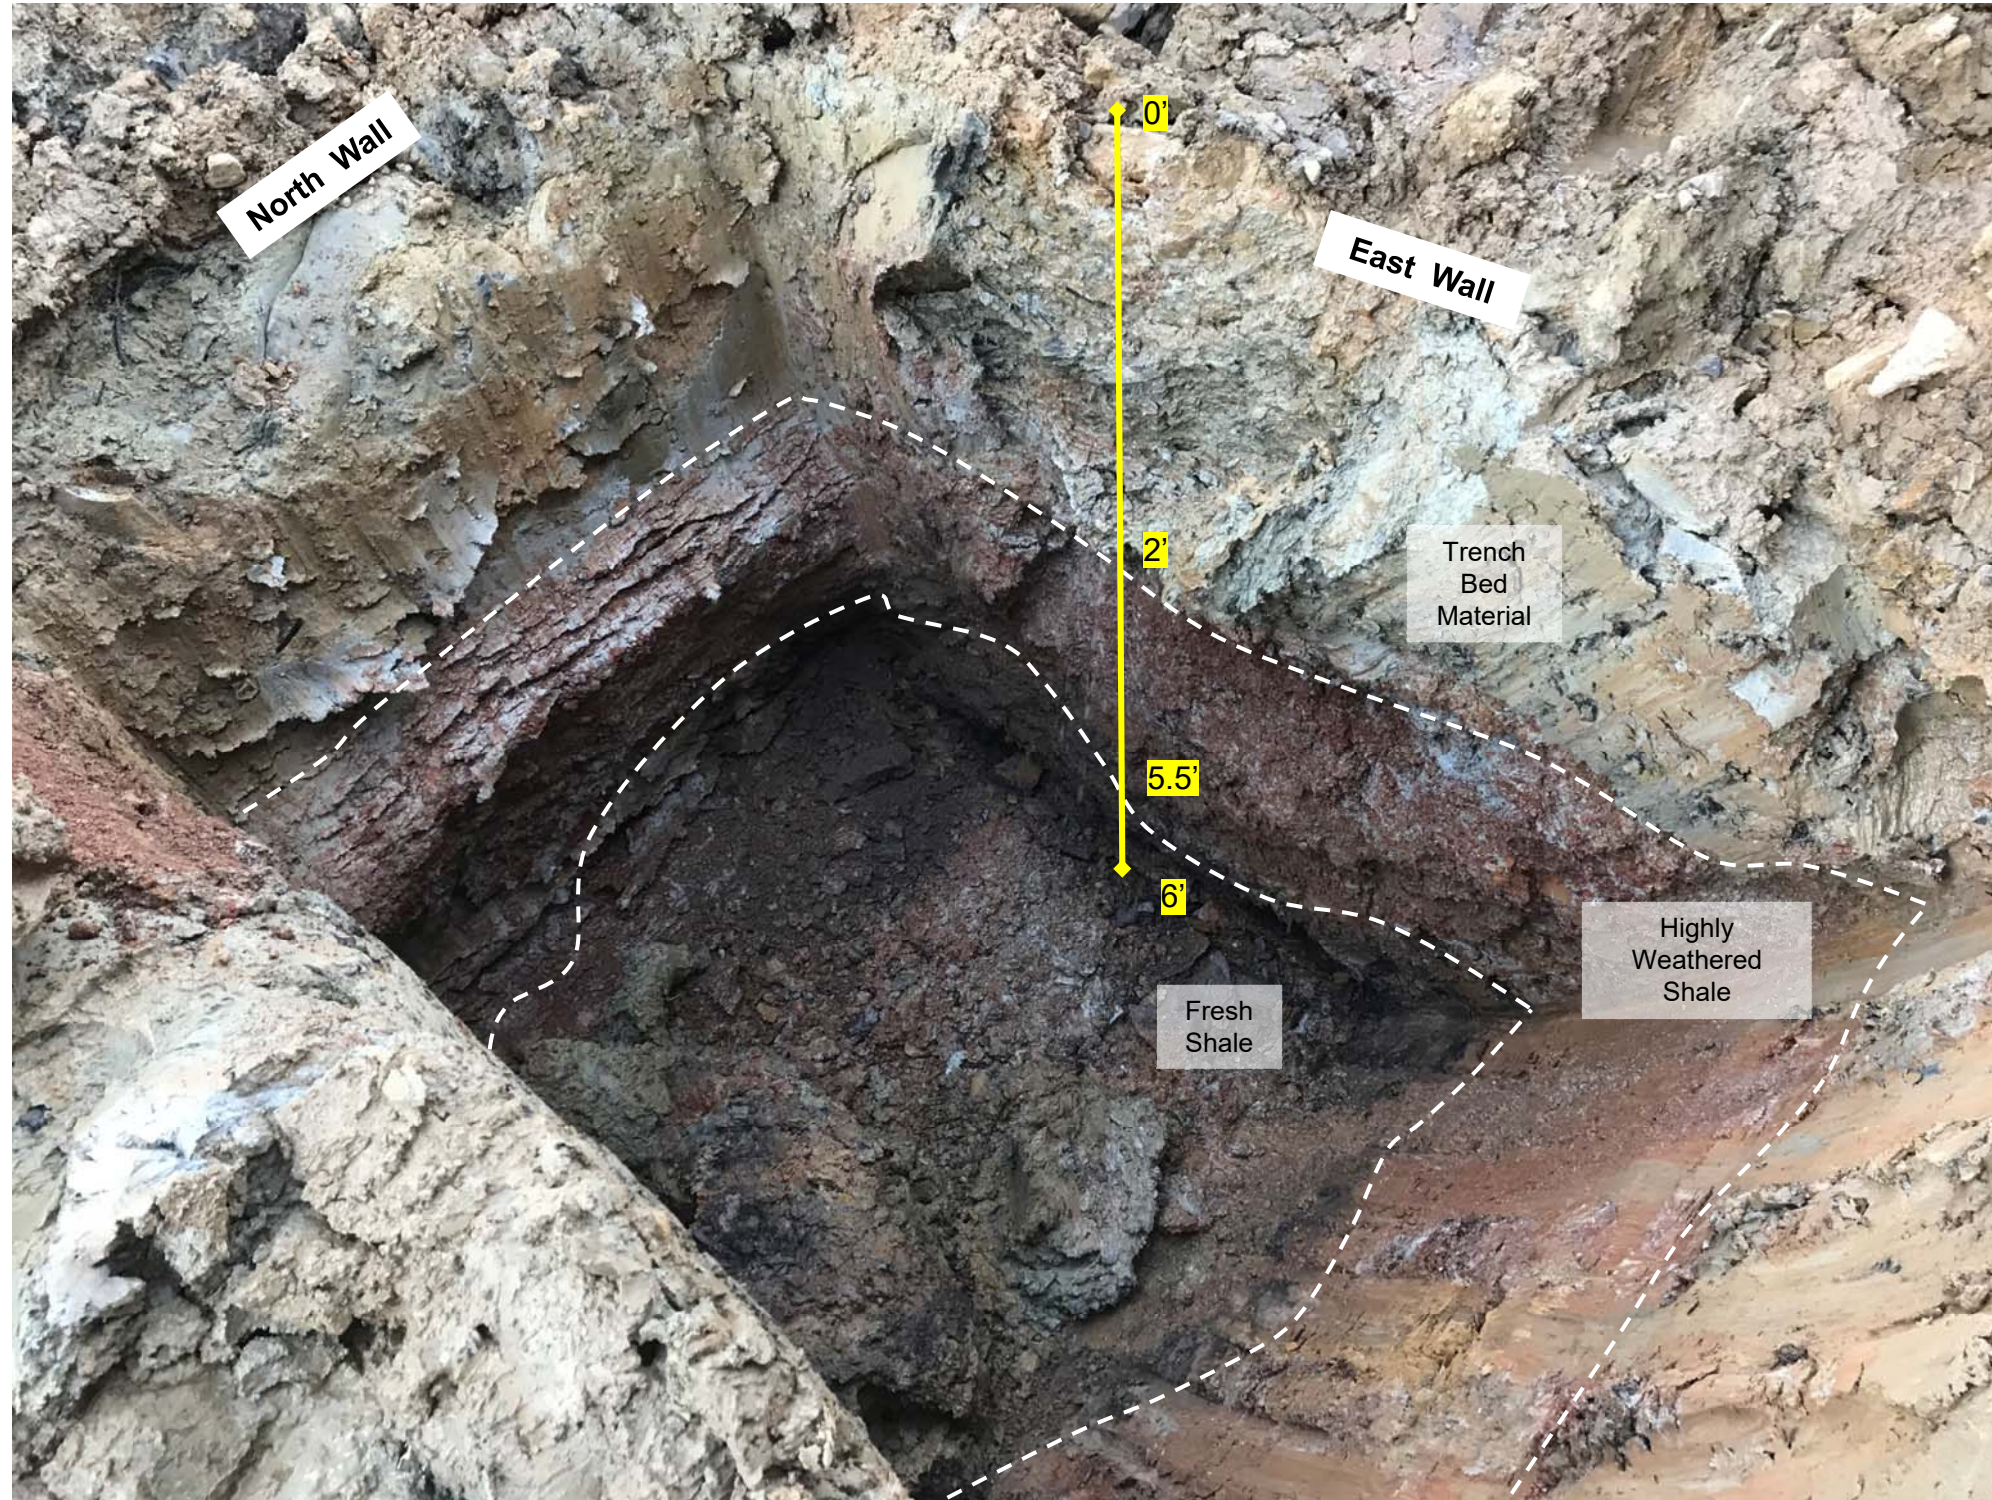
PREPARED BY: WCD	FIGURE TITLE TP 21 PHOTO LOG		
CHECKED BY: TM	CLIENT: TEXAS EASTERN TRANSMISSION, LP		
APPROVED BY: CAD	SCALE: AS SHOWN	PROJECT NO: 1607024	FIGURE NO: E-27

Test Pit 21: Photo log showing fresh shale exposed at the base of the excavation.

Feature	Depth (ft, from trench bottom)
Top of Weathered Shale	2
Top of Fresh Shale	5.5
Bottom of Excavation	6

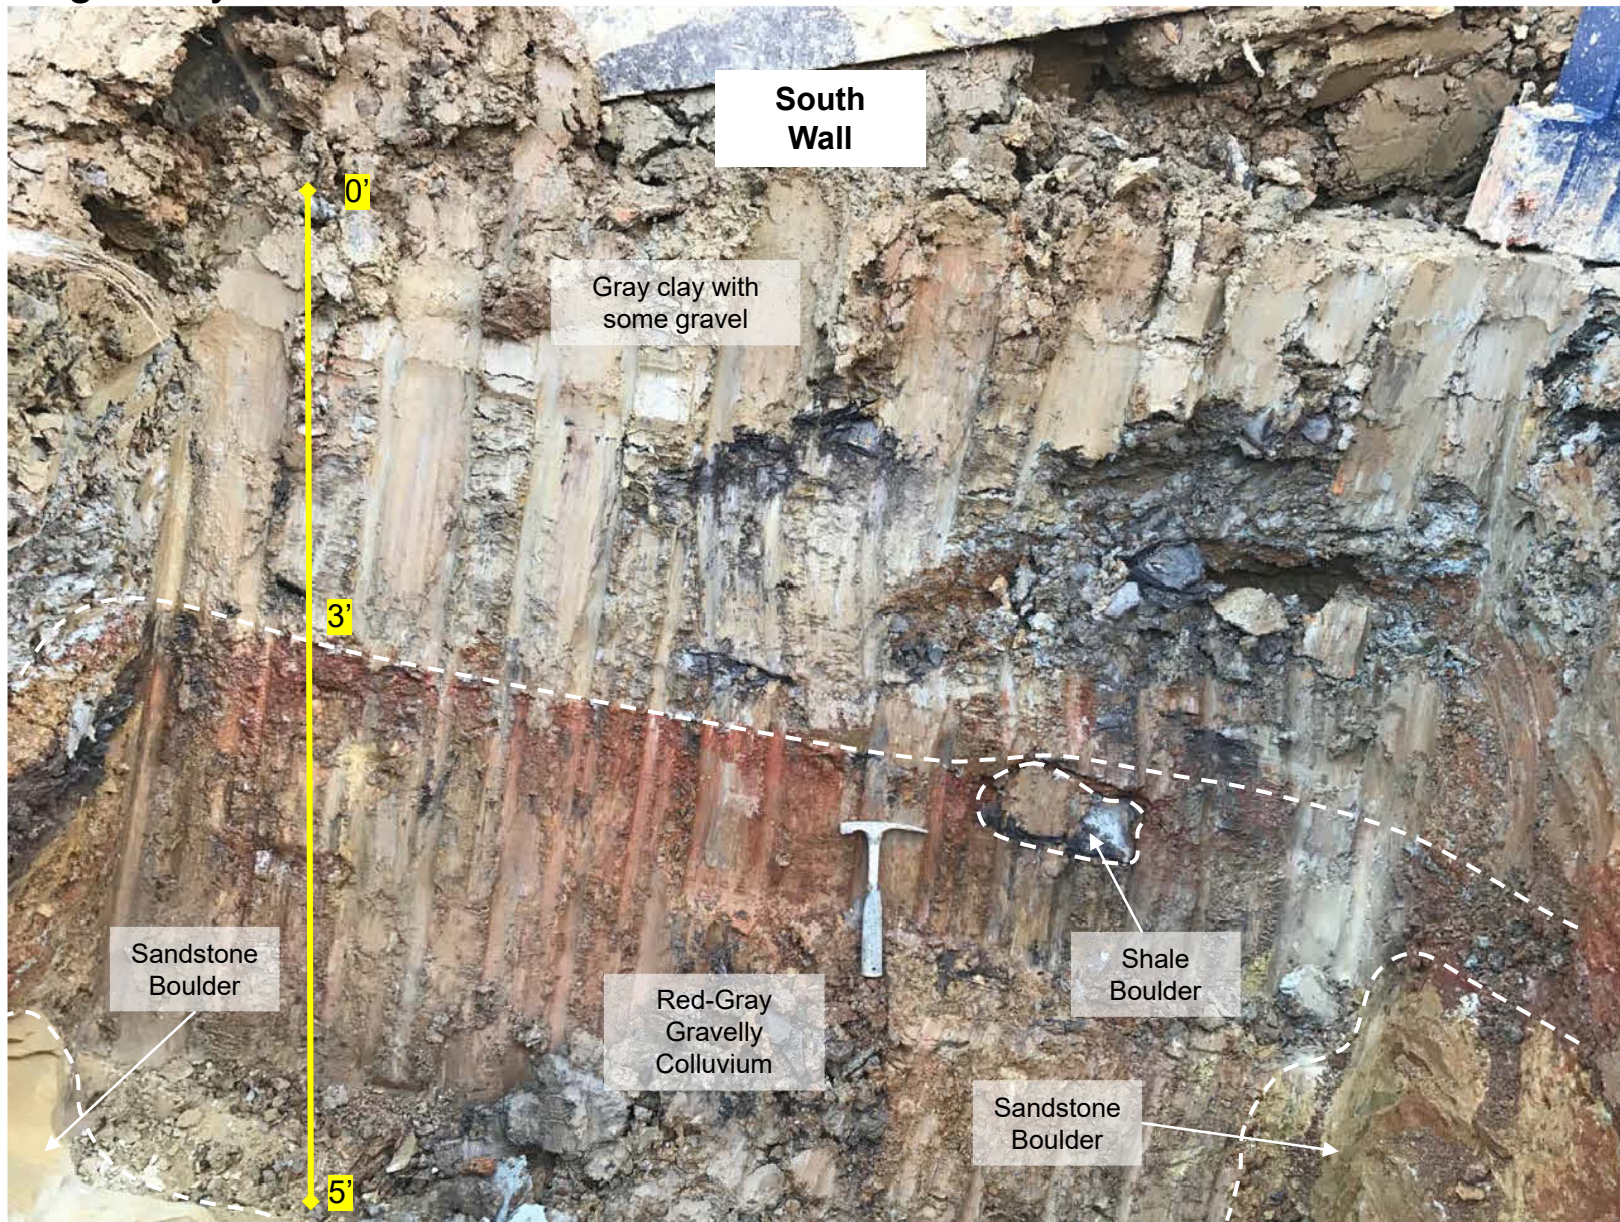
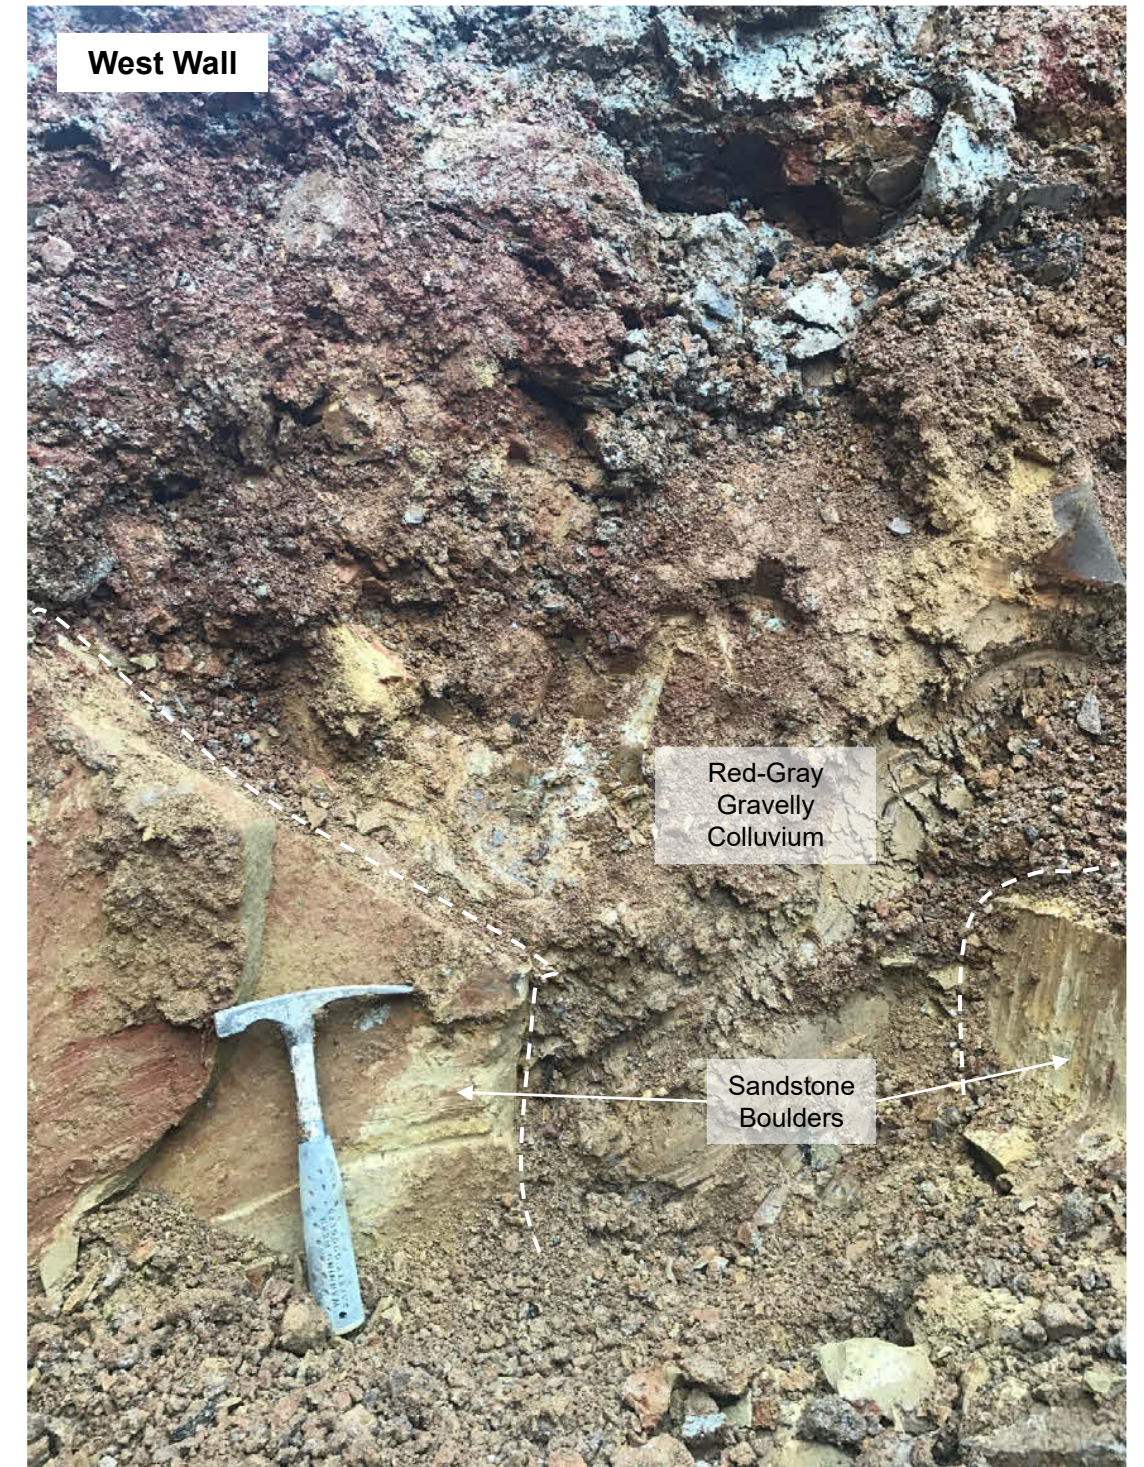
PREPARED BY: WCD	FIGURE TITLE TP 22 PHOTO LOG		
CHECKED BY: TM	CLIENT: TEXAS EASTERN TRANSMISSION, LP		
APPROVED BY: CAD	SCALE: AS SHOWN	PROJECT NO: 1607024	FIGURE NO: E-28

Test Pit 22: Left photo shows clear contact between gray clay with some gravel and red to gray clay with abundant pebble to boulder sized shale and sandstone clasts. The right images shows two sandstone boulders suspended in gravelly colluvium at the base of the west wall of the excavation.

Feature	Depth (ft, from trench bottom)
Top of Red-Gray Gravelly Colluvium	3
Bottom of Excavation/top of Sandstone Boulders	5

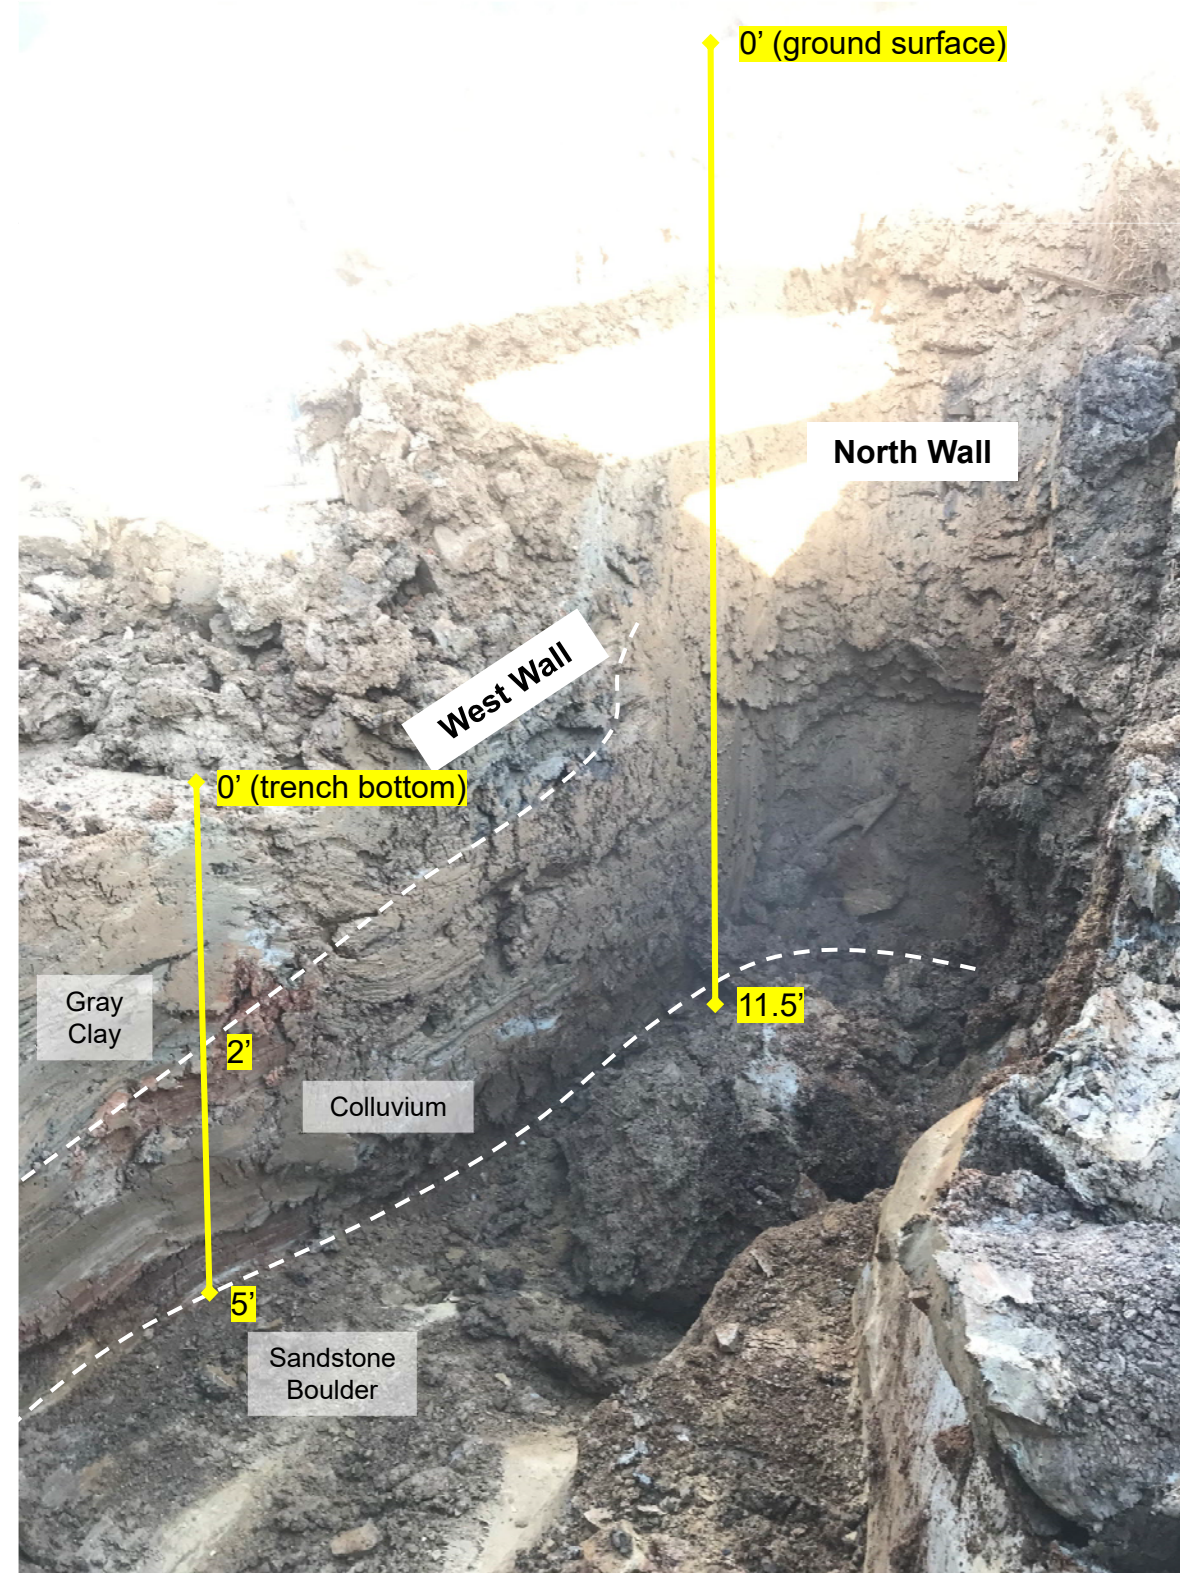
PREPARED BY: WCD	FIGURE TITLE TP 23 PHOTO LOG		
CHECKED BY: TM	CLIENT: TEXAS EASTERN TRANSMISSION, LP		
APPROVED BY: CAD	SCALE: AS SHOWN	PROJECT NO: 1607024	FIGURE NO: E-29

Test Pit 23: Sandstone floor for the entire bottom of excavation (interpreted as boulders). Refusal as the sandstone prevented further digging.

Feature	Depth (ft, from trench bottom)
Top of Colluvium	2
Bottom of Excavation/top of Sandstone Boulders	5 (11.5' from ground surface)

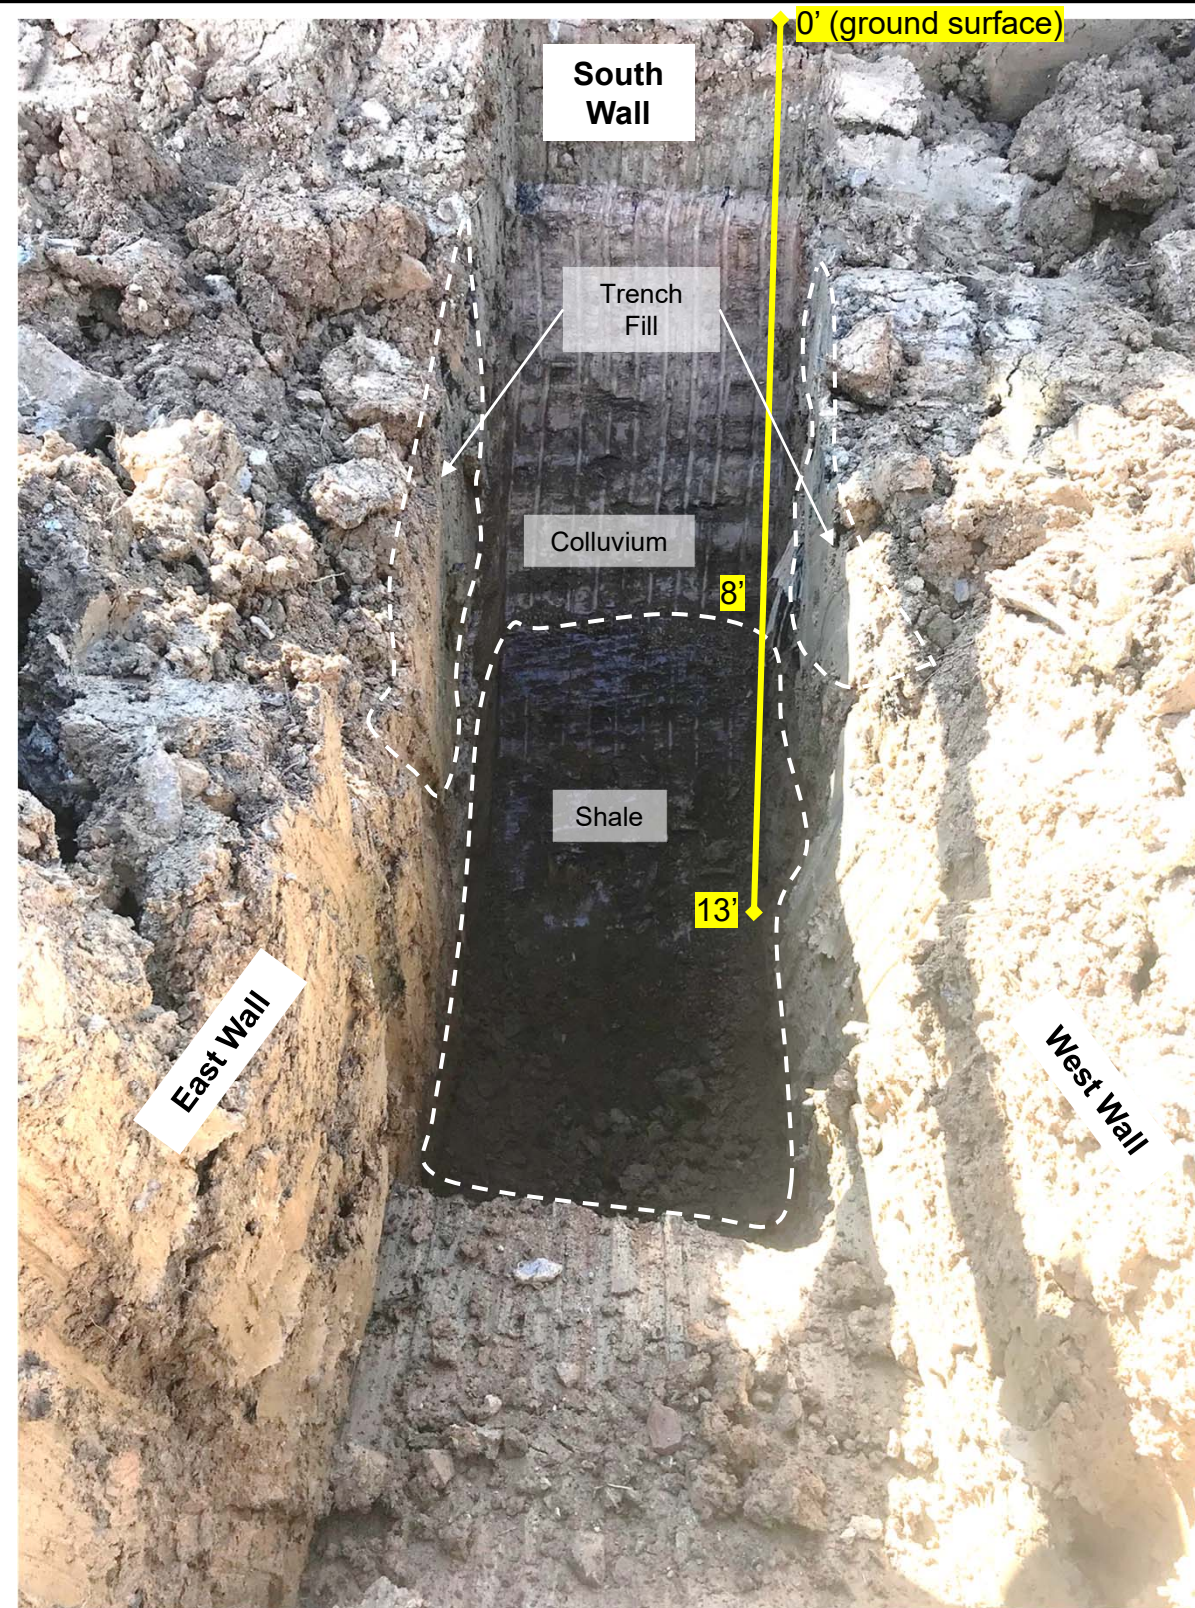
Test Pit 24: Photo log looking south from the excavator. Shale-colluvium contact dives to the north and colluvium contains large sandstone boulders which caught on the excavator bucket near the end of digging.

Feature	Depth (ft, from ground surface)
Shale (Bedrock) Contact	8
Bottom of Excavation	13

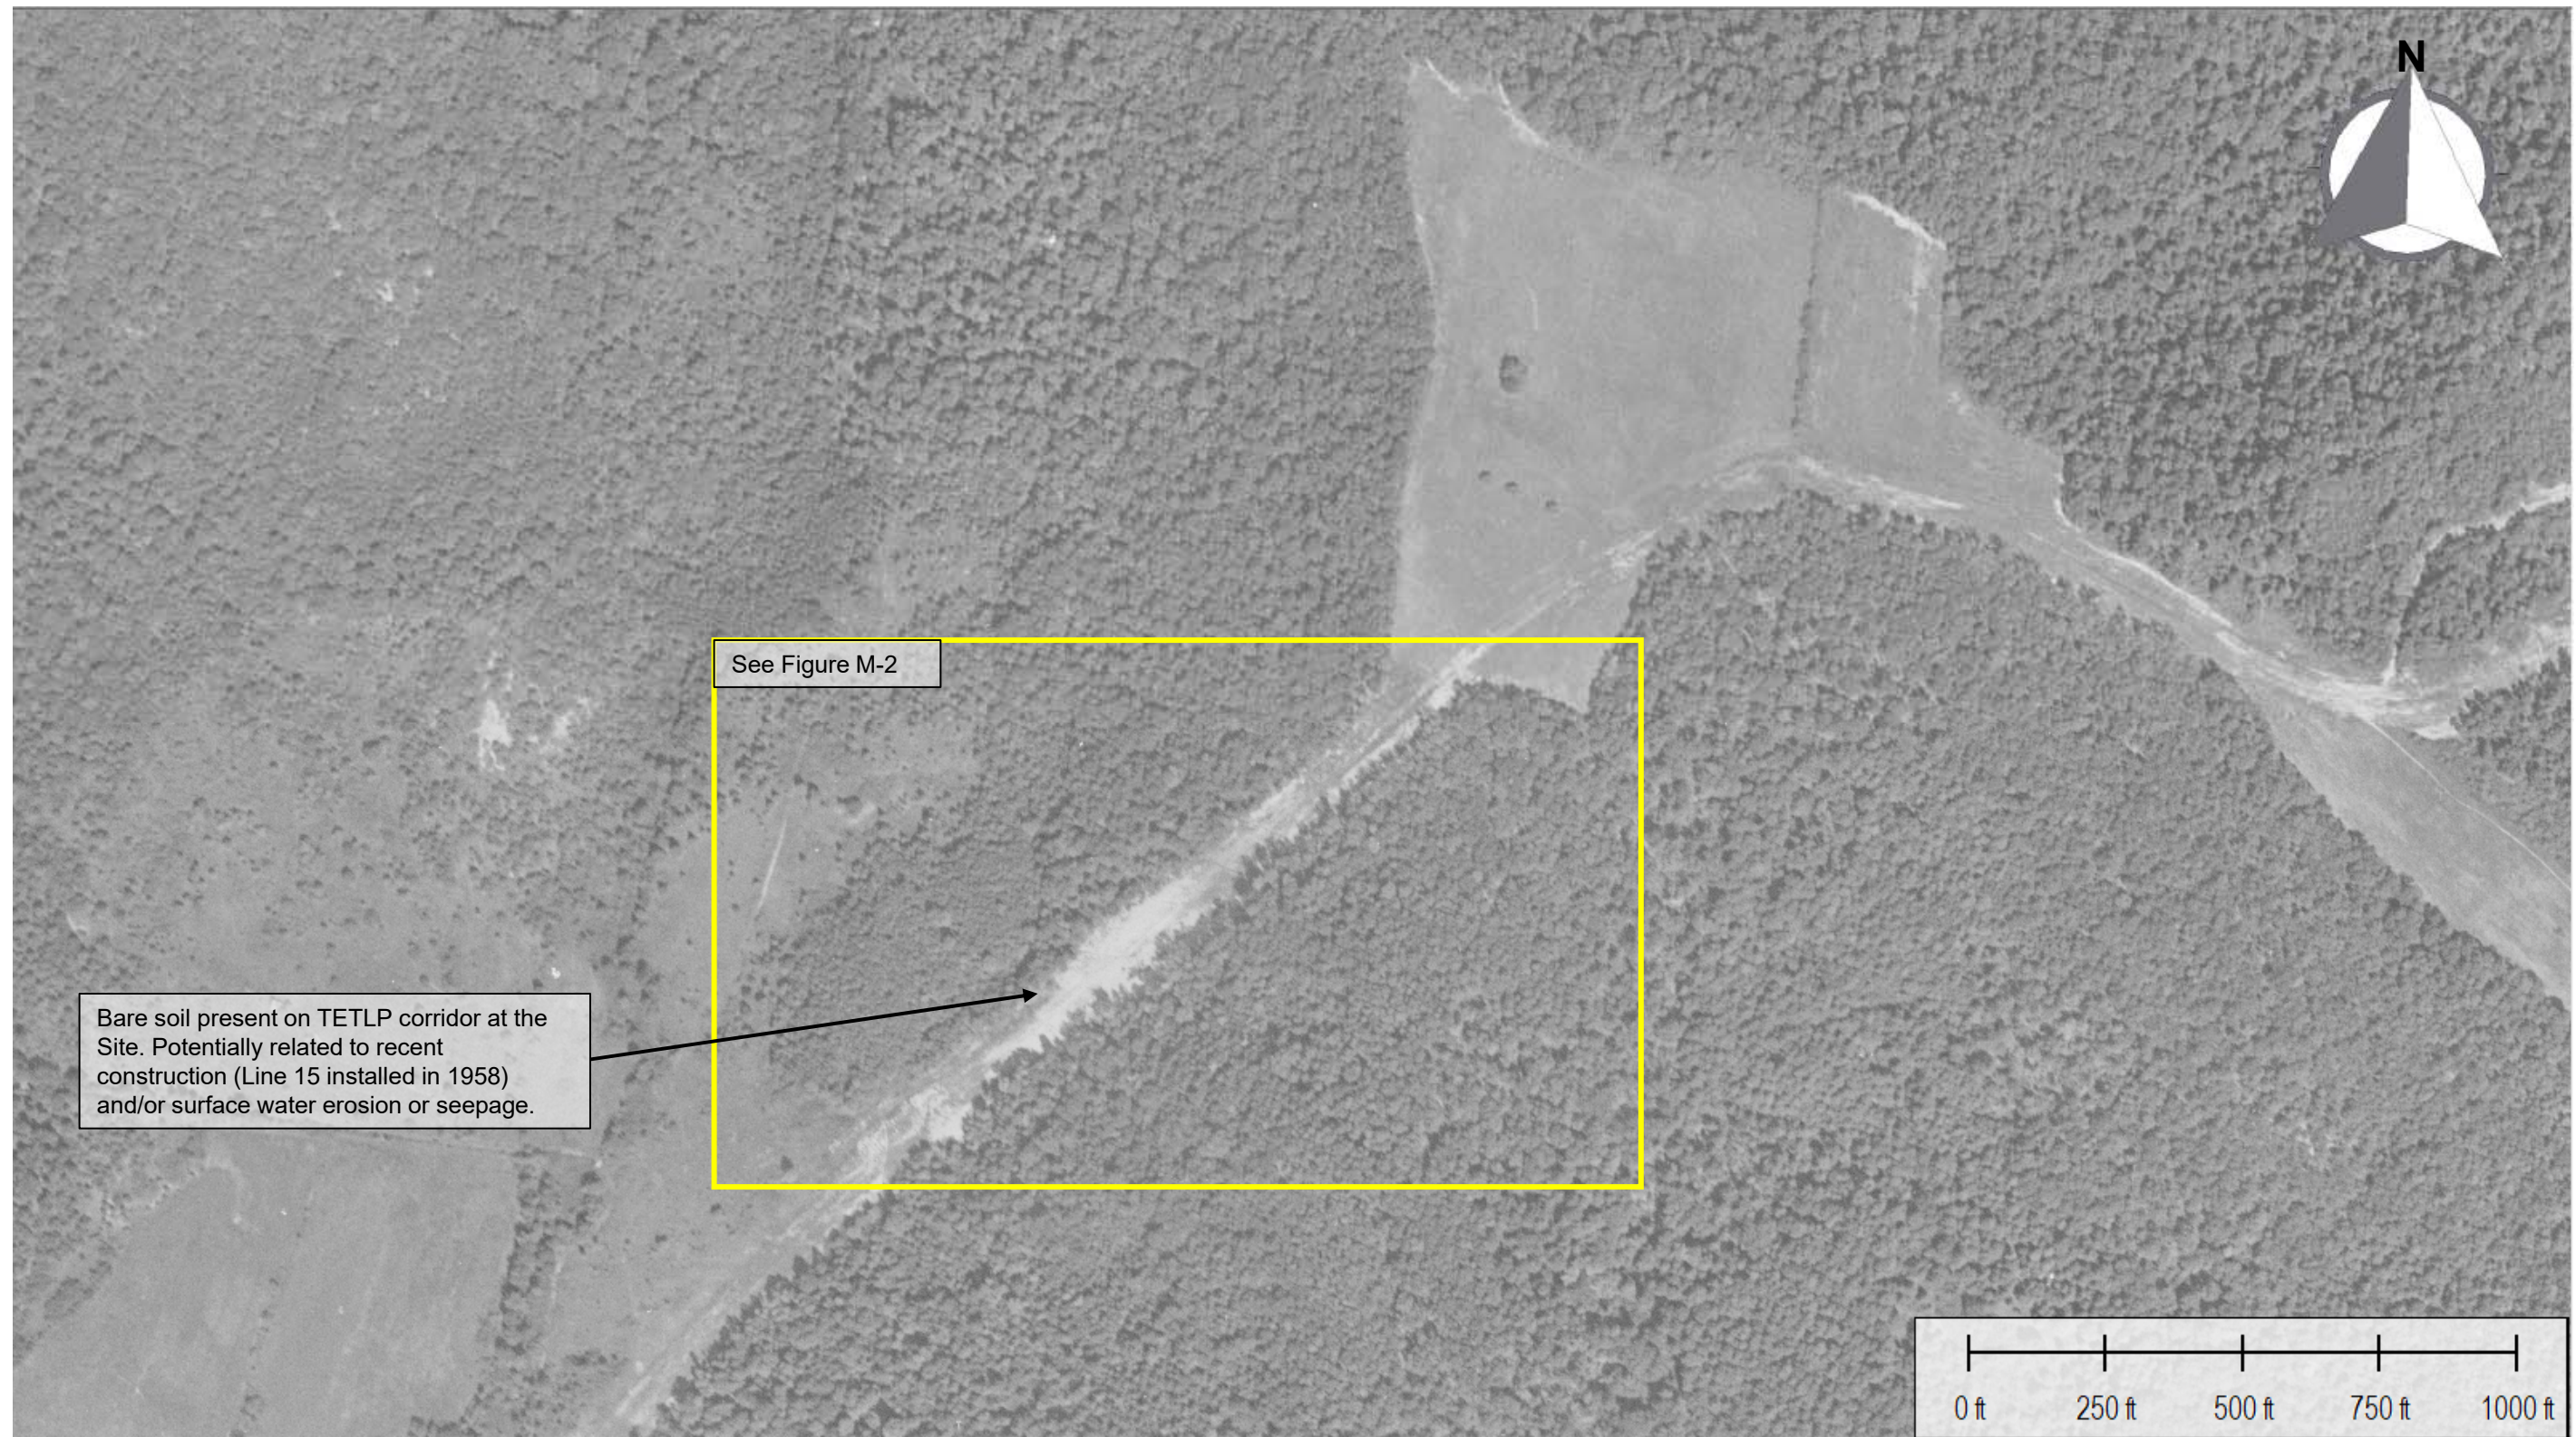
PREPARED BY: CAD	FIGURE TITLE FCI SEPTEMBER 12, 1959 AERIAL PHOTO		
CHECKED BY: CRS	CLIENT: TEXAS EASTERN TRANSMISSION, LP		
APPROVED BY: CAD	SCALE: AS SHOWN	PROJECT NO: 1607024	FIGURE NO: M-1

Bare soil present on TETLP corridor at the Site. Potentially related to recent construction (Line 15 installed in 1958) and/or surface water erosion or seepage.

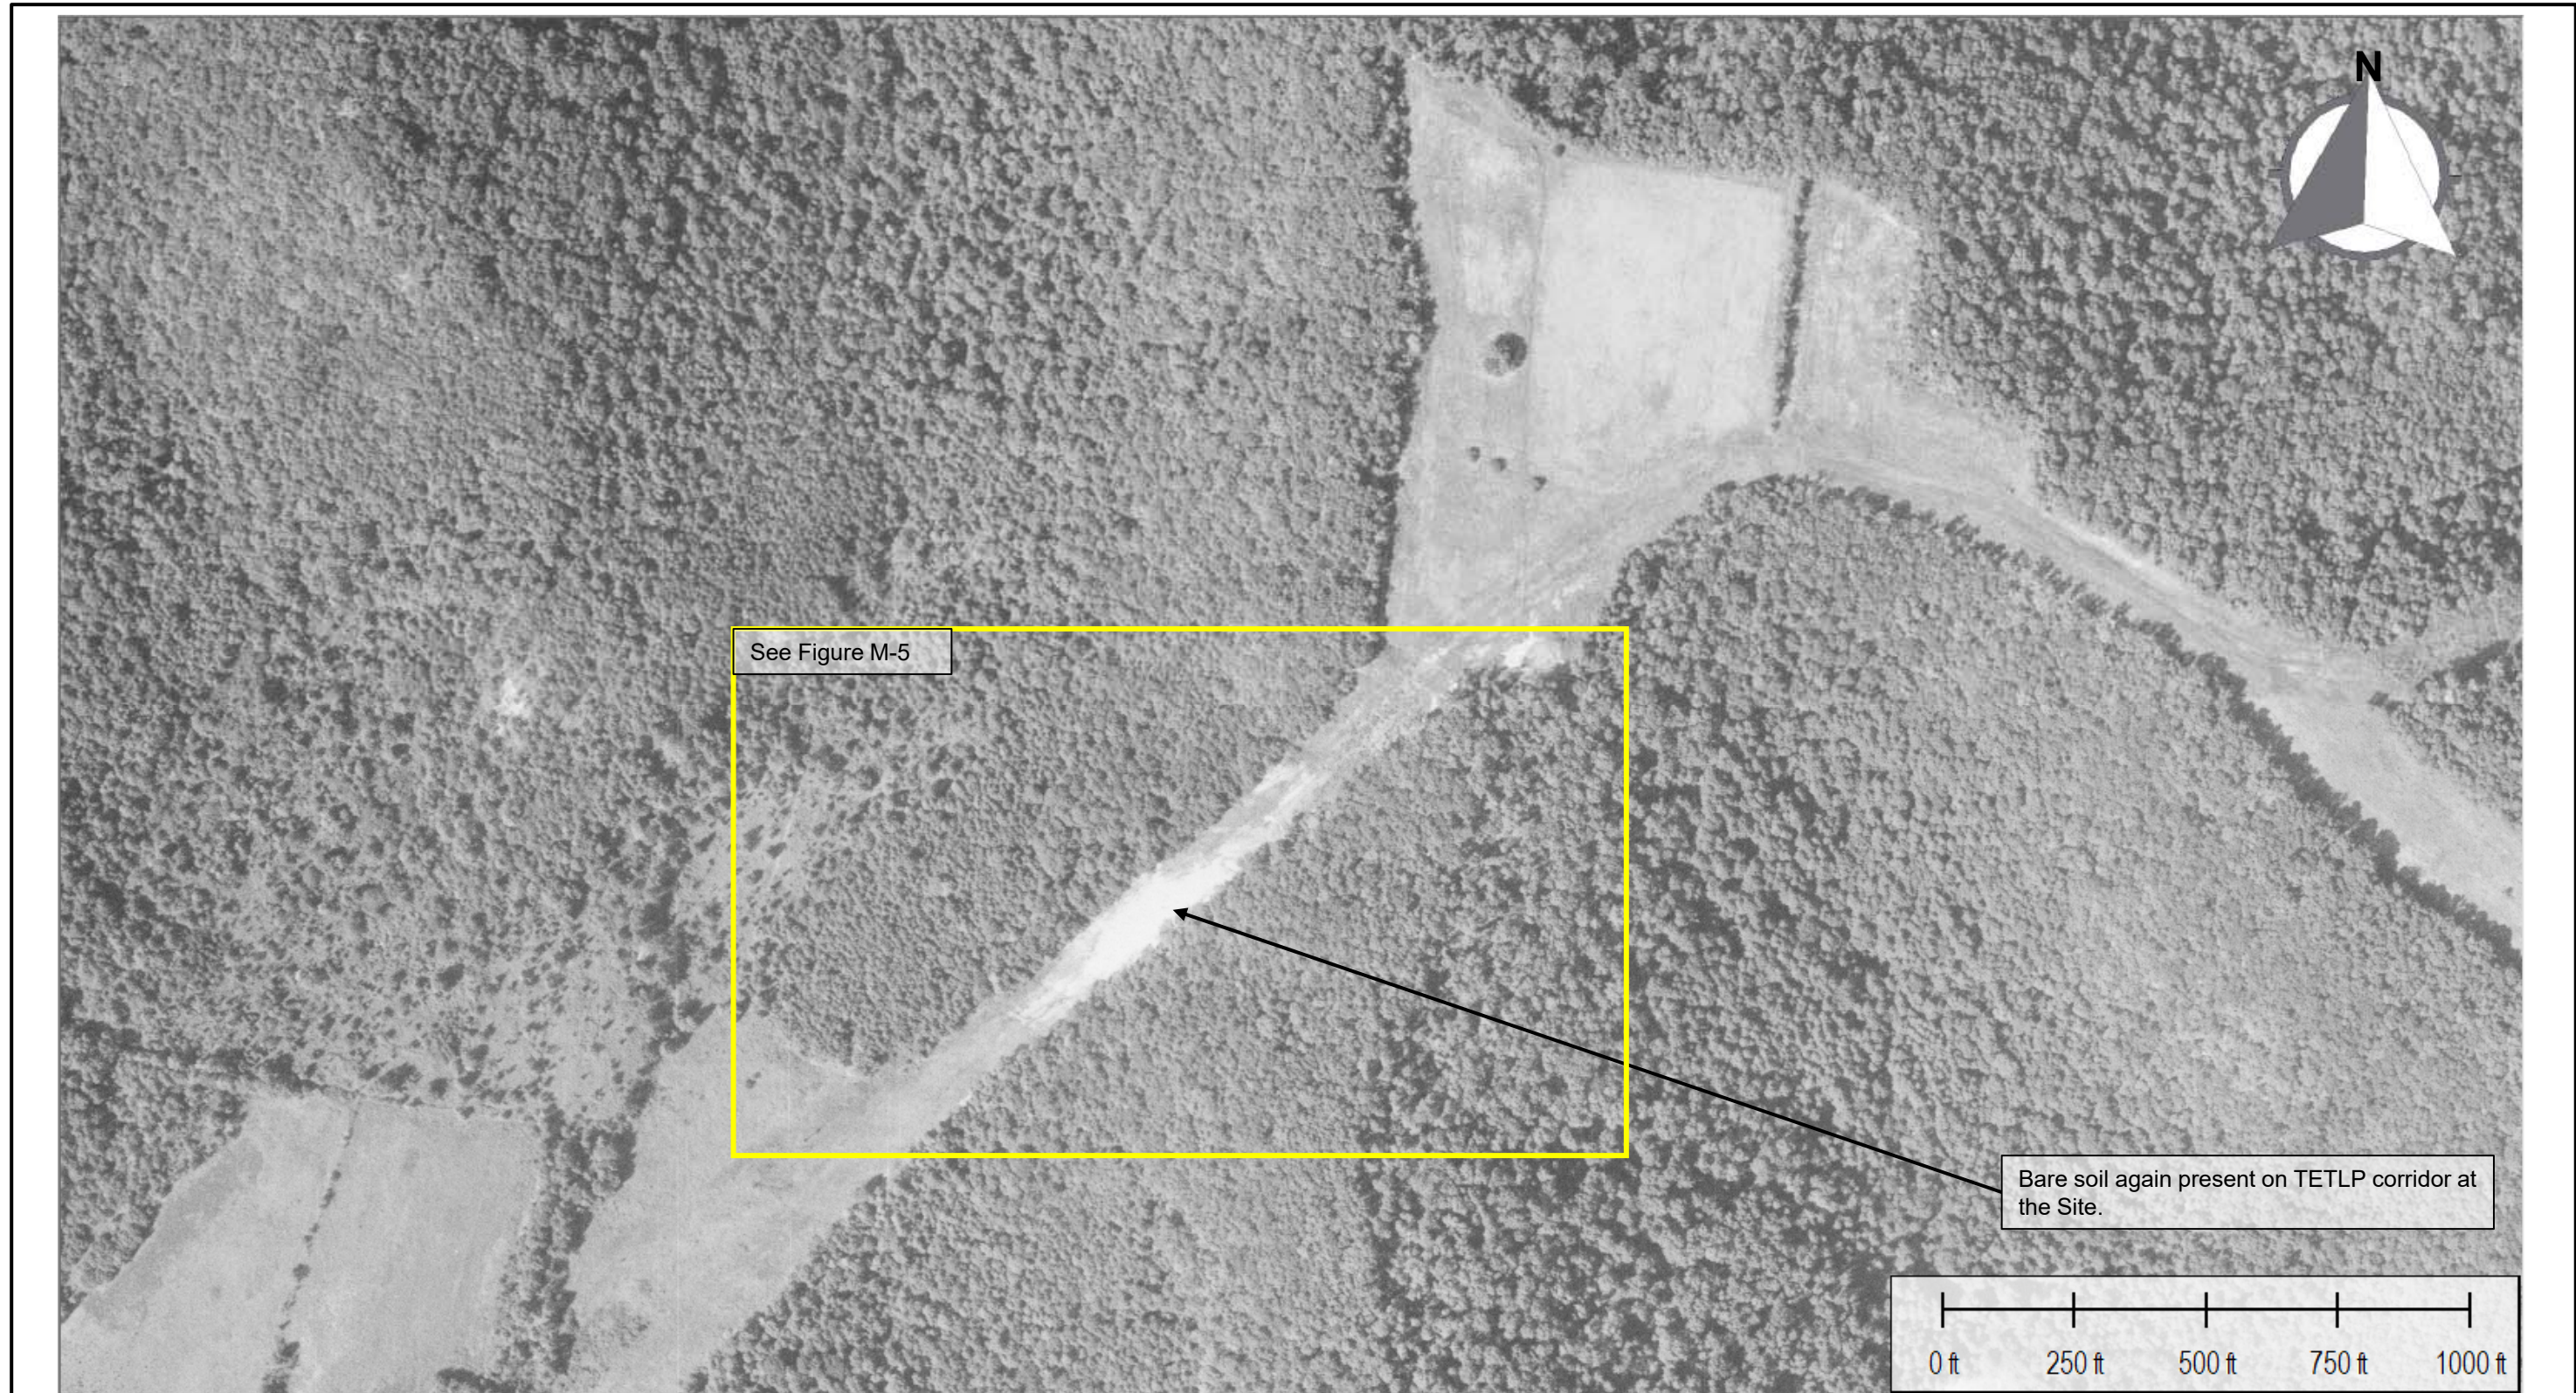
PREPARED BY: CAD	FIGURE TITLE FCI SEPTEMBER 20, 1972 AERIAL PHOTO		
CHECKED BY: CRS	CLIENT: TEXAS EASTERN TRANSMISSION, LP		
APPROVED BY: CAD	SCALE: AS SHOWN	PROJECT NO: 1607024	FIGURE NO: M-4

Bare soil again present on TETLP corridor at the Site.

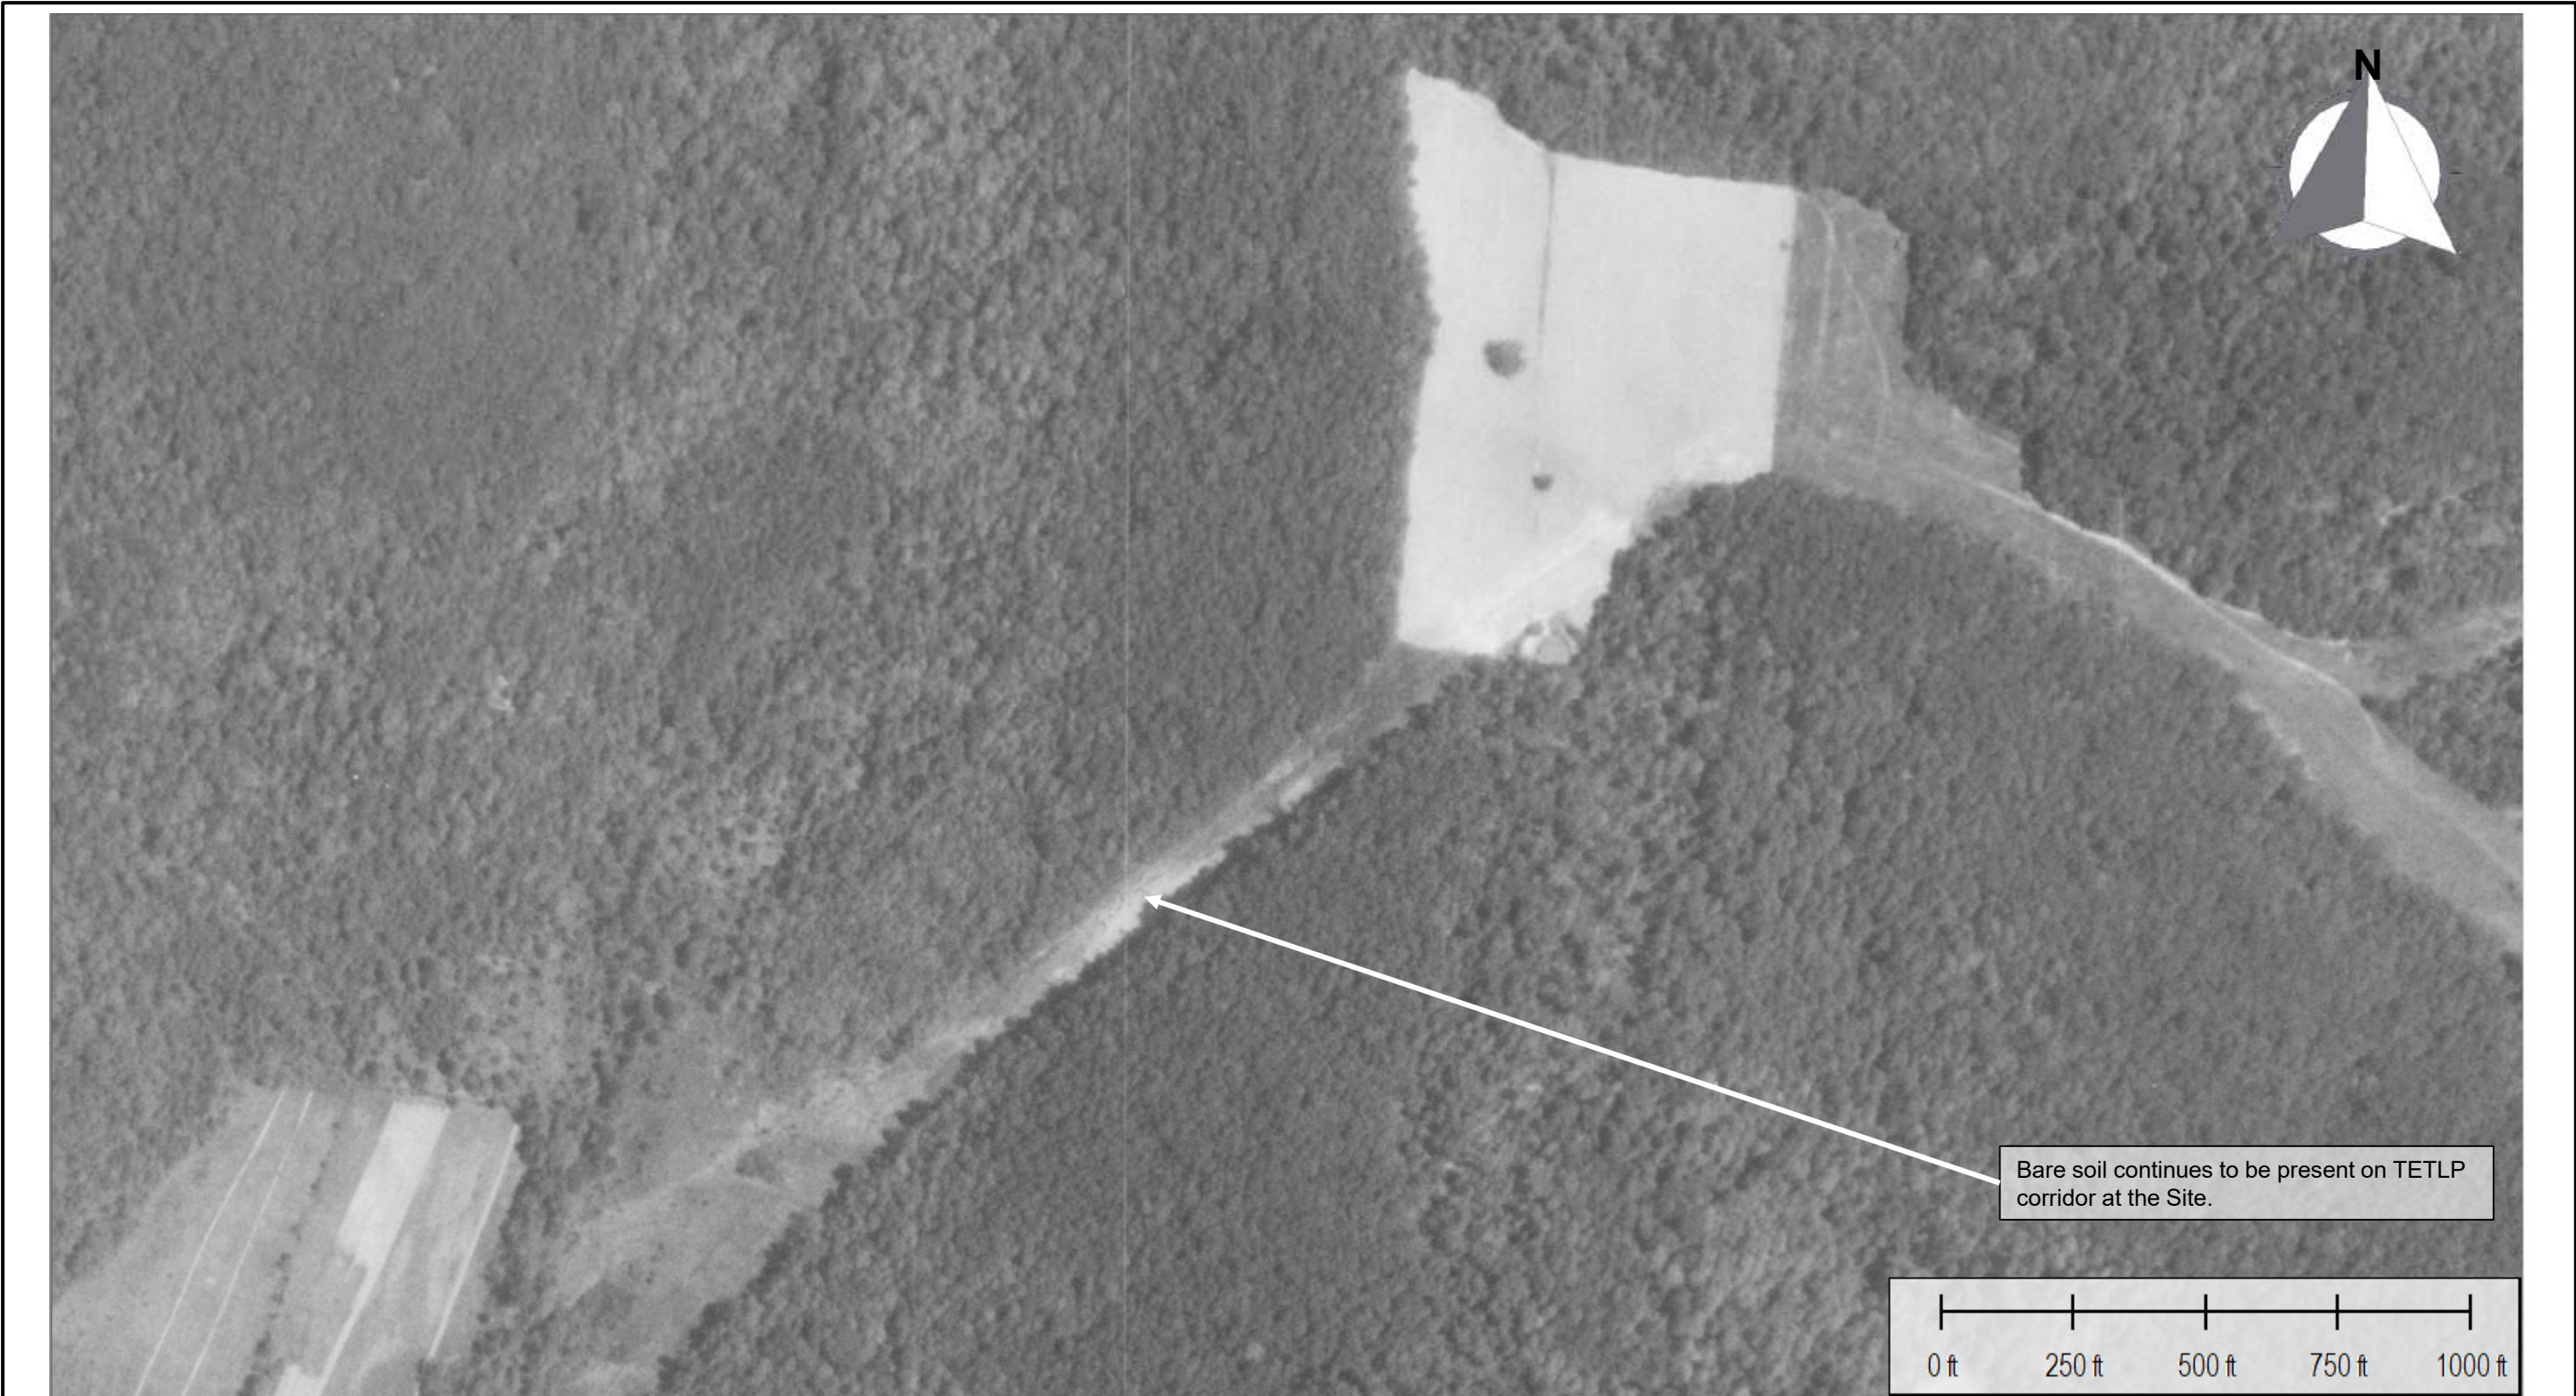
PREPARED BY: CAD	FIGURE TITLE FCI MAY 22, 1981 AERIAL PHOTO		
CHECKED BY: CRS	CLIENT: TEXAS EASTERN TRANSMISSION, LP		
APPROVED BY: CAD	SCALE: AS SHOWN	PROJECT NO: 1607024	FIGURE NO: M-6

Bare soil continues to be present on TETLP corridor at the Site.
