## **TEXAS EASTERN TRANSMISSION, LP**

### **MAY 4, 2020 FLEMING COUNTY INCIDENT GEOTECHNICAL CAUSATION REPORT**

PROJECT NO.: 1607024  
DOCUMENT NO.: Rev A

DATE: April 26, 2021

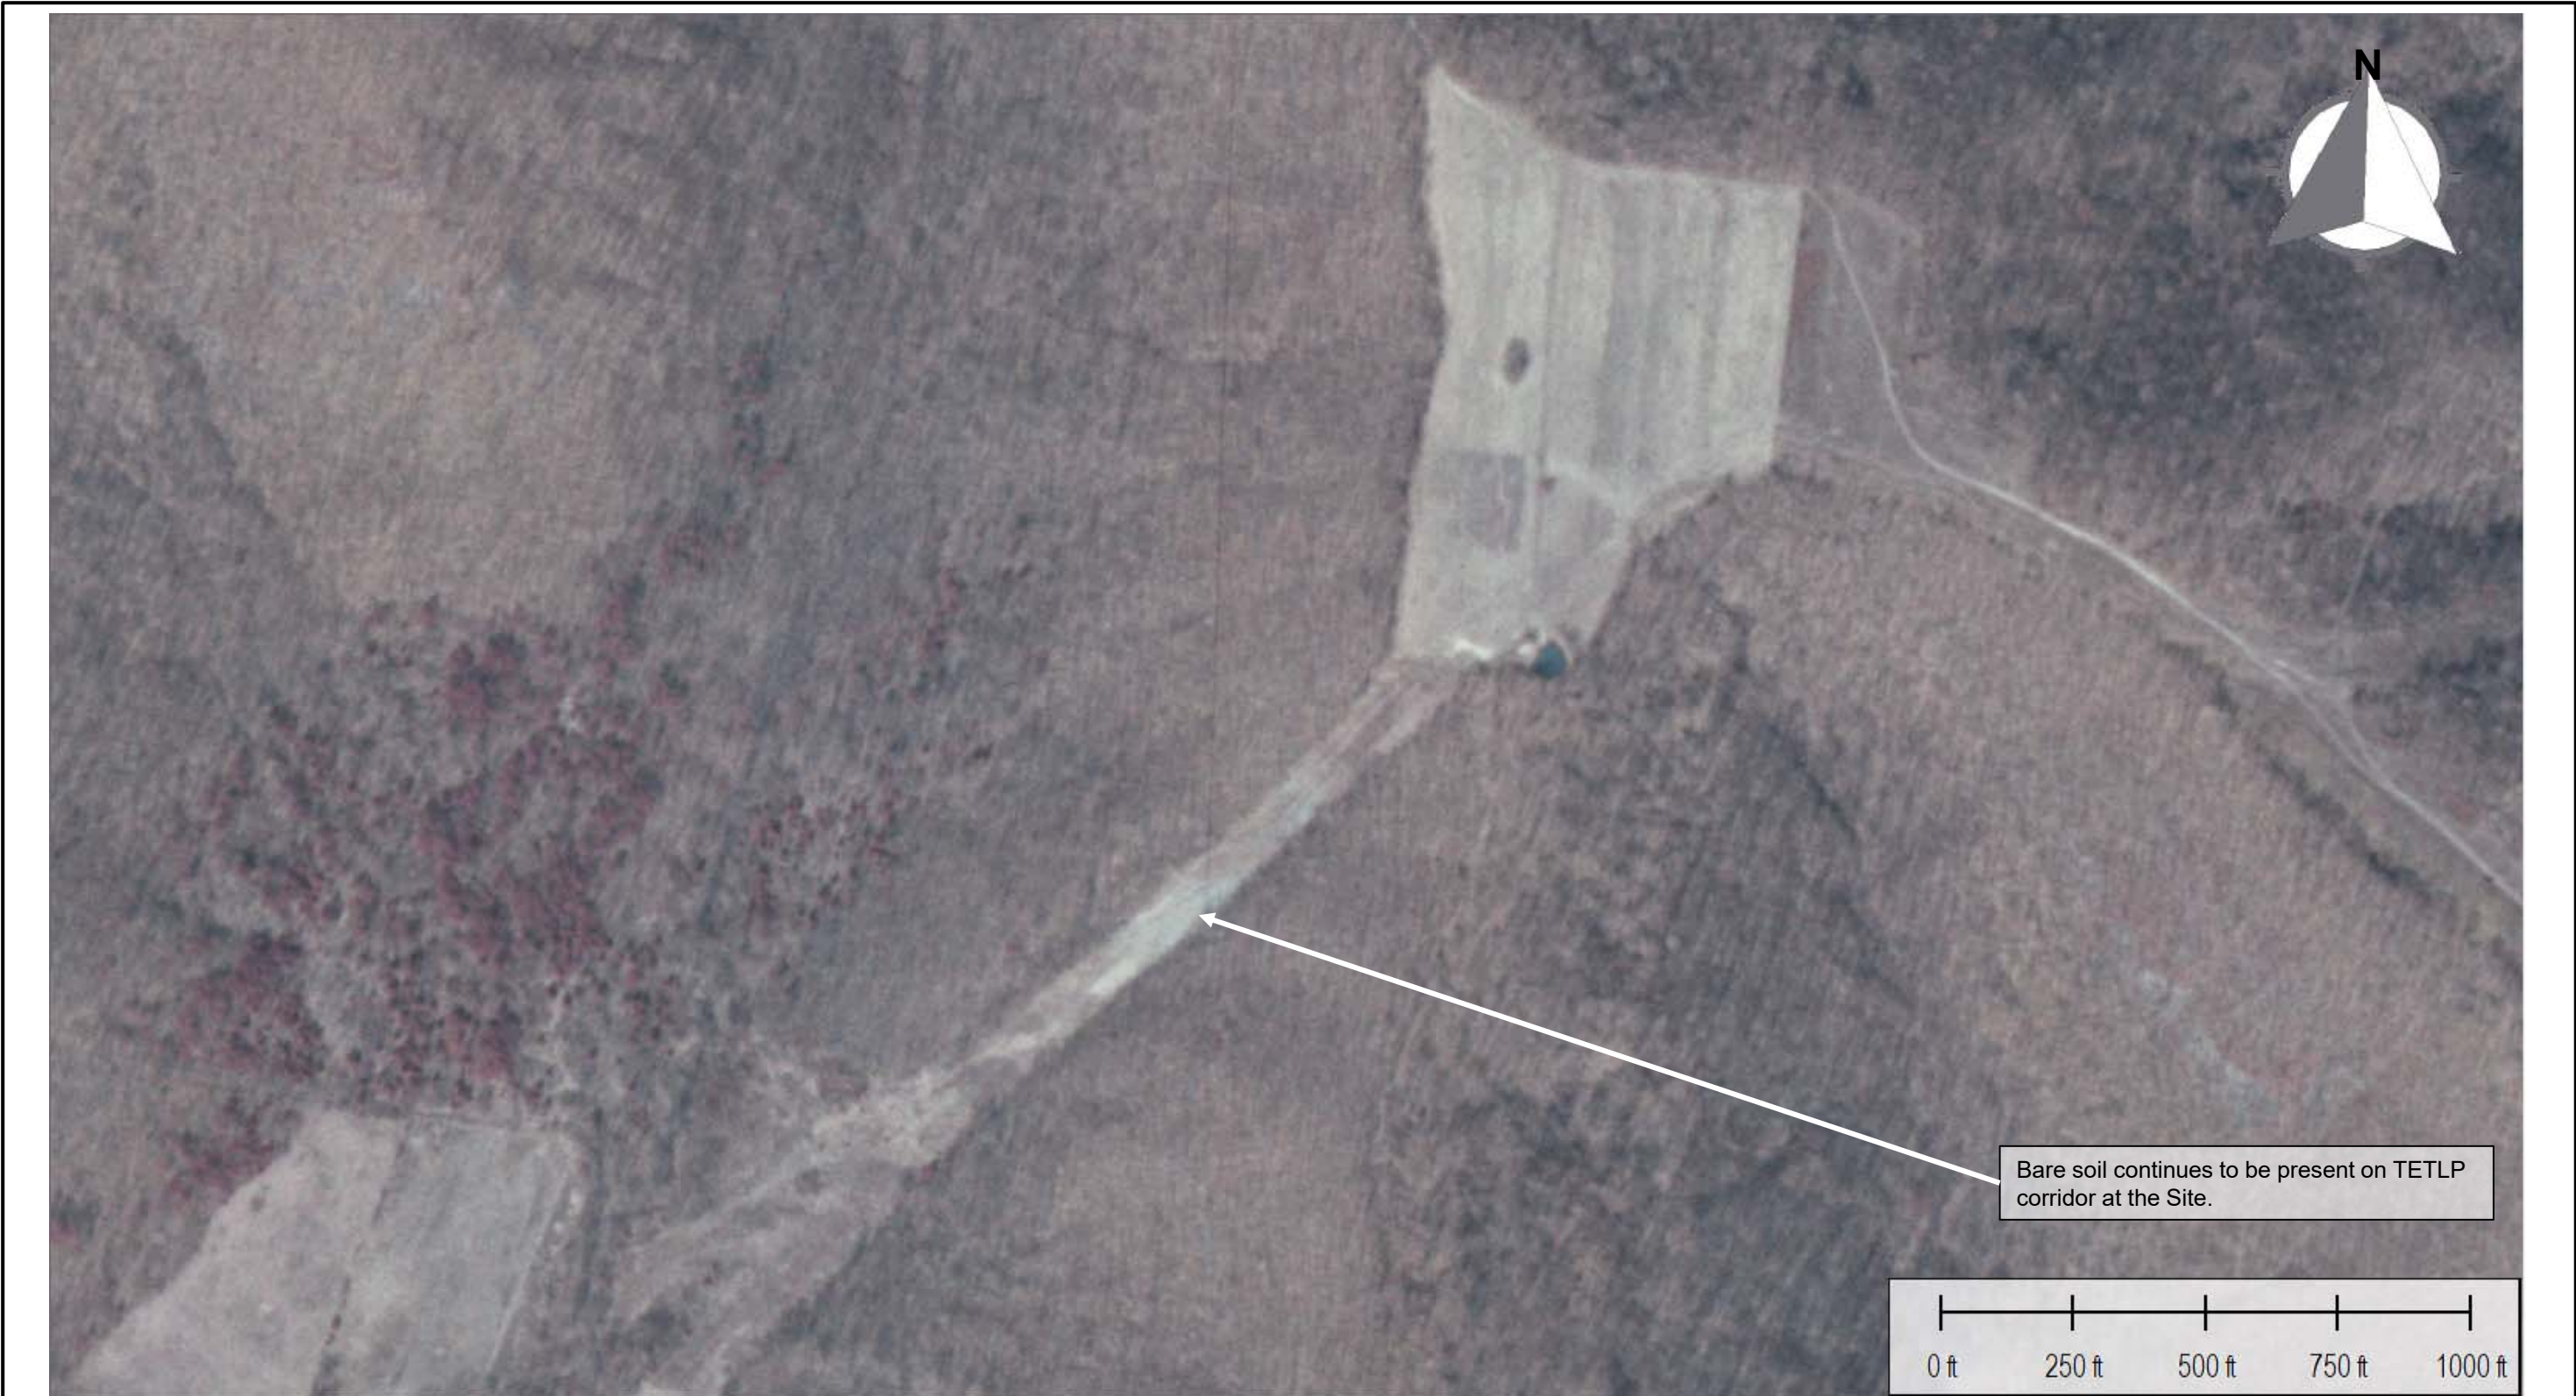
PREPARED BY: CAD	FIGURE TITLE FCI MARCH 18, 1983 AERIAL PHOTO		
CHECKED BY: CRS	CLIENT: TEXAS EASTERN TRANSMISSION, LP		
APPROVED BY: CAD	SCALE: AS SHOWN	PROJECT NO: 1607024	FIGURE NO: M-7

Bare soil continues to be present on TETLP corridor at the Site.

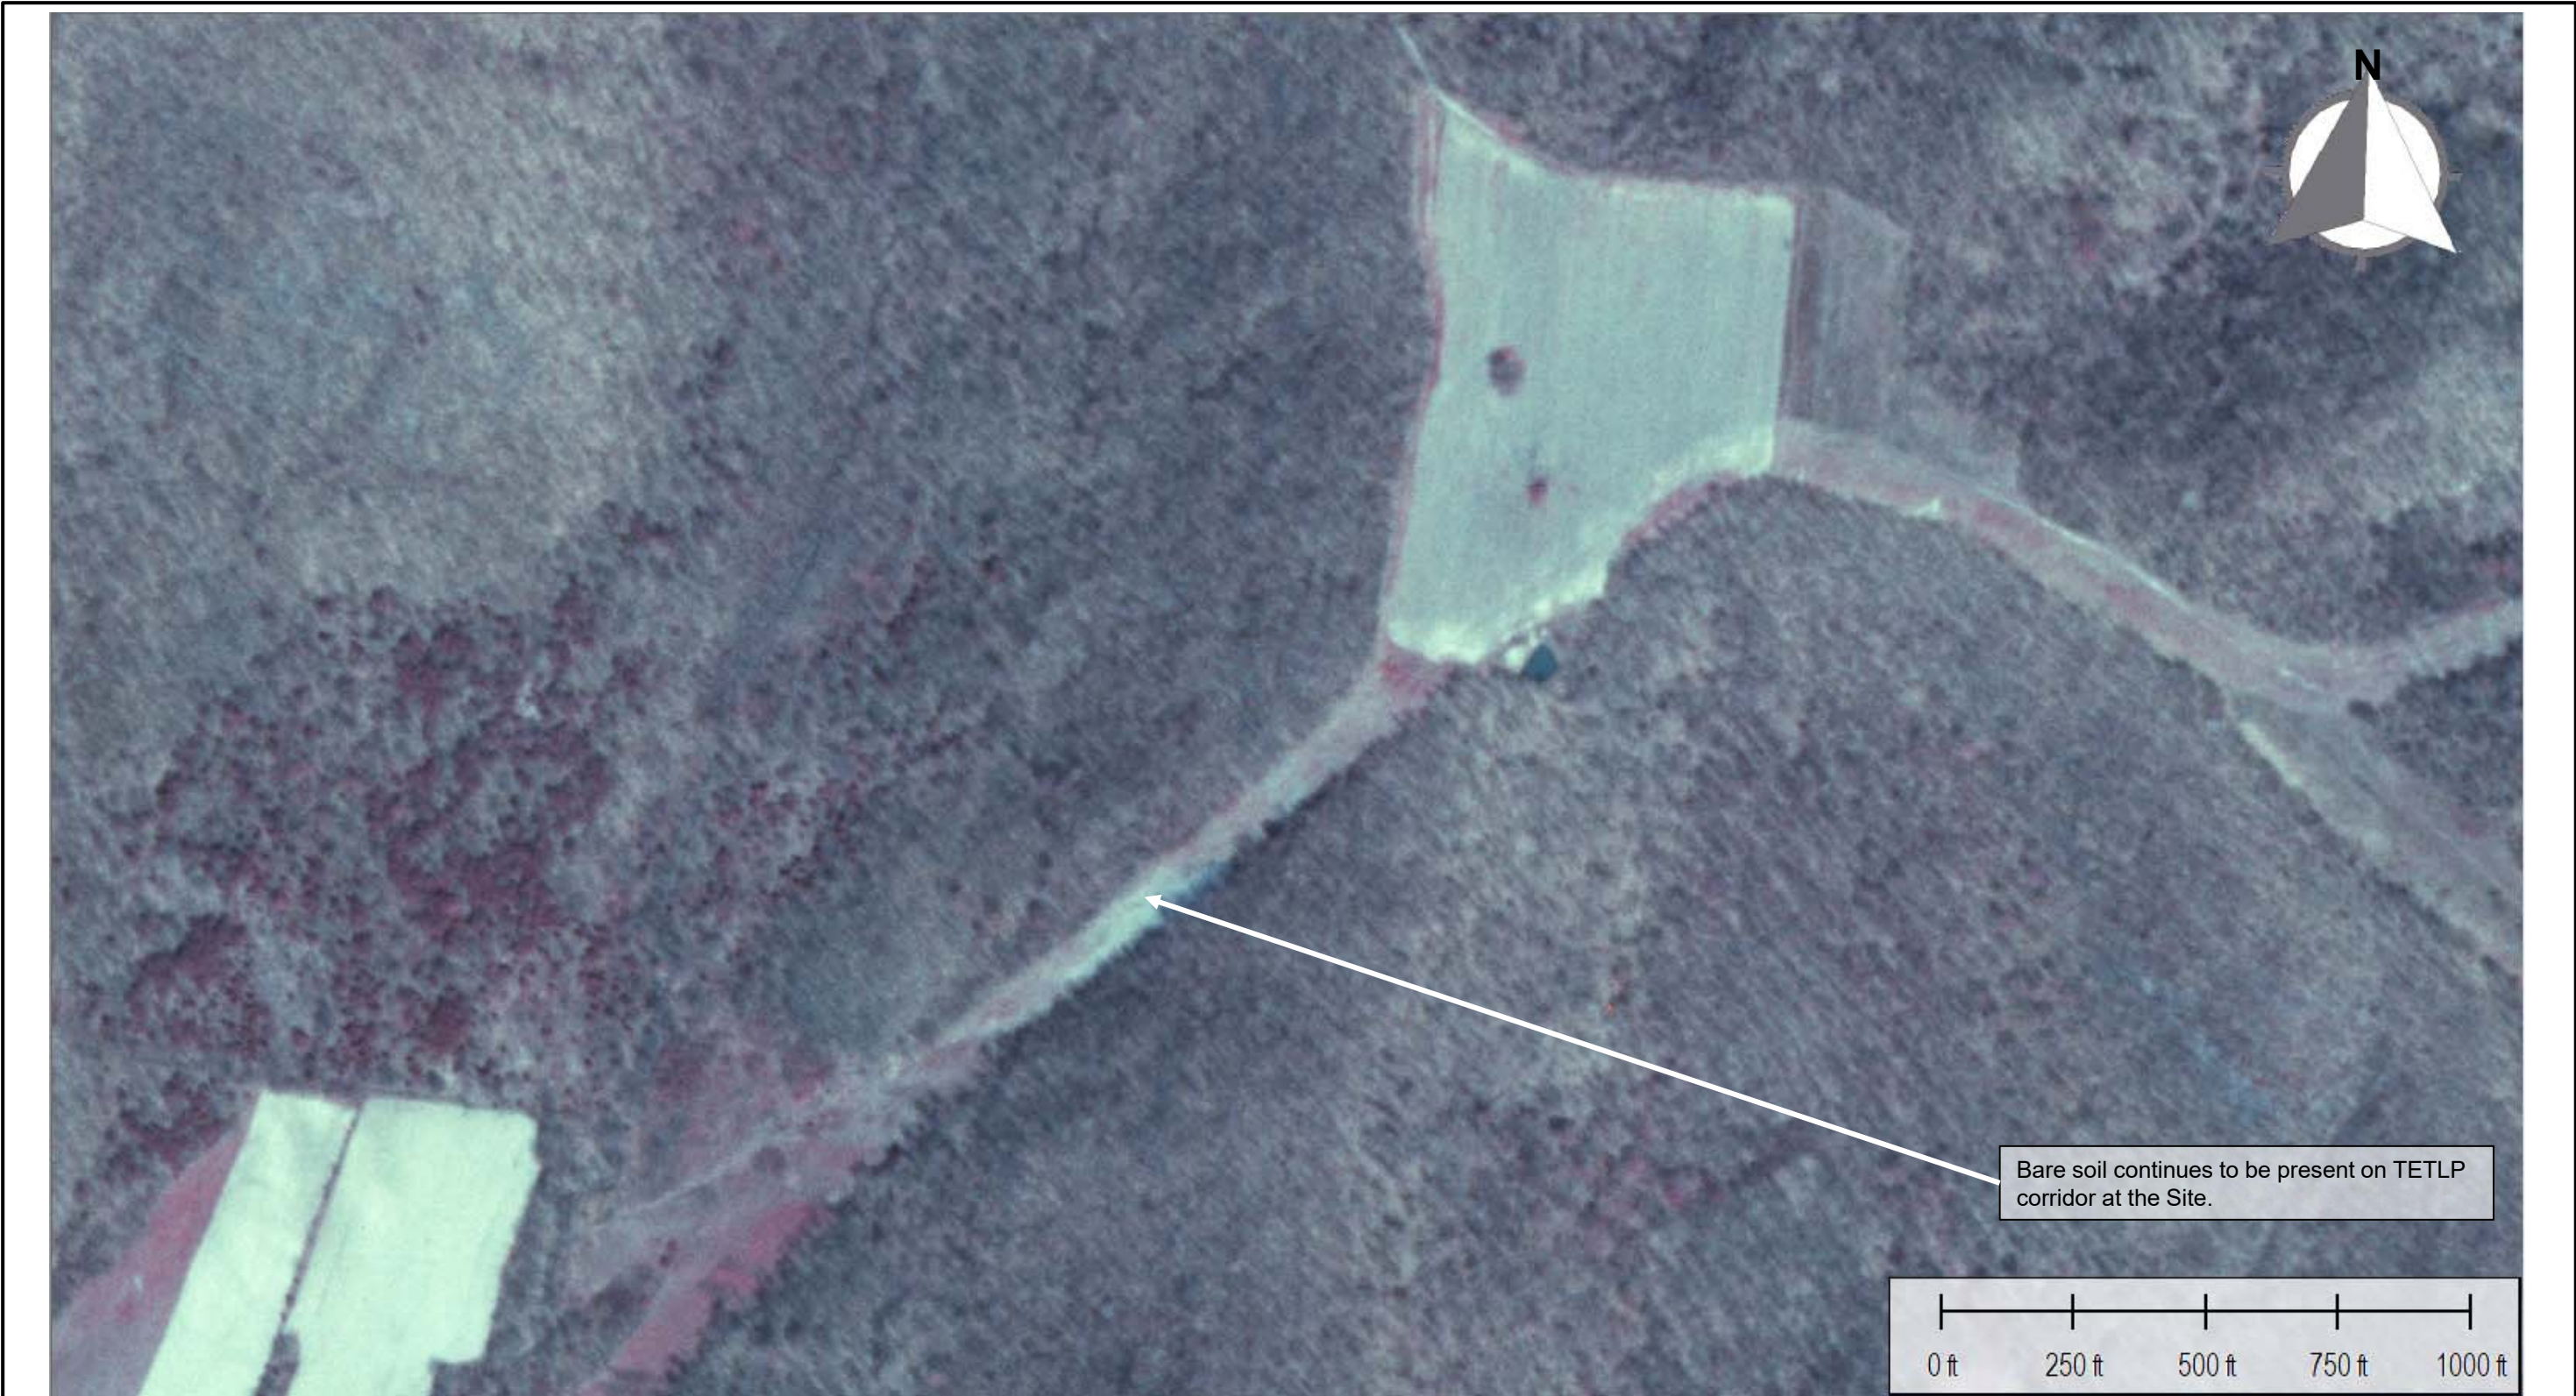
PREPARED BY: CAD	FIGURE TITLE <b>FCI APRIL 17, 1985 AERIAL PHOTO</b>		
CHECKED BY: CRS	CLIENT: TEXAS EASTERN TRANSMISSION, LP		
APPROVED BY: CAD	SCALE: AS SHOWN	PROJECT NO: 1607024	FIGURE NO: M-9

Bare soil continues to be present on TETLP corridor at the Site.

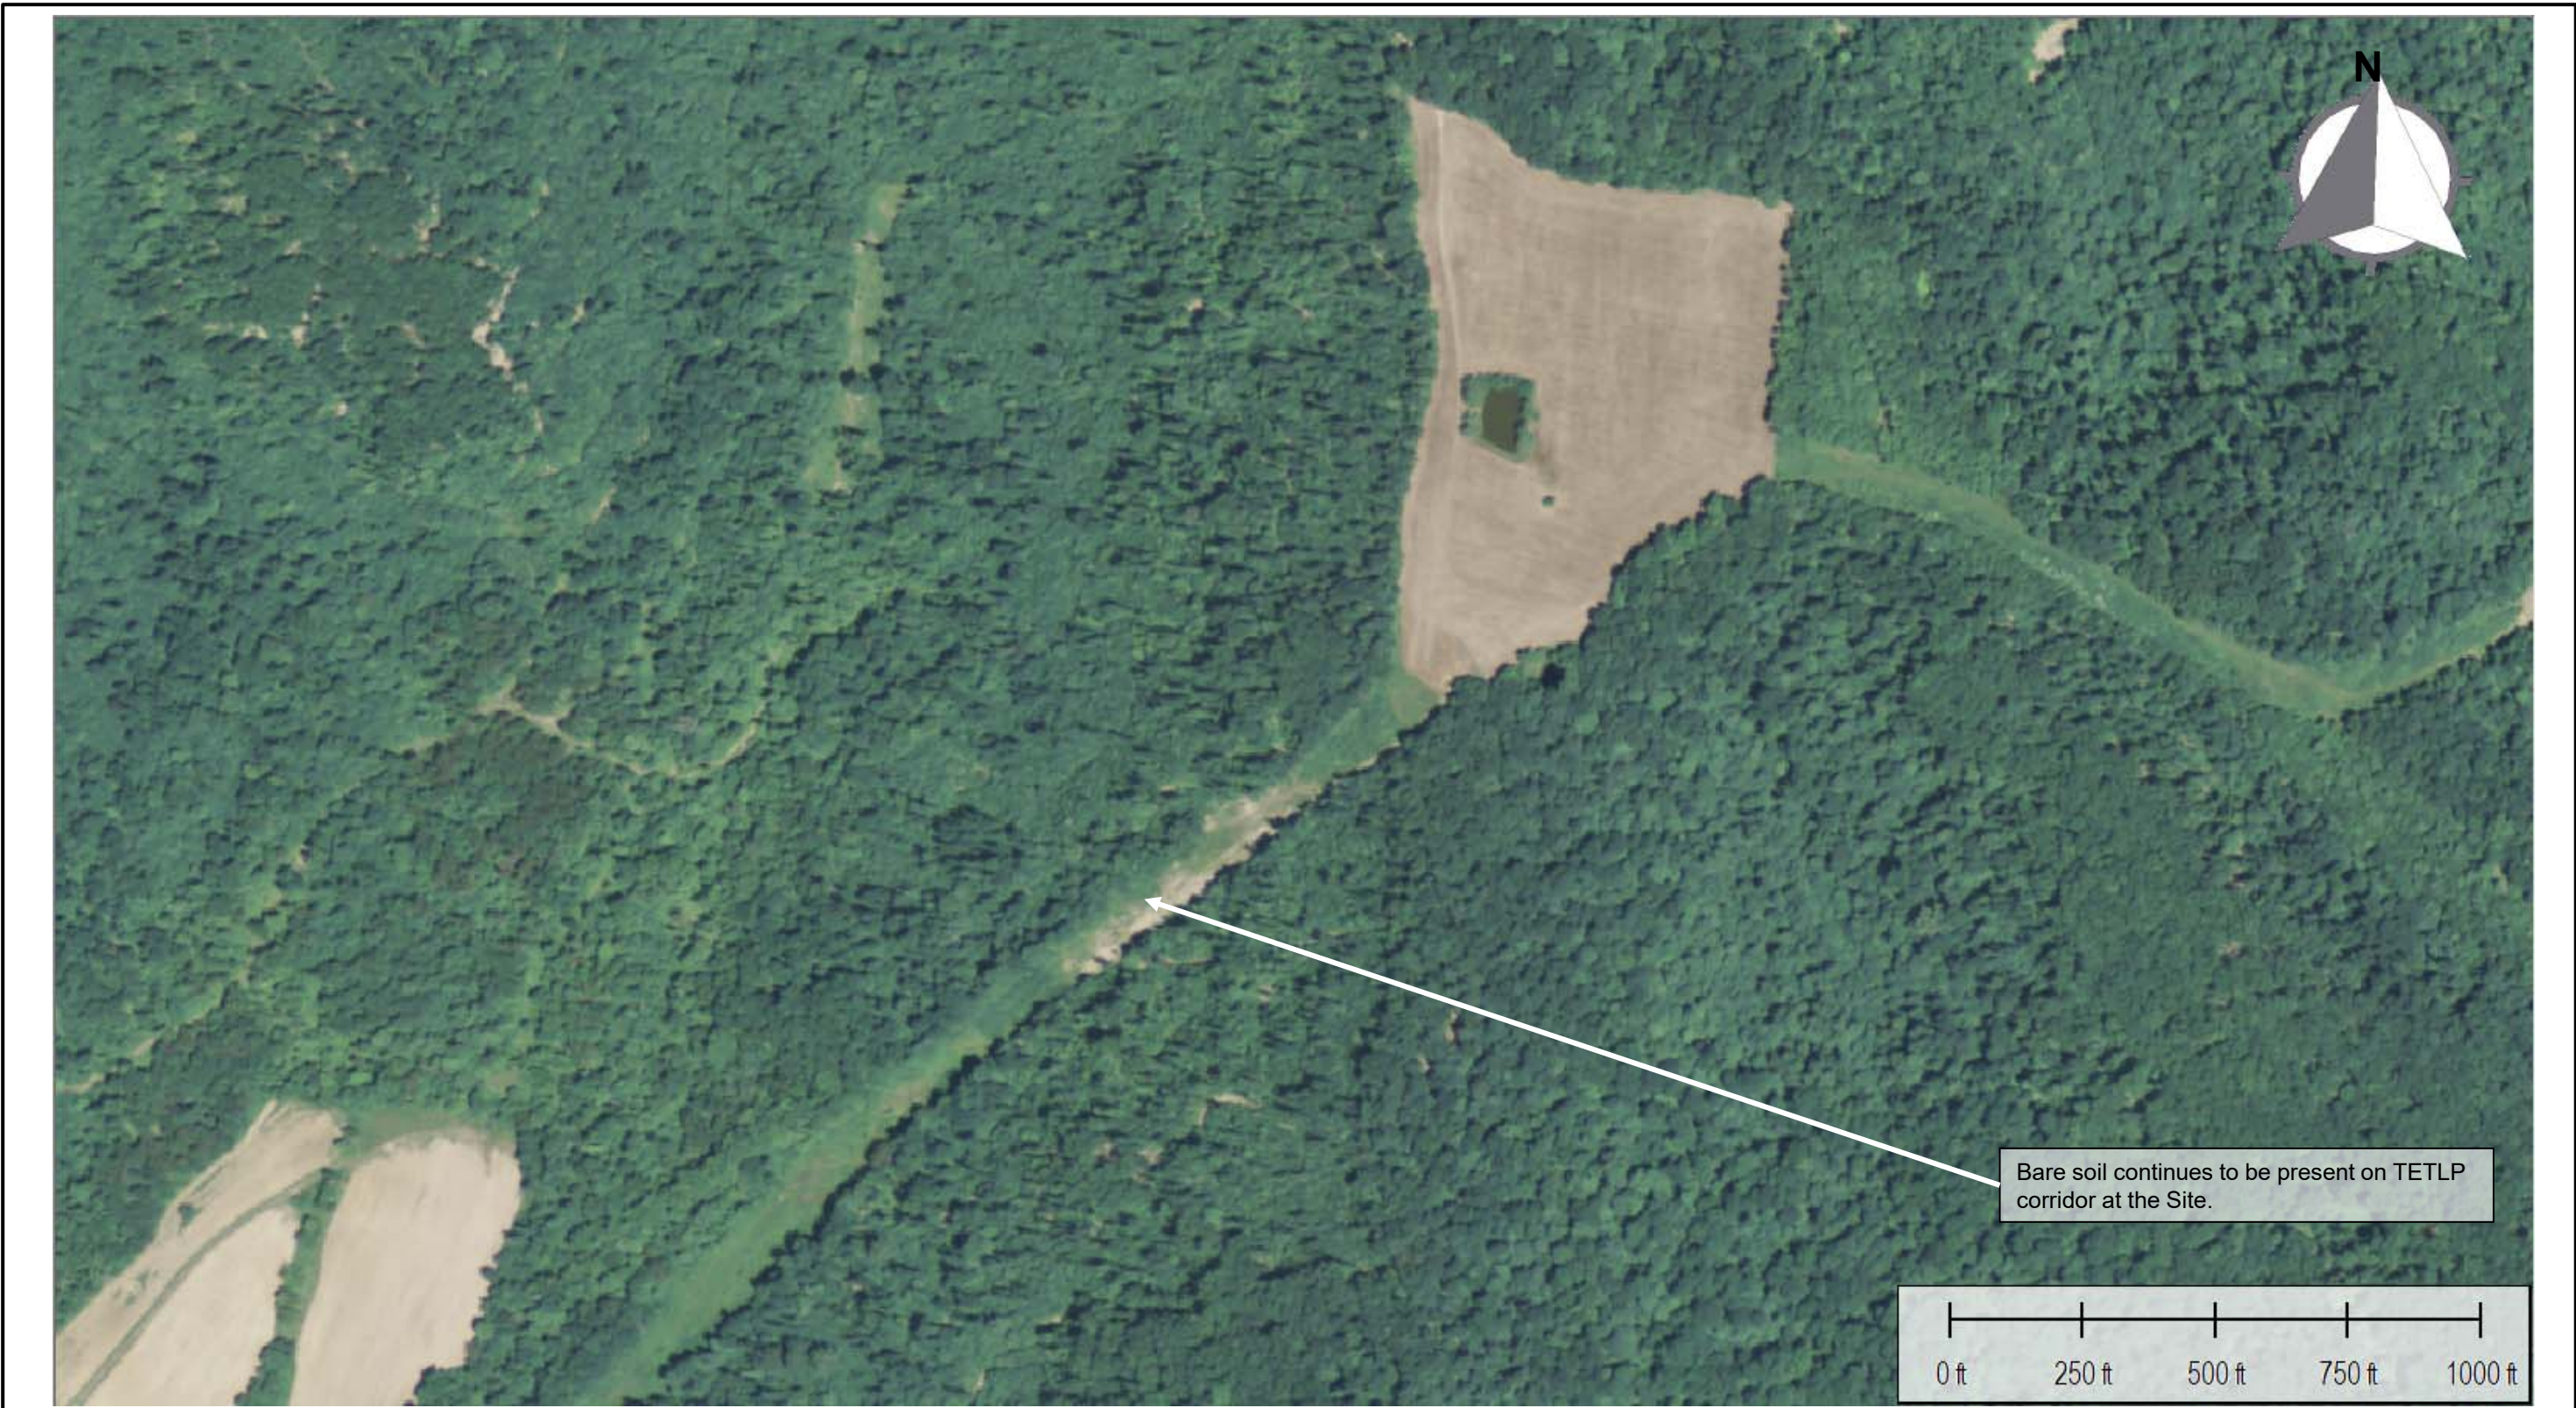
PREPARED BY: CAD	FIGURE TITLE FCI JULY 5, 2012 AERIAL PHOTO INSET		
CHECKED BY: CRS	CLIENT: TEXAS EASTERN TRANSMISSION, LP		
APPROVED BY: CAD	SCALE: AS SHOWN	PROJECT NO: 1607024	FIGURE NO: M-19

Bare soil continues to be present on TETLP corridor at the Site.
