PRESENTATION OF PARTY SUBMISSION TO THE NATIONAL TRANSPORTATION SAFETY BOARD

**FIU UniversityCity Prosperity Pedestrian Bridge
Construction Accident of March 15, 2018**

FIU University City Prosperity Pedestrian Bridge
Construction Accident
Miami, Florida | March 15, 2018
Submitted by - Figg Bridge Engineers, Inc.

**PARTY
SUBMISSION
BY FIGG
BRIDGE
ENGINEERS**

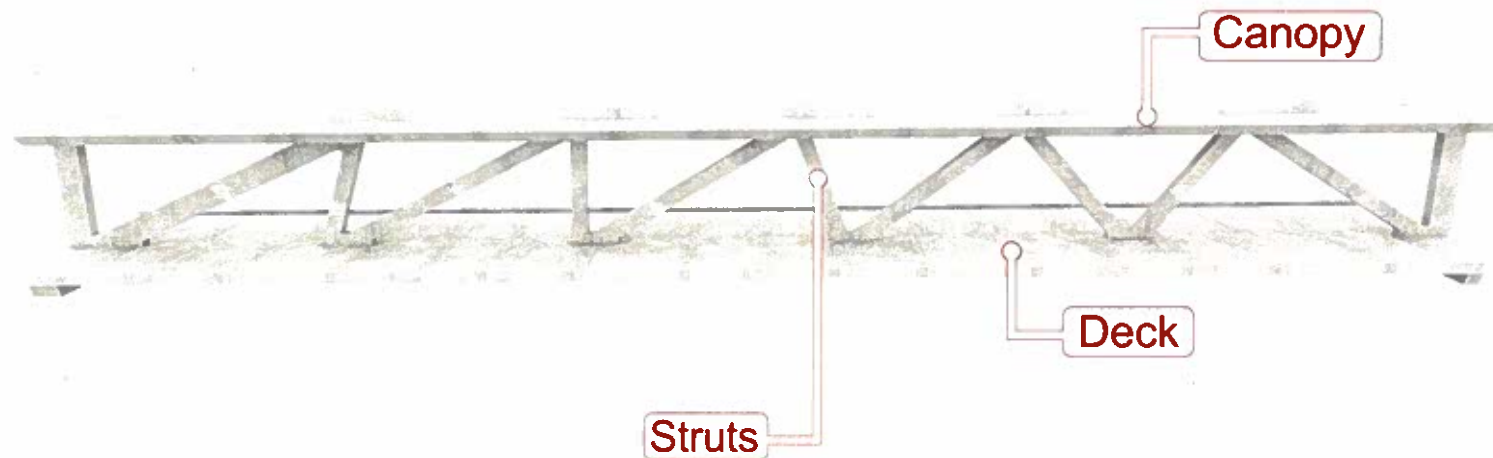
Construction Joints in the Main Span Truss

Contractor Preference to Pour Concrete in 3 stages

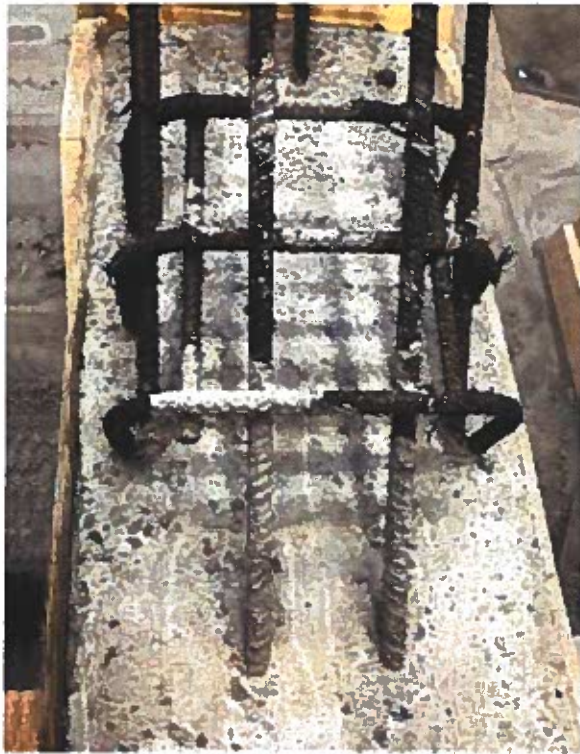
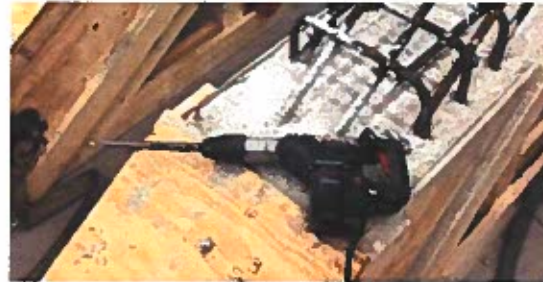
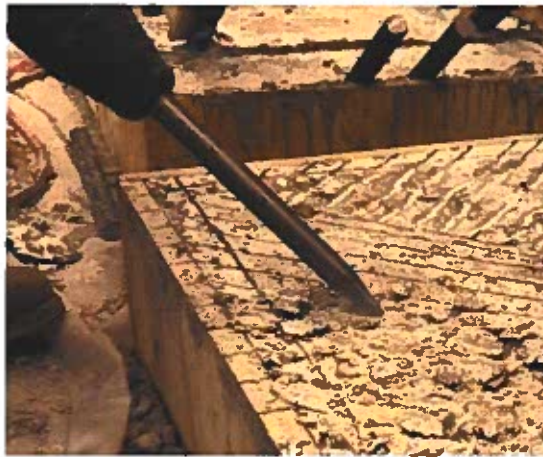
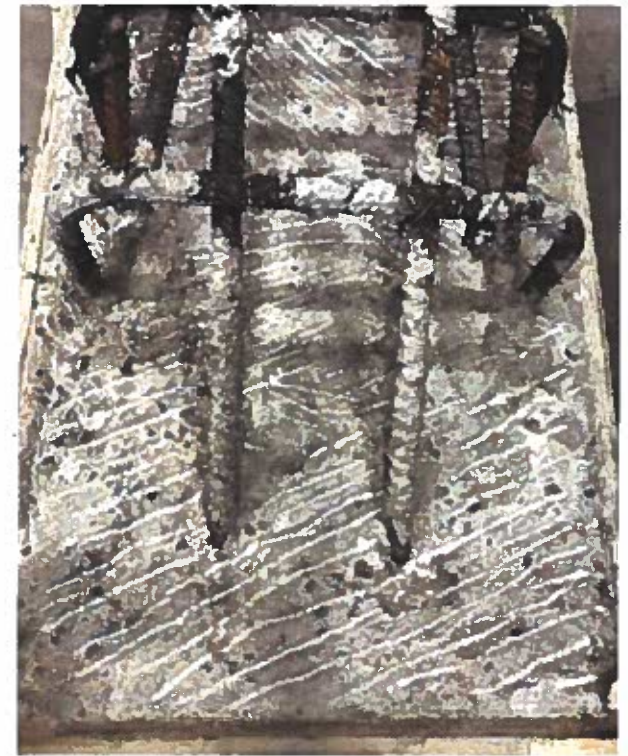
Common Roughening Tool - Electric Chipping Hammer

Un-Roughened

Roughened per FDOT Specifications

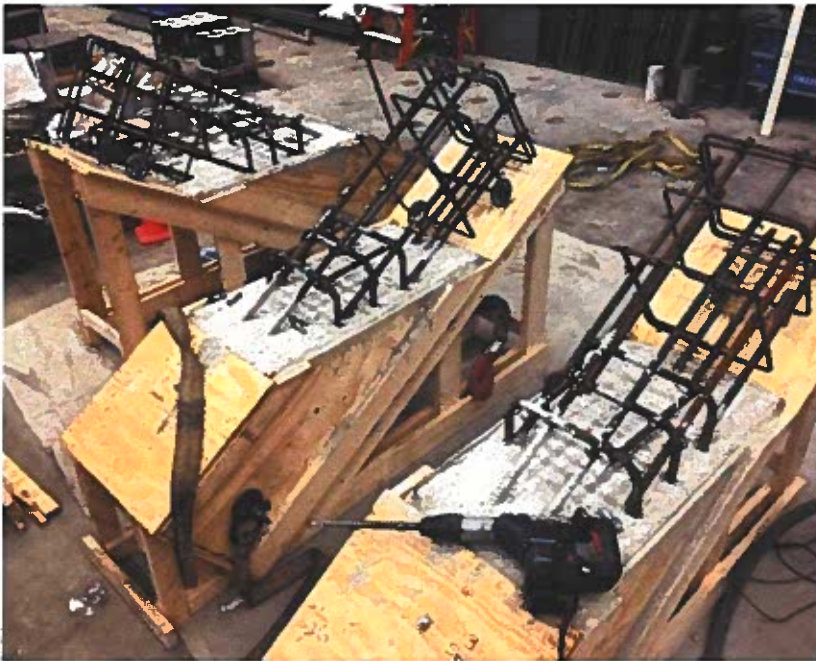
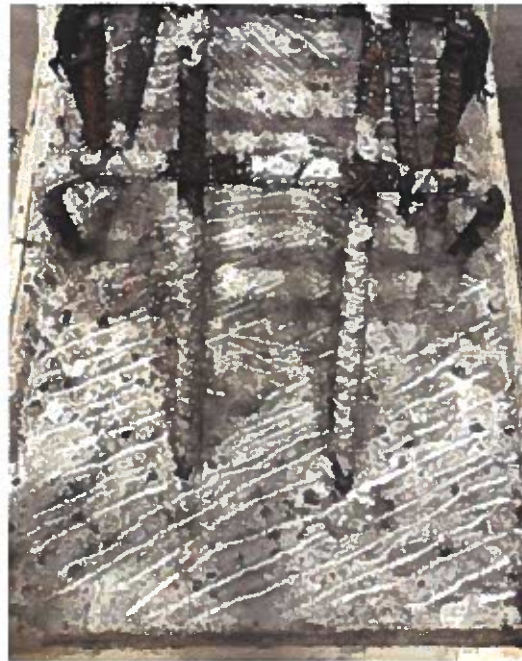
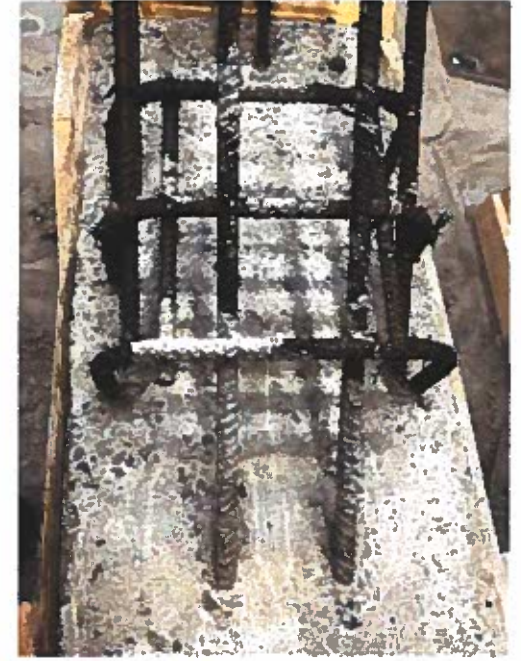
Construction Joints

Six (6) Full-sized specimens replicating the Truss Member 11 connection to the bridge deck.
Three (3) specimens had construction joints roughened per FDOT Specifications.
There (3) specimens had non-roughened construction joints (as-placed)

Roughened per
FDOT Specifications

Non-Roughened

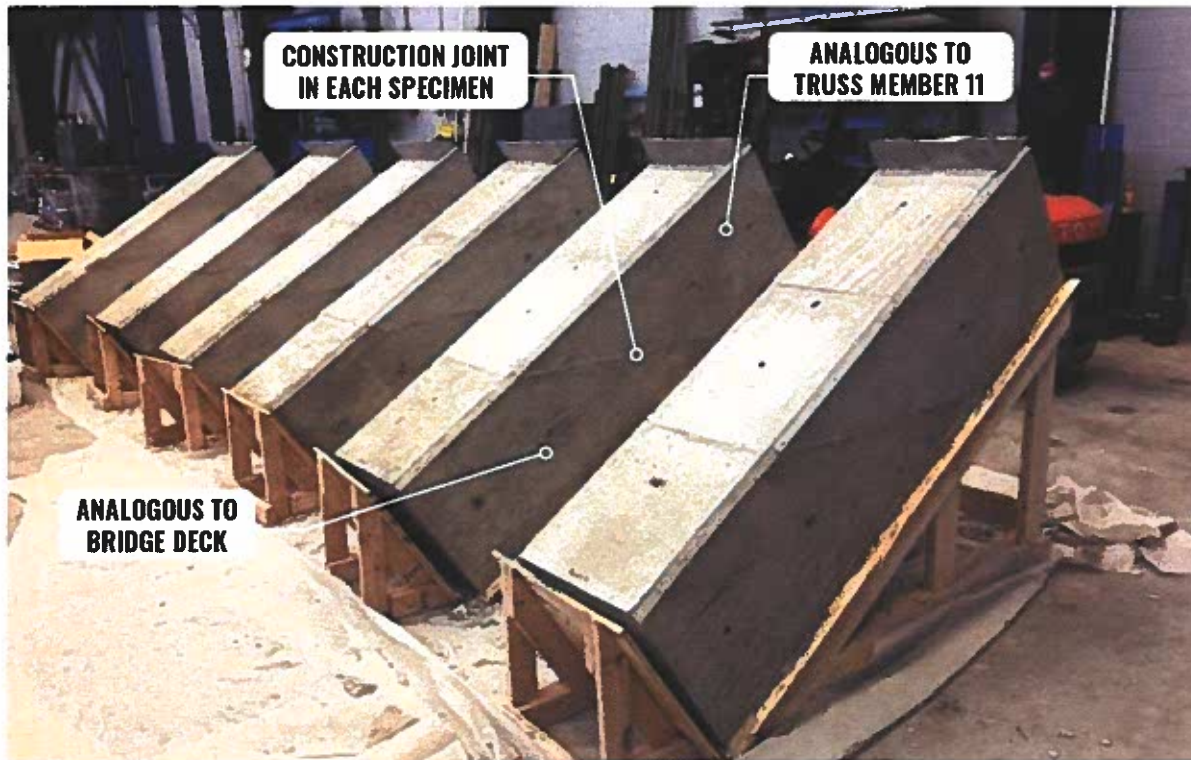
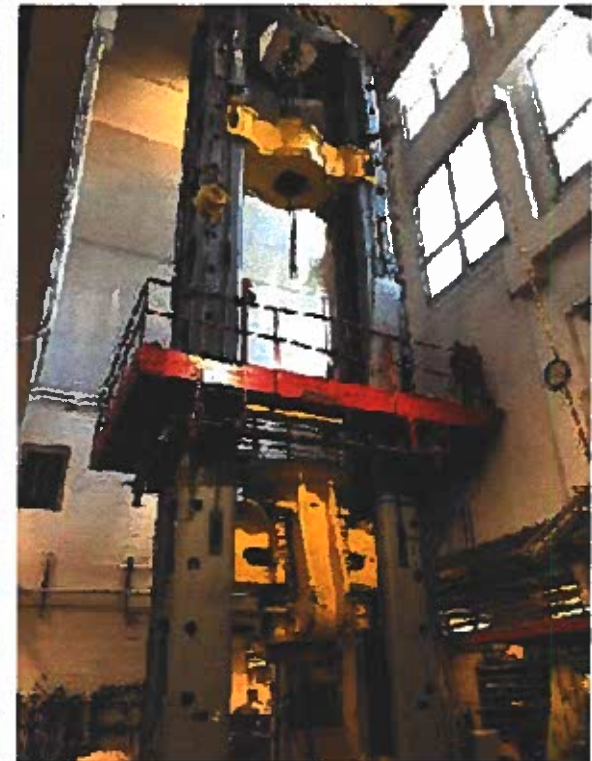
Completed test specimens

Specimens tested with same loads as FIU Bridge experienced and then to failure

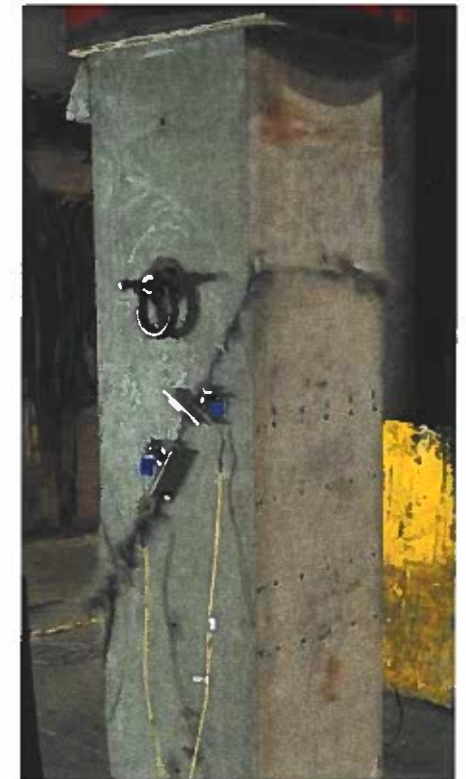
Specimen at Failure Load

Test Results: No failure if construction joint is roughened per FDOT Specifications

Specimen	Peak Load (Average)	Member 11 Load at Failure	%
Roughened	2,594 kips	1,743 kips	149%
Non-roughened	1,455 kips	1,743 kips	83%

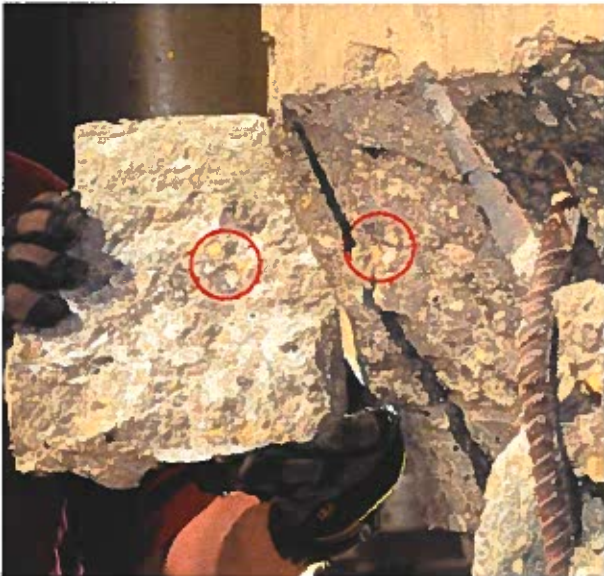
Fractured Aggregate
Roughened Joint Interface

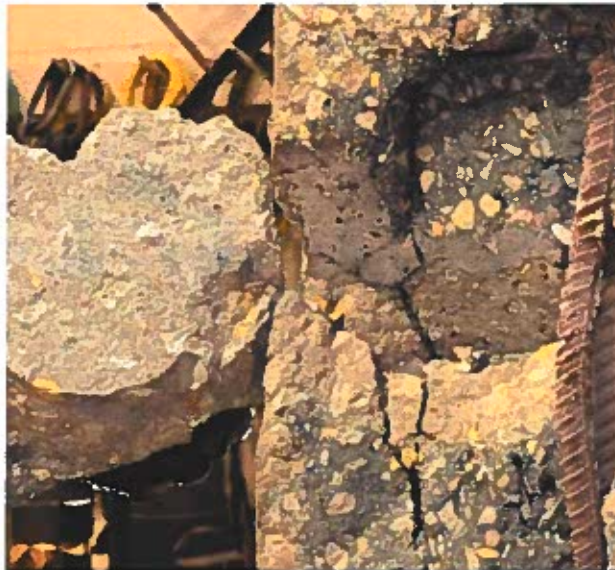
Actual FIU Bridge failure surface is consistent with non-roughened test specimen, further proving construction joint was not roughened

No Fractured Aggregate
Non-roughened Joint Interface

No Fractured Aggregate
Proves actual bridge joint
was non-roughened

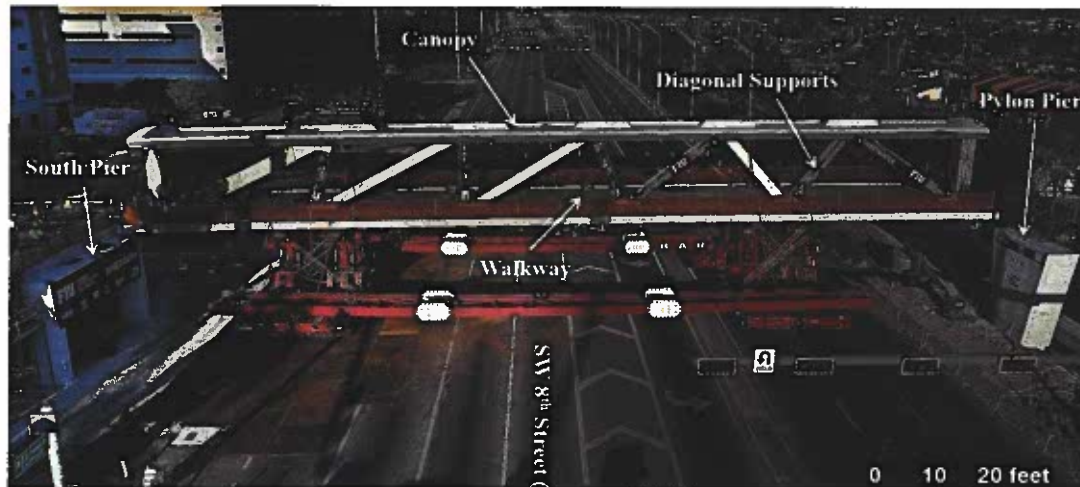
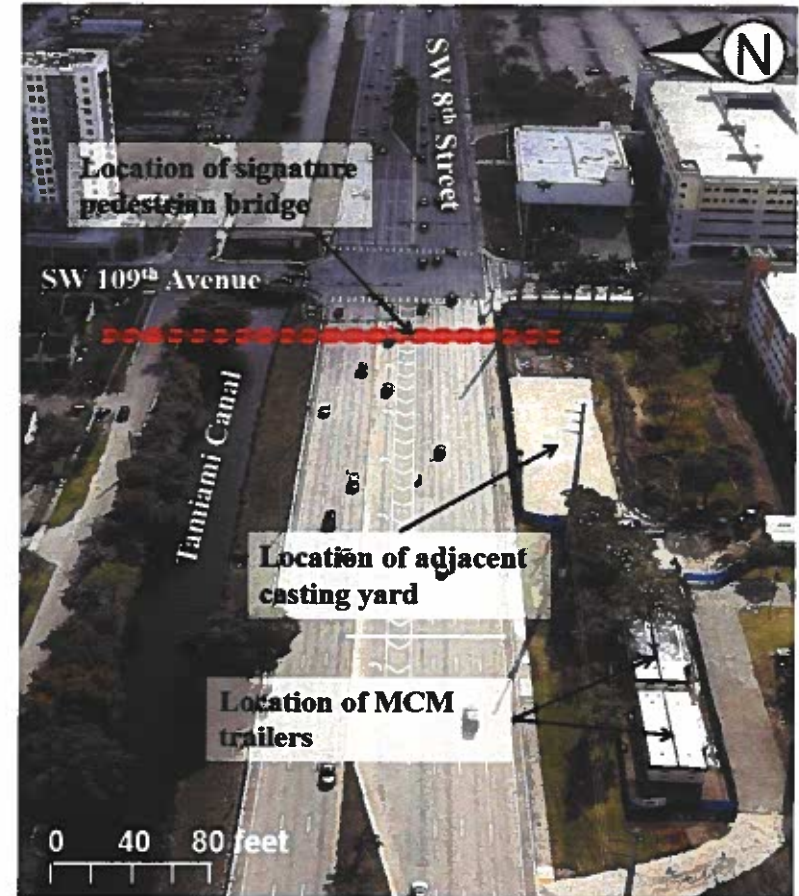
Damage sustained in moving the span from casting area to the piers - twisted by 168% of the limit (unknown by FIGG).

Main span moved from precast area using transporters to permanent piers over SW 8th Street

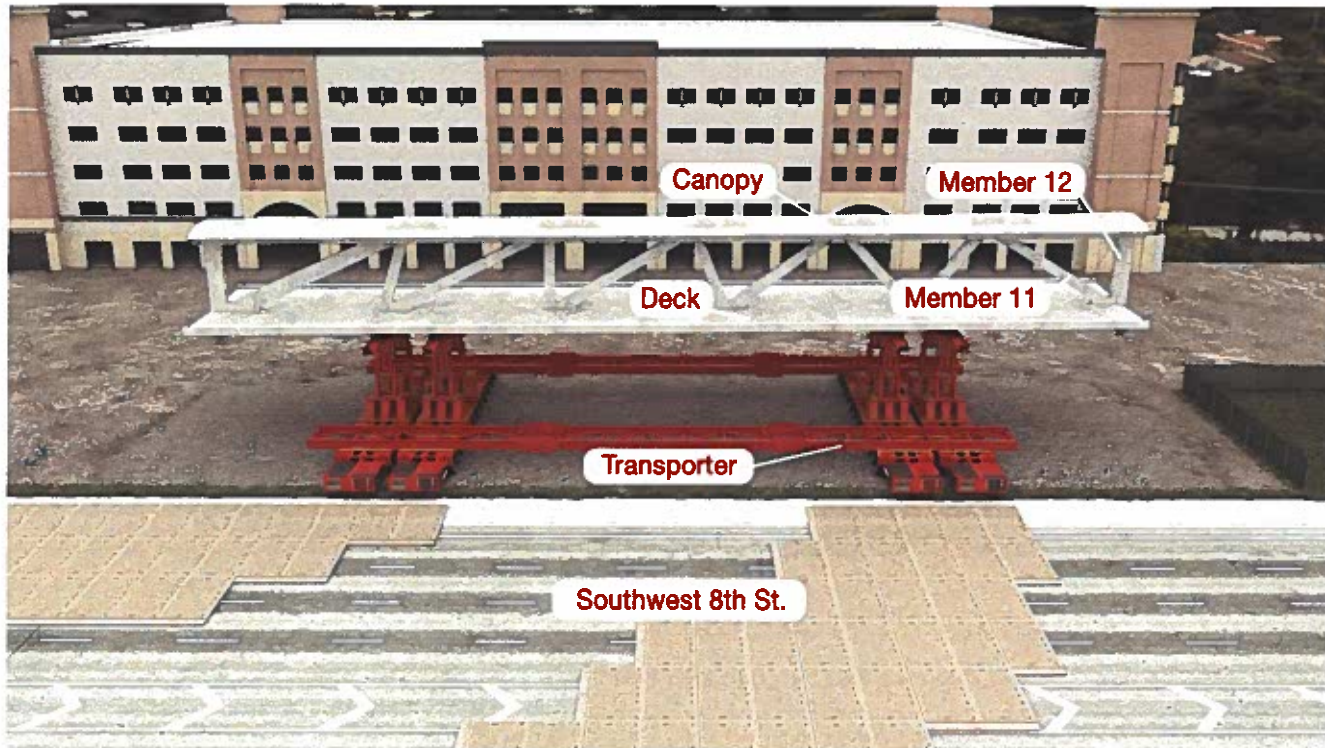
Contributory Cause - Damage From Bridge Move

Limit set by FIGG of 0.5 degrees maximum twist

Span instrumented and monitored by subcontractor during move

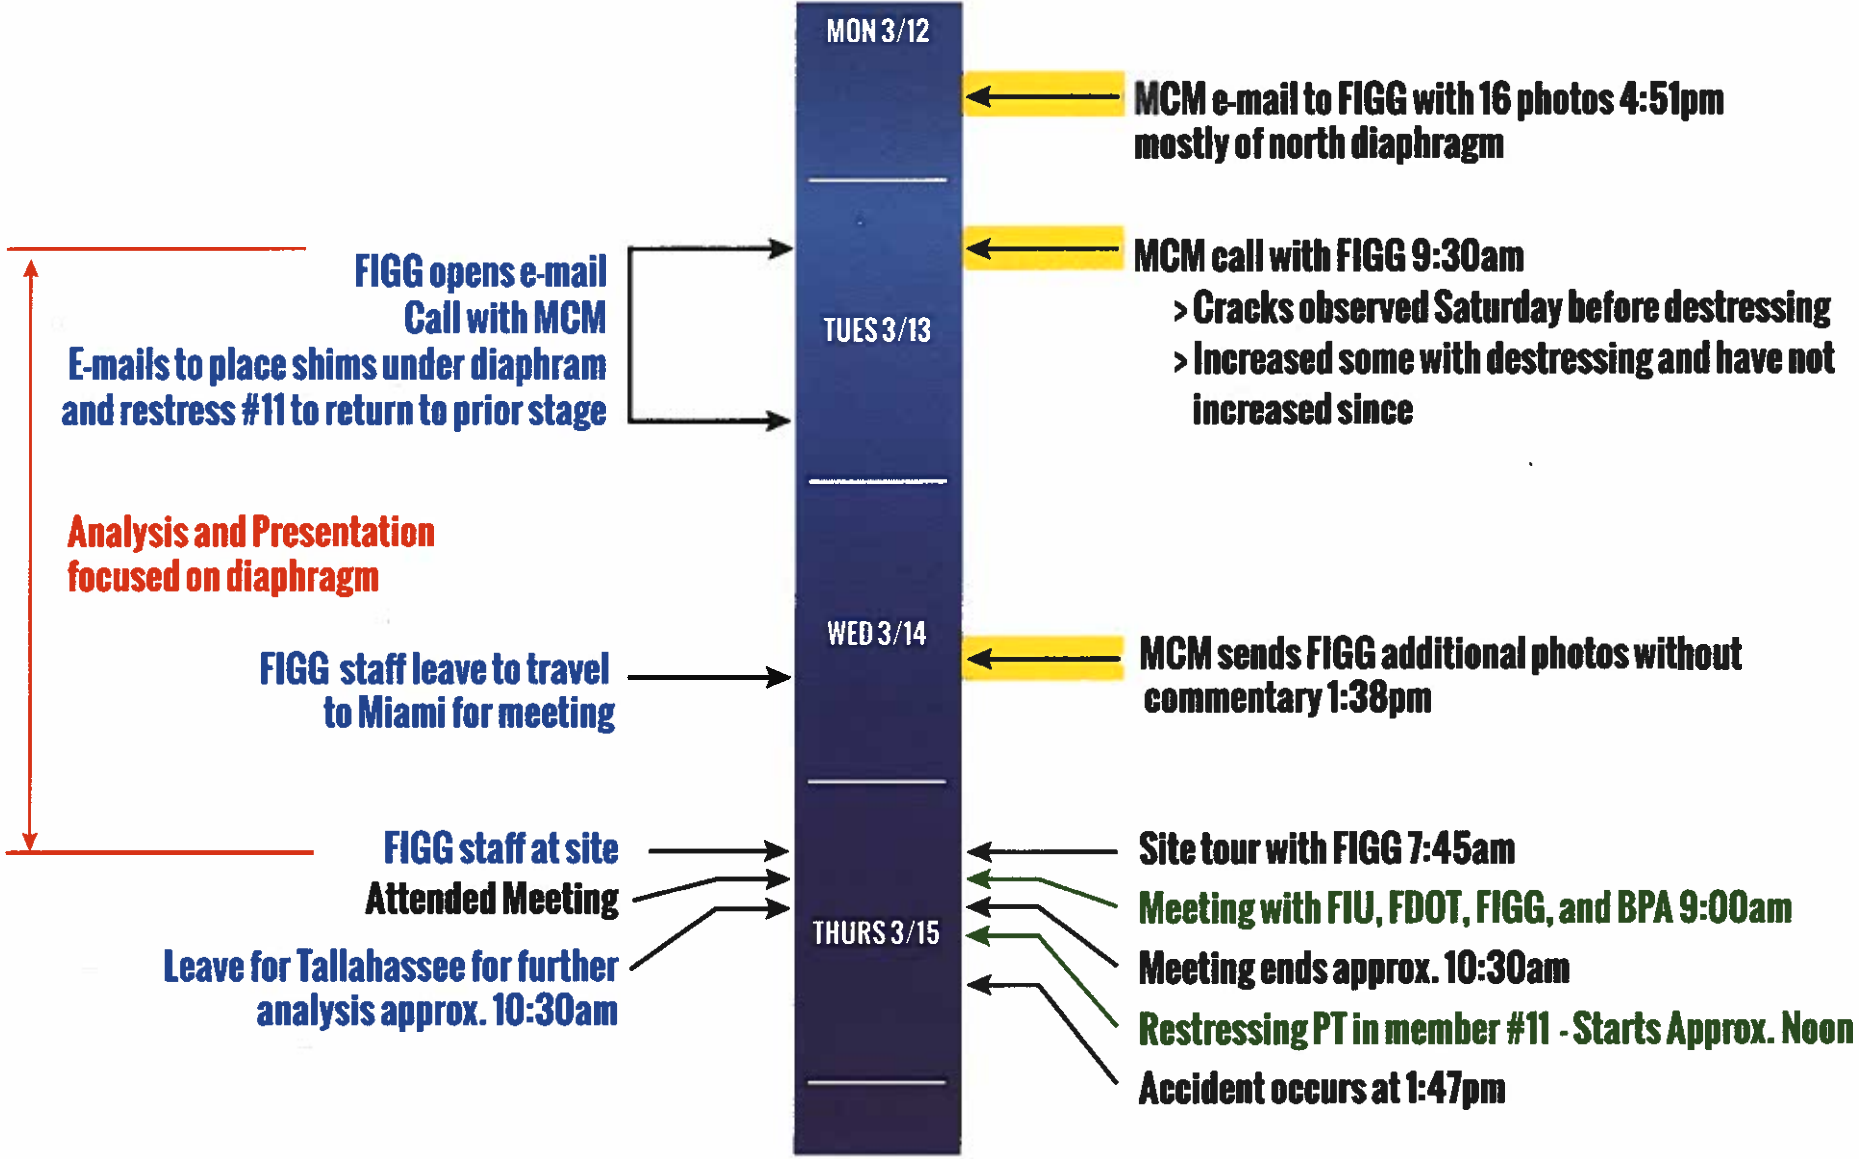
**MCM e-mail to FIGG with 16 photos 4:51pm
mostly of north diaphragm**

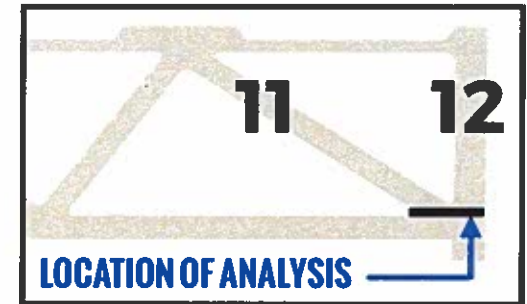
Roughened Construction Joint Surface Following FDOT Standard Construction Specifications

METHOD OF DETERMINING CAPACITY	CAPACITY MEMBER 11/12 CONNECTION SHEAR CAPACITY (KIPS)	>	LOAD SHEAR LOAD ON MEMBER 11/12 CONNECTION (KIPS)	=	SAFETY FACTOR OF SAFETY	GOOD
WJE - Preeminent Forensic Structural Engineers						
AASHTO Design Code	2389	>	1677		1.42	✓
Full Scale Laboratory Specimen - Test Results	2485	>	1677		1.48	✓
FIGG						
AASHTO Design Code	2084	>	1661		1.25	✓

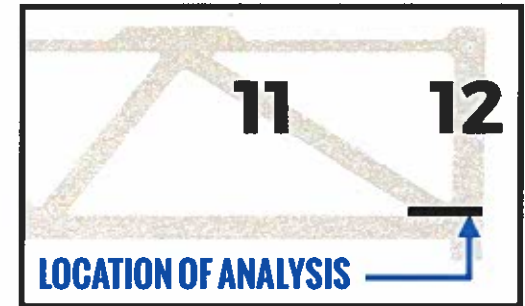
Non-Roughened Construction Joint Surface Not Following FDOT Standard Construction Specifications

METHOD OF DETERMINING CAPACITY	CAPACITY MEMBER 11/12 CONNECTION SHEAR CAPACITY (KIPS)	<	LOAD SHEAR LOAD ON MEMBER 11/12 CONNECTION (KIPS)	≠ SAFETY FACTOR OF SAFETY	NOT GOOD
WJE - Preeminent Forensic Structural Engineers					
AASHTO Design Code	1285	<	1677	0.77	✘
Full Scale Laboratory Specimen	1677	≤	1677	1	✘
FIGG					
AASHTO Design Code	1374	<	1661	0.83	✘

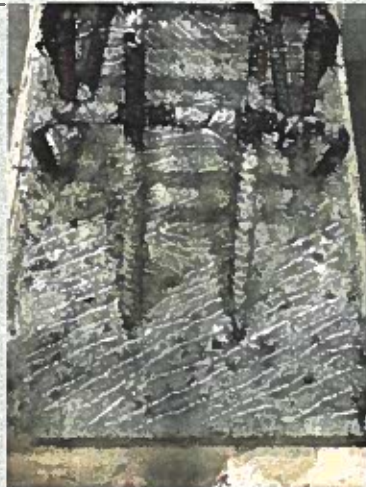
**EXAMPLE OF
INTENTIONALLY
ROUGHENED
CONCRETE SURFACE
(ROUGHENED JOINT)**

per Florida Department
of Transportation's
Standard Construction
Specifications

1. Hands-on training and photographic examples
2. Physical specimen examples for visual inspection. Create test questions on which samples meet the Standard Construction Specifications.
3. Hands on practice sessions with various on-site tools.
4. Industry presentations on lessons learned.
5. Share the FDOT program with other states nationally including benefits to the training and certifications.
