PARTY SUBMISSION

TO THE
NATIONAL TRANSPORTATION
SAFETY BOARD

FIU University City Prosperity Pedestrian Bridge
Construction Accident
Miami, Florida | March 15, 2018

Submitted by - Figg Bridge Engineers, Inc.

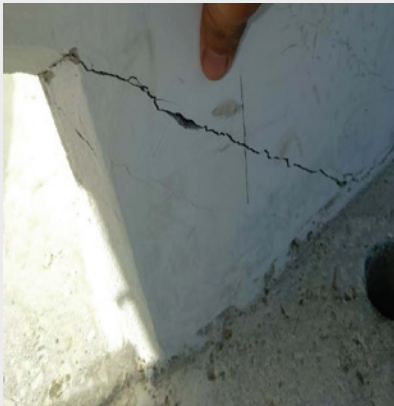
FIGURE 1-2A

After the main span precasting was complete and the falsework removed in February 2018, BPA provided a report of some observed concrete cracking, including cracks in the chamfer between the end truss diagonal members and the bridge deck (**FIGURE 1-2**). These were evaluated by FIGG and deemed to be

Crack in east side chamfer of member 11 connection to bridge deck.

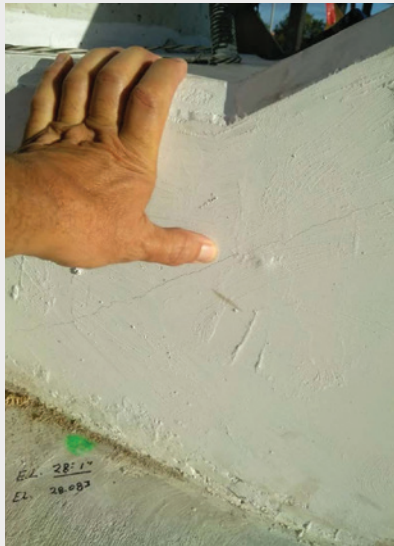
FIGURE 1-2B

Crack in west side of truss member 11.

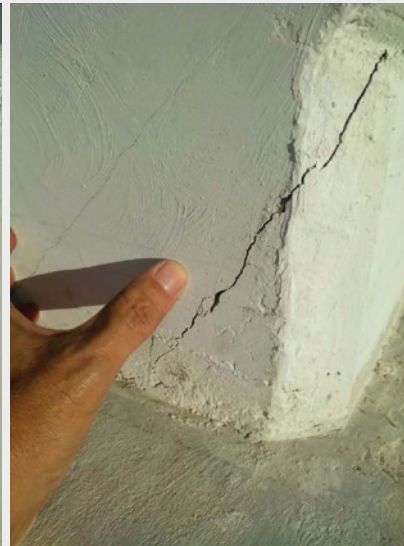
FIGURE 1-3C

Crack in west side chamfer of member 11 connection to bridge deck.

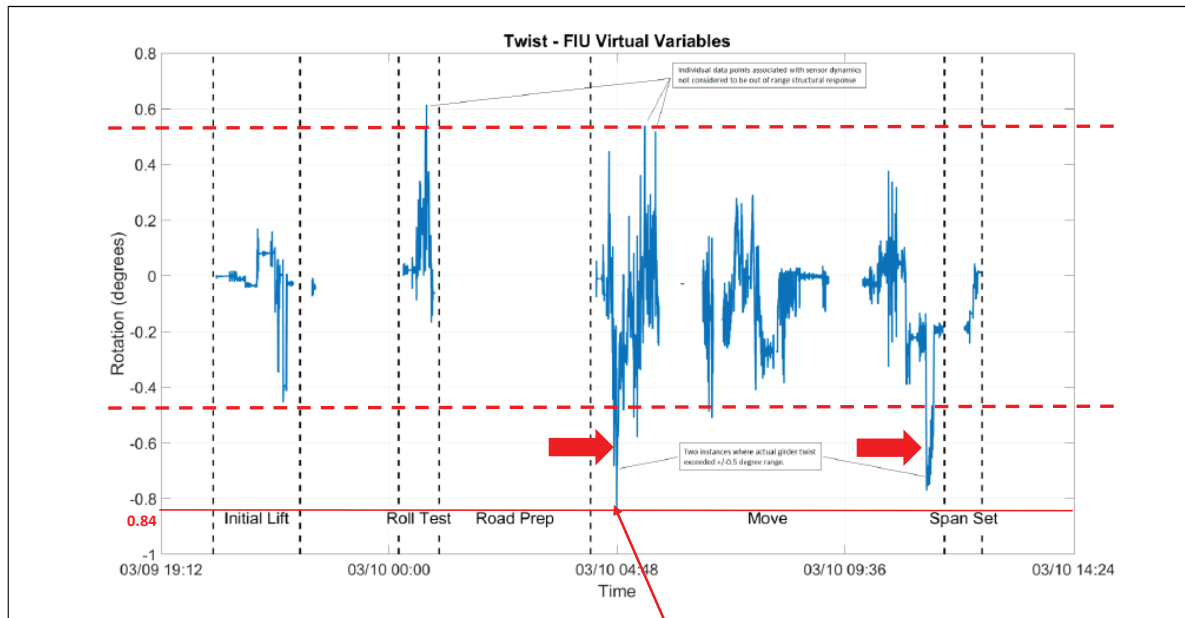
FIGURE 1-4

FIGG was present for the span move and was not informed either during or after the move that there were any recorded instances of span twist exceeding the established limits. However, a report prepared 20 days after the accident by BDI indicated that the twist limits had been exceeded during the move, and that the span had been subjected to at least 150% and possibly 168% of the maximum limit as seen in the graph in **FIGURE 1-4**. A post-accident structural analysis by forensic engineers Wiss, Janney, Elstner Associates (WJE) determined that this caused high stresses in the truss member connection region at the north end of the span.

Figure 32 from BDI monitoring report on twist of the main span during the bridge move (as modified in WJE report). Twist limit of 0.5 degrees was substantially exceeded on multiple occasions.

Figure 32 – Girder Twist – Difference in angle between Sections J & L

Difference in rotation between north and south supports: 0.84°

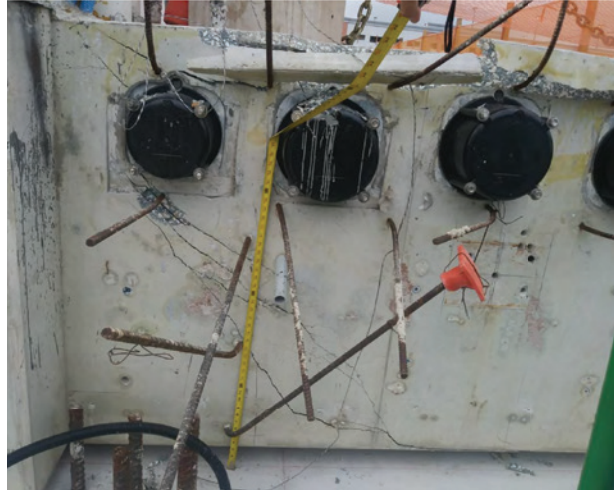
FIGURE 1-5

Late Monday afternoon March 12, MCM sent FIGG 16 photos, 13 of which were of the north diaphragm showing distress (**FIGURE 1-5**). After opening the e-mail on the morning of March 13, the MCM and FIGG project managers had two phone calls in which MCM told FIGG that the cracking had been noticed on Saturday prior to the distressing operation, the cracks had gotten slightly worse after the distressing, and the cracks had not increased in size since Saturday afternoon. FIGG sent

Photo of the member 11/12 node provided to FIGG. (Source: NTSB Factual Report Attachment #24 and Bridge Factors Photographs #'s 90, 83 and 76)

e-mails to MCM recommending installing additional shims beneath the diaphragm (to reduce stress in the diaphragm) and to restress the end diagonal truss member (to revert to the prior state of the structure where it had been reported there was less cracking). The restressing was to be performed in 12 steps with close monitoring of the cracks. If the cracks worsened, the restressing operation was to be halted immediately and FIGG notified.

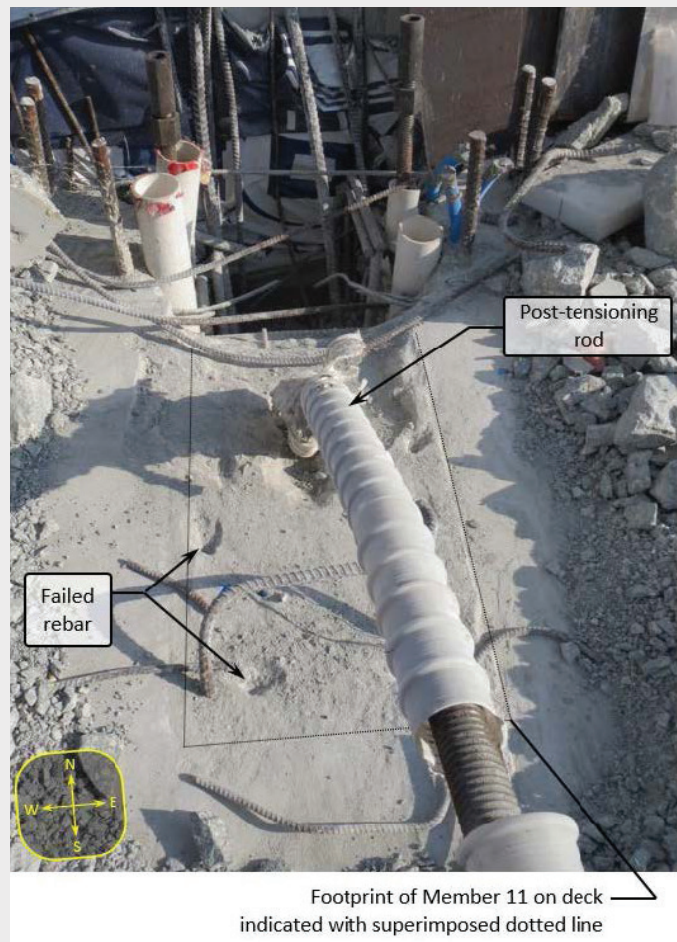
FIGURE 1-6

The FIU UniversityCity Prosperity Pedestrian Bridge construction accident occurred because the construction joint at the north end of the main span between the truss members and the bridge deck was not roughened as required by the Florida Department of Transportation (FDOT) Standard Specifications for Road and Bridge Construction. This failure to meet the construction specification requirements was not noticed by either the contractor's quality control personnel or by the construction inspectors under contract to FIU.

Interface under member 11 showing smooth construction joint surface (Source: TFHRC Report “Concrete Interface under members 11 and 12”)

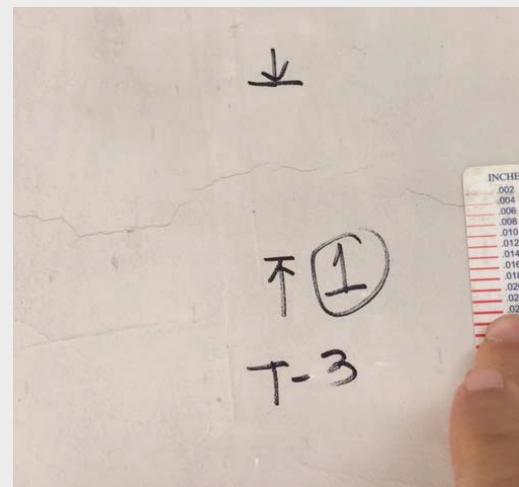
FIGURE 5-3

On February 2, 2018, while the tendons were being stressed, Bolt Perez & Associates (BPA) performed a visual inspection of the truss and identified hairline cracks in truss members 3 and 10 (**FIGURE 5-3**). This information was provided to FIGG in a Crack Inspection Report on February 13, and FIGG replied on February 15 that these were temporary in nature and would dissipate once the PT bars in these members were stressed. There is no mention in the record of cracks in members 3 and 10 after the PT bars in those members were stressed.

Typical crack photo from BPA February 13, 2018 report. Cracks 0.004 inches wide noted on truss members 3 and 10 before all post-tensioning tendons were stressed. (Source: BPA)

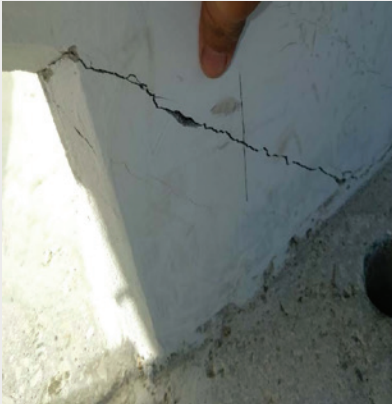
FIGURE 5-5A

On February 28, MCM sent FIGG a crack inspection report prepared by BPA along with additional photos taken by MCM (**FIGURE 5-5**). Some of the cracks shown were hairline cracks in truss members. The photos also showed cracks in the chamfer between the end diagonal truss members (2 and 11) and the bridge deck that were approximately 0.030 inches to 0.040 inches in width. Smaller cracks approximately 0.014 and 0.016 wide were shown in the top surface of the bridge deck at the end of the span near truss member 12. FIGG responded on March 7, requesting additional information and noting that in general, hairline cracks are not a concern. Also, FIGG noted that the cracks in the chamfers were at a boundary location between members and would need to be sealed per FDOT specifications.

Crack in east side chamfer of member 11 connection to bridge deck.

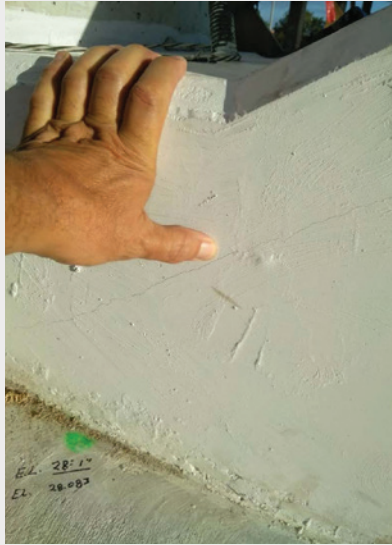
FIGURE 5-5B

Crack in west side of truss member 11.

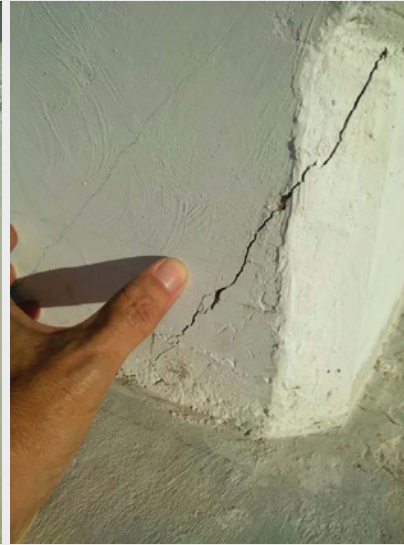
FIGURE 5-5C

Crack in west side chamfer of member 11 connection to bridge deck.

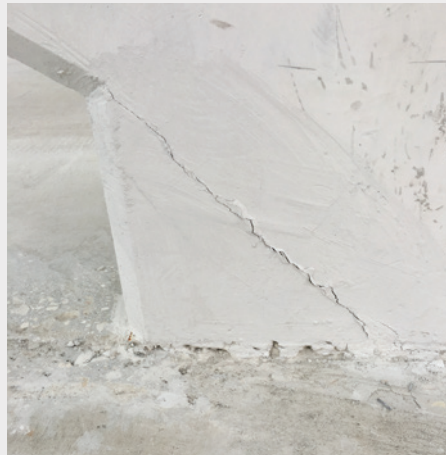
FIGURE 5-8

Cracks in member 11 chamfer with deck on March 10, 2018 at approximately 12:30 p.m. (Source: FIGG)

East face of member 11 chamfer.

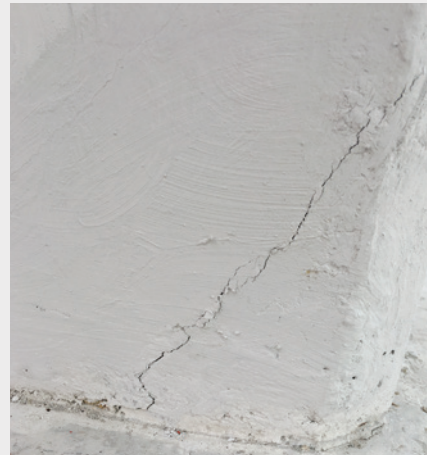
West face of member 11 chamfer.

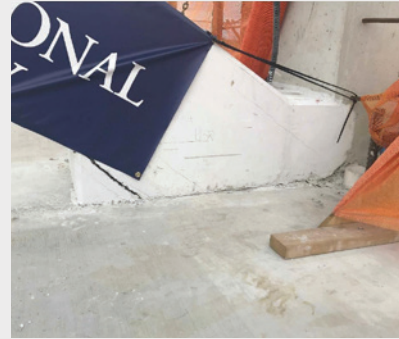
FIGURE 5-9A

Cracking observed at north end of bridge at 3:16 p.m. on March 10, 2018 after bridge move and before member 11 PT bar destressing. (Source: Bridge Factors Photos 62 - 66)

East side of member 11 at base near deck.

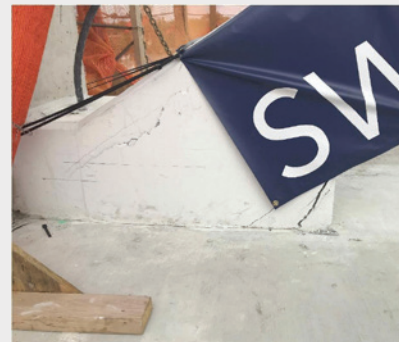
FIGURE 5-9B

West side of member 11 at base near deck.

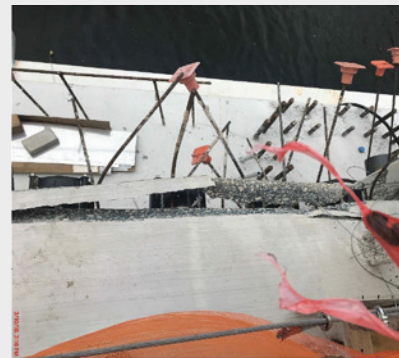
FIGURE 5-9C

North edge of diaphragm west of member 12.

11 near the connection to the deck, and the top edge of the diaphragm on the north end near member 12 spalled off (approximately 2 inches wide and 5 feet long).

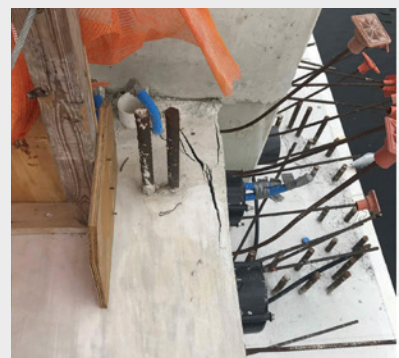
FIGURE 5-9D

North edge of diaphragm east of member 12.

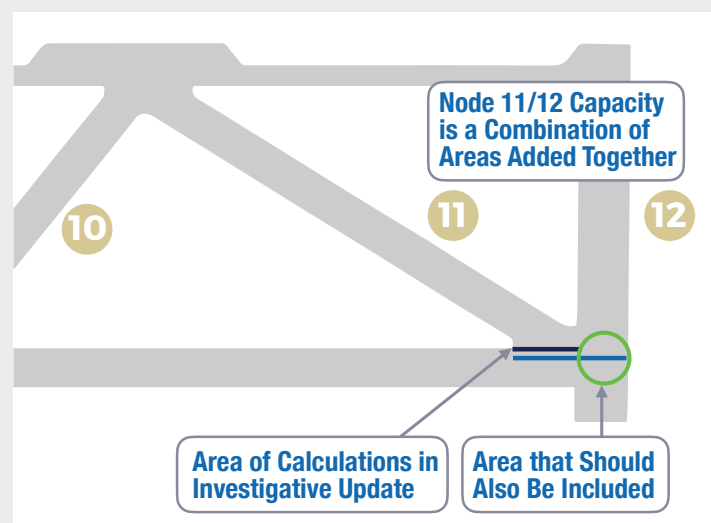
FIGURE 6-1

As noted in the Factual Report, the connection shear loads shown in the table on page 1283 of the calculations are significantly less than the loads from another design analysis model contained in the calculations.

Portion of member 11/12 nodal connection included in design calculation versus the entire connection.

The design of the member 11/12 nodal connection was based on AASHTO LRFD design specifications for shear friction (Section 5.8.4). The calculations used a friction coefficient of 1.0 which is specified in the design code for "normal weight concrete placed against a clean concrete surface, free of laitance, with surface intentionally roughened to an amplitude of 0.25 in."

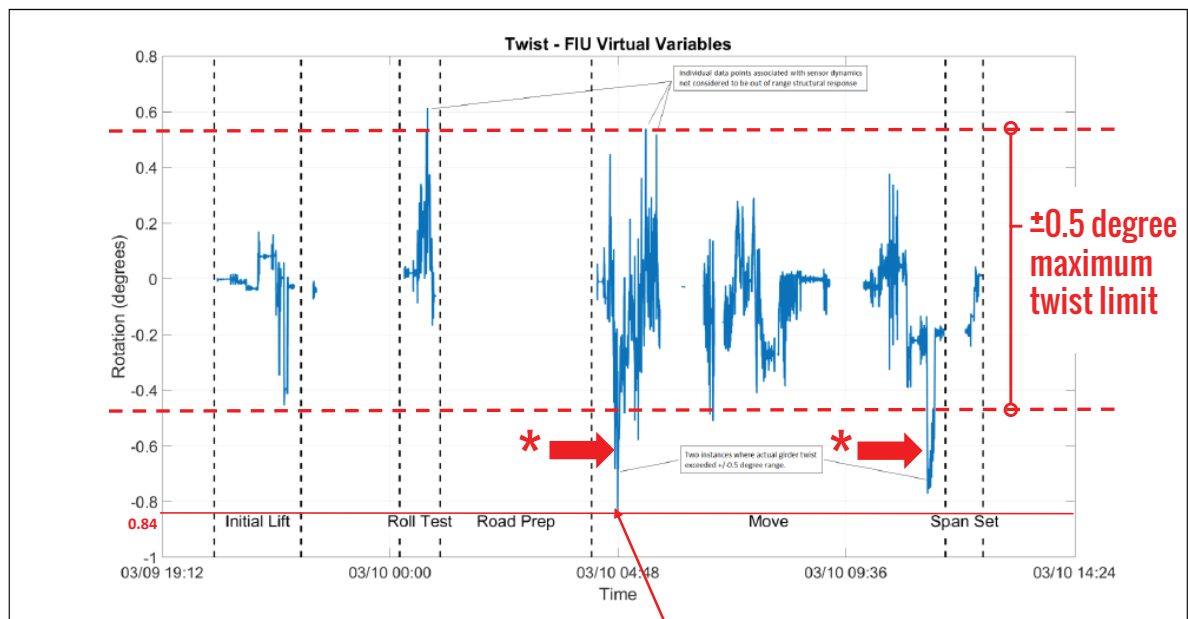
FIGURE 6-12

Figure 32 from BDI monitoring report on twist of the main span during the bridge move (as modified in WJE report). Twist limit of 0.5 degrees was substantially exceeded on multiple occasions.

***Instances where twist substantially exceeded limits**

The graph shows the twist was exceeded on at least three occasions, with a maximum twist of over 0.84 degrees (see **FIGURE 6-12**). In their report, BDI asserts that some of this is due to “sensor dynamics” and “based on visual interpretation of data plot” they conclude that the maximum twist was exceeded in two instances with values of 0.65 and 0.75 degrees. Assuming that this is the case, the actual twist was still 150% of the maximum limit for twist in the bridge span of 0.5 degrees. If the raw data is used, the actual twist would be 168% of the maximum limit.

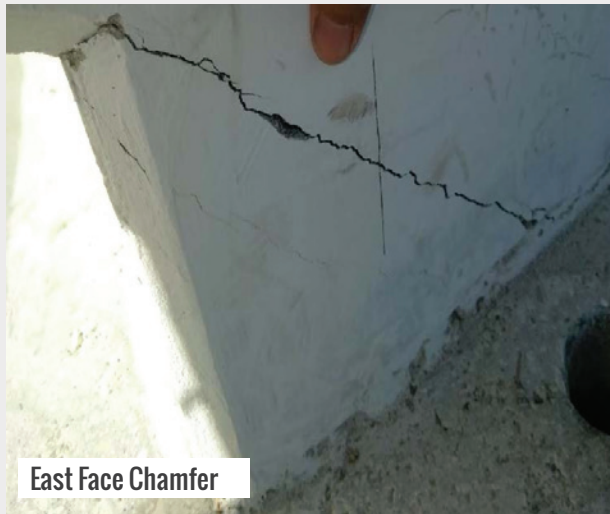
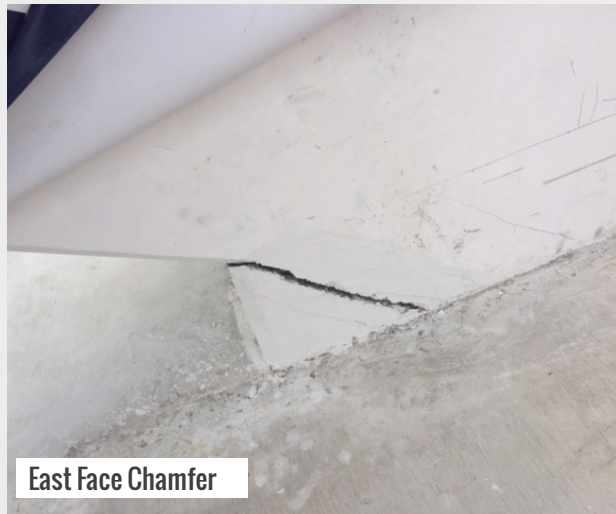
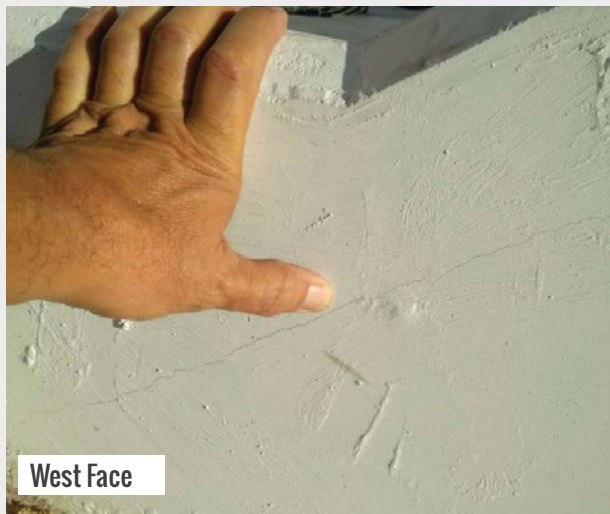
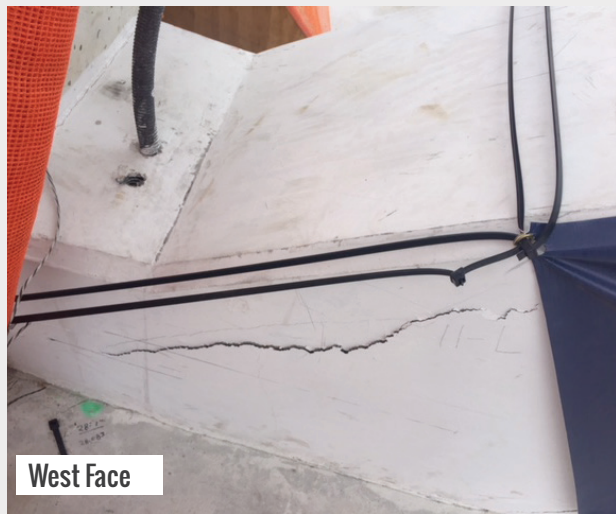
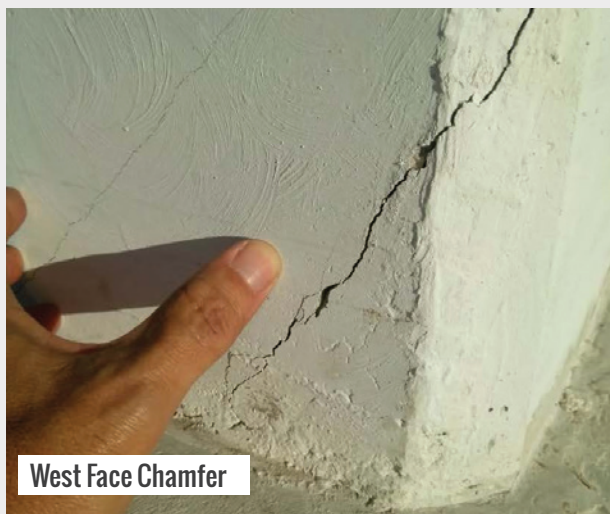
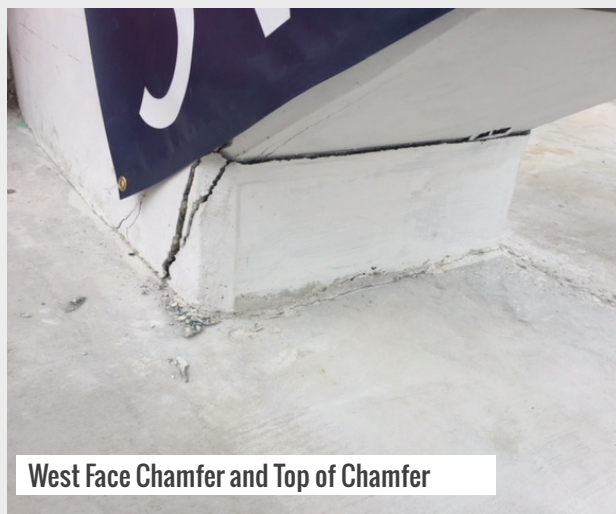
Cracking at the base of member 11 before versus after the span move.
(Source: BPA February photos; Corradino March photos)

FIGURE 6-13 is a series of photographs illustrating the change in the observed cracking at the truss member 11/12 connection to the deck prior to the move on February 28, and about three hours after the move on March 10, 2018. Cracking in the area is noticeably more significant. Other photos showed that the top outside edge of the diaphragm on the north end near member 12 had spalled off.

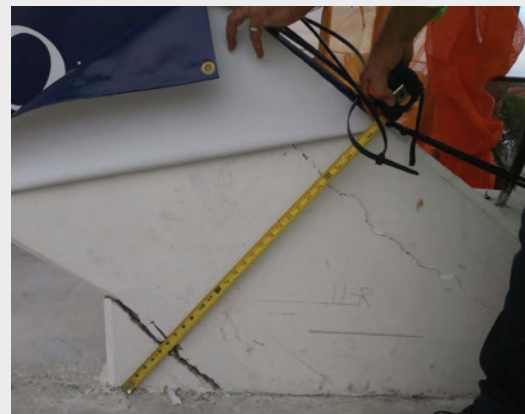
FIGURE 6-14

the deck. A ruler in the photo indicated that the crack at the member 11 chamfer at the deck connection was approximately 1/2 inch wide. MCM requested in the e-mail that FIGG review the photos and respond as quickly as possible.

Member 11 crack photo attached to March 12, 2018 e-mail sent to FIGG by MCM. The larger crack in chamfer (“wedge crack”) is outside of region compressed by member 11 PT bars. (Source: Attachment 24 to Factual Report)

Later that day, FIGG recommended placing shims between the pier and the bridge deck at the north end and restressing the PT bars in member 11 while further evaluation was performed. This recommendation to restress the PT bars was based on the observation relayed by MCM that the cracking worsened when the PT bars had been destressed, so the intent was to revert back to the prior state of the structure. The more significant cracking reported to FIGG at the time was at the member 11 chamfer and at the end diaphragm (**FIGURE 6-14**). These were outside of the area that would be compressed by restressing the PT bars, so it was anticipated that the bars could be restressed to restore the same forces in the structure as before destressing the bars on Saturday, March 10, and potentially reduce the diaphragm crack size.

FIGG provided instructions in an e-mail to MCM on March 13 for restressing the member 11 PT bars. This was to be performed in 12 incremental steps while the cracks were being closely monitored. Stressing a PT bar is normally done in one step in a short amount of time. The 12-step stressing sequence required about two hours. If the cracking worsened, the restressing was to immediately stop and notify FIGG.

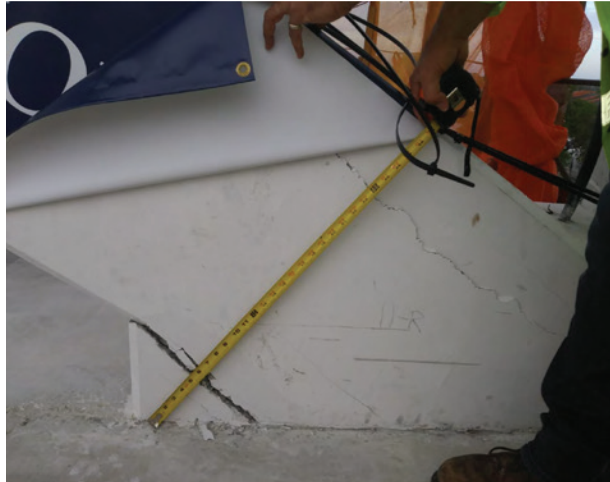
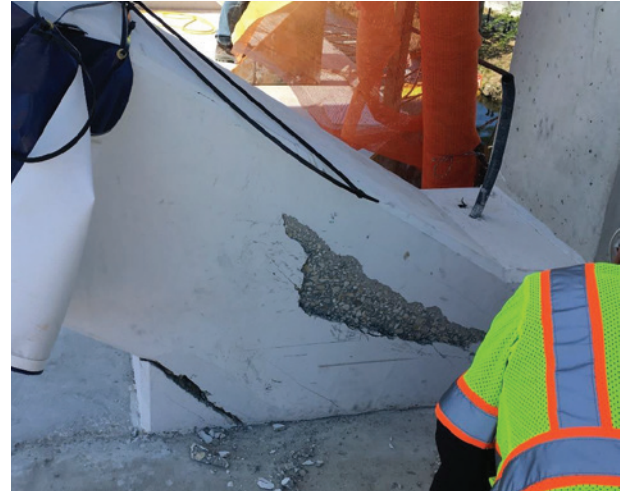
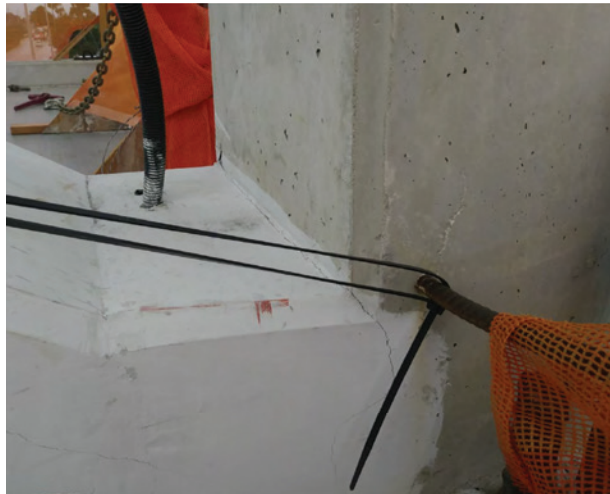
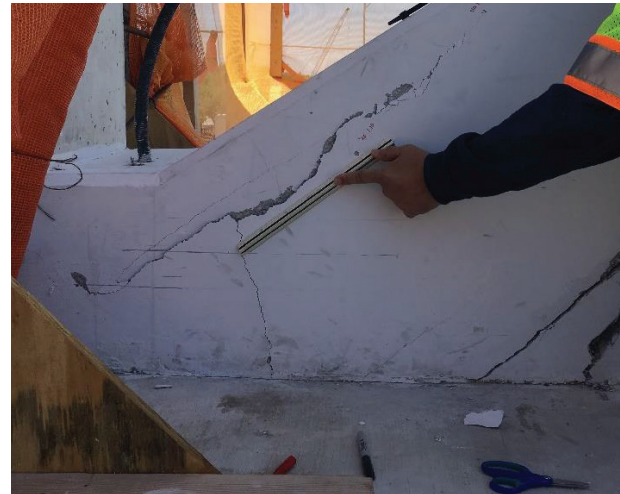
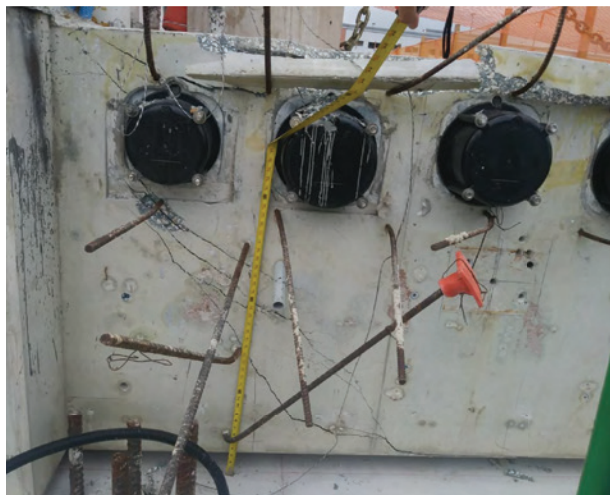
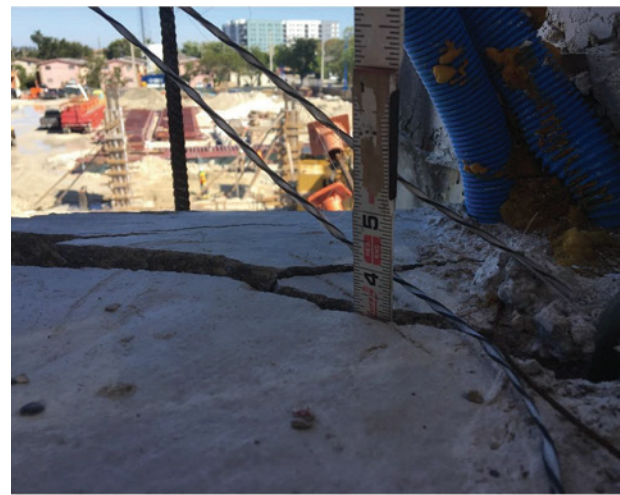
FIGURE 6-17

Photos of the member 11/12 node provided to FIGG are shown on the left side of this figure. There were 13 photos of the north diaphragm provided. Many other photos of the member 11/12 node were taken during the time between the bridge move on March 10, 2018, and the accident on March 15, but not provided to FIGG in a timely manner. Some examples of these are shown on the right side of this figure. (Source: NTSB Factual Report Attachment #24 and Bridge Factors Photographs #'s 90, 83 and 76)

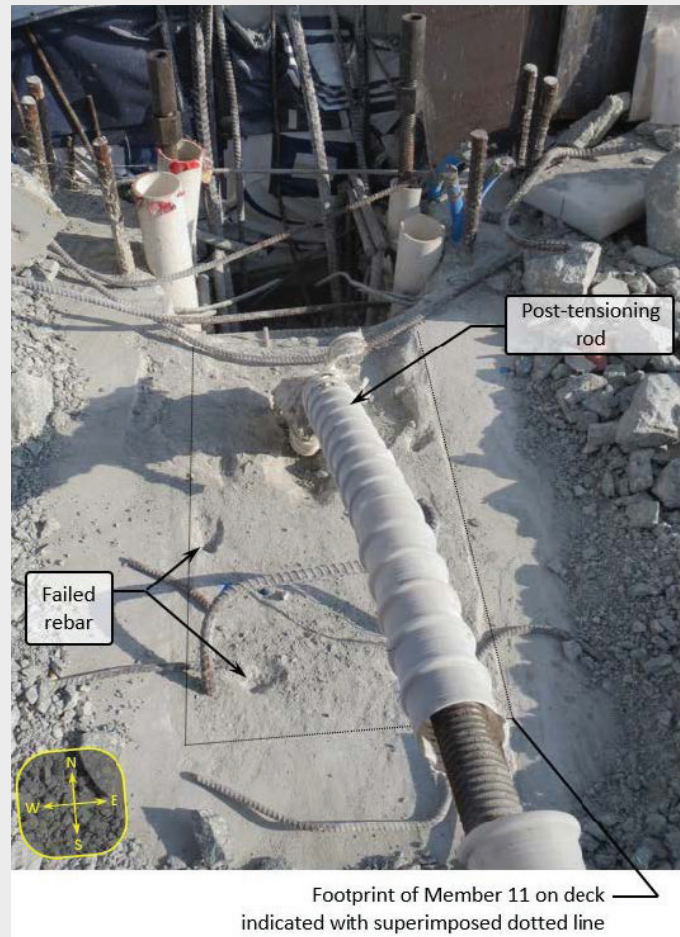
FIGURE 6-18

TFHRC found that the construction joint between the deck and truss members 11/12 was smooth and covered in concrete paste (FIGURES 6-18 AND 6-19). The report concludes "that the failure interface coincides with the original cold joint and that the cold joint was not intentionally roughened".

Interface under member 11 showing smooth construction joint surface (Source: TFHRC Report "Concrete Interface under members 11 and 12")

Had the construction joint been prepared in accordance with FDOT Construction Specification 400-9.3 the surface would have been rough, with cement paste removed and aggregate exposed. Therefore, the joint was not constructed in accordance with the Released For Construction (RFC) project specifications.

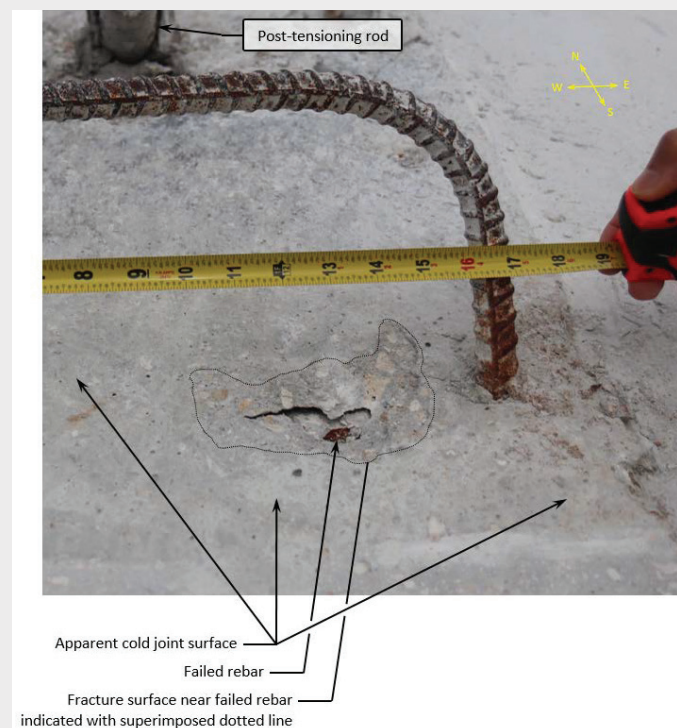
FIGURE 6-19

Interface under southeast corner of member 11 showing smooth construction joint surface (Source: TFHRC Report "Concrete Interface under members 11 and 12")

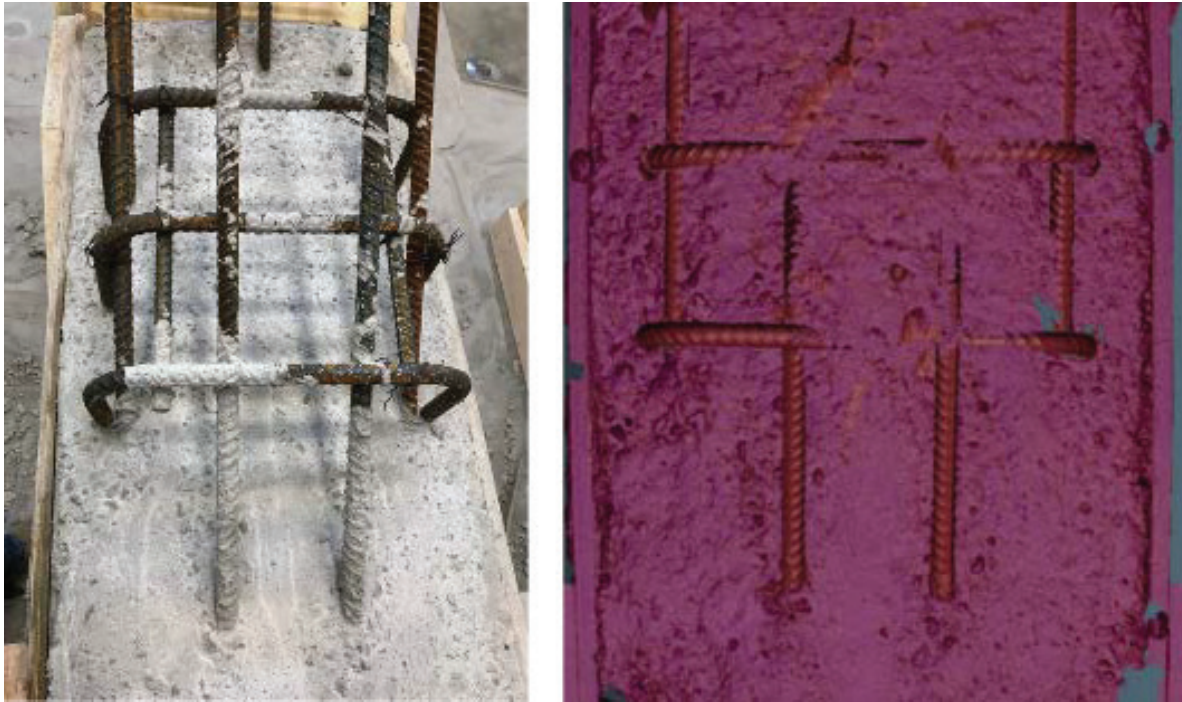
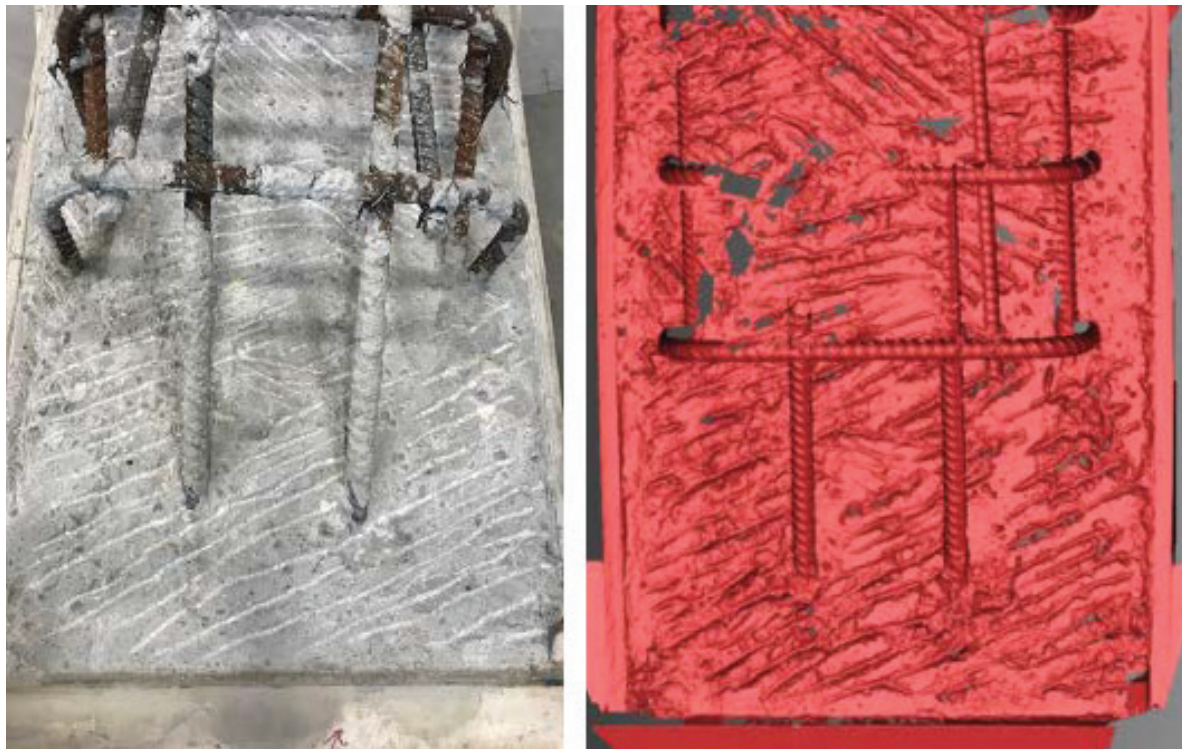
To establish the degree of surface roughening, laser scans were performed on one non-roughened joint surface and one roughened joint surface, similar to the scans performed as part of NTSB Materials Laboratory Study Report No. 19-043 discussed in Section 6.8.4 above. FIGURE 6-24 shows a comparison of the two specimens and laser scans.

As-placed (non-roughened) and roughened test specimen construction joints and laser scans. (Source: WJE)

(a) As-placed (non-roughened) specimen construction joint (left) and laser scan of surface (right)

(b) Roughened specimen construction joint (left) and laser scan of surface (right)

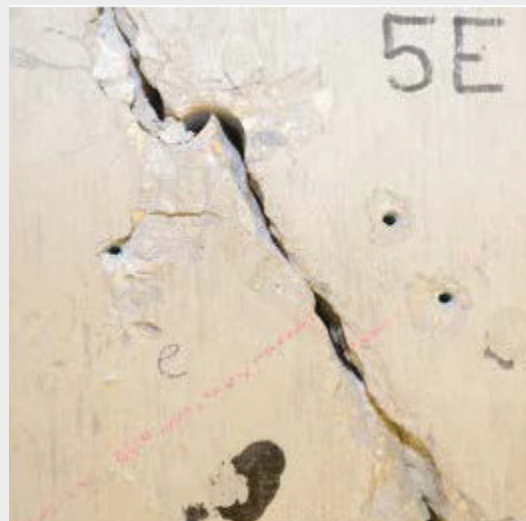
FIGURE 6-29
Specimen after failure along the construction joint.
Detail shows close-up of sliding along the joint
surface. This specimen had a roughened pre-cracked
construction joint surface. (Source: WJE)

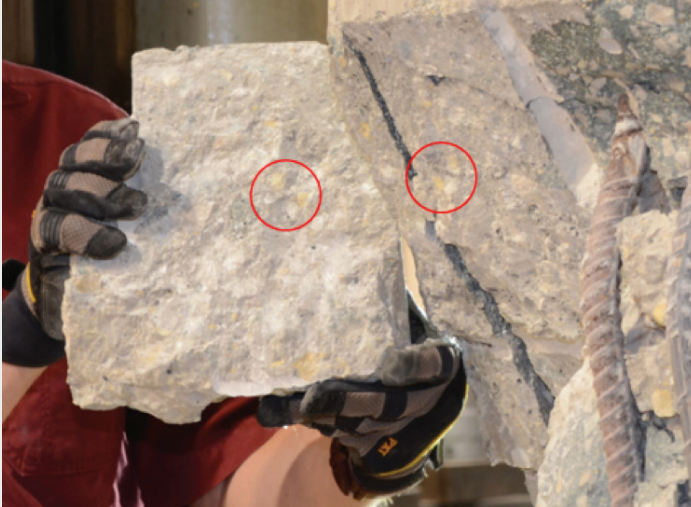
FIGURE 6-30 shows the construction joint surface after failure from a roughened pre-cracked specimen. **FIGURE 6-31** shows the construction joint surface after failure from a non-roughened specimen, which appears similar to the observed post-failure construction joint surfaces of the member 11/12 node.

FIGURE 6-30
Construction joint interface surface after failure for a roughened specimen. Circled areas show corresponding fractured aggregate on each side of the joint interface. (Source: WJE)

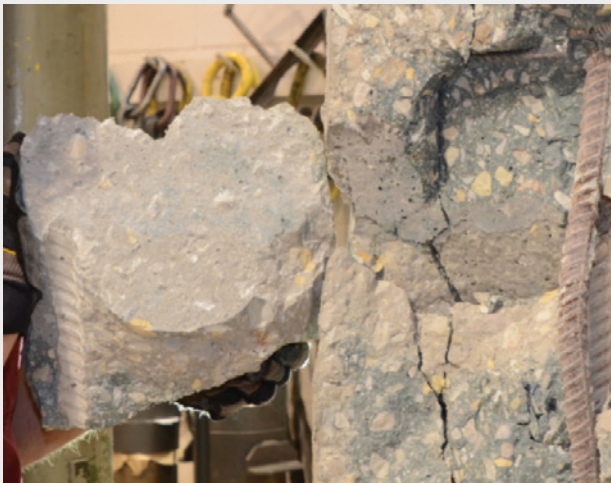
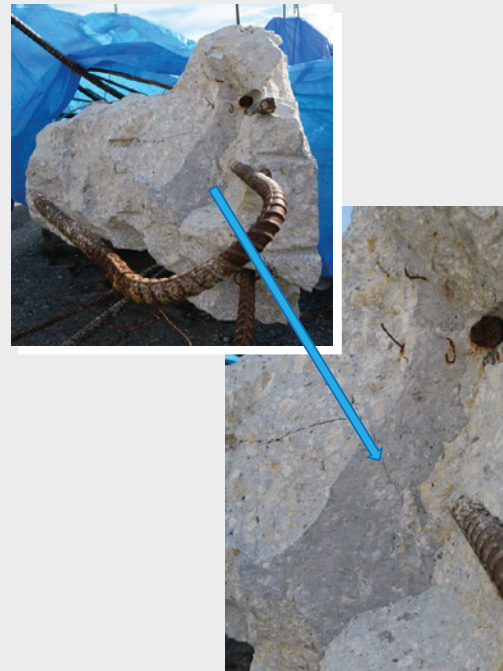
FIGURE 6-31
Construction joint interface surface after failure for an as-placed (non-roughened) specimen on the top, compared to the actual interface under member 12 on the bottom. (Source: WJE and NTSB Material Laboratory Study Report 19-043)

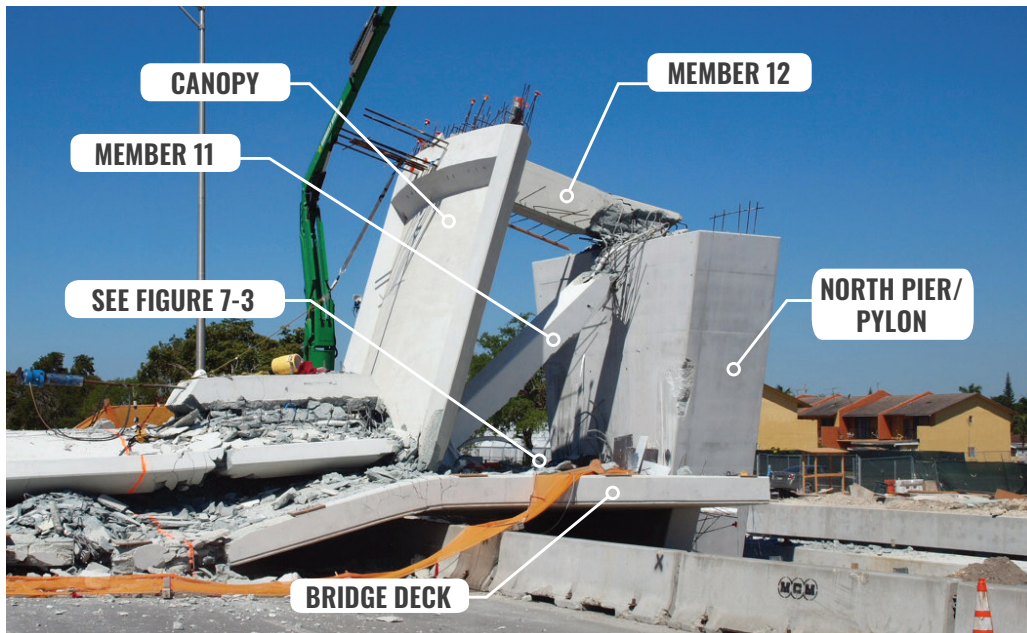
FIGURE 7-2

Forensic engineer WJE analyzed available photographs and video from when the main span truss was in the precasting area, through the time of the accident and post-accident (SEE **WJE'S FULL 132 PAGE REPORT IN EXHIBIT A**). Frames extracted from a dashboard video in a vehicle headed east on SW 8th Street are shown in **FIGURE 7-1**. From the photos and videos, they concluded that the collapse sequence developed at the north end of the main span truss where truss members 11 and 12 connect to the bridge deck and north diaphragm (SEE **FIGURES 7-2 AND 7-3**).

North end of main span after collapse (looking west). (Source: NTSB)

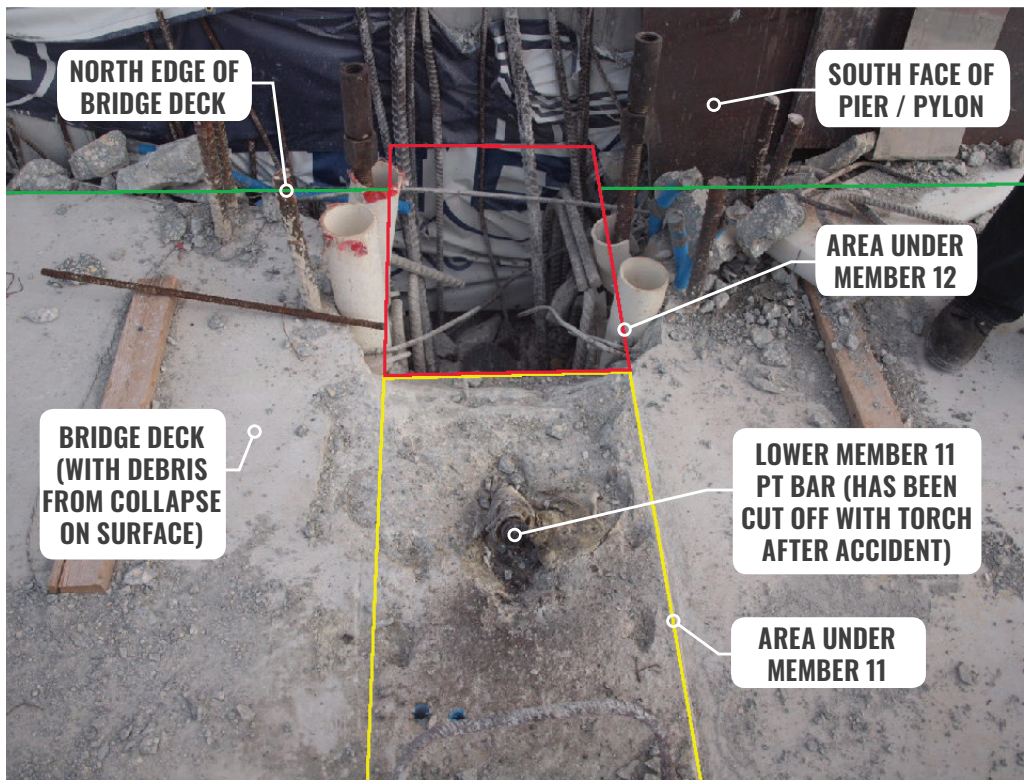
FIGURE 7-3

North end of main span bridge deck after collapse resting on the ground adjacent to the north pier / pylon (looking north). (Source: NTSB)

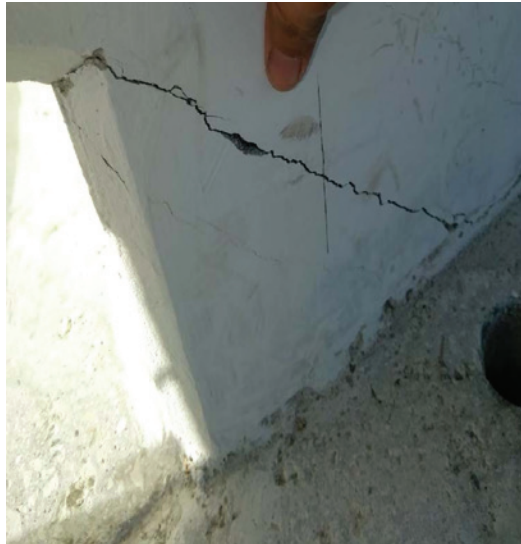
FIGURE 7-4

Prior to the bridge move, cracking in the chamfer between member 11 and the deck was documented by BPA on February 28, 2018 (also referred to as "wedge cracks"). A photo taken March 8 shows a crack in the top side of the deck adjacent to member 12. It is now considered that these cracks were the result of debonding of the construction joint between the deck and member 11, and northward sliding of member 11 (SEE **FIGURES 7-4 AND 7-5**).

East side of member 11 at the chamfer with the bridge deck after falsework removal in the casting area as reported by BPA on February 28, 2018. (Source: BPA)

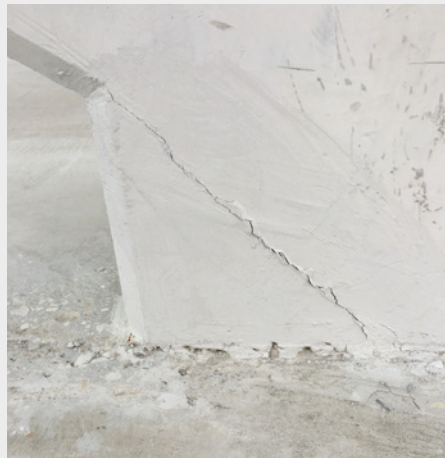
FIGURE 7-6

Photographs taken immediately after the move on March 10 at 12:30 p.m. show that the cracks had not noticeably changed (**FIGURE 7-6**). However, photos taken after 3:00 that afternoon before the member 11 post-tensioning (PT) bars were destressed show a widening of the previous cracks in the member 11/12

Cracks in member 11 chamfer with deck on March 10, 2018 at approximately 12:30 p.m. (Source: FIGG)

East face of member 11 chamfer.

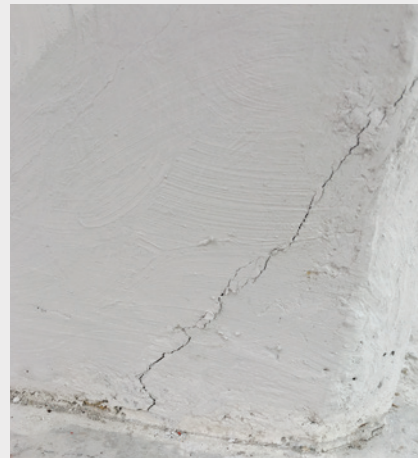
West face of member 11 chamfer.

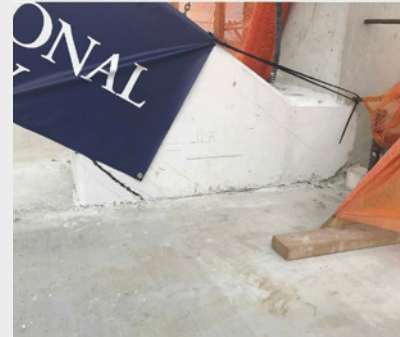
FIGURE 7-7

nodal area, and spalling developing at the north outside edge of the deck. This now suggests that member 11 slid northwards while the chamfer (“wedge”) stayed attached to the deck (**SEE FIGURE 7-7**).

Cracking observed at north end of bridge at 3:16 p.m. on March 10, 2018 after bridge move and before member 11 PT bar destressing. (Source: Bridge Factors Photos 62 - 66)

Cracking at the north end in member 11 and at the top of the end diaphragm was noted prior to the move. After the move, the cracks significantly widened as shown in **FIGURE 7-7**. There are four possible contributors to widening of the cracks:

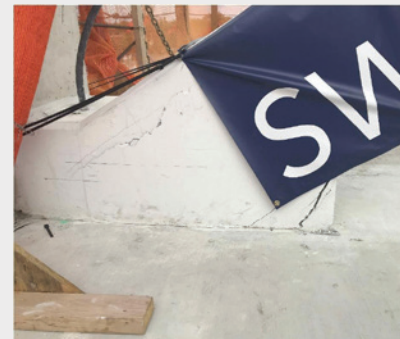
FIGURE 7-7A

East side of member 11 at base near deck.

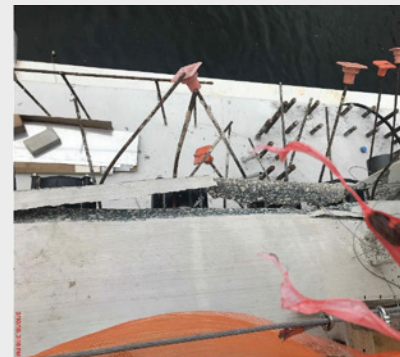
FIGURE 7-7B

West side of member 11 at base near deck.

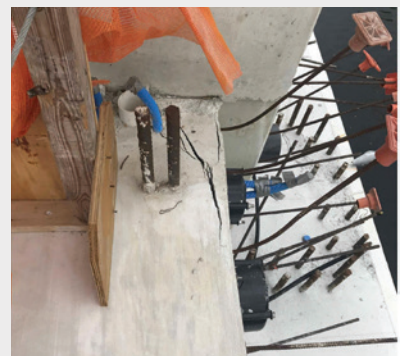
FIGURE 7-7C

North edge of diaphragm west of member 12.

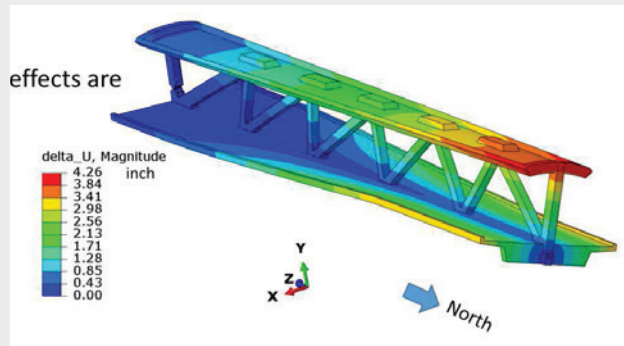
A 0.5-degree twist limit was established prior to the move, and this limit was exceeded on several occasions during the move. The degree of the exceedance is somewhat uncertain due to “spikes” in the rotation and twist readings. As shown through a detailed finite element analysis (**SEE FIGURE 7-13**), the rotation associated with the twist exceedances caused high transverse bending stress near the base of

FIGURE 7-13
WJE analysis model of main span twist during span move on March 10 (deformations shown with increased scale by a factor of 20 for illustration). (Source: WJE)

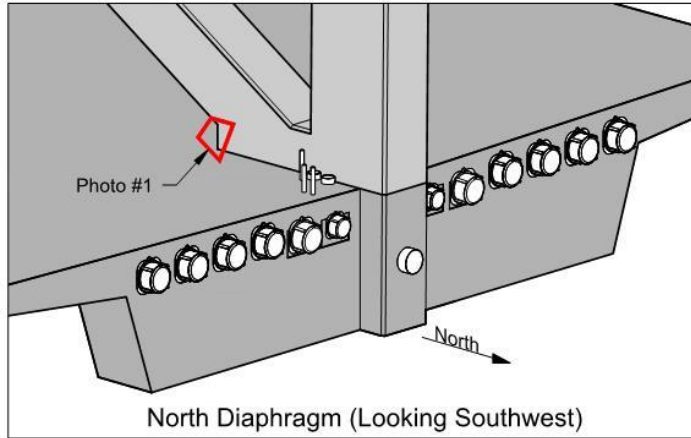
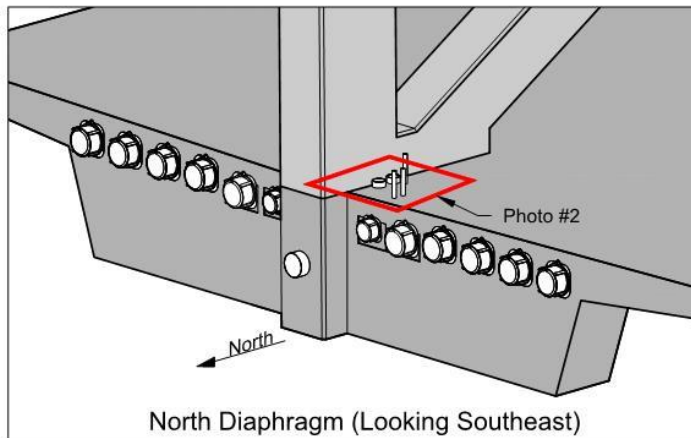
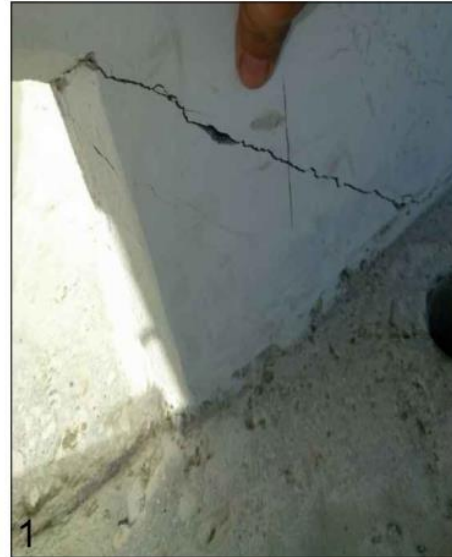
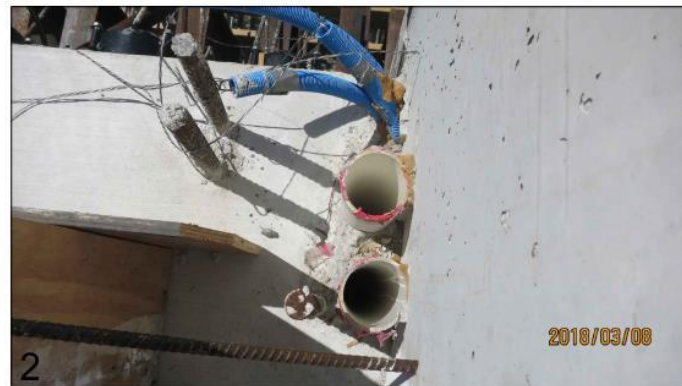
Exhibit 2.1.1
OBSERVED AND ESTIMATED CRACKS AT MEMBER 11/12 DECK CONNECTION
Shoring Removal to Pre-Move (Before March 9, 2018)

The first known indication of distress in the Member 11/12 region was documented in a crack report prepared by BPA on February 28, 2018. The observed crack occurred between Member 11 and the deck chamfer or “wedge.” Although difficult to see, debonding and northward sliding of Member 11 is also evident in the photograph. BPA did not measure the crack; however, a vertical marking, consistent with techniques used to visually track crack growth, is drawn across the crack.

On March 8, a Barnhart photo documented a crack on the topside of the deck, west of Member 12. Crack width was not measured. No photograph was taken on the east side of Member 12; however, WJE assumes that a matching crack likely occurred on the east side, based upon the symmetry shown by future cracking.

1. East side of Member 11. Included in crack report email on February 28, 2018 from Jose Morales (BPA) to Rodrigo Isaza (MCM).
2. Topside of deck end diaphragm II, west of Member 11. Produced by Barnhart. Photo dated March 8, 2018.
