PARTY SUBMISSION

TO THE
NATIONAL TRANSPORTATION
SAFETY BOARD

FIU University City Prosperity Pedestrian Bridge
Construction Accident
Miami, Florida | March 15, 2018

Submitted by - Figg Bridge Engineers, Inc.

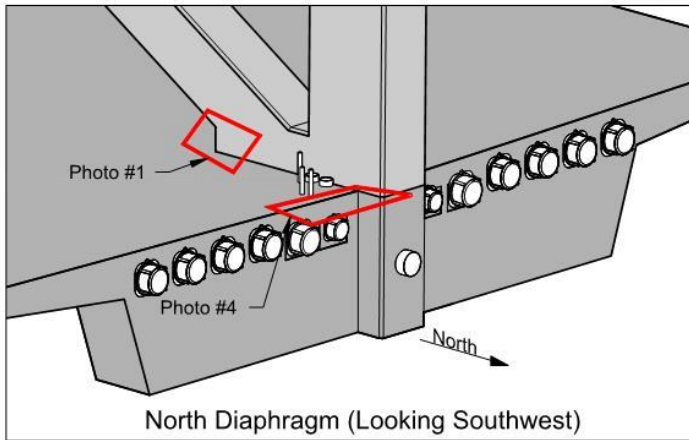
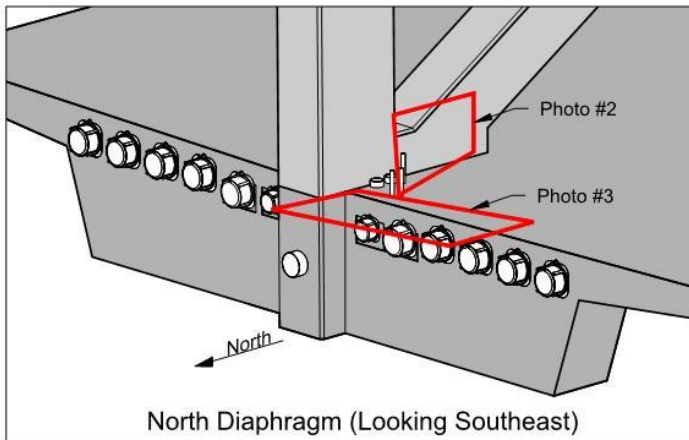
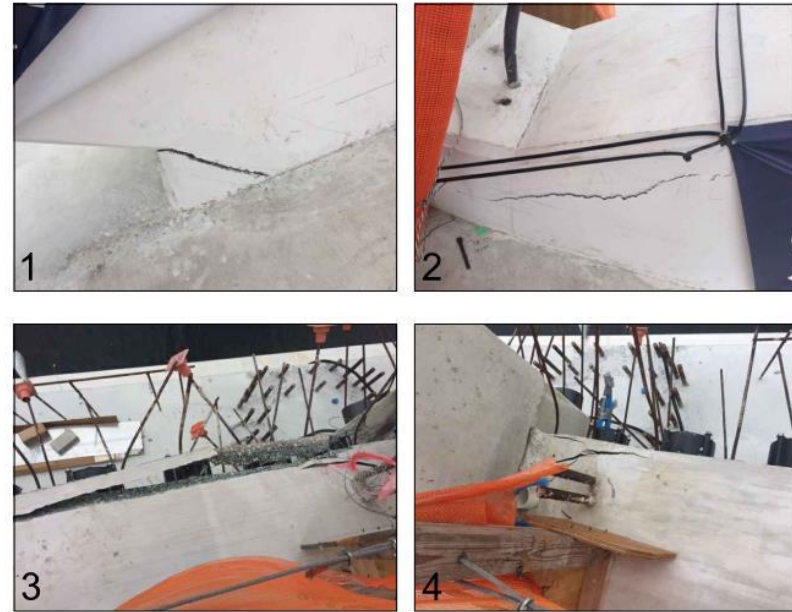
Exhibit 2.2.1
OBSERVED AND ESTIMATED CRACKS AT MEMBER 11/12 DECK CONNECTION
Post-Move (March 10, 2018)

The bridge was placed on its final supports at approximately 12:30 p.m. on March 10, 2018. The bridge remained in this state until approximately 4:30 p.m. when VSL de-tensioned Member 11. During this time frame, at approximately 3:07 p.m., the on-site post-tensioning inspector, Corradino, took photos of the deck near Members 11 and 12. These photos show widening of the cracks documented in Exhibits 2.2.1 to 2.2.3.

These photos show widening of the “wedge” crack. Analysis of this crack profile suggests that Member 11 slid northwards while the “wedge” stayed attached to the deck. This is evident from post-collapse photographs to be discussed later. Some of the cracking on the topside of the deck, adjacent to Member 12, developed into spalls and detached from the deck. Member 11 also developed longitudinal cracks generally in line with the longitudinal PT bars.

1. East side of Member 11. Photo taken by Coradino. Photo metadata is time stamped 3:07 PM on March 10, 2018.
2. West side of Member 11. Photo taken by Coradino. Photo metadata is time stamped 3:07 PM on March 10, 2018.
3. Topside of deck end diaphragm II, west of Member 12. Photo taken by Coradino. Photo metadata is time stamped 3:14 PM on March 10, 2018.
4. Topside of deck end diaphragm II, west of Member 12. Photo taken by Coradino. Photo metadata is time stamped 3:14 PM on March 10, 2018.

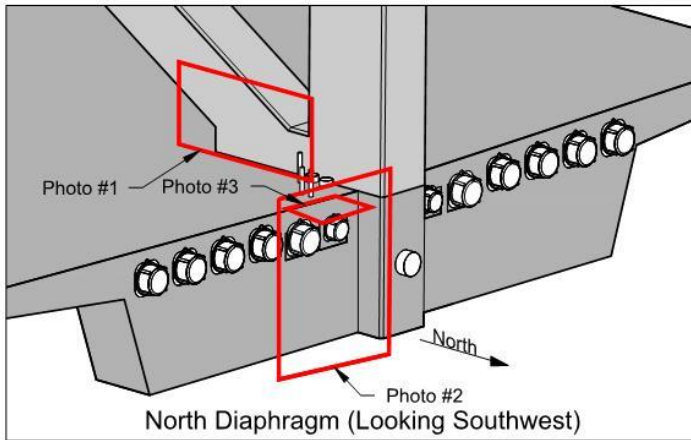
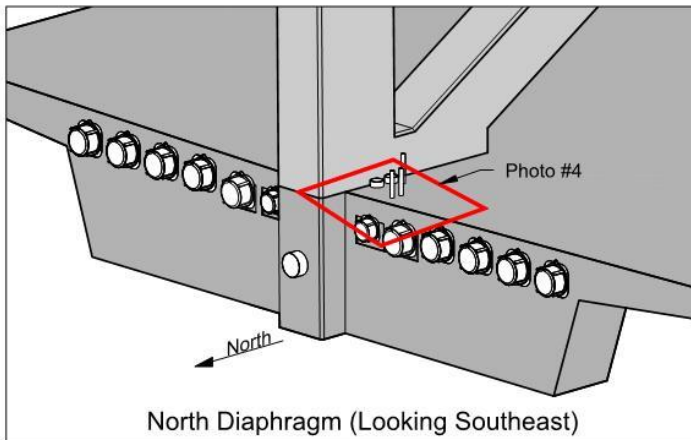
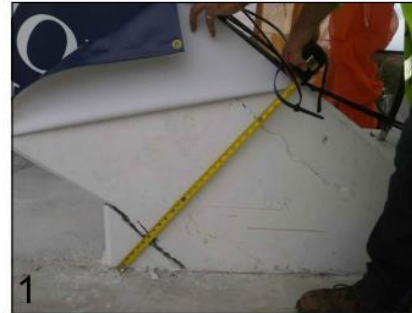
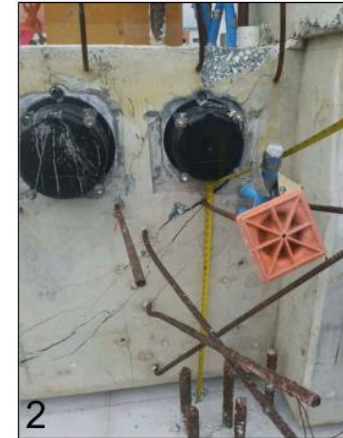
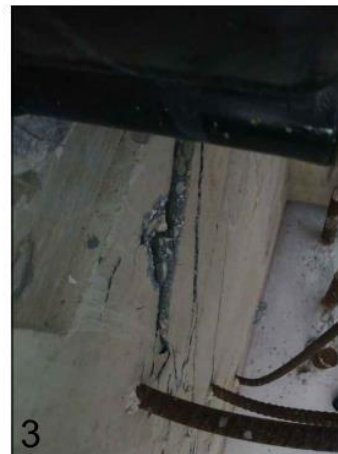
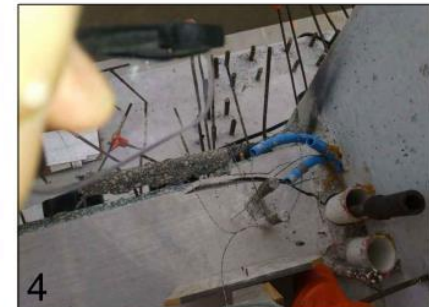
Exhibit 2.3.1
OBSERVED AND ESTIMATED CRACKS AT MEMBER 11/12 DECK CONNECTION
Two Days After Move (March 12, 2018)

Two days after the move, MCM documented the cracks and sent an email to FIGG asking for a review. Conditions generally appear similar to those shown in Exhibits 2.2.1 to 2.2.3 but with several of the cracks appearing to have slightly widened.

1. East of member 11, looking west. Photo included in email from MCM to FIGG on March 12, 2018.
2. North end of deck end diaphragm II, east of Member 12, looking south west. Photo included in email from MCM to FIGG on March 12, 2018.
3. North end of deck end diaphragm, east of Member 12, looking down. Photo included in email from MCM to FIGG on March 12, 2018.
4. Topside of deck end diaphragm II, west of Member 12. Photo included in email from MCM to FIGG on March 12, 2018.

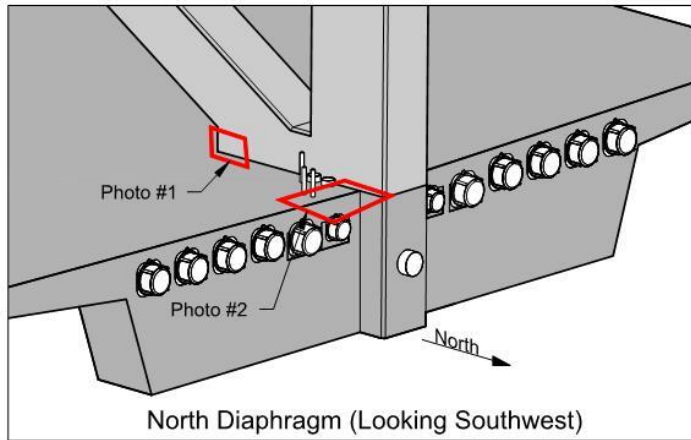
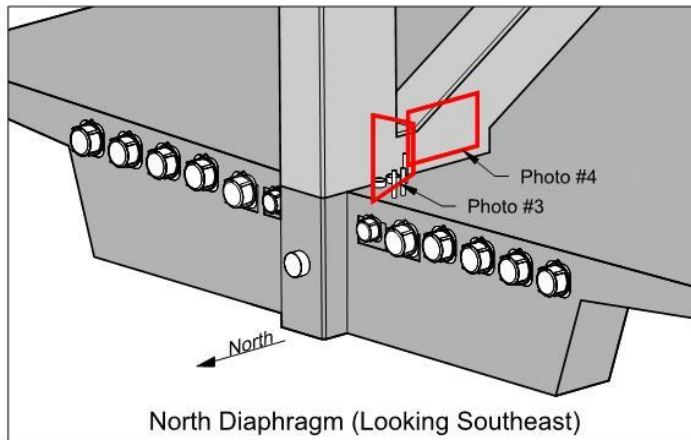
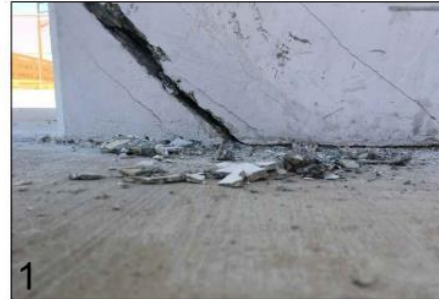
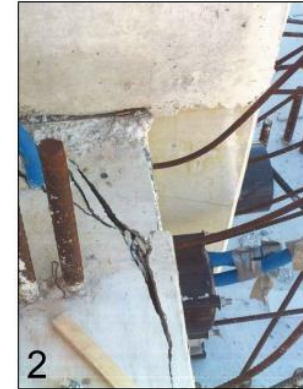
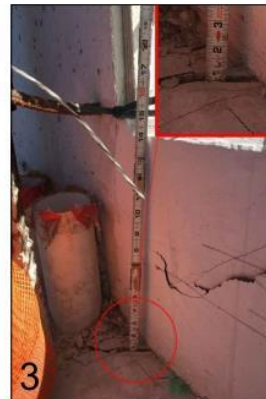
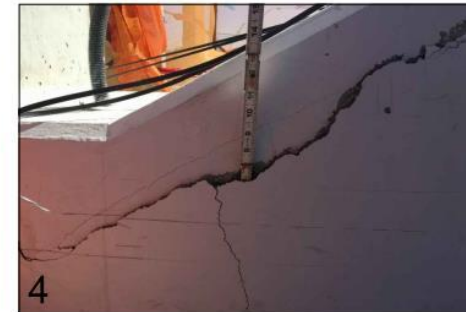
Exhibit 2.4.1
OBSERVED AND ESTIMATED CRACKS AT MEMBER 11/12 DECK CONNECTION
One Day Before Collapse (March 14, 2018)

An additional longitudinal crack developed near the base of Member 11. WJE believes the development and widening of this crack is a result of additional sliding.

1. East side of Member 11. Photo taken on March 14, 2018 by BPA.
2. Topside of deck end diaphragm II and east side of Member 11/12, looking northeast. Photo taken on March 14, 2018 by BPA.
3. Topside of deck end diaphragm II, east of Member 12, looking down. Photo taken on March 14, 2018 by BPA.
4. West side of Member 11. Photo taken on March 14, 2018 by BPA.

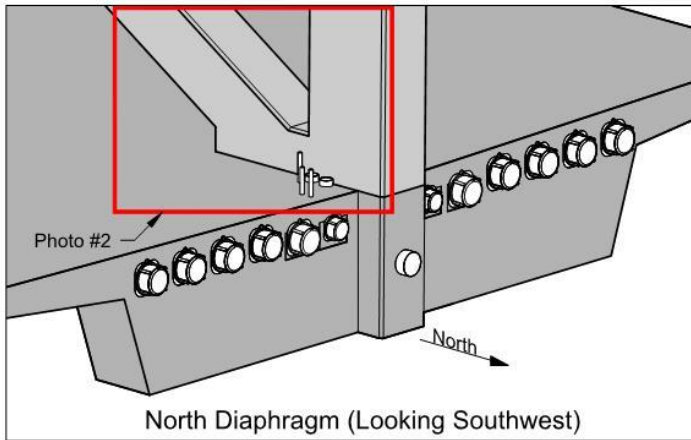
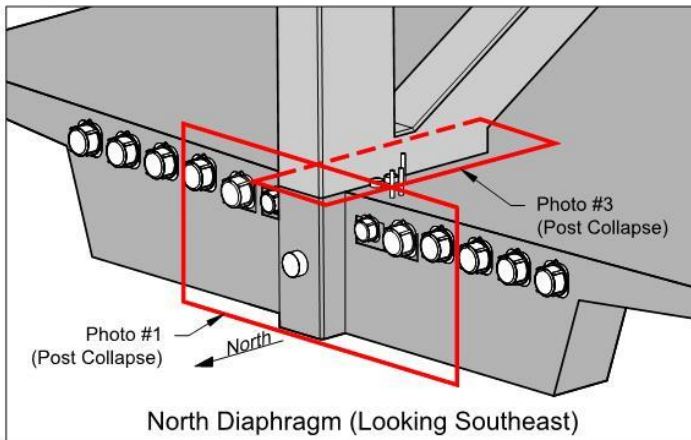
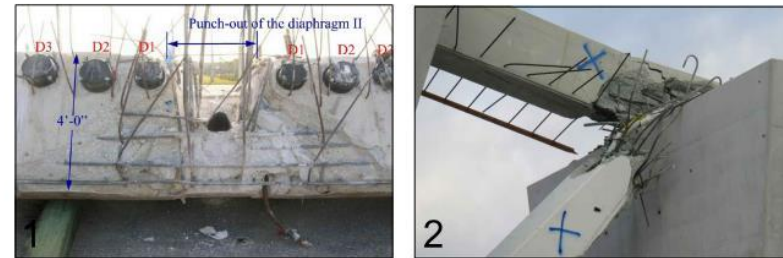
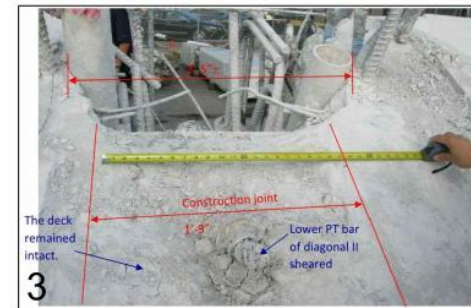
Exhibit 2.5.1
OBSERVED AND ESTIMATED CRACKS AT MEMBER 11/12 DECK CONNECTION
After Collapse (March and April, 2018)

In summary, a debonding and sliding failure at the construction joint below Member 11 led to breakout failure of the north-end diaphragm and ultimately collapse, triggered by sudden crushing of Member 11 near its base. The reasons for the connection failure are addressed in subsequent sections of this report.

1. North end of deck end diaphragm II, post collapse. OSHA report figure 62, dated April 8, 2018.
2. East side of Member 11&12. Taken by WJE on March 19, 2018.
3. Topside of north deck under Member 11&12, post collapse. OSHA report figure 63, dated April 8, 2018.

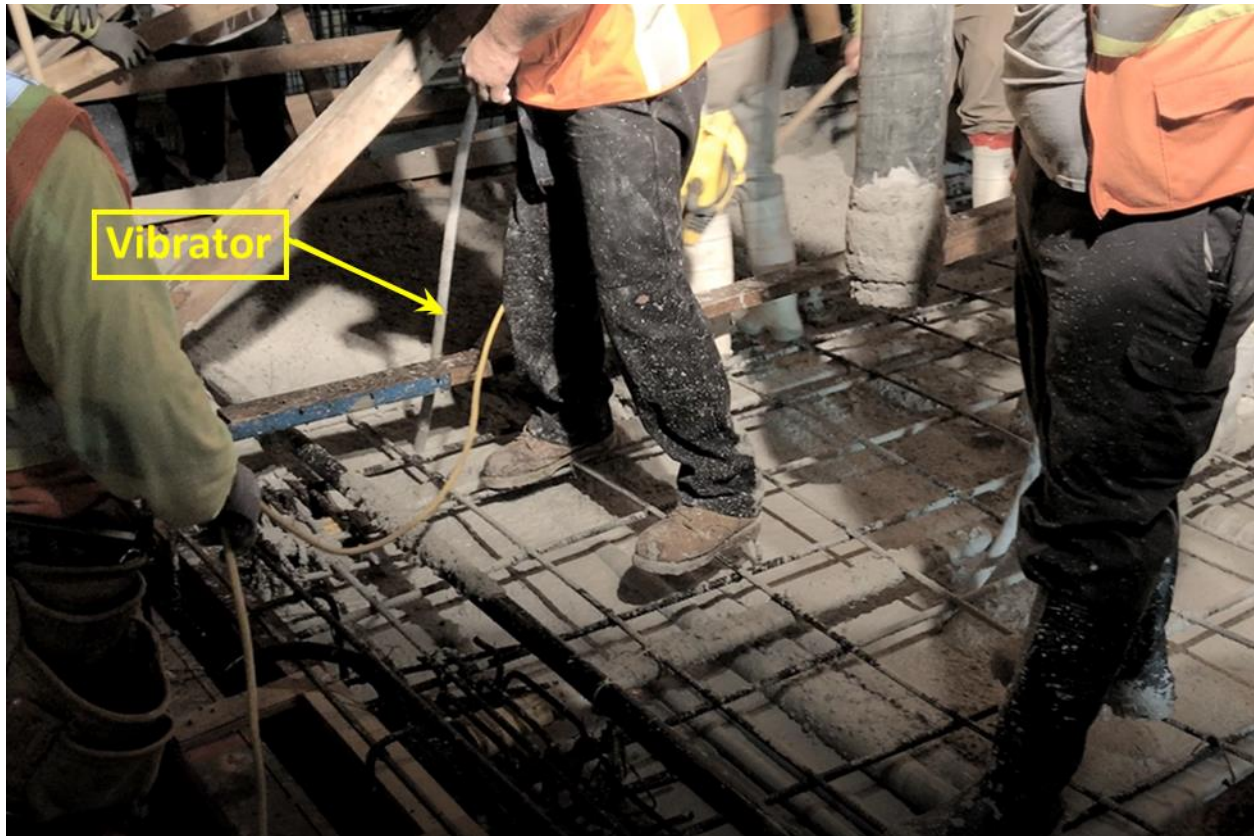
An initial attempt to place the concrete deck was made on September 1, 2017. The placement was aborted when it was learned that concrete could not be continuously supplied due to a problem at the ready-mix plant. Nevertheless, the video from this first placement attempt shows the placement methods, consistency of the concrete, and surface texture. Figure 3.4 is a screenshot from one of the videos showing concrete placement and internal vibration. At the time the video was taken, the concrete level had not yet reached the top reinforcing bar mat. Note that the surface texture is relatively smooth, especially in the vicinity of the vibrator, although the coarse aggregate occasionally protrudes above the surface. The surface texture appears comparable to the as-placed (non-roughened) surface texture of the WJE interface shear transfer Specimen 3 (Figure 3.4).

Figure 3.4. Screenshot of video of first deck concrete placement attempt.

Comparison of the OSHA photograph to the WJE test specimens indicates that the construction joint below Members 11 and 12 was most likely left as-placed (non-roughened) after internal vibration; that is, the condition shown in the video of the first deck placement attempt (Figure 3.4). This observation is contrary to the project specifications, which were reconfirmed before the deck concrete was placed.

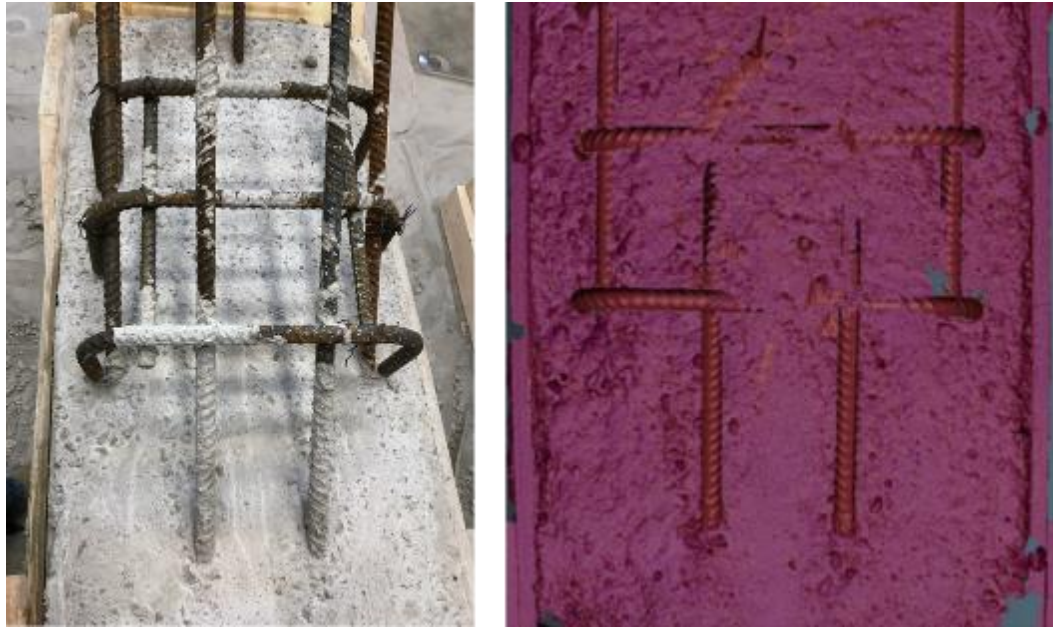
Figure 3.6 shows a photograph of the as-placed (non-roughened) surface of the Specimen 3 construction joint, and a laser scan of the same surface. The as-placed surface was created by internally vibrating the concrete during placement without further treatment. Note that the surface texture is similar to that shown in Figure 3.4, which is a screenshot of the first deck placement attempt.

Figure 3.6. Photograph and laser scan of Specimen 3 (as-placed). (Note: the mortar adhering to the reinforcing bars in the left photo was removed before scanning and placement of the upper lift.)

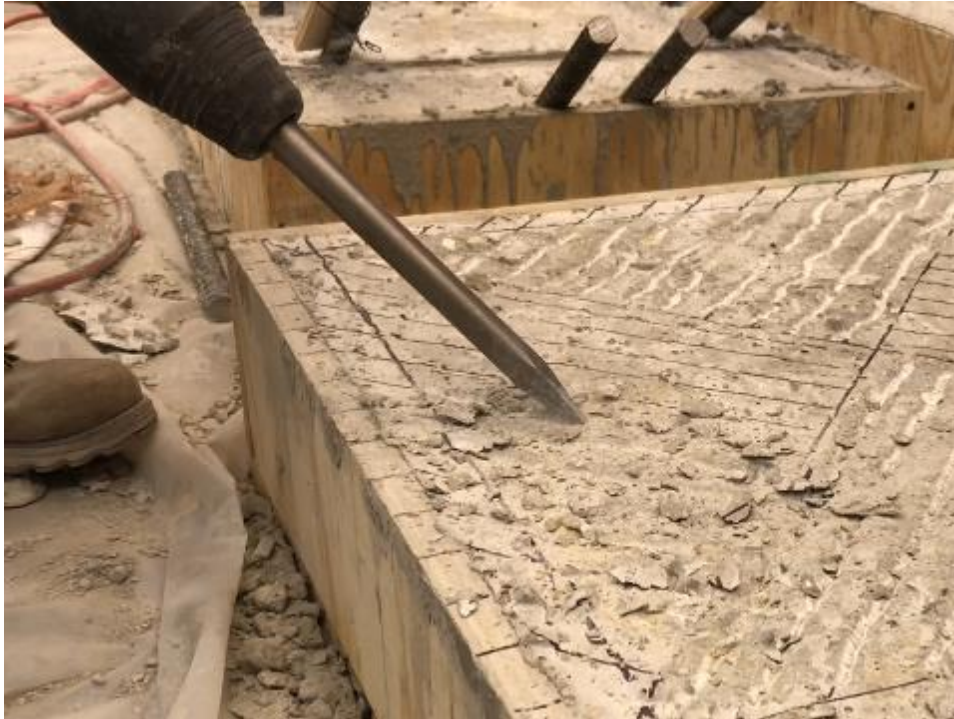
For the *roughened* condition, the hardened concrete was roughened one day after placement using an electric chipping hammer with amoil bit (a rectangular bit tapered to a sharp point). The roughening operation is shown in Figure 4.6.

Figure 4.6. Roughening operation using an electric chipping hammer with amoil point (trial slab shown)

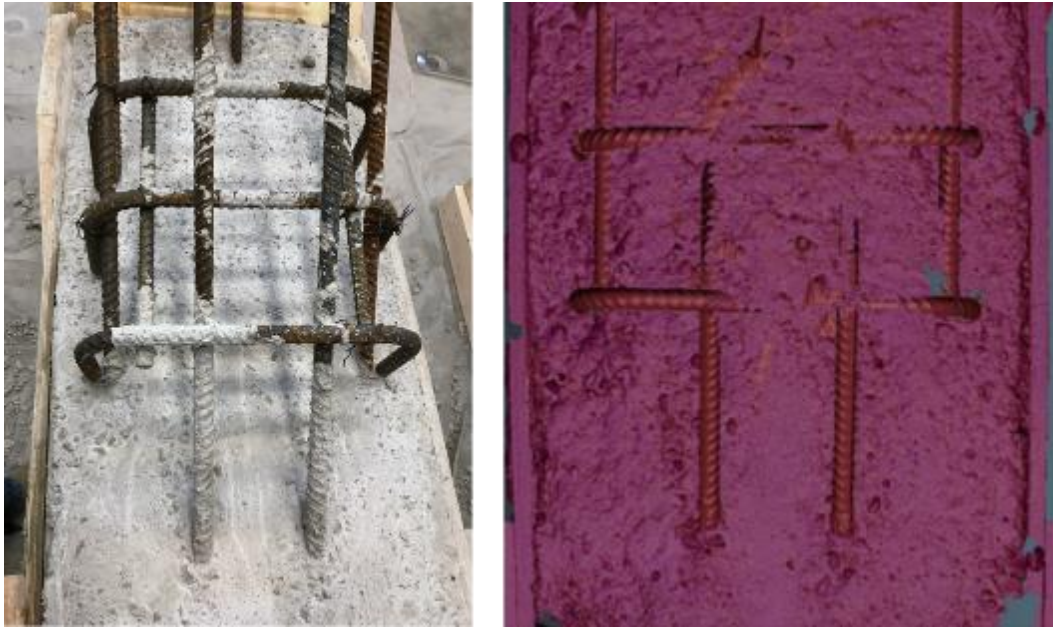
Figure 4.7. Photograph and laser scan of Specimen 3 (as-placed). (Note: the mortar adhering to the reinforcing bars in the left photo was removed before scanning and placement of the upper lift.)

Table 4.5 compares the surface roughness parameters for the as-placed (non-roughened) and roughened test specimens. Using the standard deviation for comparison purposes, Specimen 4 (roughened) is more than twice as rough as Specimen 3 (as-placed). Comparison using the sum of average positive and negative deviations indicates that the roughened surface is about 2.2 times as rough as the as-placed surface.

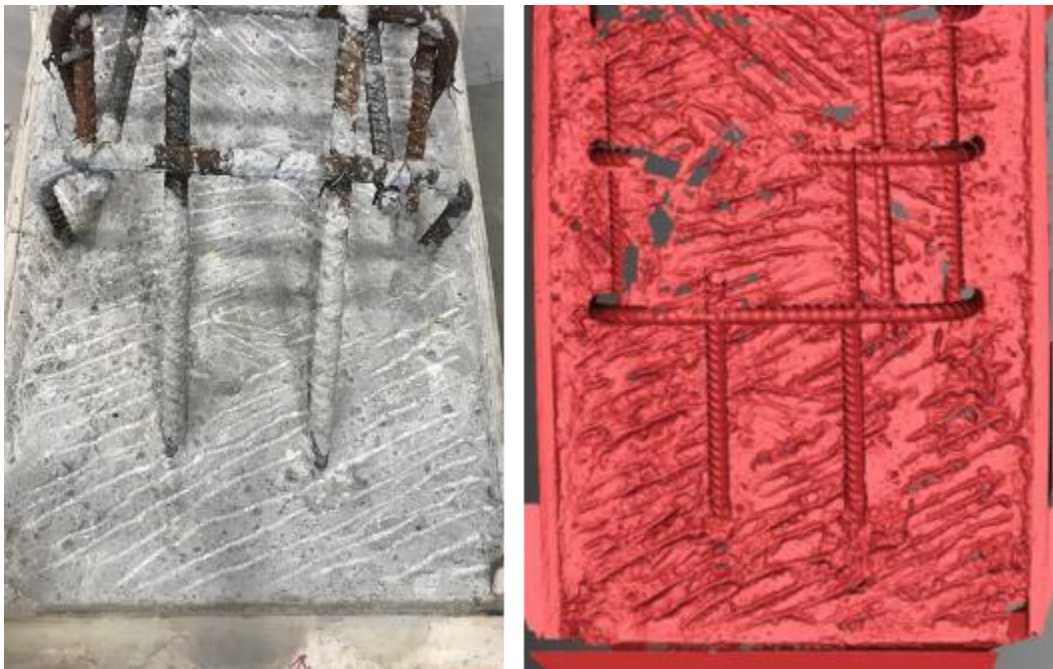
Figure 4.8. Photograph and laser scan of Specimen 4 (roughened in accordance with FDOT Standard Specifications). (Note: the mortar adhering to the reinforcing bars in the left photo was removed before scanning and placement of the upper lift.)

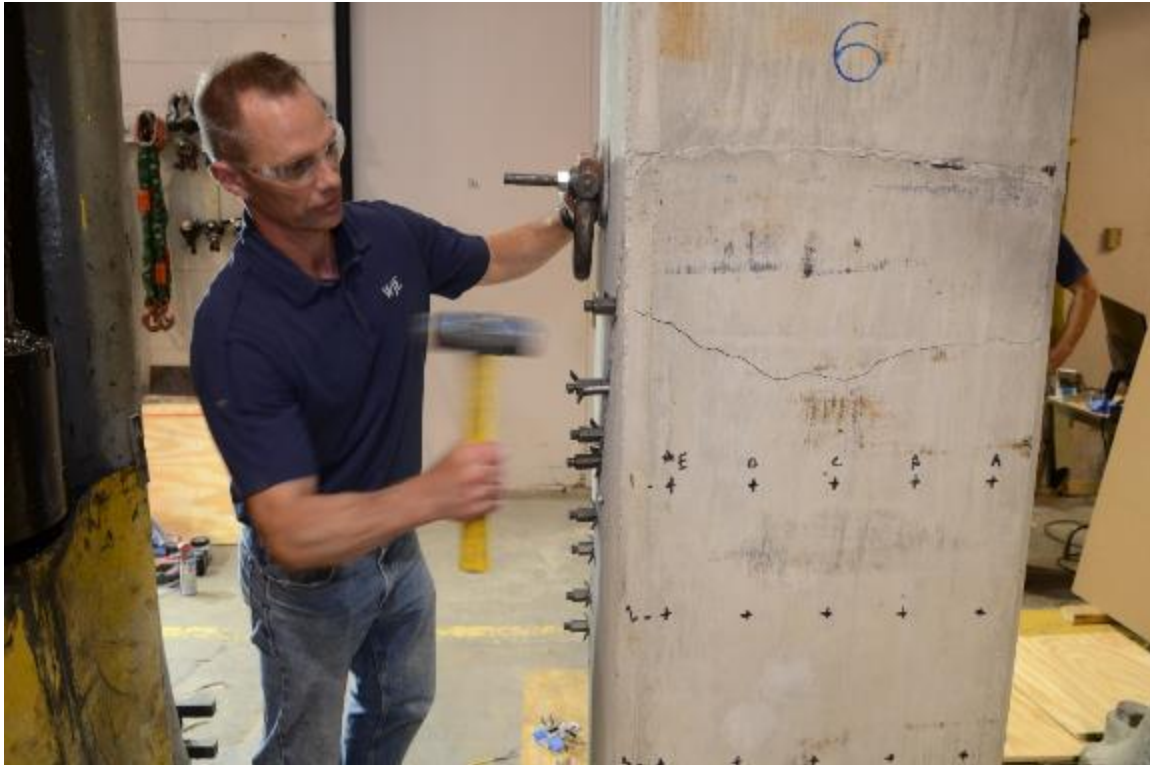
Stone-splitting wedge sets in drilled holes were used to create the cracks at the construction joint. Figure 4.9 is a photograph of the cracking operation at Specimen 6. Machined measurement points and a digital caliper were used to detect and monitor the width of the crack at the surface. The wedge sets were driven until the surface crack width was approximately 0.012 to 0.014 inches. In WJE’s laboratory, an ultrasonic pulse velocity meter was used to verify that this surface crack width was sufficient for propagation of the crack across the width of the specimen. The wedge sets were removed after cracking.

Figure 4.9. Stone-splitting wedge sets being used to create a crack across the construction joint of Specimen 6

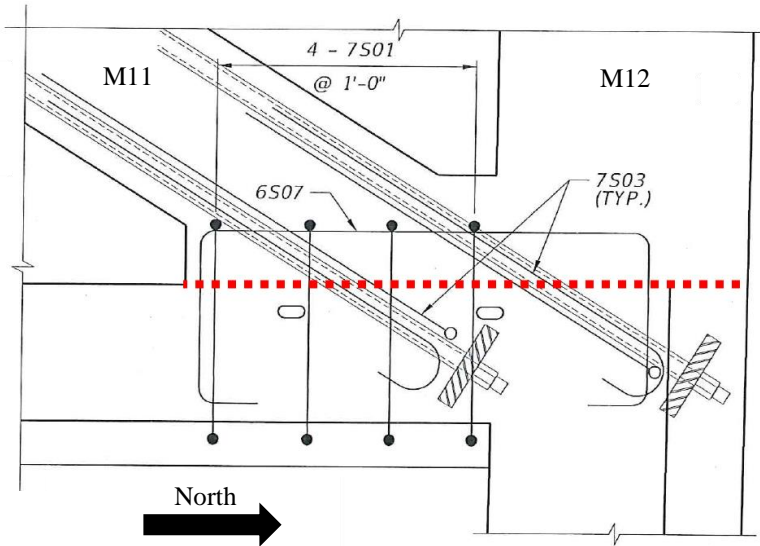
Figure 5.2. Excerpt from Design Drawings showing configuration of joint area. Construction joint indicated by dotted line.

The capacity of the connection between Member 11/12 and the deck is shear-friction at the construction joint below Members 11 and 12, the dashed red line in Figure 5.2.

Shear-Friction Assumptions. Although inconsistent with the failure mode described in Section 2, which involved a combination of shear-friction below Member 11 and breakout below Member 12, shear-friction was evaluated across the entire construction joint shown in Figure 5.2. The AASHTO Code does not require or even address evaluation of a combined shear-friction and breakout resistance. As such, the assumption of shear-friction resistance across the entire construction joint is considered to be a likely choice in design.

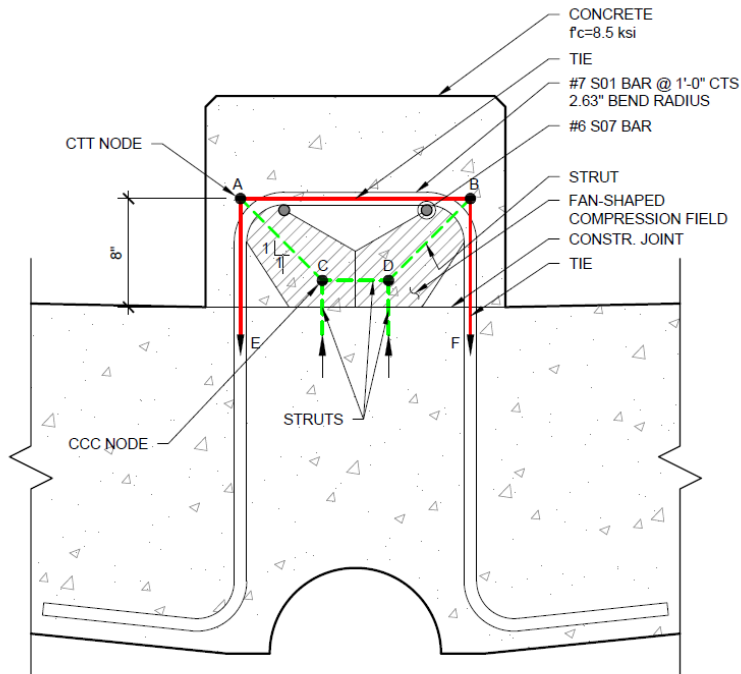
The #6 and #7 stirrups shown in Figure 5.3 were not fully developed above the interface in accordance with the AASHTO Code requirement for development of hooked bars in tension (AASHTO 5.11.2.4). However, the vertical legs of the #6 and #7 stirrups are connected across the top. The vertical legs of these bars are fully developed based on the AASHTO requirements for strut-and-tie models in Section 5.6.3. The strut-and-tie model for the #7 stirrups is shown in Figure 5.3. As such, these bars were considered to contribute to shear-friction resistance.

Figure 5.3. Strut-and-tie model of #7 stirrups across construction joint

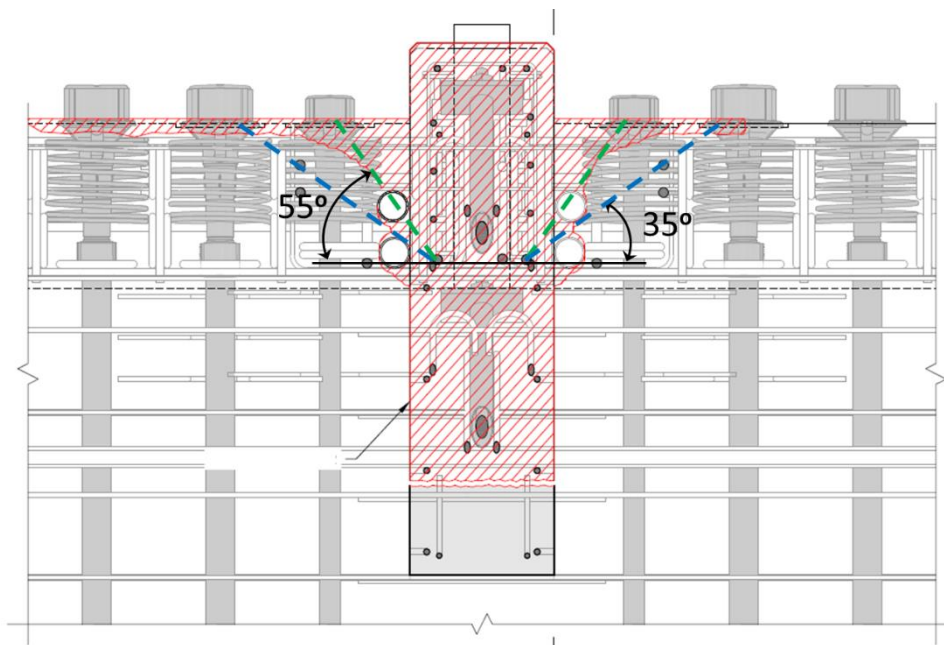
However, the interior post-tensioning tendons forced a narrow breakout cone. The angle between the outermost #11 bars and the interior post-tensioning tendons is about 55 degrees relative to an east-west line, as illustrated in Figure 5.4. In contrast, the breakout angle on which the ACI 318 resistance model is based is 35 degrees¹⁸.

Figure 5.4. Plan view at north end showing breakout angle

Adjusting for both breakout angle and the conservatism of the ACI expression, a breakout resistance of 440 kips would be expected ($161 \times 2.04 \times 1.34 = 440$ kips).

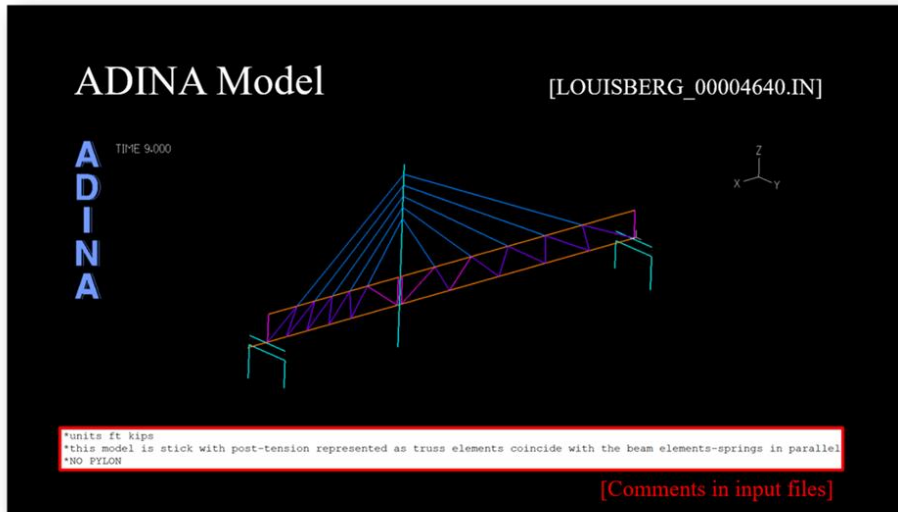
Figure 6.4. Adina finite element model of the bridge re-created from the Berger input file

As can be seen in Figure 6.4, the model includes the stay pipes as well as the concrete truss members in the main span and back span. Figure 6.5 shows the deformed shape under dead load according to Berger's model. In this model, the stay pipes work with the truss members to resist dead load from the concrete structure. However, according to the construction sequence, the concrete structure must support itself before the stay pipes are installed. As previously noted, the stay pipes are intended only to increase bridge stiffness and mitigate vibration. As such, the Berger model could not have been used to reasonably estimate the forces in the concrete truss members, which was required by their peer review contract.

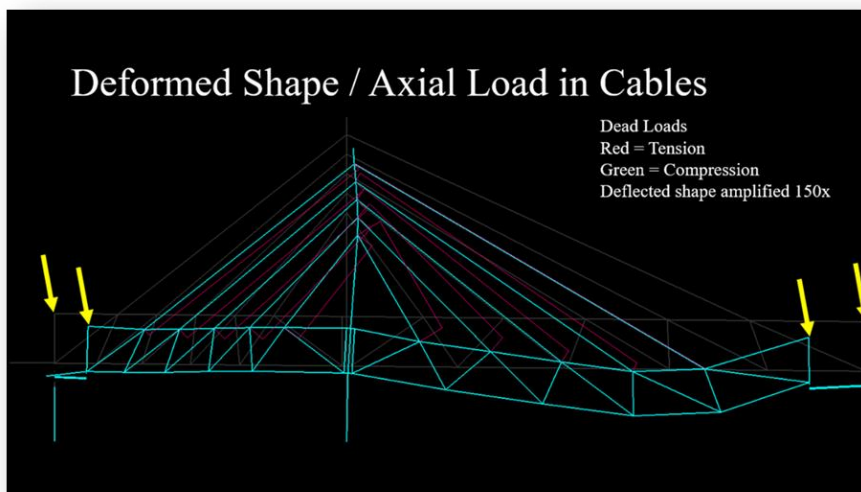
Figure 6.5. Deformed shape according to Berger model

The factored axial force considering construction staging is 2365 kips, 34 percent more than the value considered by Berger. The discrepancy is apparently due to the unconservative Adina model in which the stay pipes are incorrectly assumed to work with the truss members to resist dead load of the concrete structure. As noted in the previous section, the Berger model could not have been used to reasonably estimate the forces in the concrete truss members, which was required by their peer review contract.

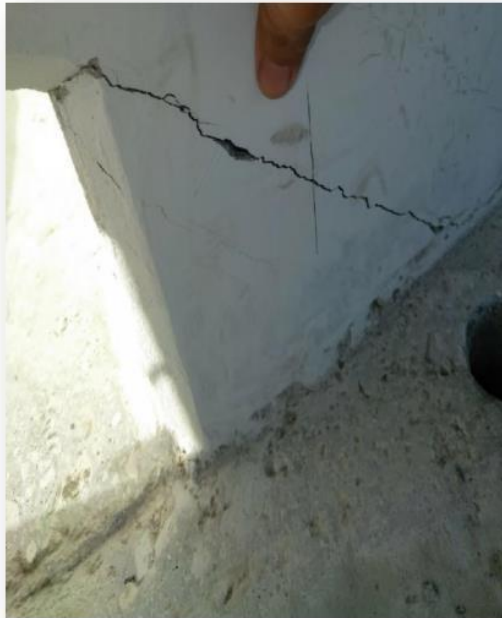
Exhibit 7.1.3. Diagonal “wedge” crack at Member 11 before and after move

Diagonal “wedge” crack along the bottom of Diagonal 11 on the east face. Photo taken by BPA prior to the move on February 24, 2018.

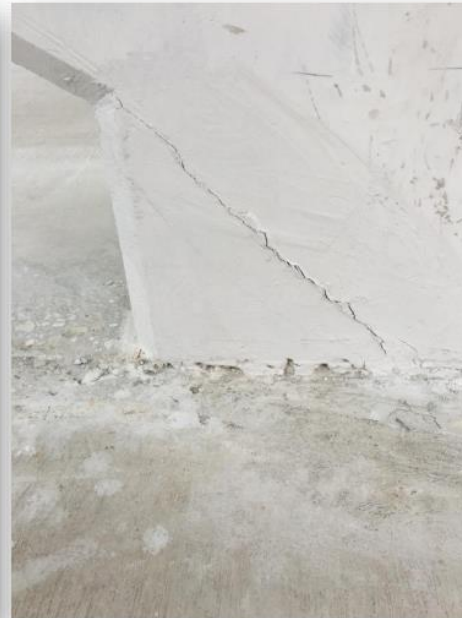
Same diagonal “wedge” crack shortly after the move. Photo taken by FIGG at about 12:30 p.m. on March 10.

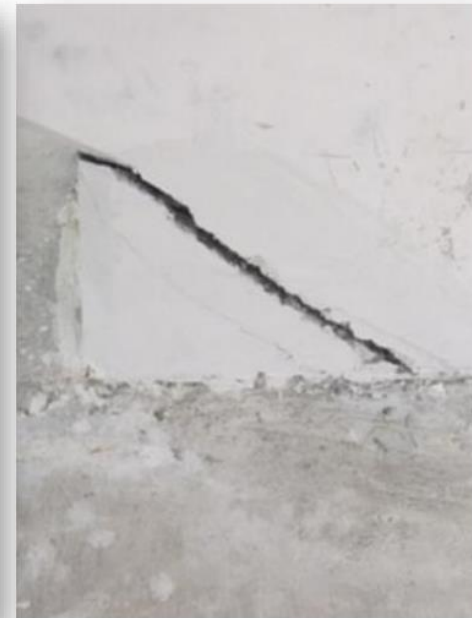
Same diagonal “wedge” crack 3 hours after the move. Photo taken by Molina at about 3 p.m. on March 10.

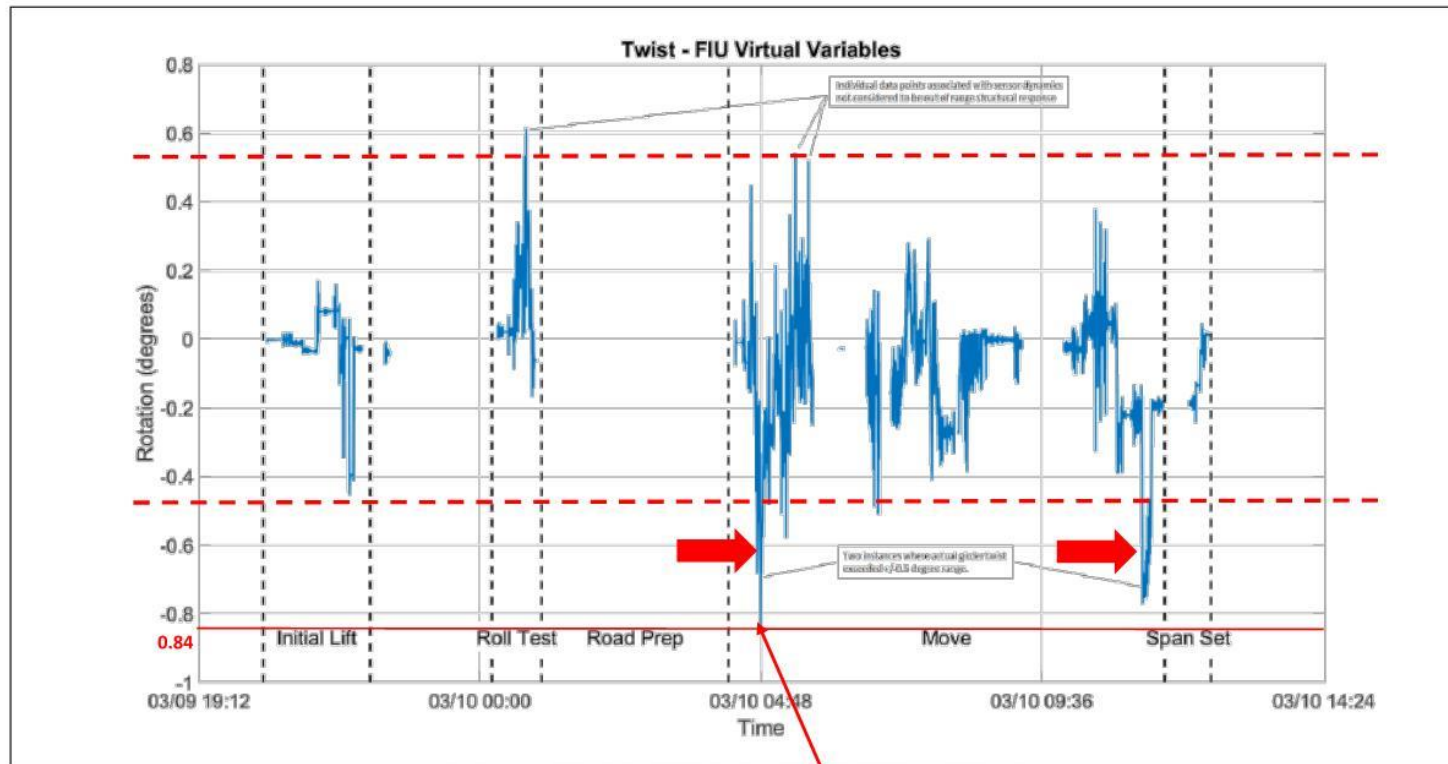
Exhibit 7.2.1. Twist rotation between support points versus time

(From BDI monitoring report Figure 32. Red arrows and dashed lines indicating tilt exceedances added by WJE.)

Difference in rotation between north and south supports: 0.84°

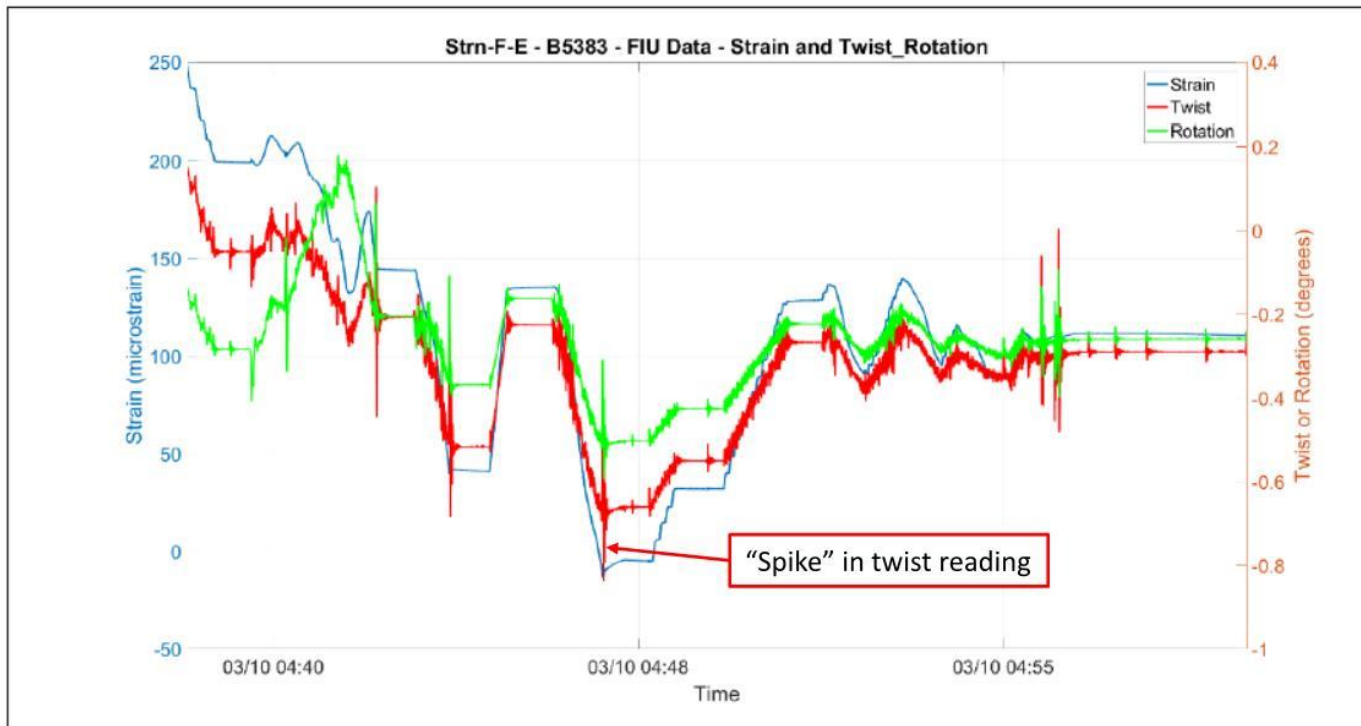
Exhibit 7.2.4. Twist, rotation and strain readings versus time
(From BDI monitoring report Figure 21. Boxed note added by WJE.)

The BDI report discusses this tilt exceedance. Specifically, BDI points to Figure 7 in their report, which is reproduced herein as Exhibit 7.2.4. The figure shows spikes in the rotation and twist data. In particular, there is a significant spike at 4:48 a.m. on March 10 that is not matched in the strain measurements, although there is a smaller peak in the strain measurement at that time. BDI indicates that the spike “was observed to be an artifact of the tilt sensor dynamics.” However, BDI acknowledges that the “peak static twist value” at this time was approximately 0.65 degrees, which exceeds the 0.5 degree limit. Also, there is concurrent peak in strain readings at 4:48 a.m., indicating that the actual peak static twist value is greater than 0.65 degrees.

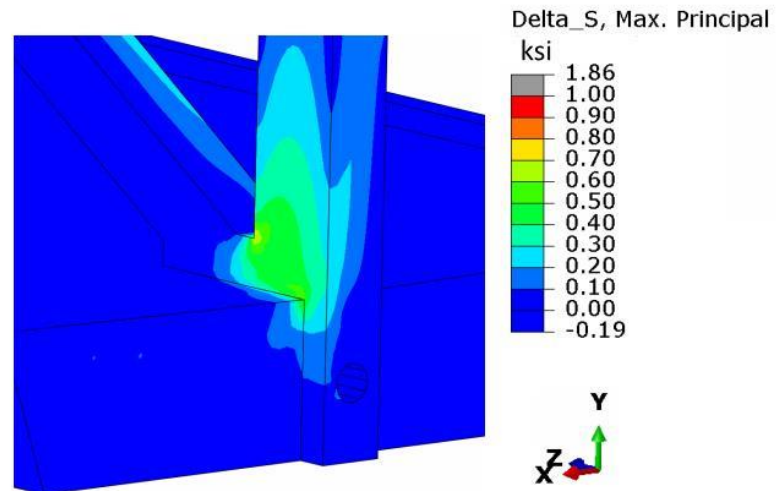
Exhibit 7.3.3. Maximum principle tensile stress due to twist only

Looking southwest at north end and east face. Green color indicates more than 500 psi tensile stress.

Dark blue areas have zero tensile stresses or they are compression dominant

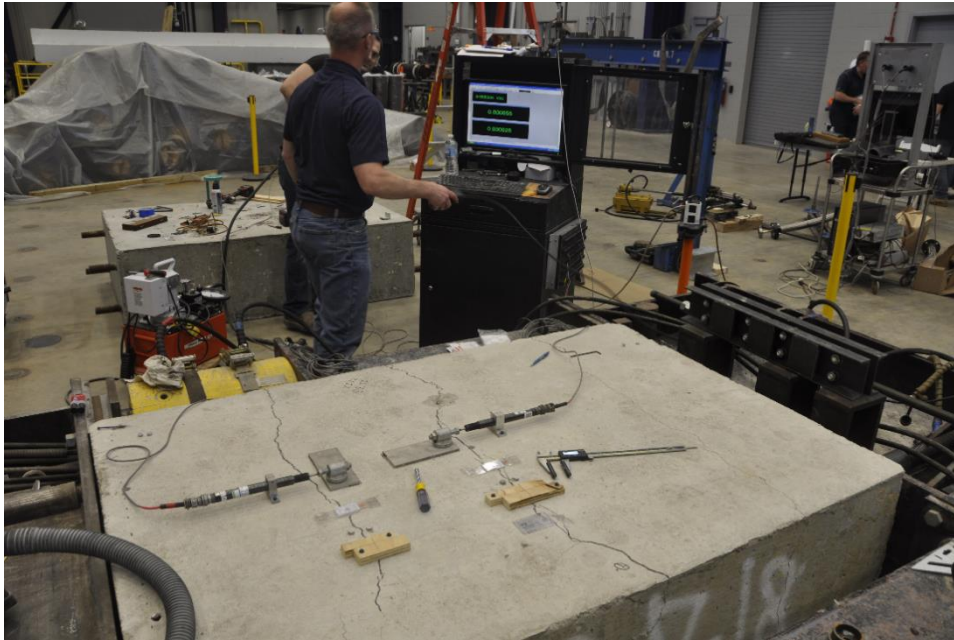
Figure 8.2. Crack induced in concrete specimen in WJE Northbrook laboratory

In light of FIGG’s email to monitor cracks during re-stressing and the Structural/VSL stressing safety guideline regarding cracking during stressing, WJE evaluated possible means for monitoring cracks in the north-end diaphragm. Figure 8.2 shows a concrete slab in WJE’s Northbrook laboratory used for evaluating anchors installed in cracked concrete. The specimen is mounted on a tensioning frame that induces cracks. A 0.1-inch-wide crack was induced in the concrete specimen to simulate an existing crack in the north-end diaphragm.

Small changes in crack width could have been monitored remotely using a displacement transducer. (The readout from the displacement transducer used by WJE can be seen in Figure 8.2.) All other methods would have required arm's-length or closer access to the crack.

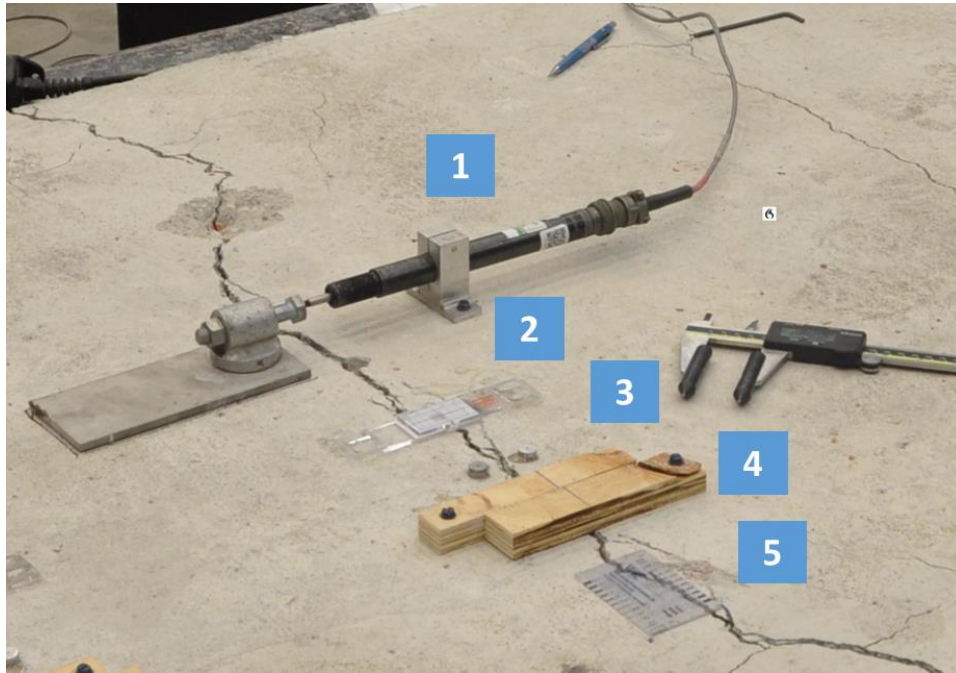
Figure 8.3. Crack monitoring methods evaluated

The devices used in these five methods are shown in Figure 8.3. The numbers in the blue boxes correspond to the numbers in the above list.

The effectiveness of these methods is summarized in Table 8.1. Effectiveness of crack monitoring methods. As indicated in Table 8.1. Effectiveness of crack monitoring methods, the first four methods, including the wood block crack gauge (similar to that used on the north end diaphragm), were effective in detecting changes in crack width as small as 0.02 inches. Much smaller changes could be detected with the displacement transducer or digital calipers. The crack comparator was only effective if used in combination with close-up photographs. Exhibit 8.6.1 provides photographs of the Humboldt crack gauge, wood block crack gauge, and crack comparator after a 0.02 inch increase in crack width.

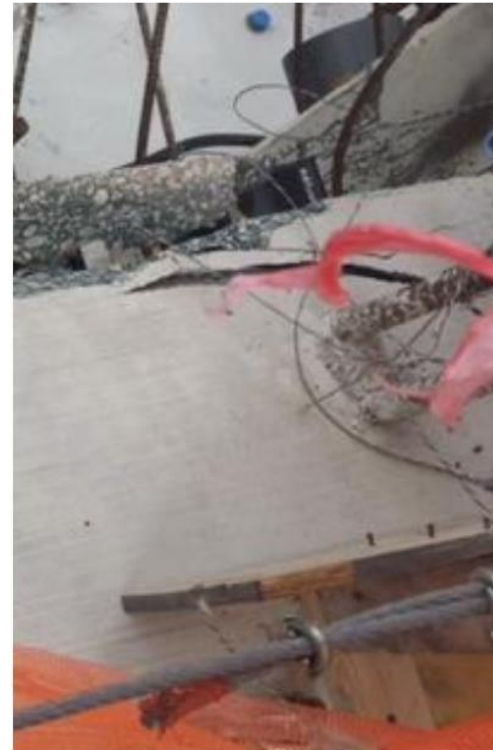
West side of Member 12. March 10 photo by Corradino at 3:14 p.m.

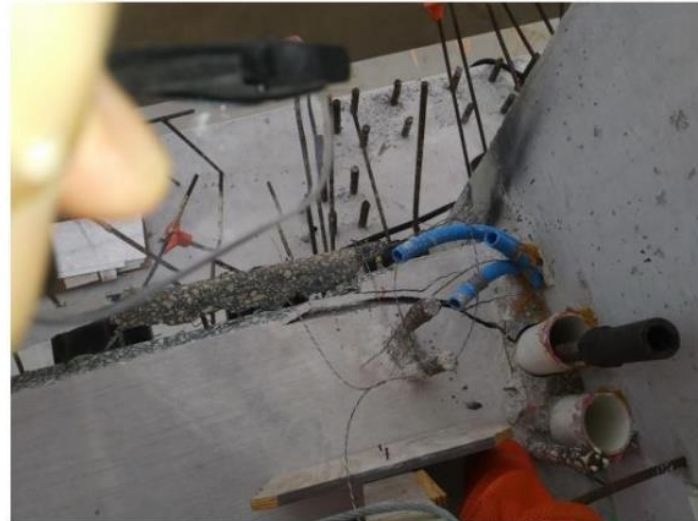
PHOTO 1: Diaphragm 2, Westside top view, crack

West side of Member 12. Photo taken March 12, 2018 by MCM.

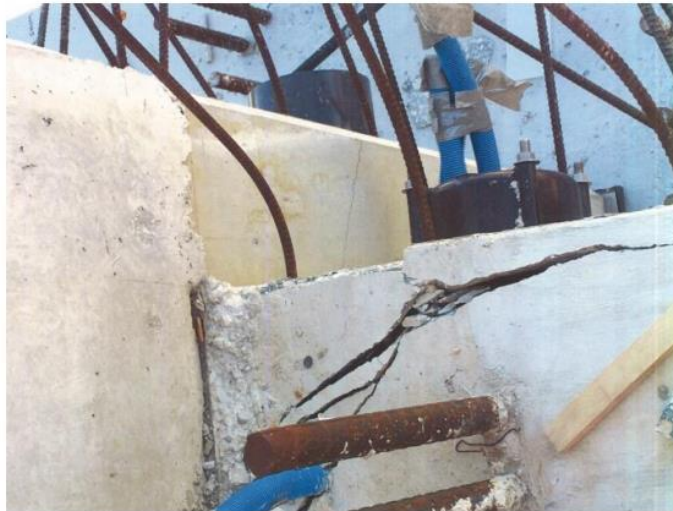
Exhibit 8.4.1. Cracks in north end diaphragm

East side of Member 12. Photo taken March 14, 2018 by BPA.

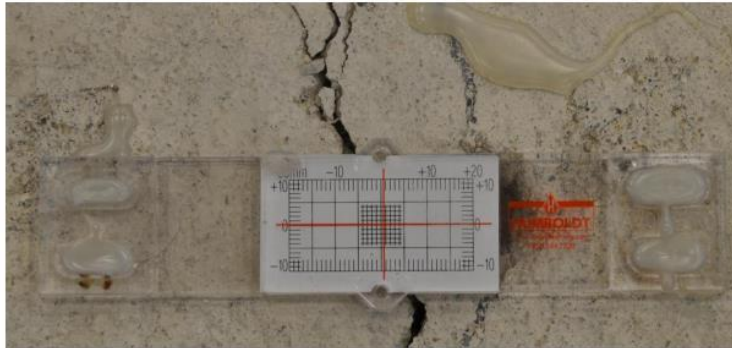
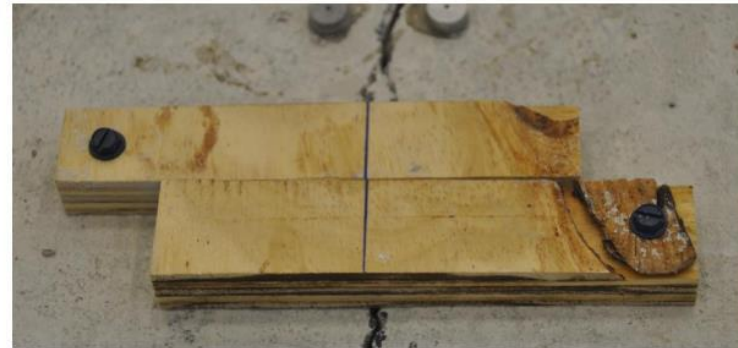
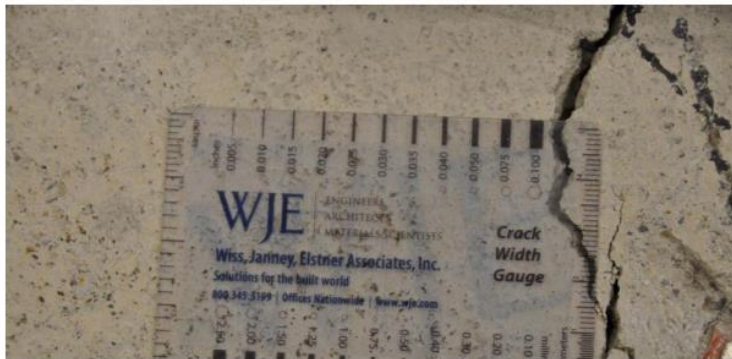
Exhibit 8.6.1. Comparison of crack monitoring methods for 0.02 inch change in crack width

*Upper left: Humboldt crack gauge
Upper right: Wood block crack gauge
Lower left: Crack comparator*
