PARTY SUBMISSION

TO THE
NATIONAL TRANSPORTATION
SAFETY BOARD

FIU University City Prosperity Pedestrian Bridge
Construction Accident
Miami, Florida | March 15, 2018

Submitted by - Figg Bridge Engineers, Inc.

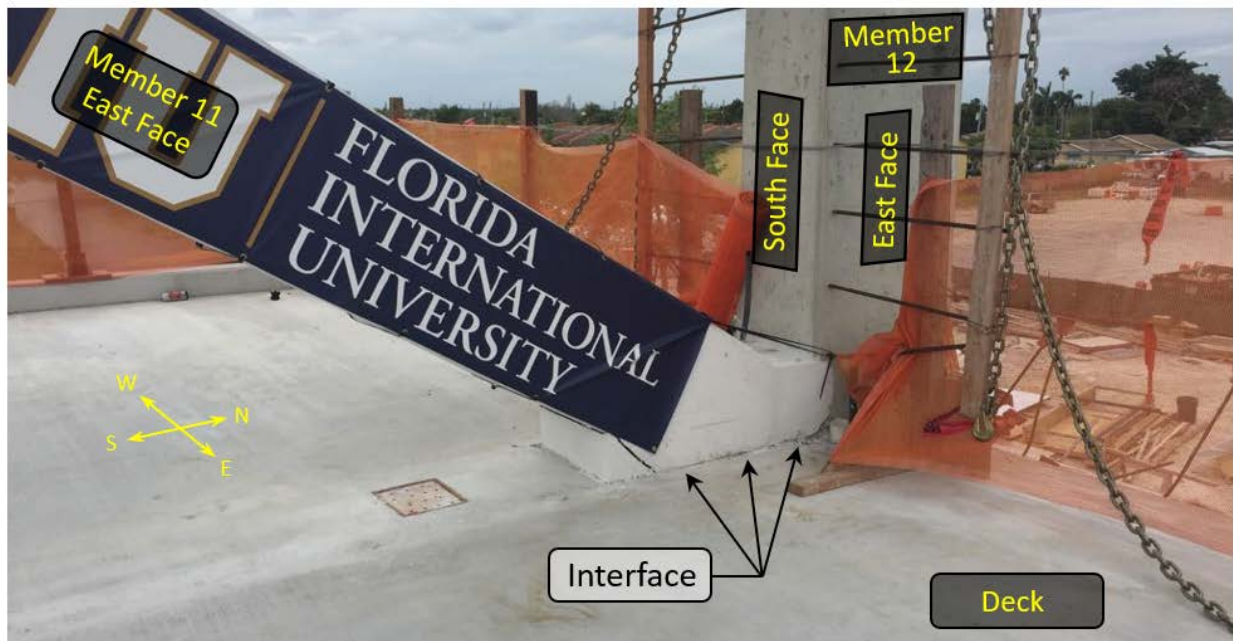
Figure 3. Annotated image showing elevation view of region of interest at the intersection of members 11 and 12 and the deck.

Finally, Figure 3 provides a local view of the location where Members 11 and 12 meet the bridge deck. The provided photograph shows the east face of diagonal Member 11 and the south and east faces of vertical Member 12. The deck surface can be seen around the base of where the two members frame into the deck. The interface under discussion is annotated in this figure.

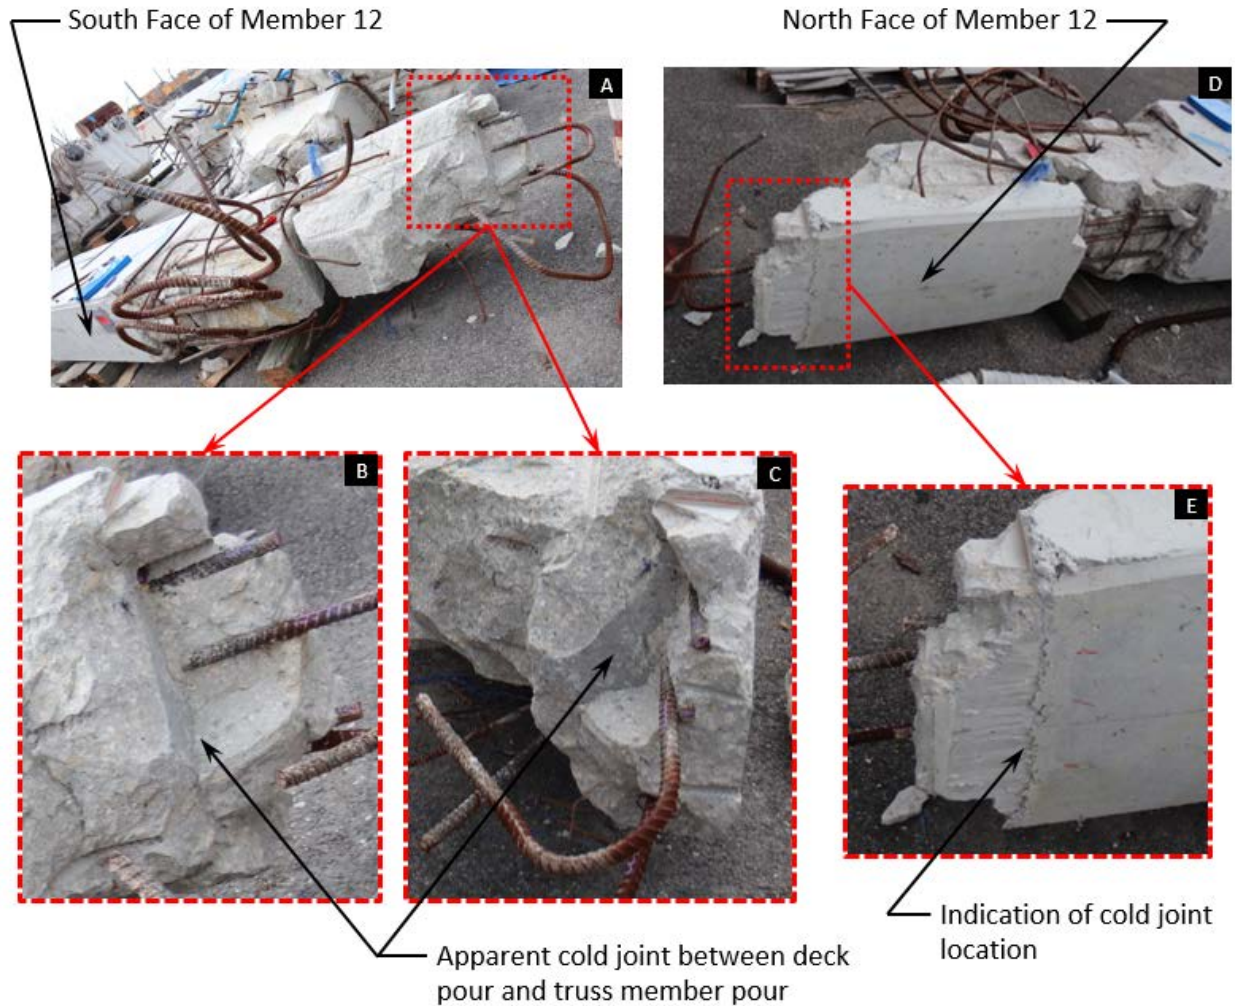
Figure 6. Indications of cold joint near the bottom end of Member 12.

Figure 6 provides a set of photographs showing the bottom end of Member 12. The photos in Part D and E show the north face of Member 12, with the left side of the member in each photo being the bottom end of Member 12. Part E and the annotation call attention to the location of a cold joint interface between concrete pours. From a construction process standpoint, this surface feature indicates a location where vertical formwork for a secondary pour of concrete was nearly pressed against the existing hardened concrete of the first pour. The small gap between the formwork and the first pour allowed a small amount of concrete paste to flow slightly past the leading edge of the hardened concrete on the north face of the member, thus creating the ragged horizontal paste line at the cold joint location.

Parts A through C of Figure 6 show the remnants of the south face and bottom end of Member 12. The boxed area in Part A draws attention to bottom end of Member 12 where it met the bridge deck. The key feature in this image is shown in both Parts B and C. A flat, nearly smooth plane of concrete paste is visible. This plane coincides with the cold joint surface feature visible on the north face of Member 12. This plane is part of the secondary casting of concrete that was placed and hardened against the first casting of concrete. The concrete in this plane and nearby appears well consolidated, indicating that this concrete replicated the surface geometry of the surface on which it was cast. Prior to or during the collapse, the concrete from the secondary casting debonded from the concrete from the original casting, leaving behind this preserved portion of the cold joint. This flat, nearly smooth plane does not show indications of abrasion or other mechanical actions that could have left a smoother surface than was originally present after the secondary pour of concrete was completed.

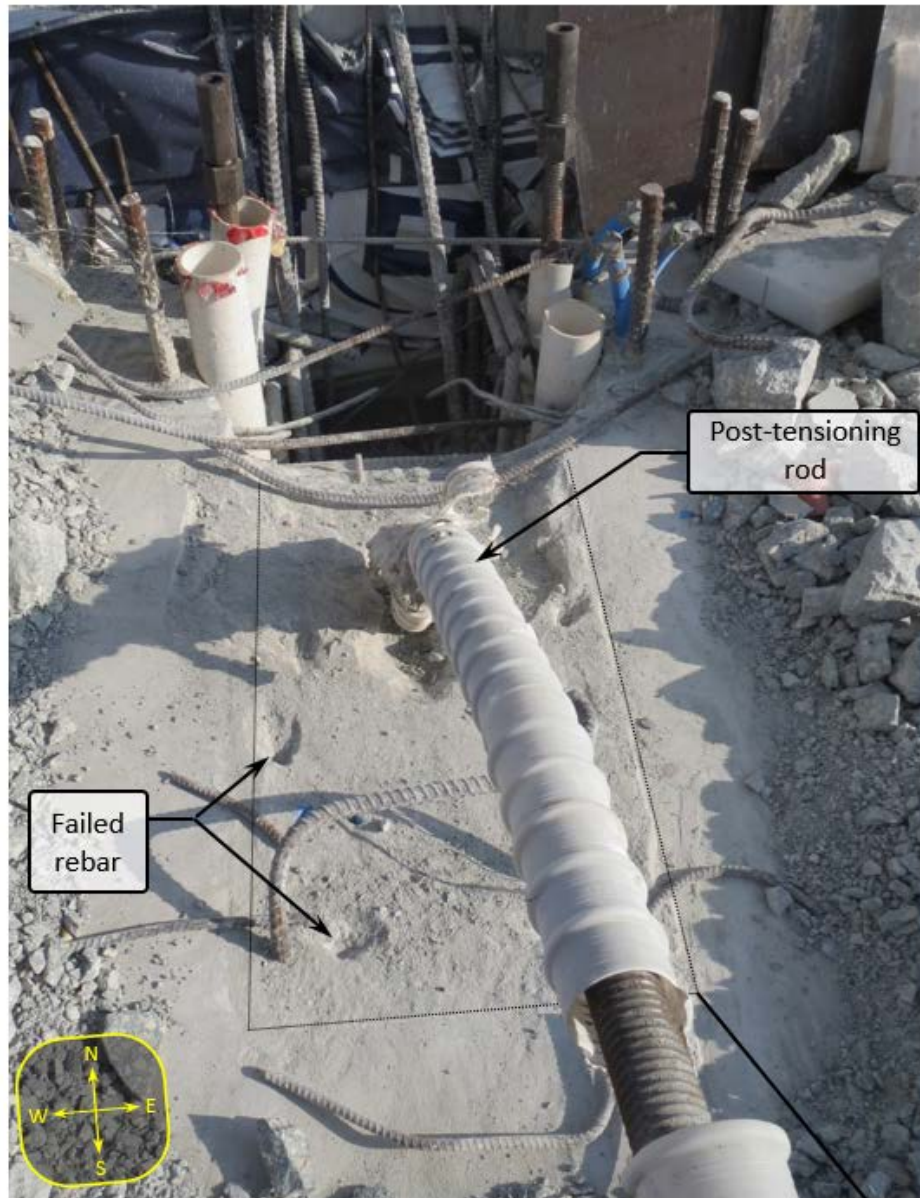
After the collapse, the deck under Member 11 was partially intact; this shown in Figure 7. This photo was captured in the days after the collapse once pulverized concrete and other debris created by the collapse had been carefully removed from the surface. This northward looking photo is taken from the vantage point of where Member 11 was heading diagonally toward the deck. The hole in the north end of the deck is the location where Member 12 met the deck. The visible post-tensioning rod was the lower rod within Member 11.

The portion of the deck under the southern end of Member 11 is largely intact from the post-tensioning rod to the southern end of the interface. This surface appears relatively smooth. The isolated depressions on the concrete surface, identified in Figure 7, are locations where reinforcing bars previously passed upward through the interface between the base of Member 11 and the deck.

Footprint of Member 11 on deck indicated with superimposed dotted line

Figure 7. Interface under Member 11 after loose debris removal.

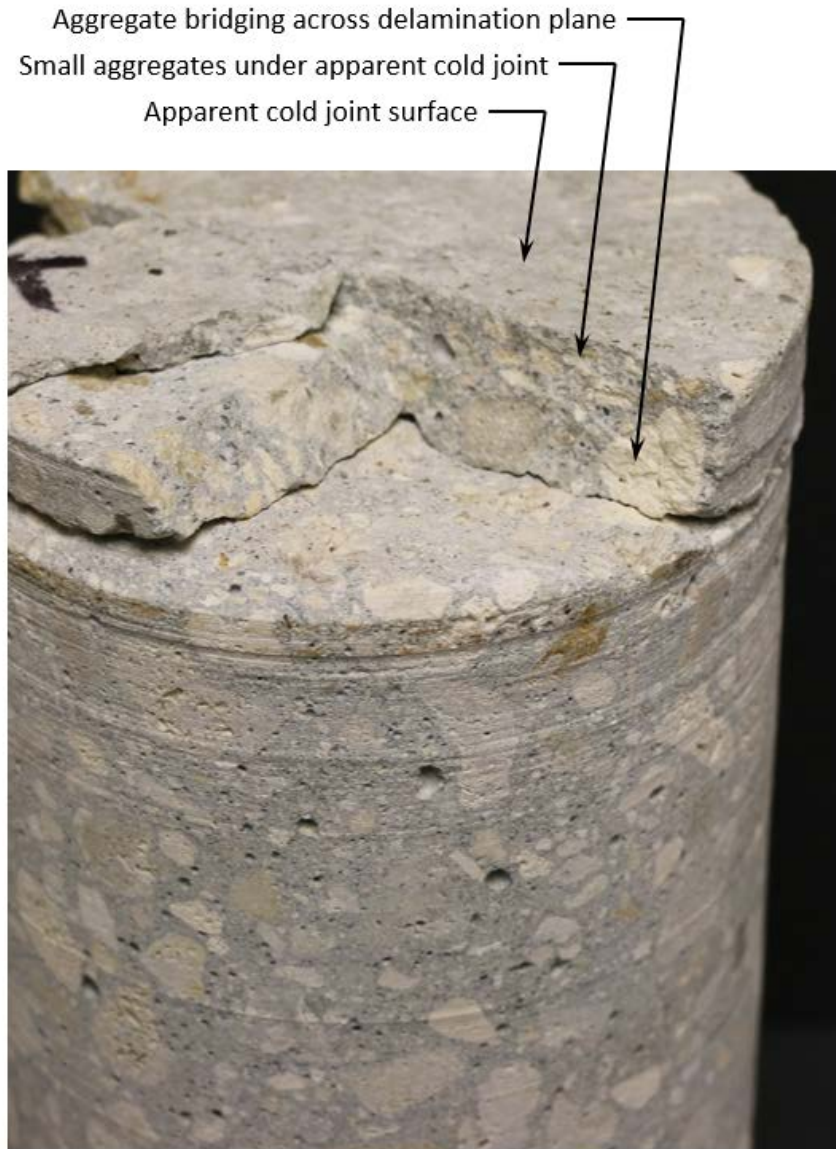
Further evidence related to the interface is provided by a core that was taken vertically down through the interface near the southern end of where Member 11 met the deck. This core is shown in Figure 10. As was discussed previously, there was a delamination layer under the interface surface. The photo in the figure is annotated to identify key features. The top of the core shows the apparent cold joint surface at the interface. This surface is largely concrete paste with a small number of fractured aggregates. The vertical fractured surface in the delaminated piece shows small aggregates immediately under the top surface. On this surface there are also a few larger aggregates, one of which is identified as being fractured where it crosses the delamination plane. This is indicative of the delamination plane having been caused by mechanical stressors and not by its having originally been a cold joint. Further examination through the depth of the core make apparent that 1) the concrete under Member 11 was well consolidated, and 2) the cold joint between the deck pour and the member pour was not at a location beneath the failure interface.

Figure 10. Annotated image of core extracted from south end of interface surface under Member 11.

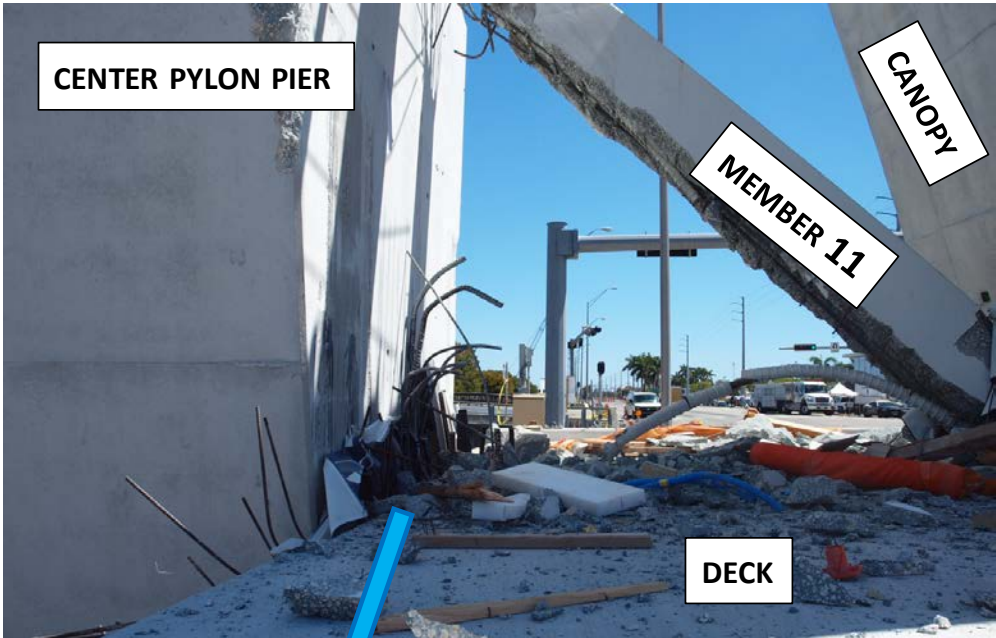
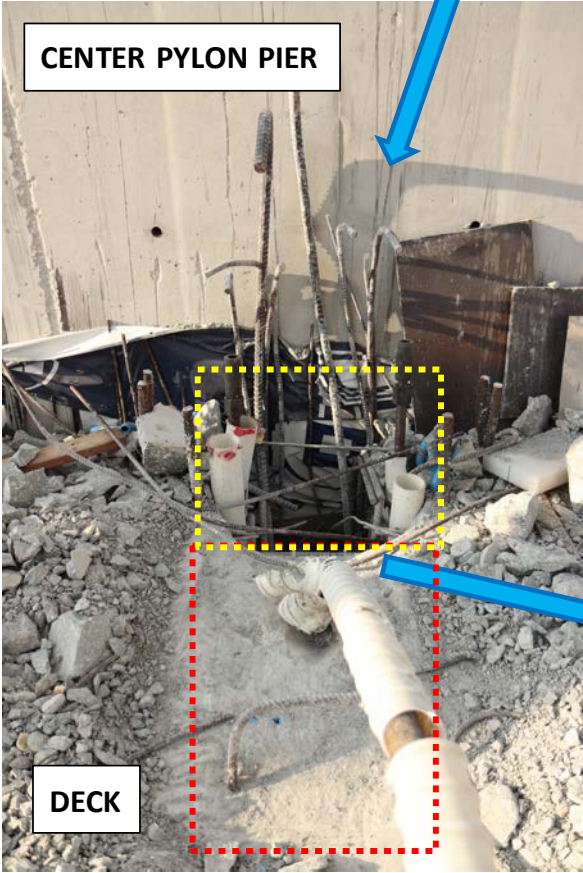
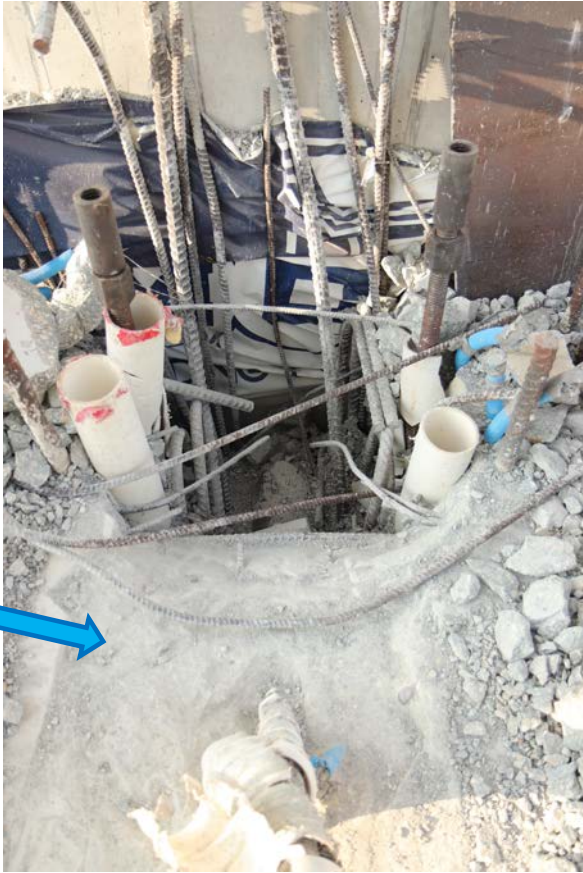
The location of the flat area on the deck surface under Member 11 is shown in Figures 1 and 2. Yellow dashed lines indicate a lip on the surface that was consistent with the edge of a cold joint. A portion of this area was sectioned and removed from the deck surface, as shown in Figure 3. The largest pieces separated from the deck were numbered 1, 2, and 3.

Figure 1: On-scene photos of the deck surface. The red box outlines the flat area on the deck surface under Member 11. The yellow box outlines where Member 12 was located.

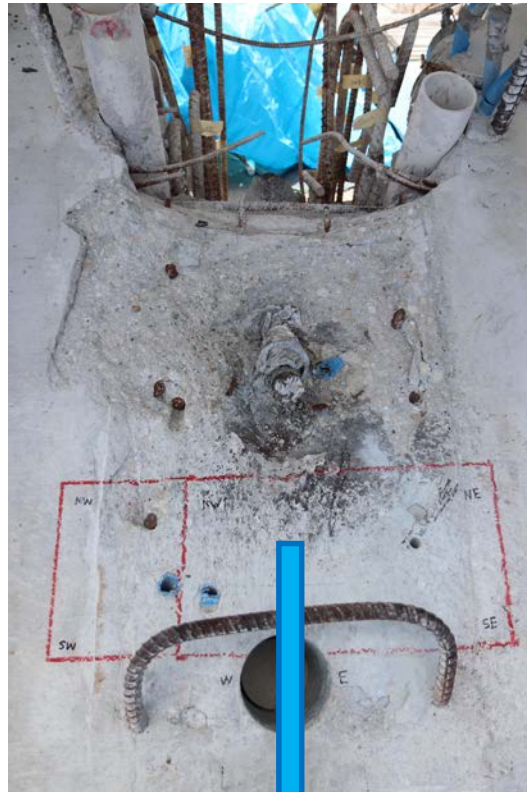
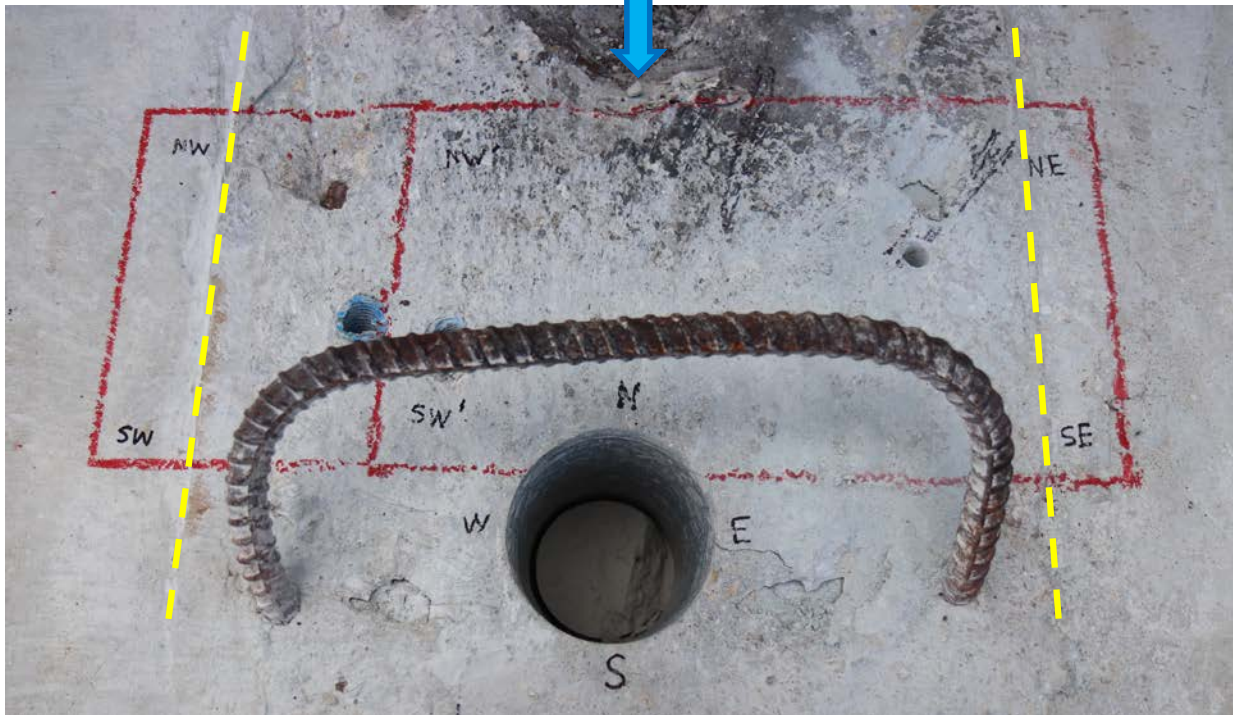
Figure 2: Close-up photos of the deck surface under Member 11. The yellow dotted lines indicate the edges of the cold joint.

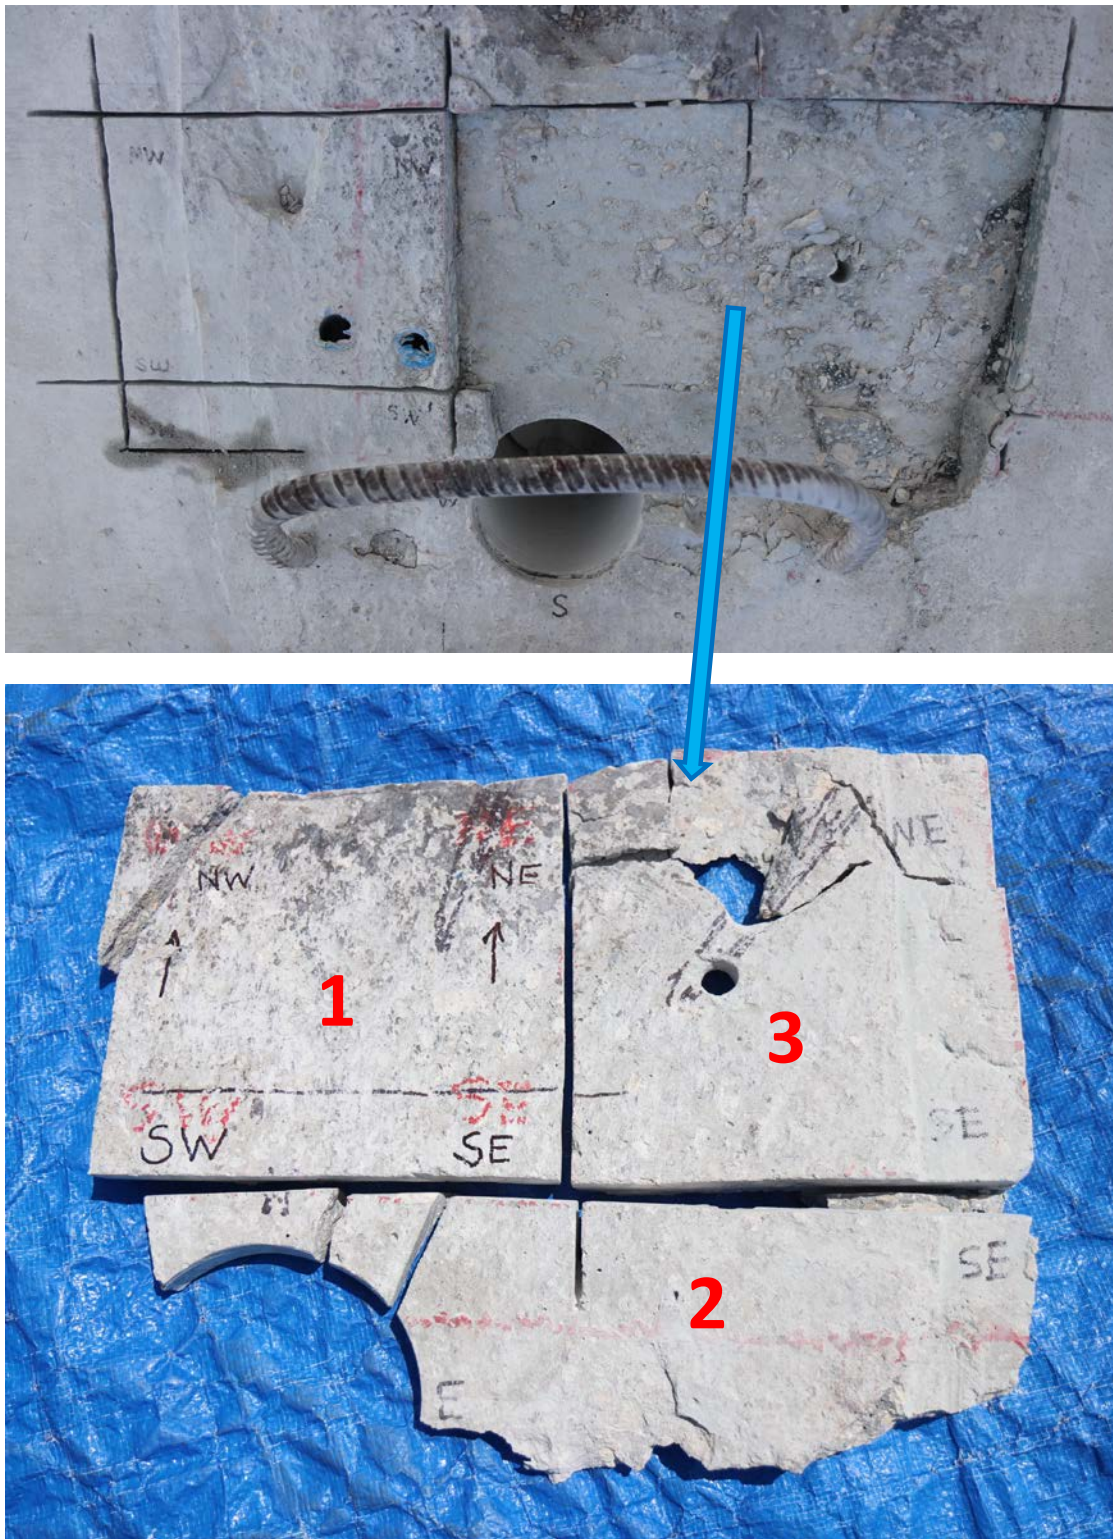
Figure 3: Close-up photos showing the portions of the deck surface under Member 11 that were sectioned for further analysis.

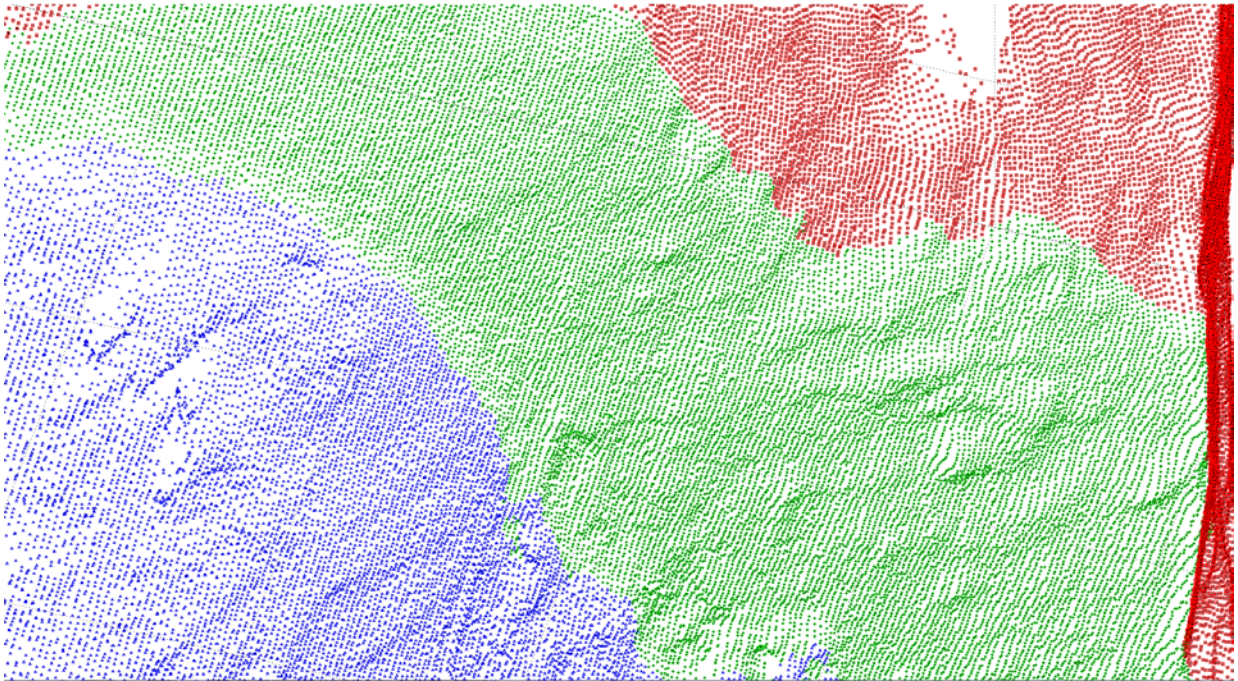
Figure 7: Subset of Member 12 point cloud obtained from digital scan (height not to scale).

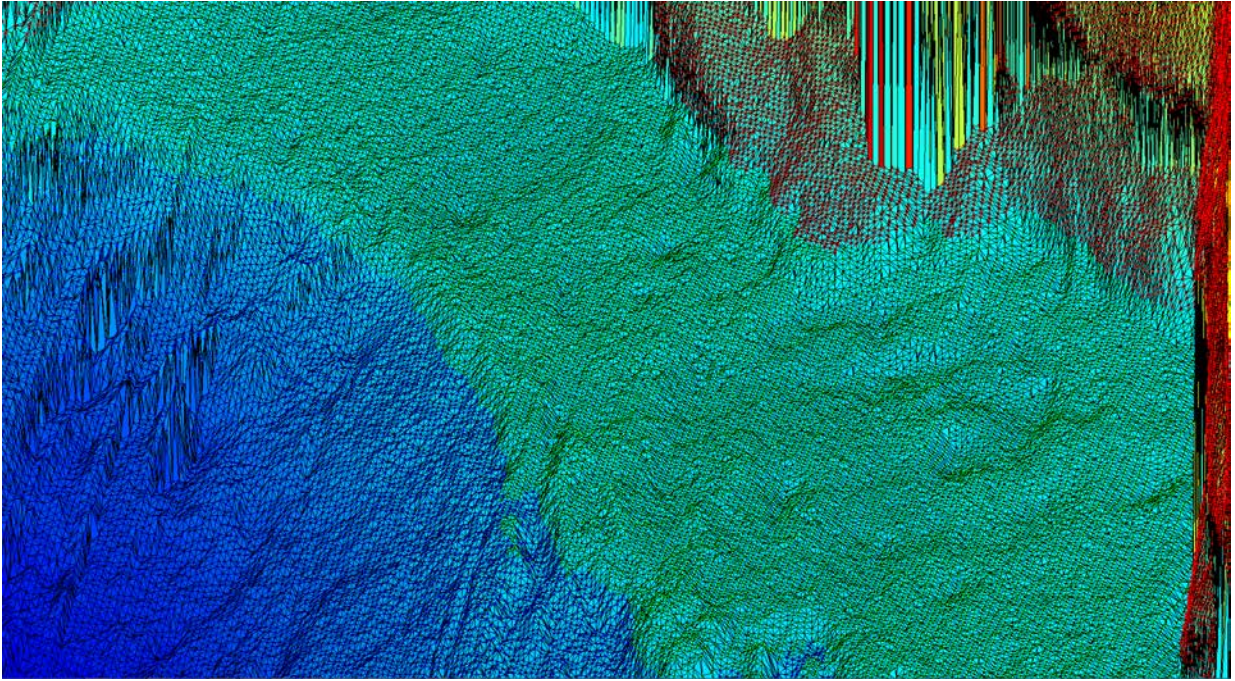
Figure 8: Subset of surface tessellation of Member 12 point cloud (height not to scale).

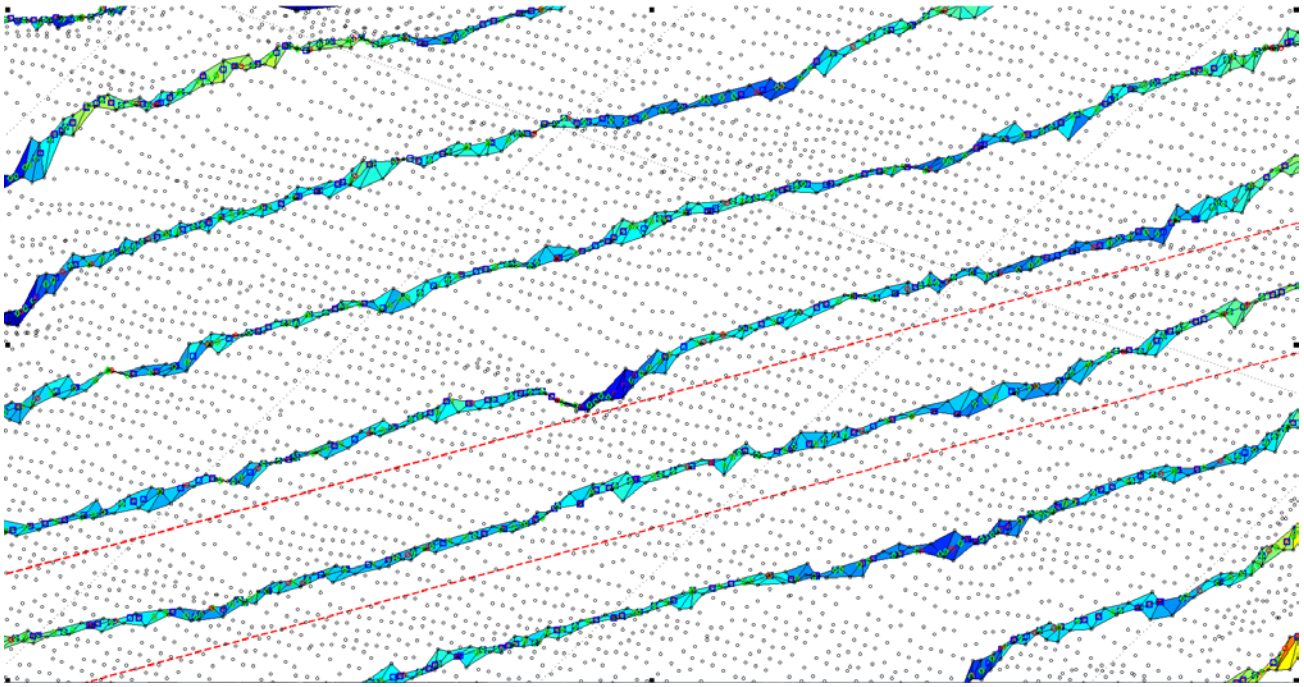
Figure 9: Exemplar intersection triangles and interpolated heights for subset of Member 12 point cloud (results shown for portions of nine parallel cutting planes).

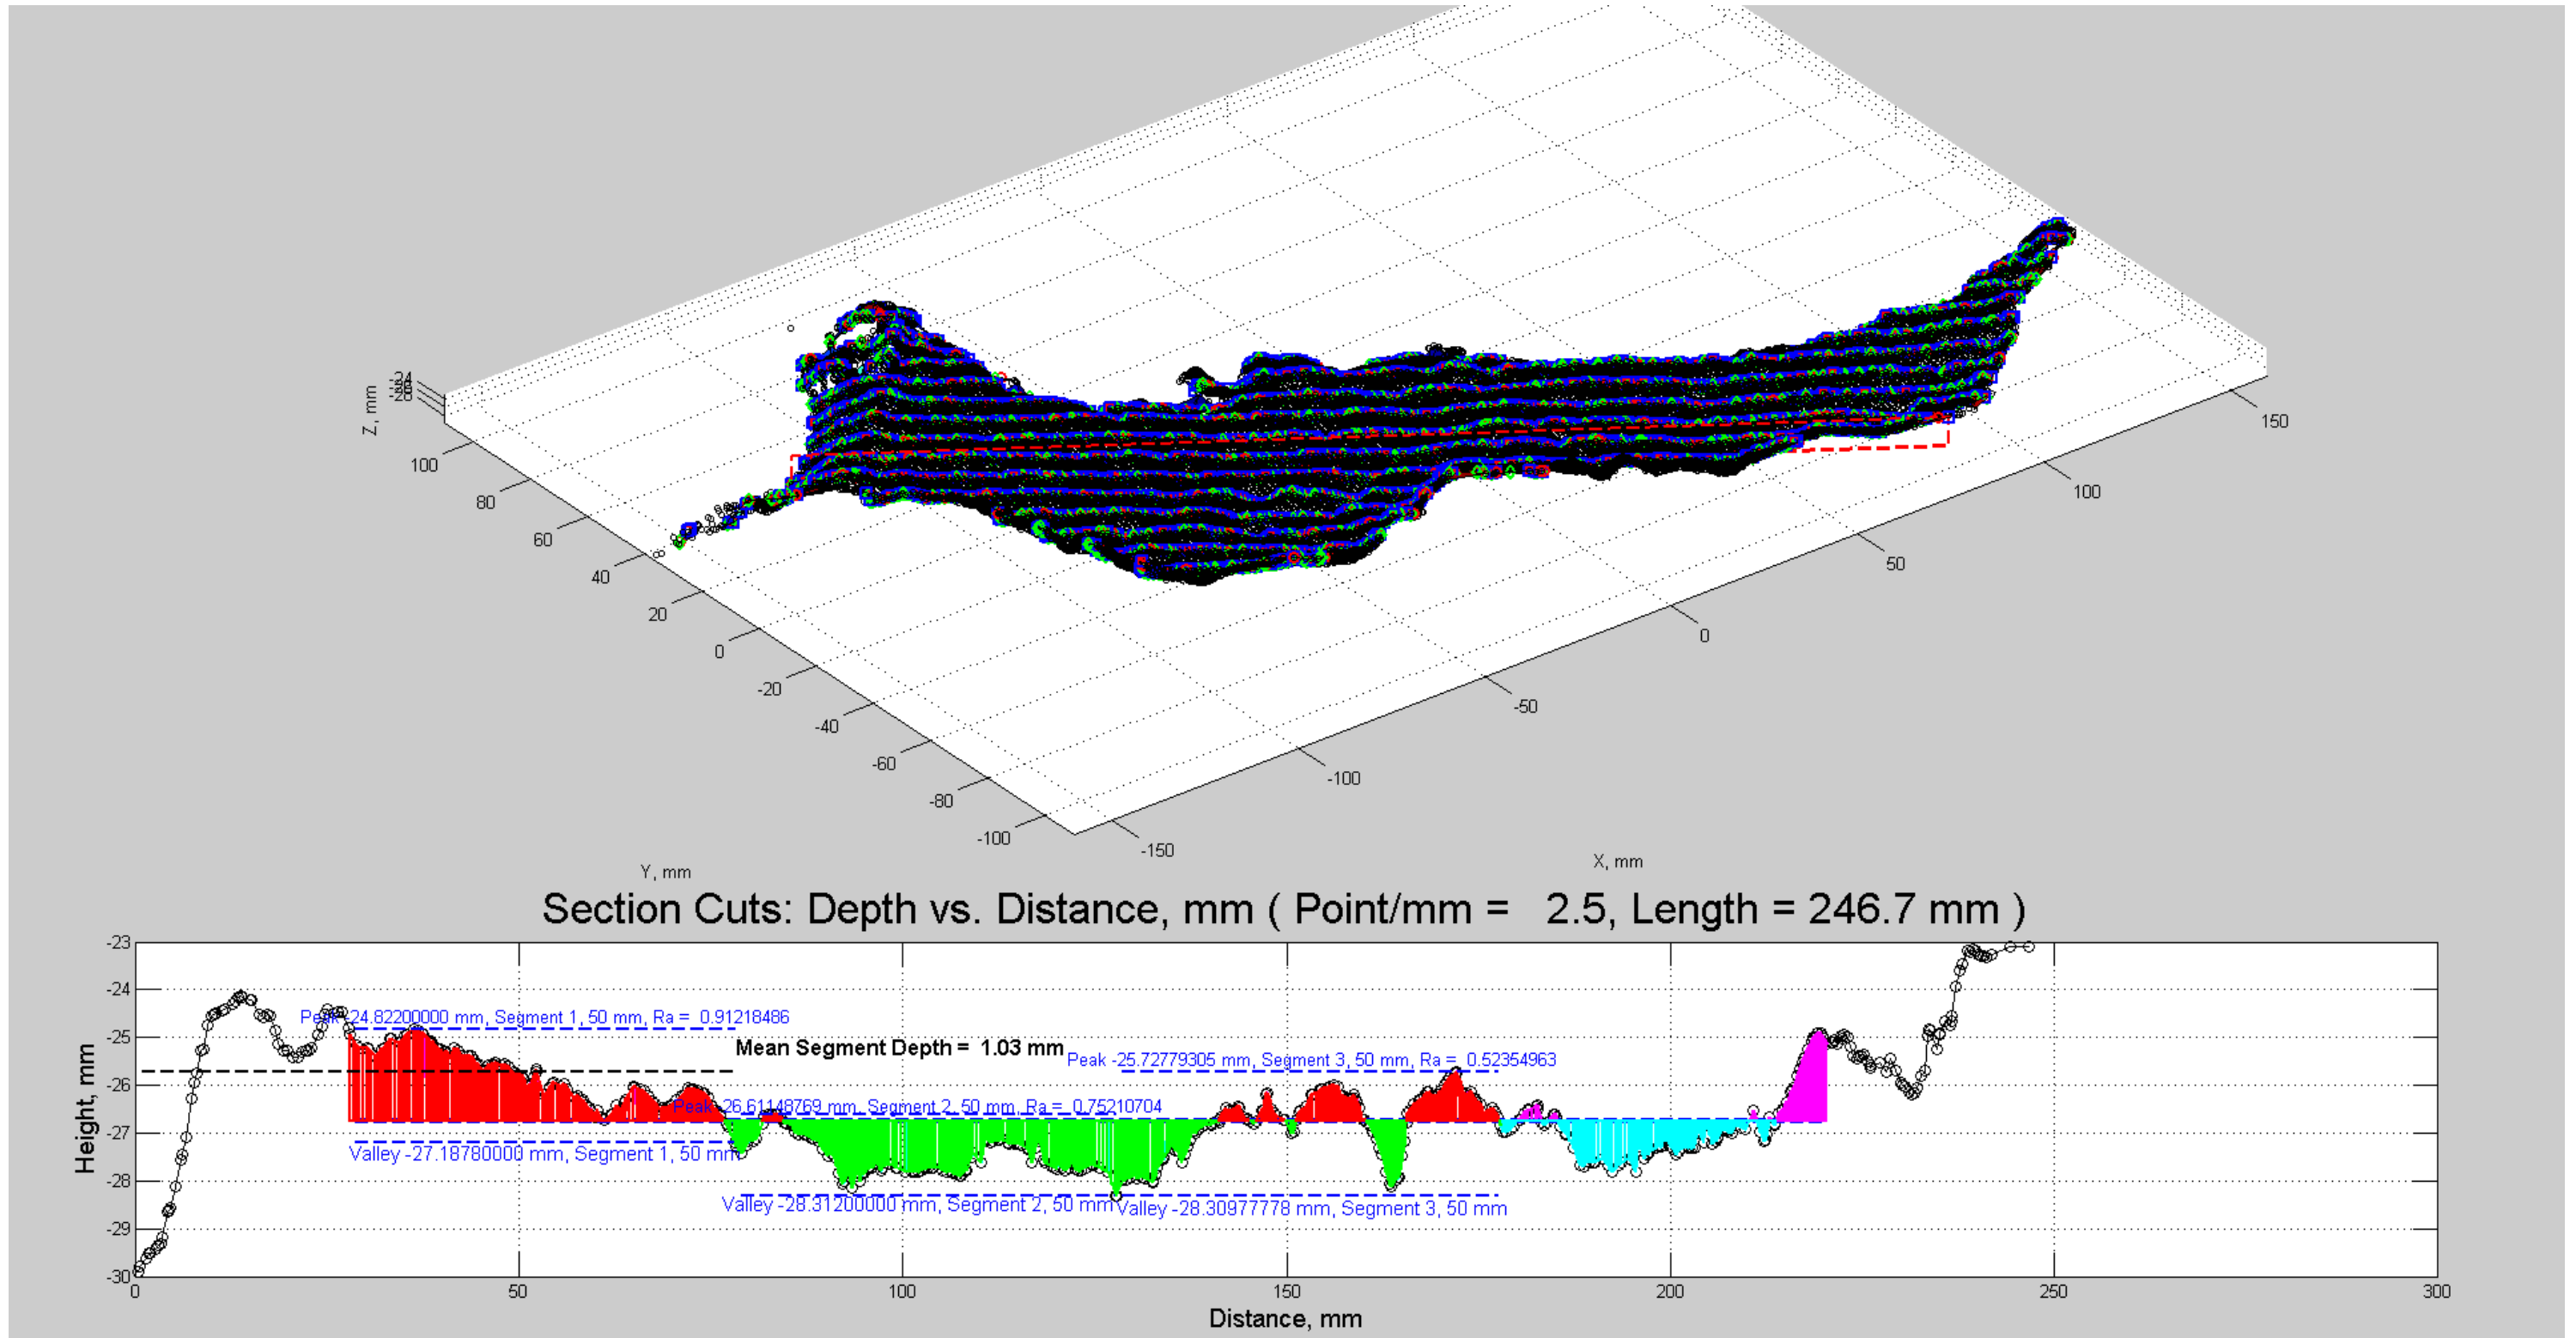
Figure 10: Exemplar section cut and MSD calculation #1 for Member 12.

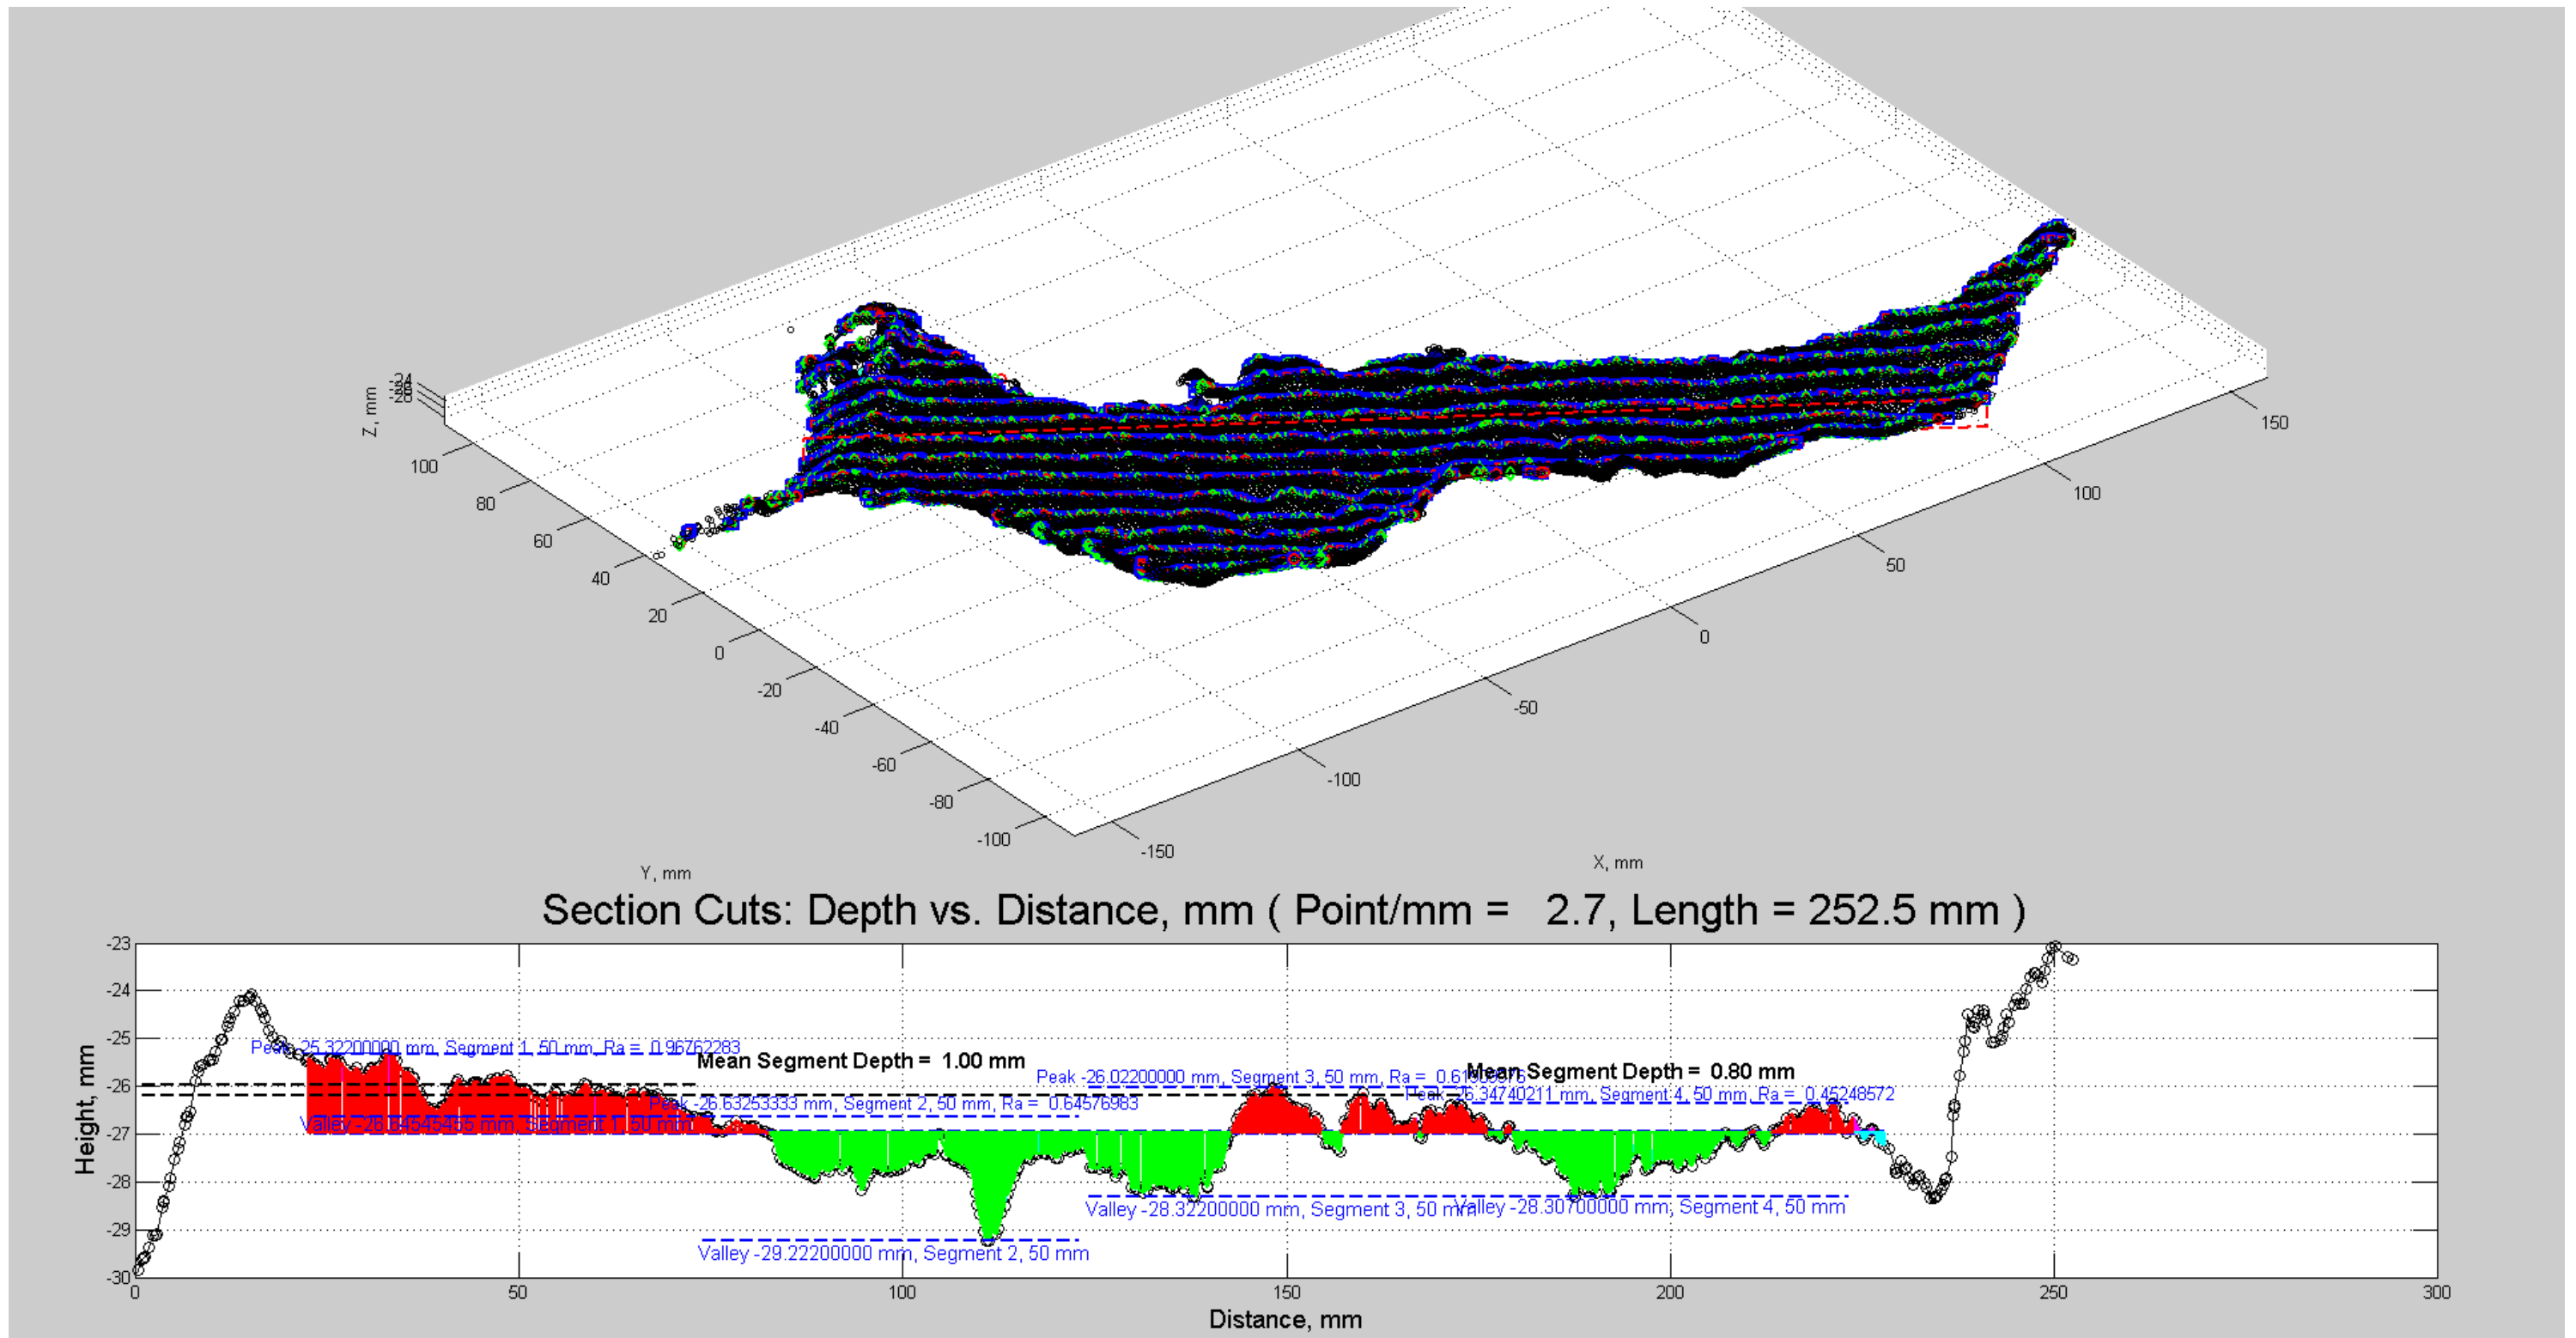
Figure 11: Exemplar section cut and MSD calculation #2 for Member 12.
