PARTY SUBMISSION

TO THE
NATIONAL TRANSPORTATION
SAFETY BOARD

FIU University City Prosperity Pedestrian Bridge
Construction Accident
Miami, Florida | March 15, 2018

Submitted by - Figg Bridge Engineers, Inc.

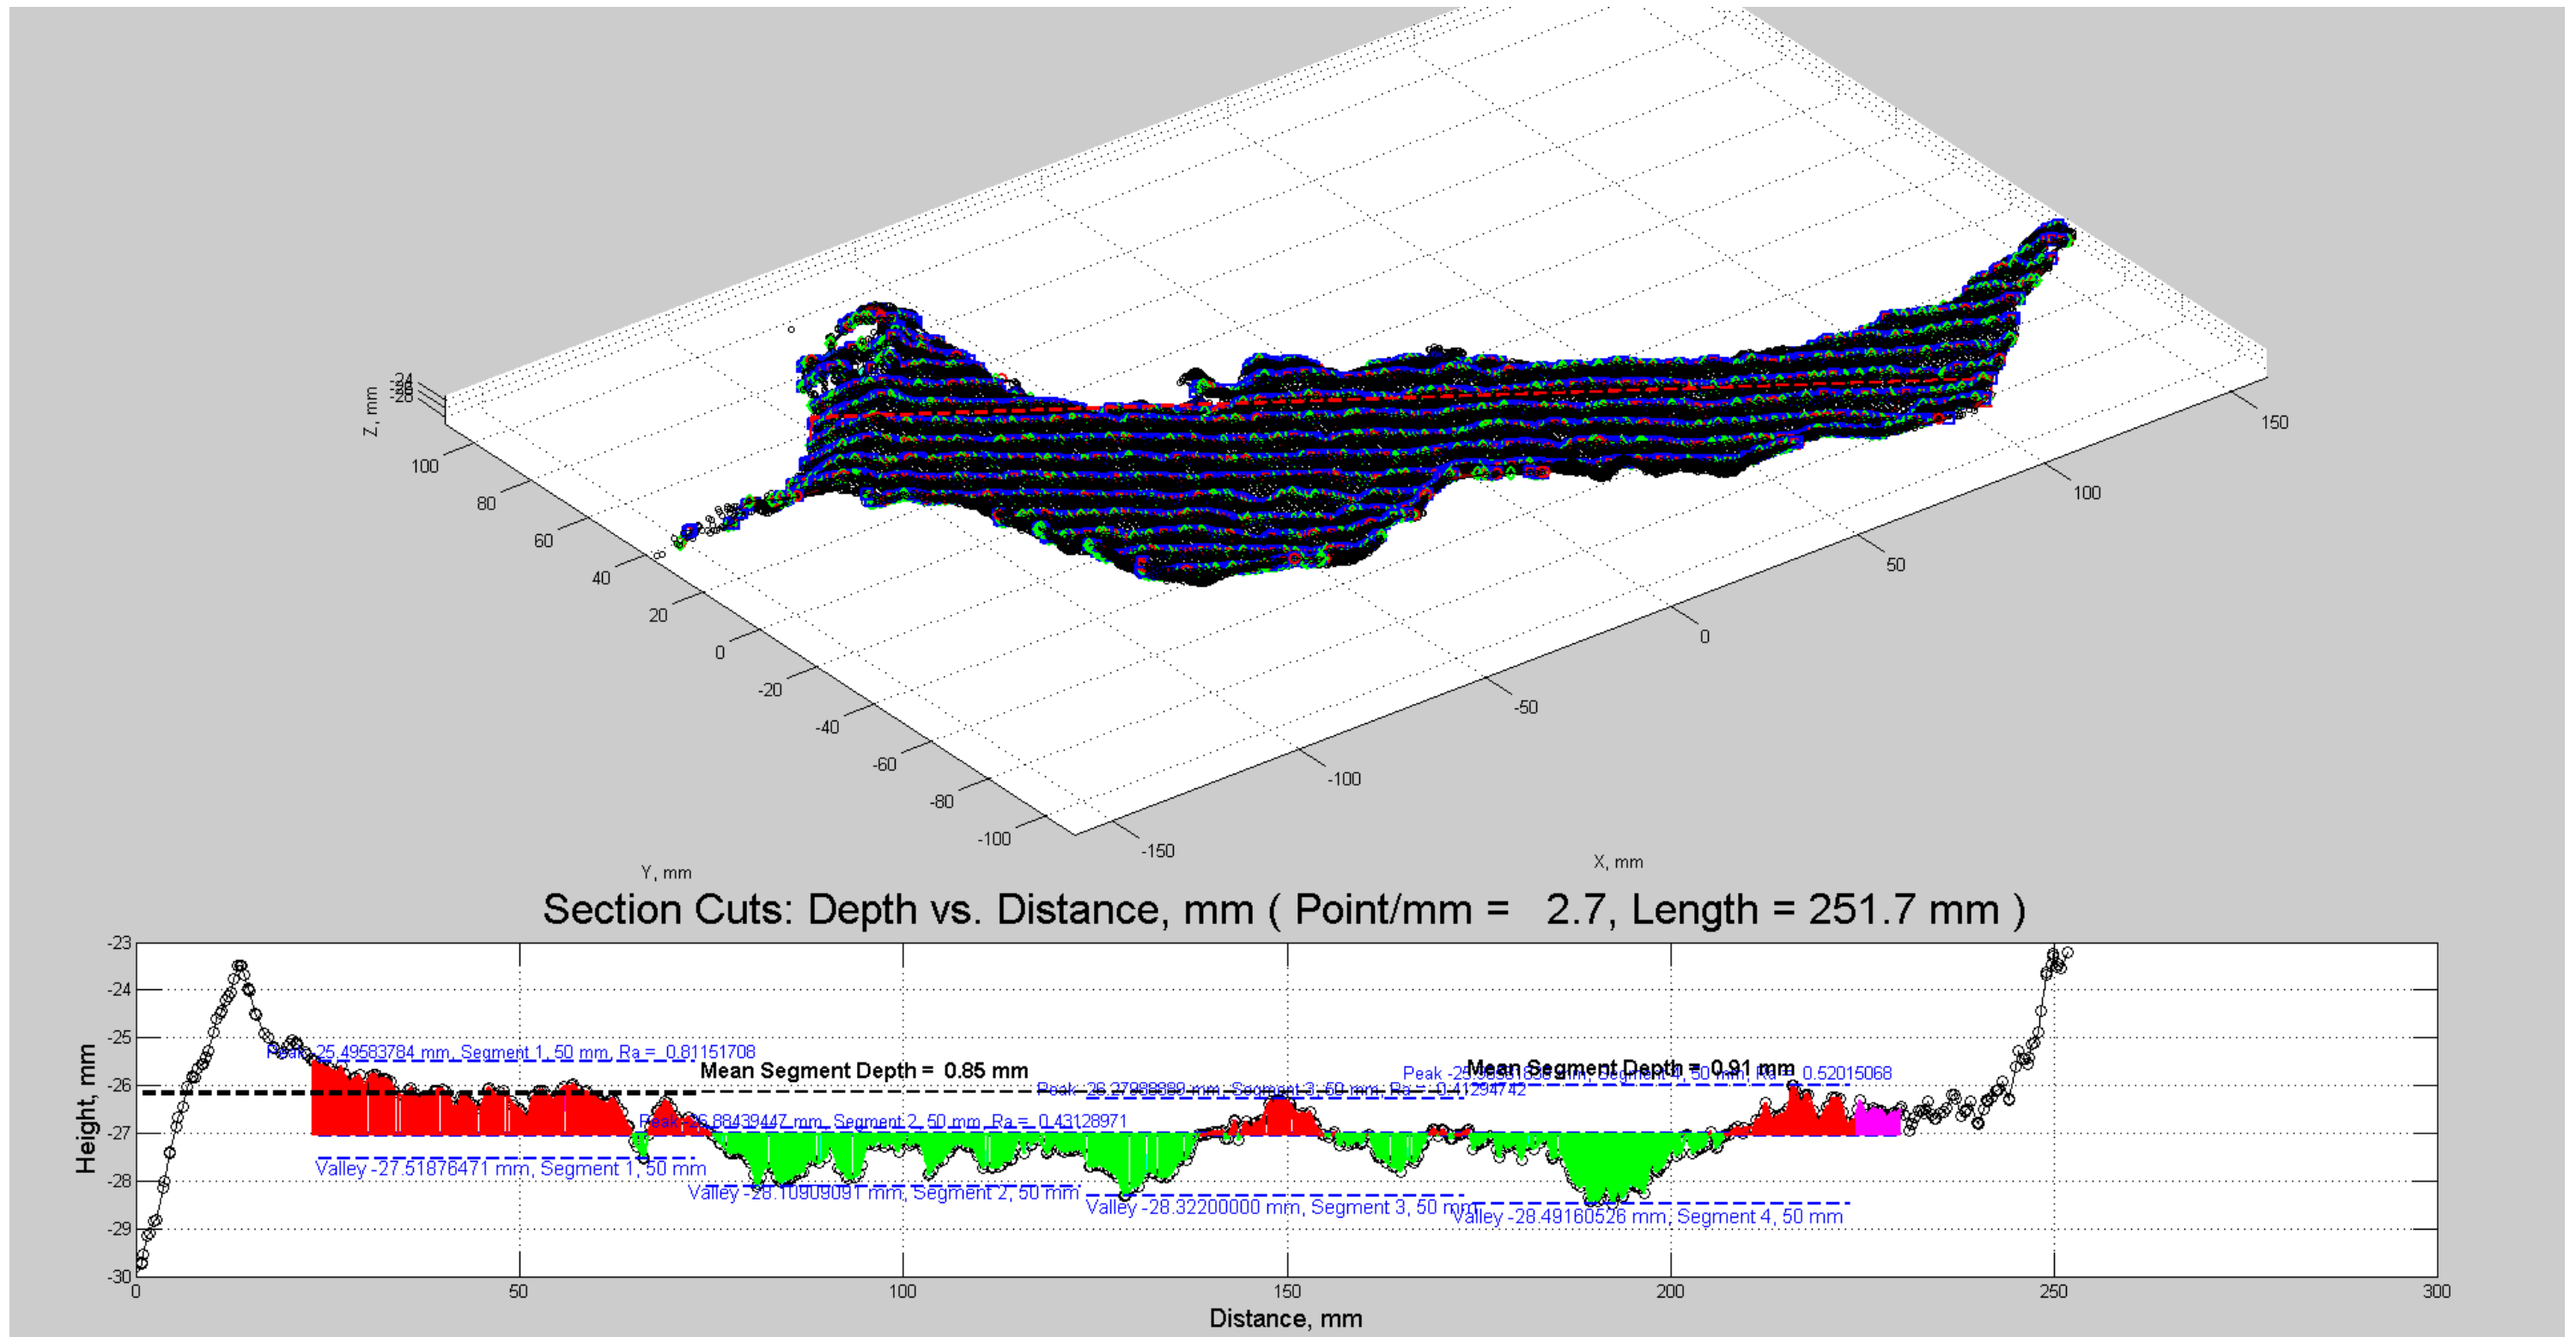
The average S_a for the flat areas evaluated on both the Member 11 pieces as well as the Member 12 surface was approximately 1 mm (0.04 in), as measured in the partially damaged post-collapse condition.

Figure 12: Exemplar section cut and MSD calculation #3 for Member 12.

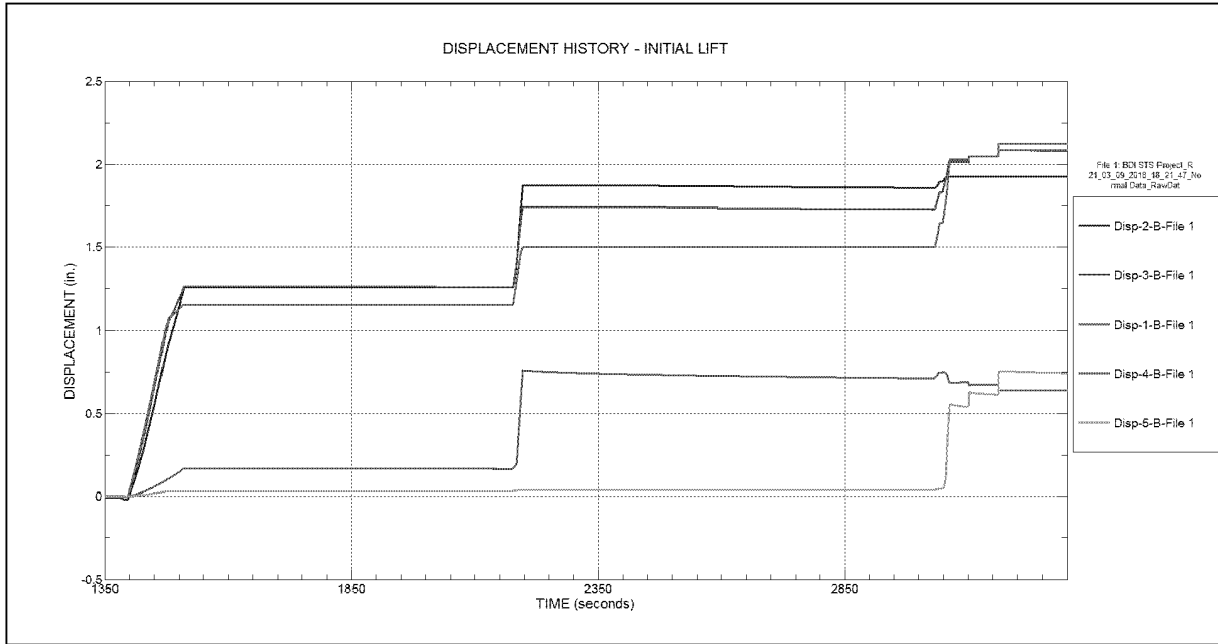
Following post processed calculations and examination of the deflected shapes, it was apparent that the measurement reference points at two locations moved. The intended static reference points for the string-pots at these locations (Location 2 & 4 centered between the lift trailers) was the ground, but the sensors were attached to the steel plates below the trailers. During the lift, the steel plates settled and deflected as the trailers acquired load during the lift and when they shed load during the span placement. Therefore, the reference point for these two measurement locations changed during the lift which resulted in amplified displacement measurements at the pick points. The effect on the deflected shape was that the relative deflections between the ends of the girder and the pick points were exaggerated and the relative displacement between the pick points and midspan were understated. However, the relative difference in displacement between the ends of the beams and midspan was accurate since these locations were measured independently of the lift point displacement measurements. This measurement discrepancy is apparent in the deflected shape diagrams in Figure 15, where the middle section of the girder is relatively flat, while the ends of the girder are very sloped. A more appropriate deflected shape is also provided in the plot using an assumed deformed shape and the three displacement sensors that had valid reference points (ends and midspan). Figure 16 contains the same deflection information during the span placement and it was apparent that the same issue of moving reference points was present, but it also shows that the girder deformation recorded during lifting and setting were nearly equal and opposite.

Figure 13 – Girder displacement measurements during lift

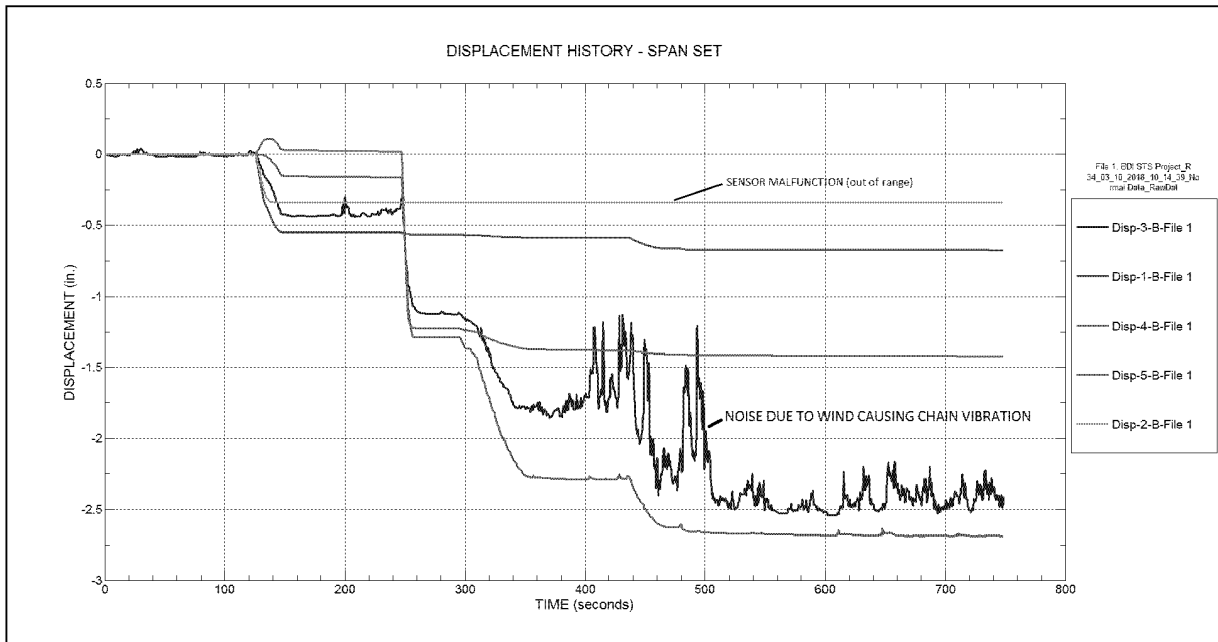
Figure 14 – Girder displacement measurements during span set

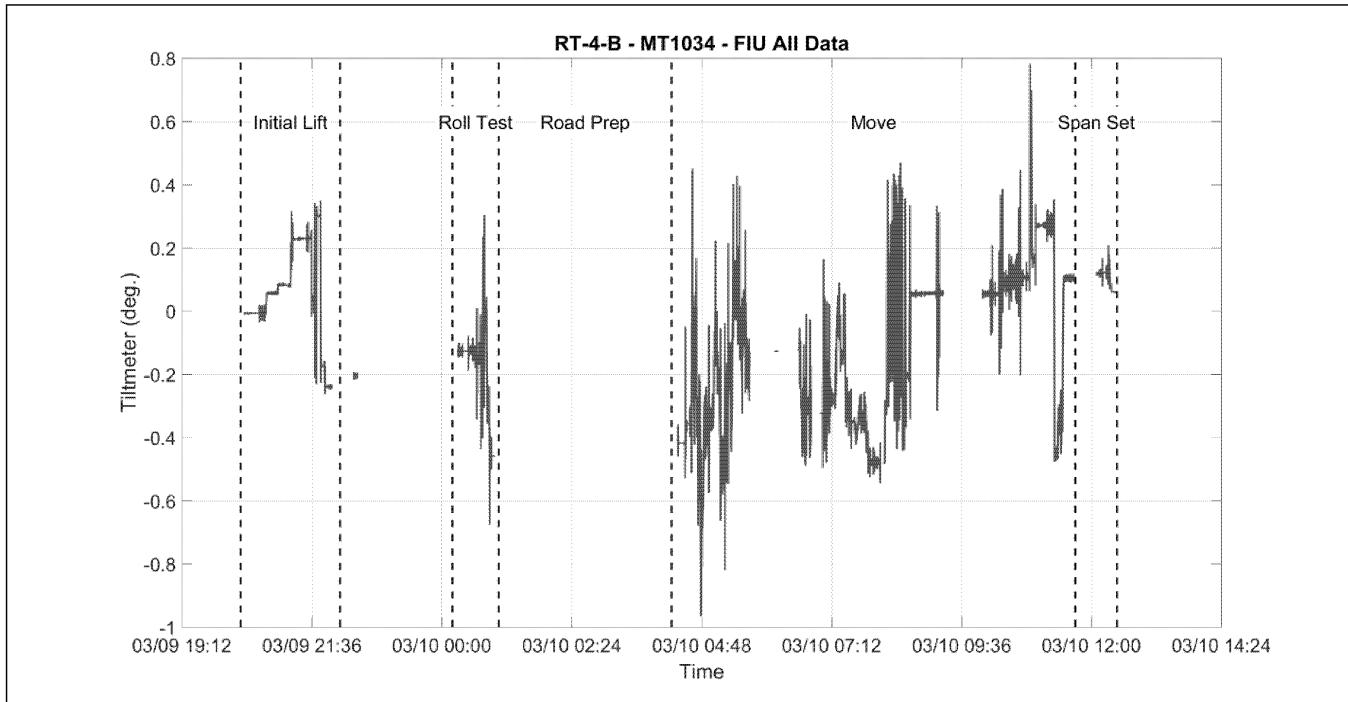
Figure 29 – Transverse rotation at Cross-Section 4 – Transverse Position B

Exhibit 7.2.2. Tilt meter readings at north support versus time
 (From BDI monitoring report Figure 29. Red lines and boxed note added by WJE.)

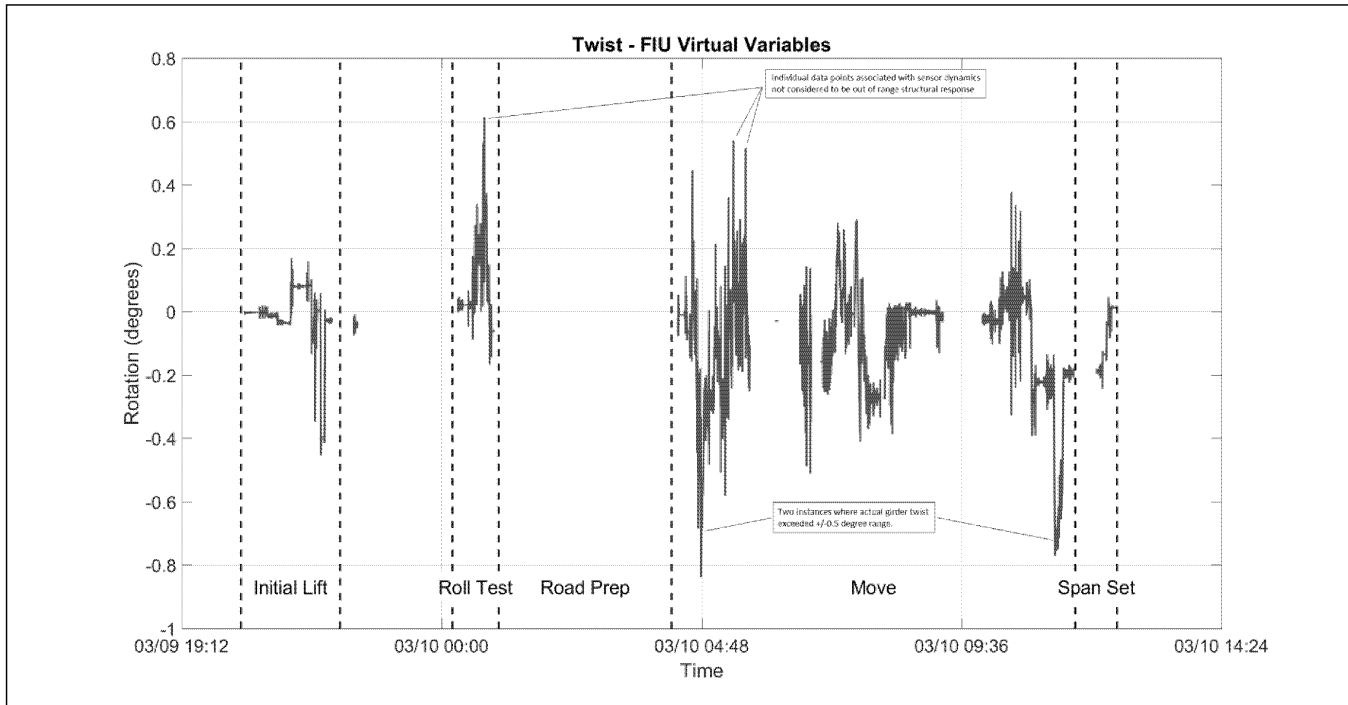
Figure 32 – Girder Twist – Difference in angle between Sections J & L

Figure 32 from BDI monitoring report on twist of the main span during the bridge move (as modified in WJE report). Twist limit of 0.5 degrees was substantially exceeded on multiple occasions.

BDI prepared a report on the results of the bridge monitoring during the span move approximately twenty days after the construction accident, dated April 4, 2018 (see Exhibit D). Figure 32 of the report is represented as the actual recorded instrumentation readings of twist between the SPMT supports.

Monitoring results indicated that the bridge span was lifted and transported within specification aside from two minor exceedances in girder twist. The girder move was halted immediately after each occurrence and BCR corrected the twist angle prior to resuming the transport. All measurements indicate the span was placed in a condition nearly identical to the state that it was originally in prior to lifting. Local and global monitoring results showed there was no significant change in measured structural response, indicating the stress state of the structure was similar when comparing prior to and after the move. The fact that strains returned to near original values (barring thermal effects) and the global deformations during load transfer were equal and opposite between lifting and setting were direct evidence that the structure remained in a linear-elastic state through the entire move. To illustrate the final state of the bridge span, data plots are provided in Appendix B for the final segment as the span was set on the bearings.
