NATIONAL TRANSPORTATION SAFETY BOARD

AIRFRAME EXAMINATION

WPR21LA082

Location: Warm Springs, Oregon
Date: January 9, 2021
Aircraft: Cessna 560, N3RB
NTSB IIC: Elliott Simpson

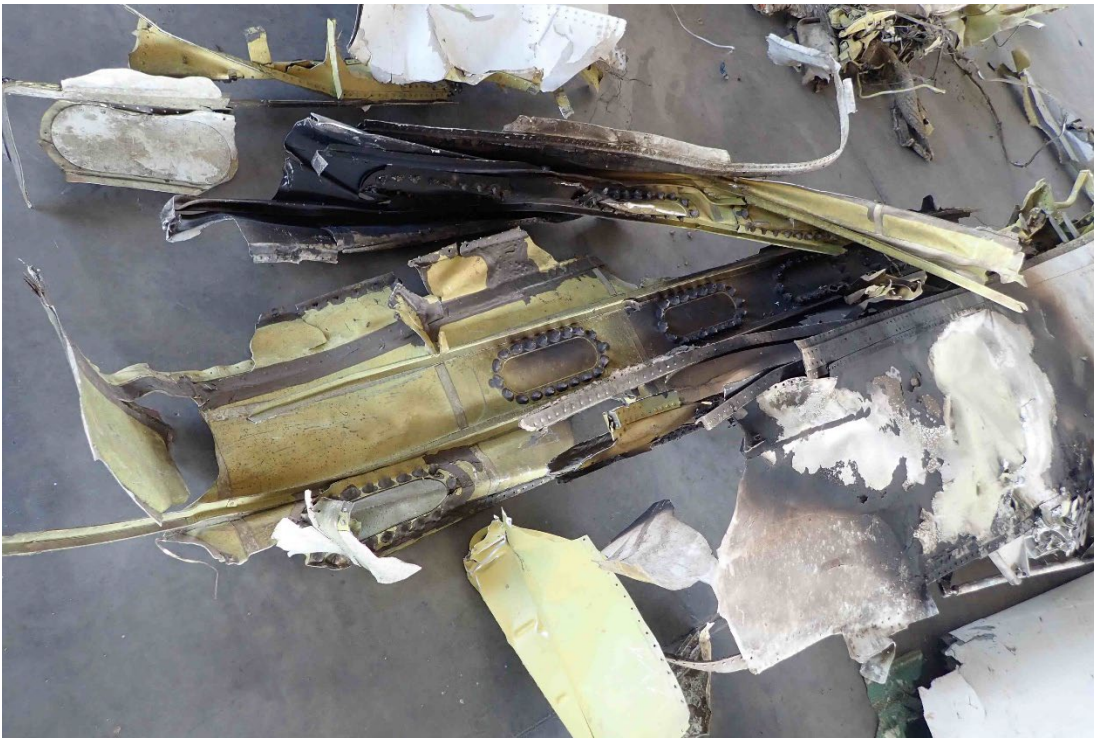
The left side of the wing center box section had detached from the cabin, was coated in mud, and remained attached to the forward and aft spar of the left wing (Photo 19). The left wing was bent about 10 ° aft at the root intersection (Photo 20). The leading edge of the entire wing (fuel tank) was crushed, had detached into long shards, and exhibited intermittent thermal damage (Photo 21). The wing tip and left position light had detached (Photo 22). The aileron and flap surfaces 1 and 2 had detached from the aft spar and were fragmented (Photo 23).

Photo 21 – Left wing leading edge fuel tank

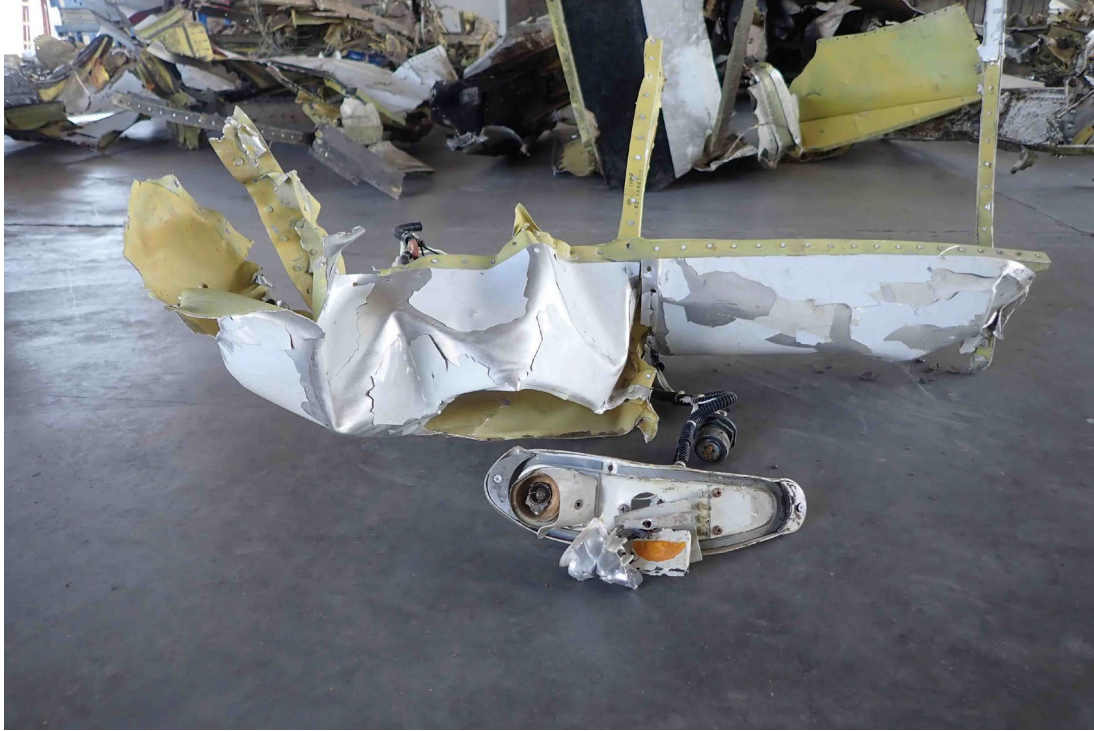
Photo 22 – Left wingtip position light

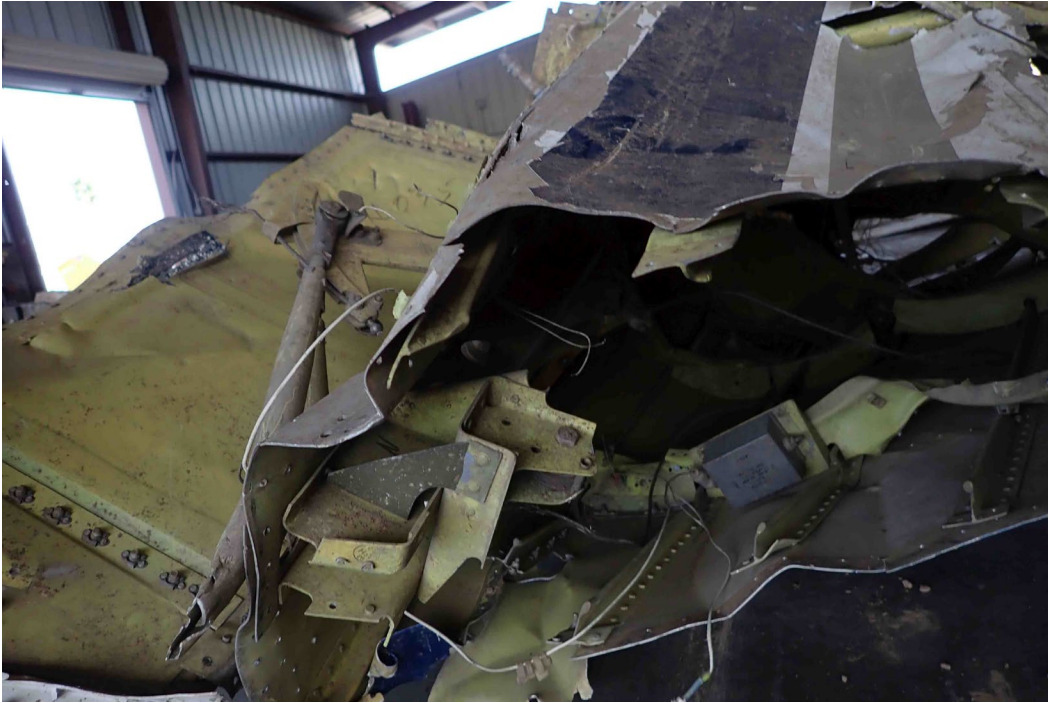
The elevator cable push-pull tube rod bearing remained attached to the elevator control assembly within the cockpit (Photo 36). The corresponding elevator bellcrank remained within the airframe, and both of its elevator cable terminations remained attached. Similarly the cable ends were in place at the aft elevator bellcrank, along with the push-pull tube ends for the control surfaces (Photo 38). The elevator control horns remained attached. The push-pull tube end for the right horn was attached, the left control had broken off (Photo 39, 40).

Photo 38 – Elevator aft bellcrank
