# NATIONAL TRANSPORTATION SAFETY BOARD

# **AIRFRAME EXAMINATION**

# WPR19FA115

Location:	Fullerton, California
Date:	April 18, 2019.
Aircraft:	Beech B60, N65MY, SN P-314
NTSB IIC:	Eliott Simpson

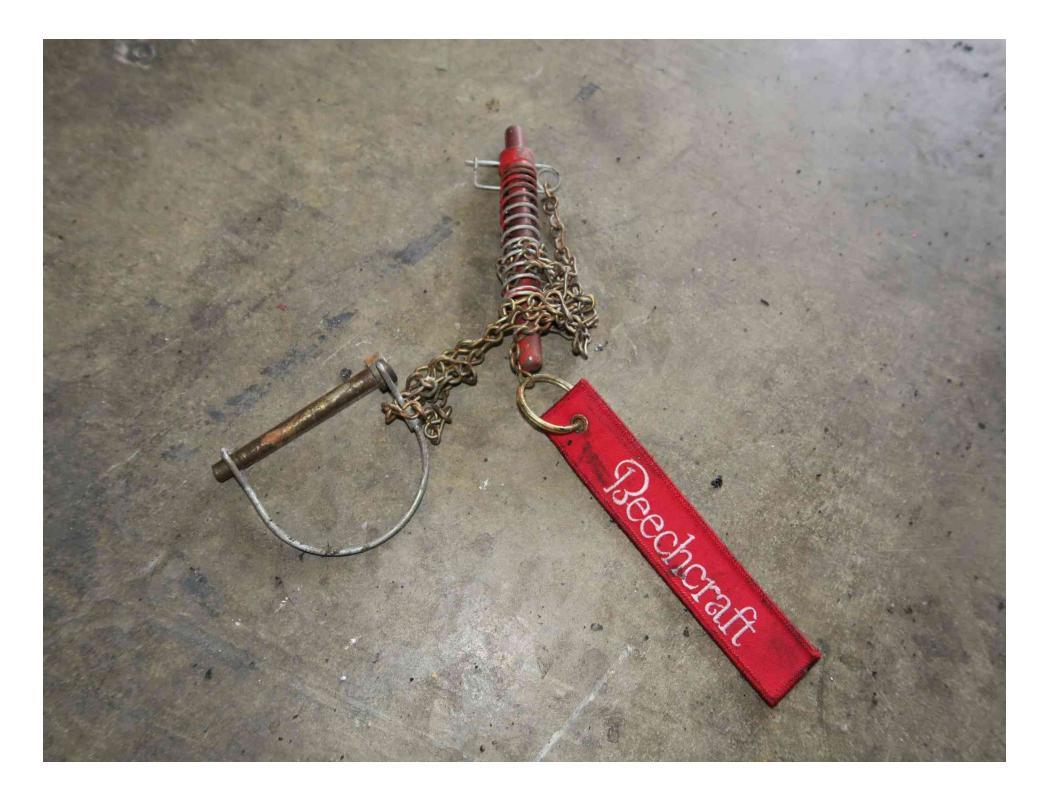
Photo 3 – Control Lock

The cockpit instruments and circuit breakers were all fire damaged, precluding an accurate assessment of their readings and positions, and the lower left section of the panel along with the left control yoke was detached and folded down into the foot well (Photo 2). The throttle and propeller engine controls were all in the full forward position, the right engine mixture control was in the full forward position, the left control was about 1.5 inches aft of full forward (Photo 2). At the accident site, the left fuel selector handle was in the ON position and the right handle was in the "CROSSFEED" position, however the right handle felt loose and did not appear to be connected to its control cable. Further examination of the right fuel selector handle revealed the fuel selector cable had been pulled from the handle assembly. A flight control lock (Photo 3) was found resting in the aft cabin, against the carpeted back face of the main wing spar. The lock did not appear to have sustained any damage, and its chain was found wrapped around the locking pins. Subsequent examination revealed that this was not the control lock for the accident airplane type. The needle for the pitch trim indicator was at the edge of the green scale, corresponding to about the 5 ° nose-up position.

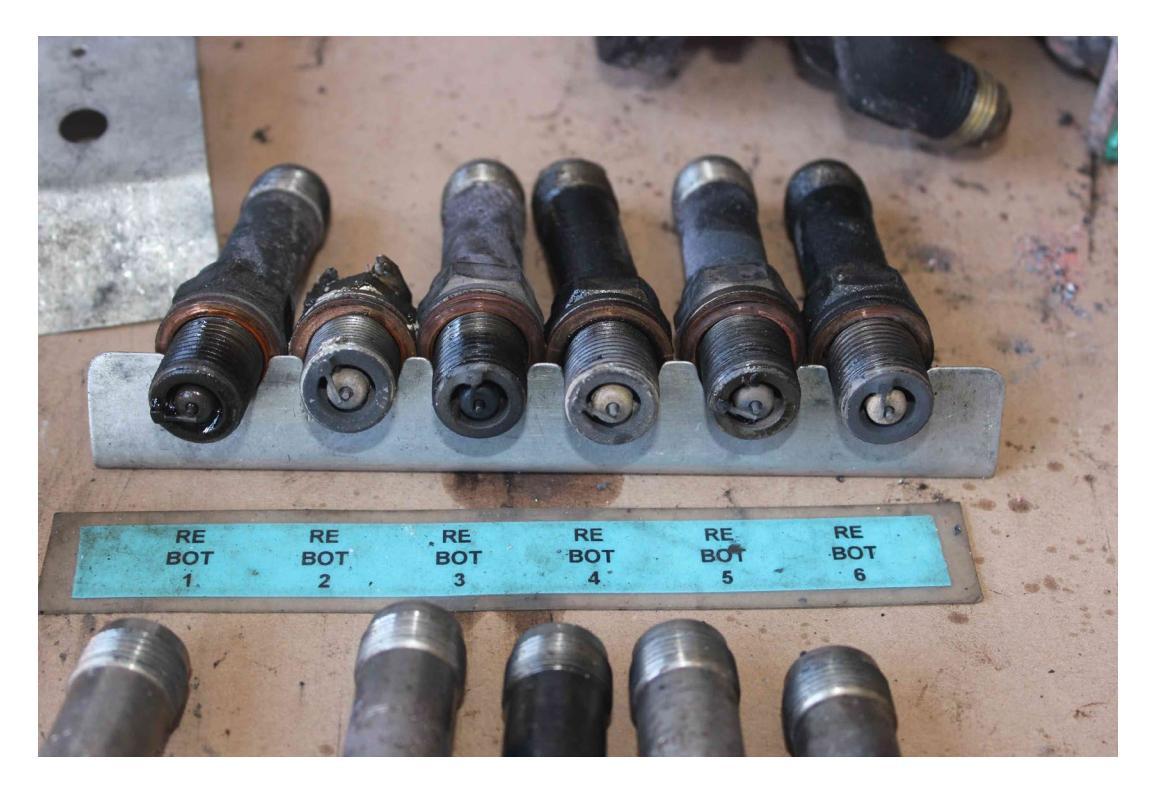
Photo 23 - Right Engine Bottom Spark Plugs

The top and bottom spark plugs were removed. All were of the fine wire type, and did not exhibit any evidence of catastrophic failure. The electrodes and insulators for plugs No 1, 2, 4, 5 and 6 were coated in light tan deposits (Photo 22). Similar coloration was observed on the bottom plugs for No 2, 4, 5, and 6 cylinders (Photo 23). Plug No 1 was coated in oil, and plug No 3 exhibited dark sooting. All plugs had a heat range of 32, and all exhibited normal wear signatures when compared to the Champion AV-27 Check-A-Plug chart.
