National Transportation Safety Board

ERA21FA135

WRECKAGE EXAMINATION SUMMARY

Location: Mayfield, Kentucky
Date: February 22, 2021
Time: 1756 CST
Airplane: Henry D Babenco / Vans RV-7A, N383DB

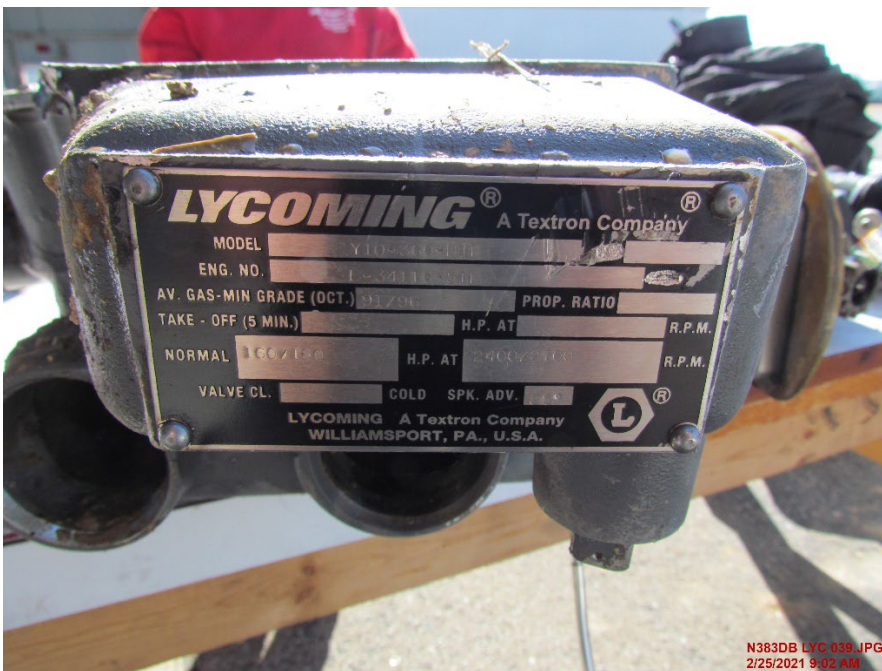
Figure 15 - Engine data plate (Courtesy of Lycoming)

The engine was manufactured as new by Lycoming on February 21, 2008.

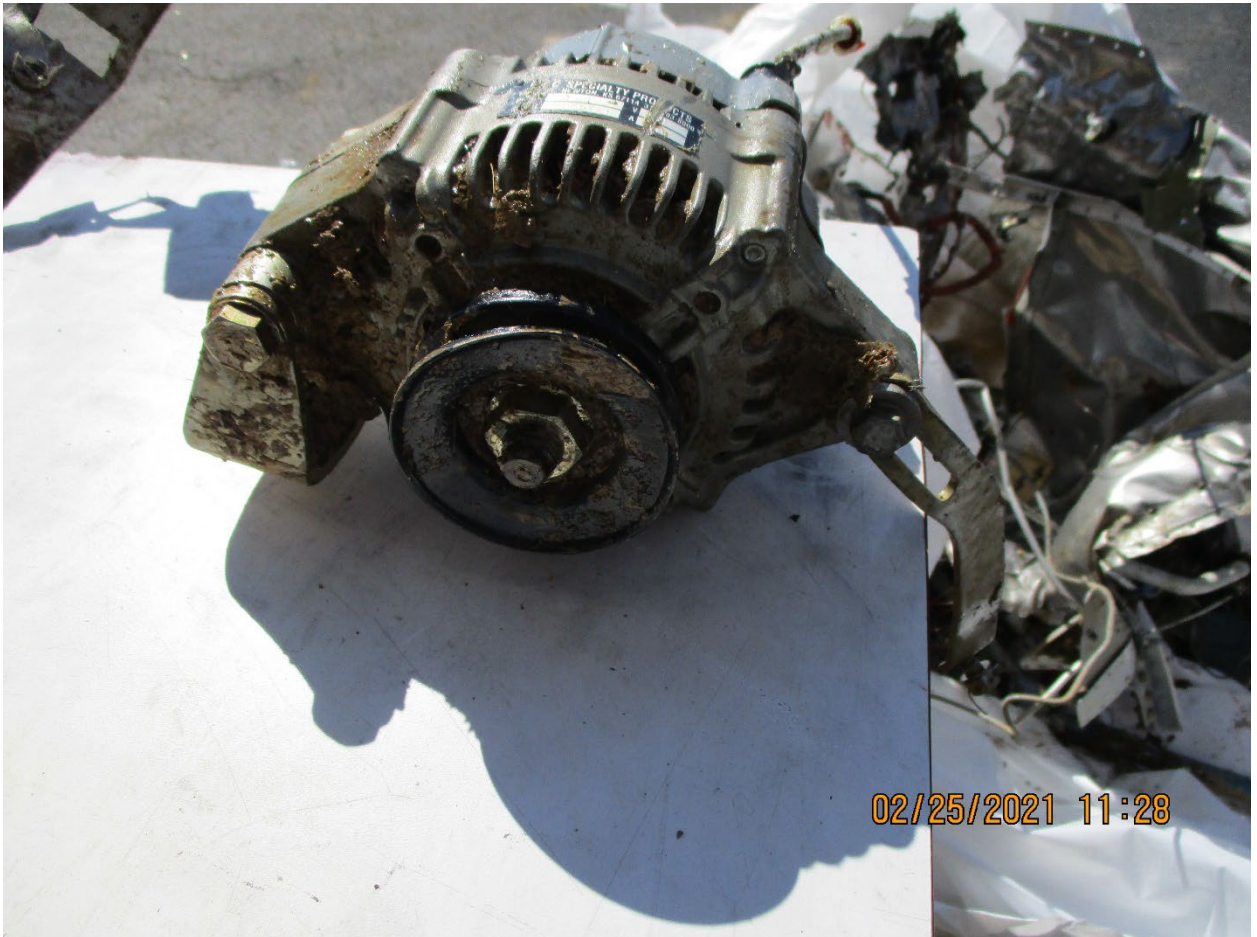
Figure 26 - Alternator, removed from engine (Courtesy of FAA)

The alternator remained attached to the engine.
