**NATIONAL TRANSPORTATION SAFETY BOARD
Office of Research and Engineering
Vehicle Recorder Division
Washington, D.C.**

SPECIALIST'S FACTUAL REPORT OF INVESTIGATION

ERA21LA036

Cockpit Voice Recorder

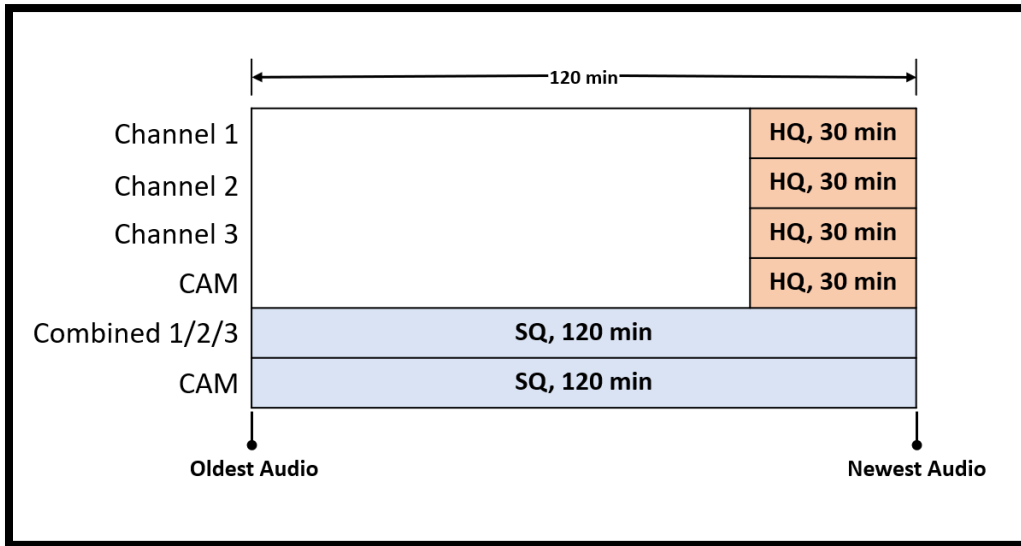
This model CVR, an L-3/Fairchild FA2100-1020, is a solid-state CVR that records a minimum of 120 minutes of digital audio. Specifically, it contains a standard quality (SQ) 2-channel recording of the last 120 minutes of operation and separately contains a high quality (HQ) 4-channel recording of the last 30 minutes of operation. The SQ 120-minute portion of the recording is comprised of one channel that combines three audio panel sources and a second channel that contains the cockpit area microphone (CAM) source. The HQ 30-minute portion of the recording contains 4 channels of audio information: one channel for each flight crew, one channel for a cockpit observer, and

one channel for the CAM. A visual representation of this recording structure is shown in Figure 1.

Figure 1. Event CVR recording structure.
