Update Service Order at 3527 DURANGO DR , DALLAS , TX

2/22/18 Leak Survey Map

AEC-NTSB-000280

LEAK REPORT

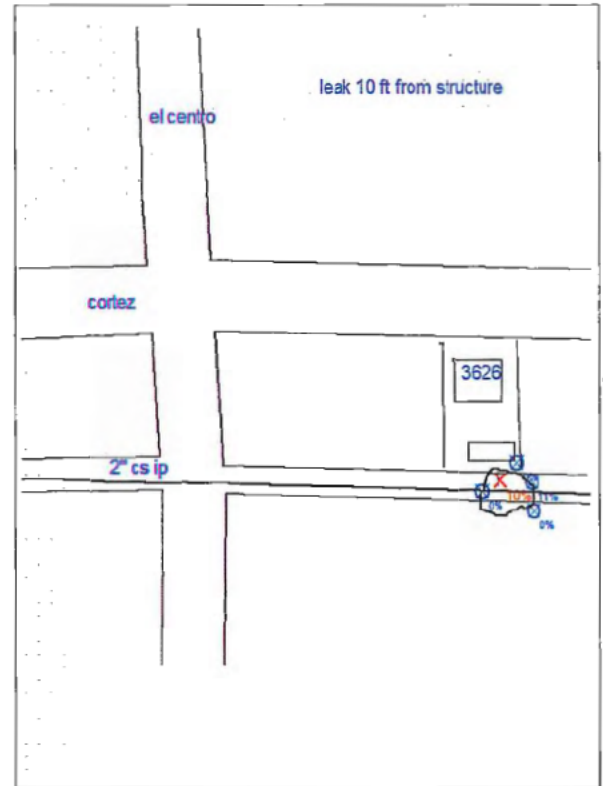
Leak Repaired On: Service
 Type: Fitting
 Material: Coated Steel
 Pipe squeezed: EFC:
 Pipe Size: 1.00
 Pressure: I.P. 1-60 PSIG
 Cause of Leak: Ground Movement
 Station Plus:

External Corrosion: None
 External Pits: None
 External Coating: Good
 Min Pit Depth:
 Min Length of Pit:
 Internal Corrosion: No Inspect
 Technician: Camacho, Miguel-CAN

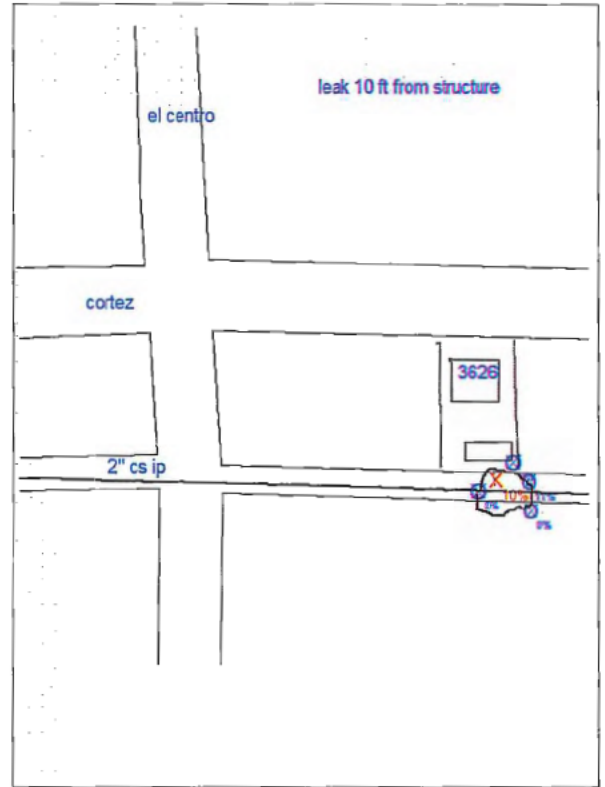
Leak Repaired On: Service
 Type: Fitting
 Material: Coated Steel
 Pipe squeezed: EFC:
 Pipe Size: 1.00
 Pressure: I.P. 1-60 PSIG
 Cause of Leak: Ground Movement
 Station Plus:

External Corrosion: None
 External Pits: None
 External Coating: Good
 Min Pit Depth:
 Min Length of Pit:
 Internal Corrosion: No Inspect
 Technician: Camacho, Miguel-CAN
