National Transportation Safety Board

Group Chairman's Factual Report

Engineering Group

Conception

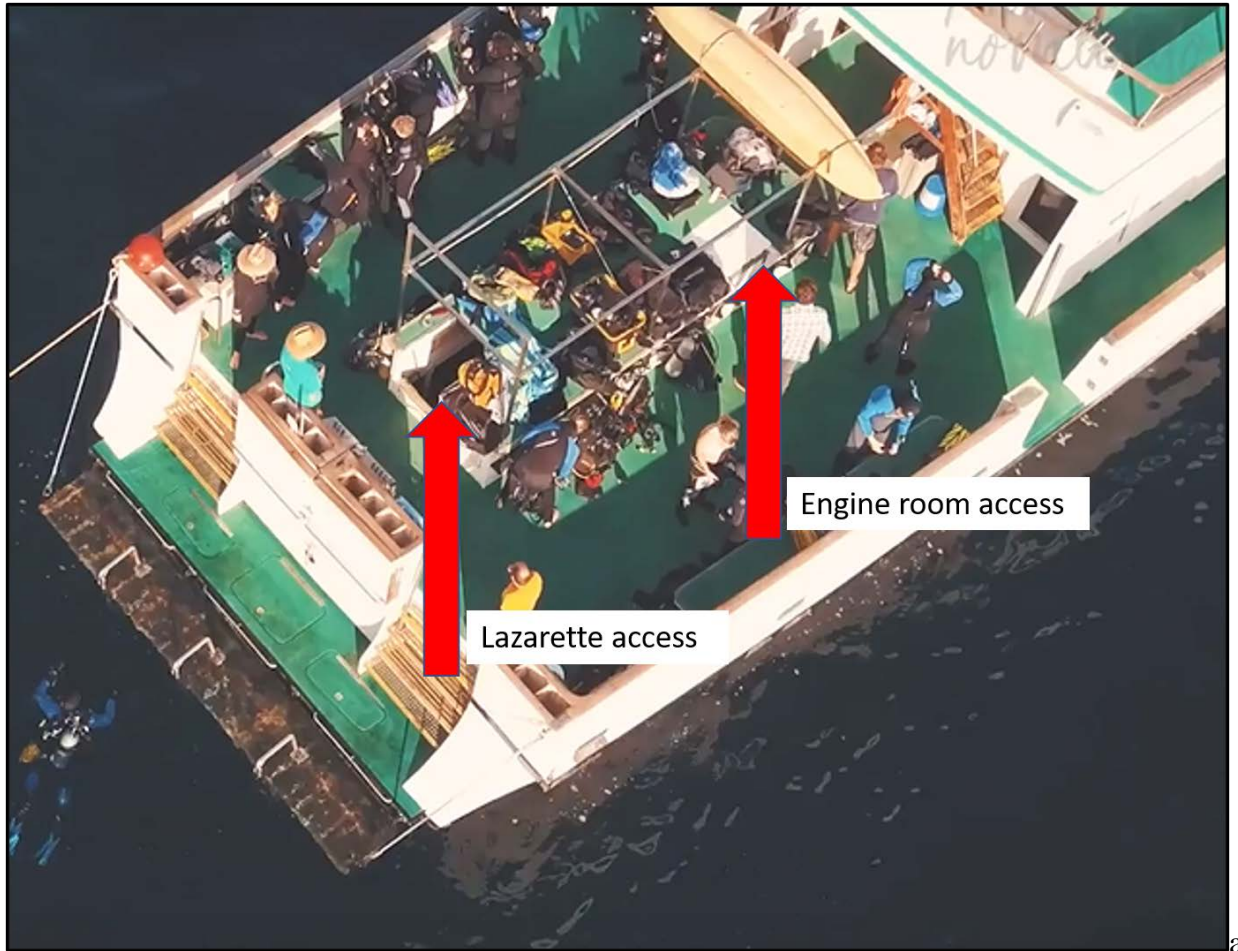
7 The lazarette was the aftermost compartment on the vessel and was located directly aft of
8 the engine room. The two spaces were separated by a wooden, watertight bulkhead. The lazarette
9 could be accessed through a single elevated hatch located on the aft main deck behind the hatch for
10 the engine room. Contained in the lazarette was a chest freezer, the hydraulic cylinders and hoses
11 for the steering system, the main engine’s wet exhaust pipes, a conventional clothes dryer, the stern
12 winch hydraulic motor/pump and oil reservoir, and a nitrox compressor unit.

2 **Figure 1. Aft main deck of the *Conception* during a previous voyage. Red arrows indicate access**
3 **hatches to the engine room and lazarette (Source: Profundo no Mundo, YouTube).**

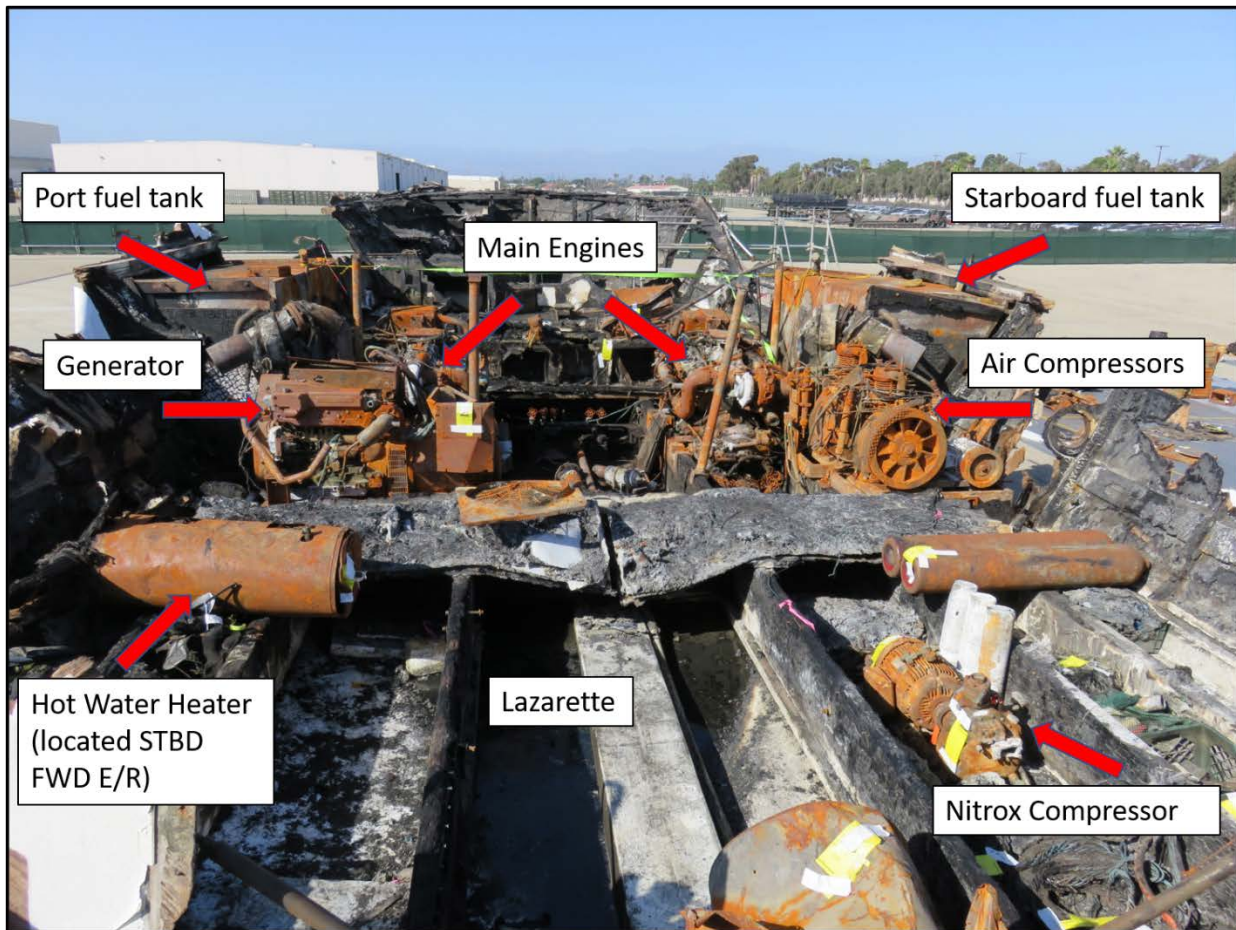
5
6 **Figure 2. The salvaged hull of the *Conception*, looking from aft to forward, with recovered engine room
7 and lazarette equipment reinstalled.**
