## NATIONAL TRANSPORTATION SAFETY BOARD

Investigator in Charge Factual Report

# Sinking of Fishing Vessel *Emmy Rose*

DCA21FM007

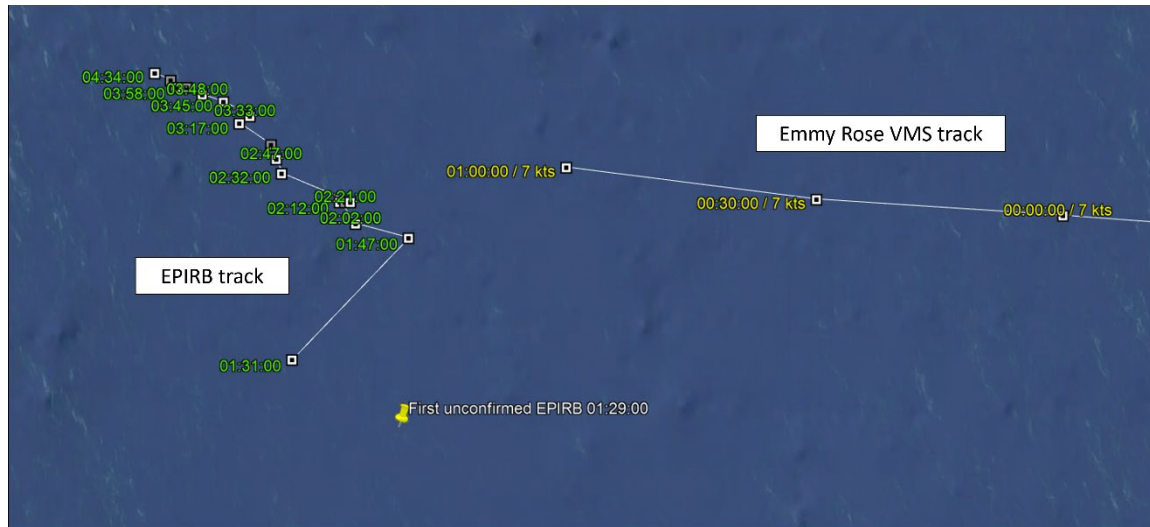
3 At 0129 on November 23, 2020, the US Coast Guard Rescue Coordination Center  
4 (RCC) received an alert from the emergency 406-MHz emergency position indicating  
5 radio beacon (EPIRB) registered to the *Emmy Rose*. This initial unlocated position was  
6 about 2.4 nautical miles southwest from the 0100 VMS position of the *Emmy Rose*. At  
7 0131, a second EPIRB alert was received with a unconfirmed position, and at 0147, a  
8 confirmed alert was received with an updated position. There were no VHF radio  
9 transmissions received from the *Emmy Rose*. The last outgoing satellite phone call was  
10 at 1848, about 6 hours before the EPIRB triggered the first alert.

1  
2 **Figure 5.** *Emmy Rose* final VNS track and EPIRB positions. (Source: Google Earth, annotated  
3 by NTSB)

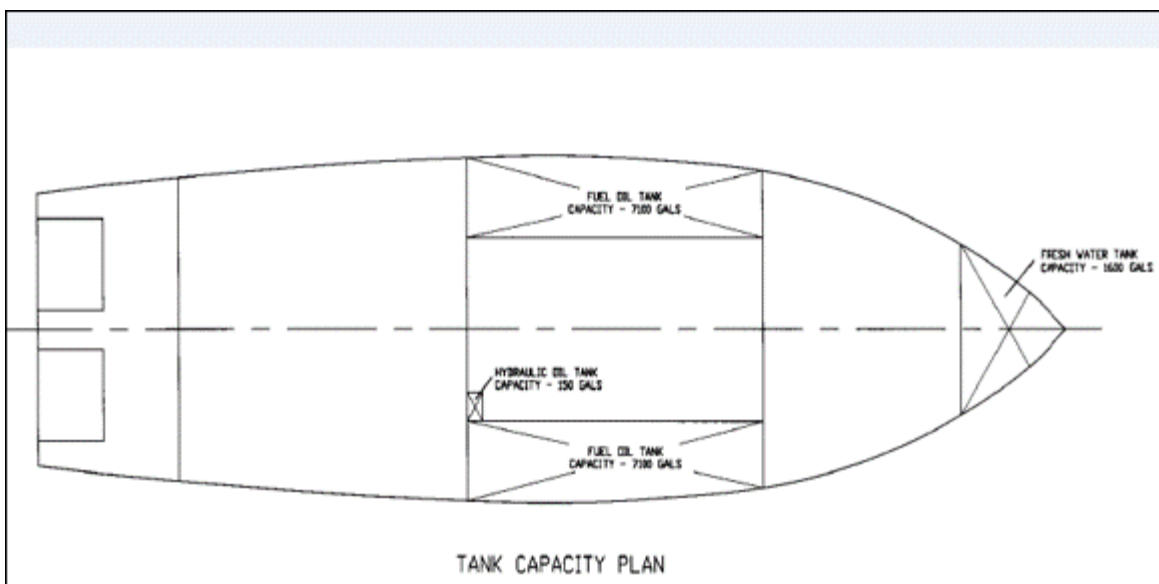
3 When the crew loaded fuel, the two fuel tanks would be filled to about 75%  
4 capacity (11,250 gallons). The *Emmy Rose* loaded 4,297 gallons of fuel on November  
5 12, 2020 and then had been underway for about 7 days before the casualty. The  
6 amount of fuel aboard the *Emmy Rose* at the time of the sinking is unknown;  
7 however, it is estimated there were about 6,000 gallons remaining aboard the vessel.

8  
9 **Figure 16.** *Emmy Rose* tank capacity plan. (Source: Marine Safety Consultants)

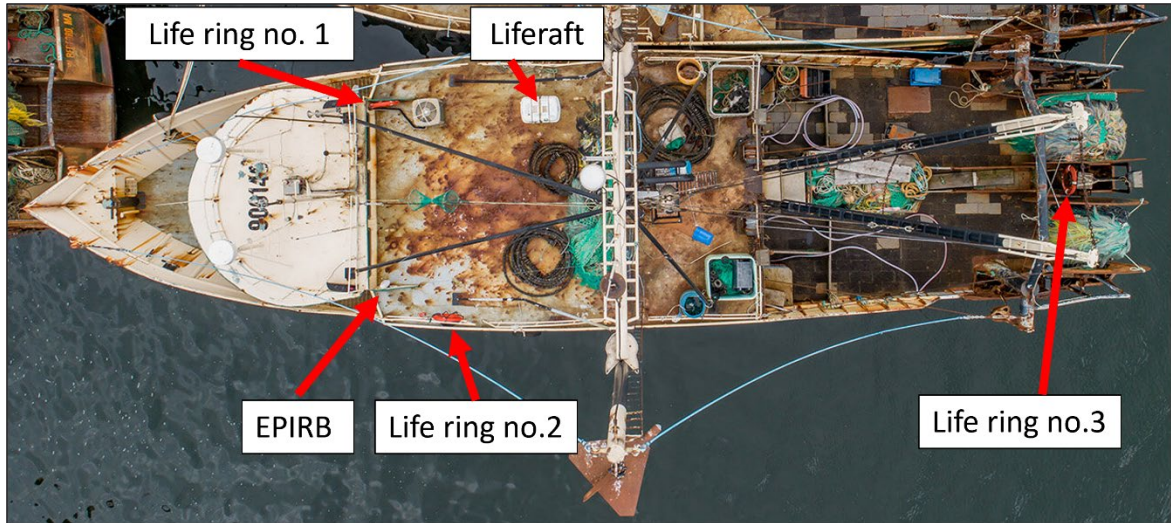
4 **Figure 18.** *Emmy Rose* lifesaving appliances. (Source: Atlantic Brokerage House)

4 Investigators inspected the EPIRB and liferaft, which were recovered by SAR  
5 crews, and determined that both pieces of equipment had functioned properly and  
6 had been deployed hydrostatically, meaning that no crewmember manually  
7 deployed either device.

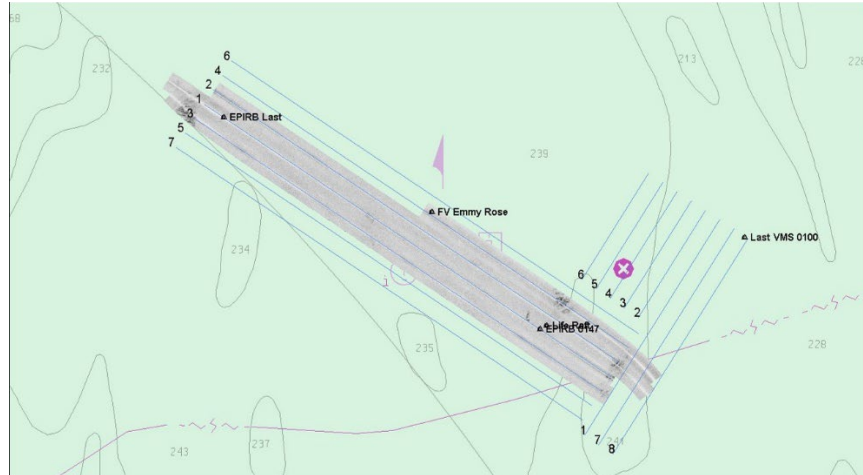
2 **Figure 20.** Side scan sonar sea floor search patterns for *Emmy Rose*. (Source: MIND

9 The side scan survey report stated that the *Emmy Rose* was found to be “sitting  
10 upright on the seafloor with the bow oriented at 135° (southeast direction) and both  
11 outriggers fully deployed.” The side scan images did not detect any debris field on the  
12 seafloor near to the sunken vessel. Additionally, the report stated that there was “no  
13 visible damage to *Emmy Rose* evident as the mast, wire rigging, and superstructure  
14 features all appeared to be intact. The ladders on both port and starboard outriggers  
15 were visible in the sonar imagery.” Sonar images indicated that both paravanes were  
16 deployed from the outriggers. Based on interpretation of imagery, MIND Technologies

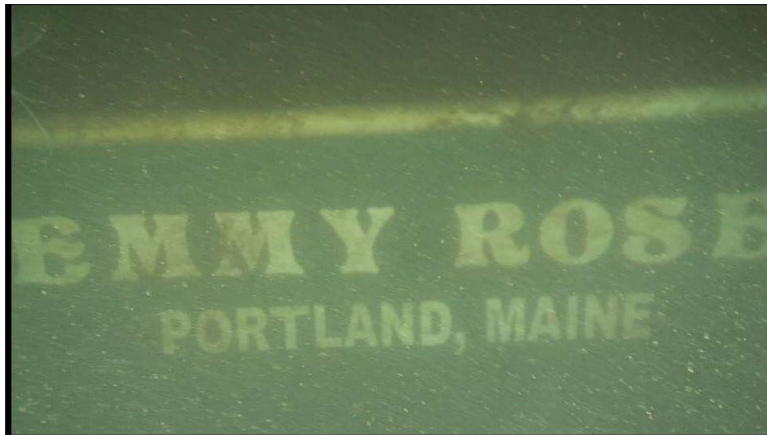
11 **Figure 22.** ROV image of *Emmy Rose* name on starboard side. (Source: WHOI)

12 The ROV could not access the hull under the outriggers, aft working deck,  
13 starboard outrigger, stern ramps, or stern deck hatches due to the risk of entanglement  
14 and maneuvering in the currents. The undersea currents had caused sediment to build  
15 up on the starboard side and at the stern of the vessel and prevented inspection below  
16 the rub rail. The vessel's position on the seafloor and the sediment buildup prevented

1 an inspection of the vessel's rudder and propeller. The two fishing nets were found  
2 stowed on the net reels and covered the storm gates, preventing the ROV from  
3 assessing the position of the gates. On the port side of the vessel aft working deck, the  
4 trawl door was found to be out of position from the typical stowage position above the  
5 bulwarks, perpendicular to the length of the vessel, and its leading edge extending  
6 over the bulwarks. The starboard trawl door was stowed inside the bulwarks. It is  
7 unknown if the portside trawl door was intentionally set on the rails for maintenance or  
8 for docking operations.
