1 **National Transportation Safety Board**

12  
13  
14 **Survival Factors Group**  
15

16  
17  
18  
19 **Conception**

20  
21 **DCA19MM047**  
22

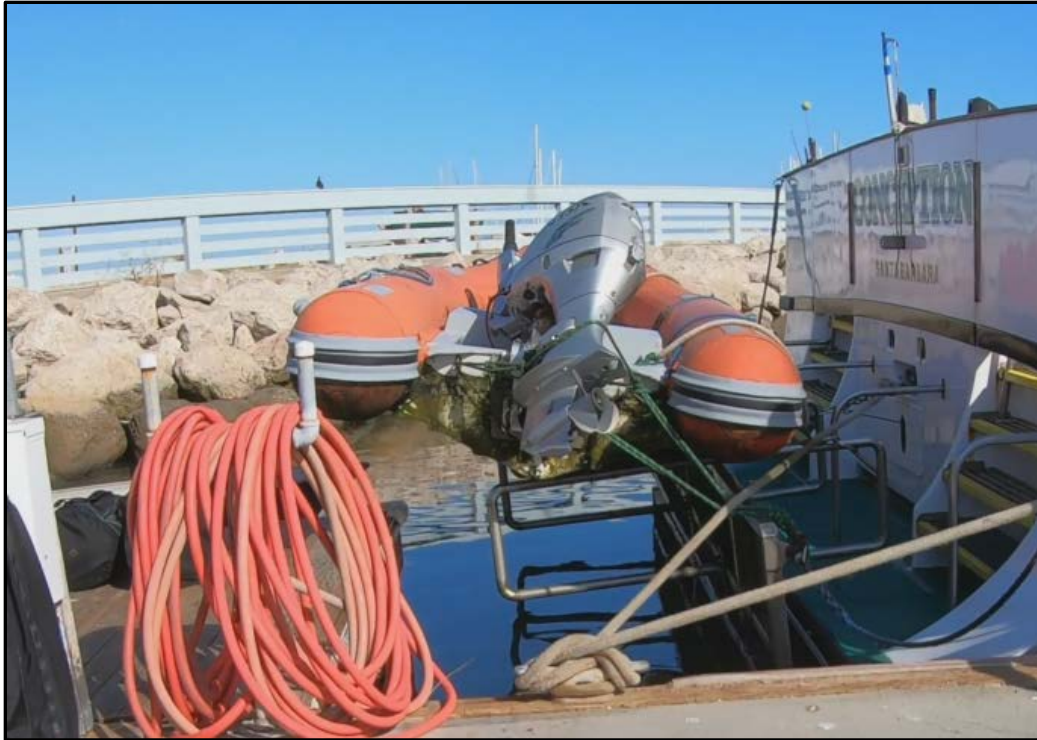
1  
2 **Figure 3: The *Conception's* skiff cradled on the stern swim step. (Source: Ralph A. Clevenger**  
3 **photography and video)**

4           The deckhand used a knife, kept near the stern, to cut the line securing the bow of the skiff.  
5 While the captain boarded the skiff and the second captain worked to start the outboard motor, the  
6 deckhand returned to the engine room hatch opening in an attempt to start the fire pump. He found  
7 the engine room full of white/grey smoke, and realizing the fire stations were inaccessible, he  
8 elected not to enter the cramped engine room. The first galleyhand had broken his left tibia in the  
9 jump from the upper to the main deck. The second galleyhand suspected he had twisted an ankle  
10 in the jump. Since the two galleyhands (without lifejackets), one of which had a serious leg injury,  
11 had yet to be rescued from the water, the deckhand joined the others in the skiff as ordered by the  
12 captain. The stern line was still attached as the three crewmembers attempted to pull away from

13 the *Conception*, requiring the deckhand to re-board the burning vessel to retrieve the knife. He cut  
14 the stern line, which then got wrapped in the outboard motor propeller. The crew paddled the skiff  
15 away from the vessel as the deckhand cleared the line, twice, from the propeller.

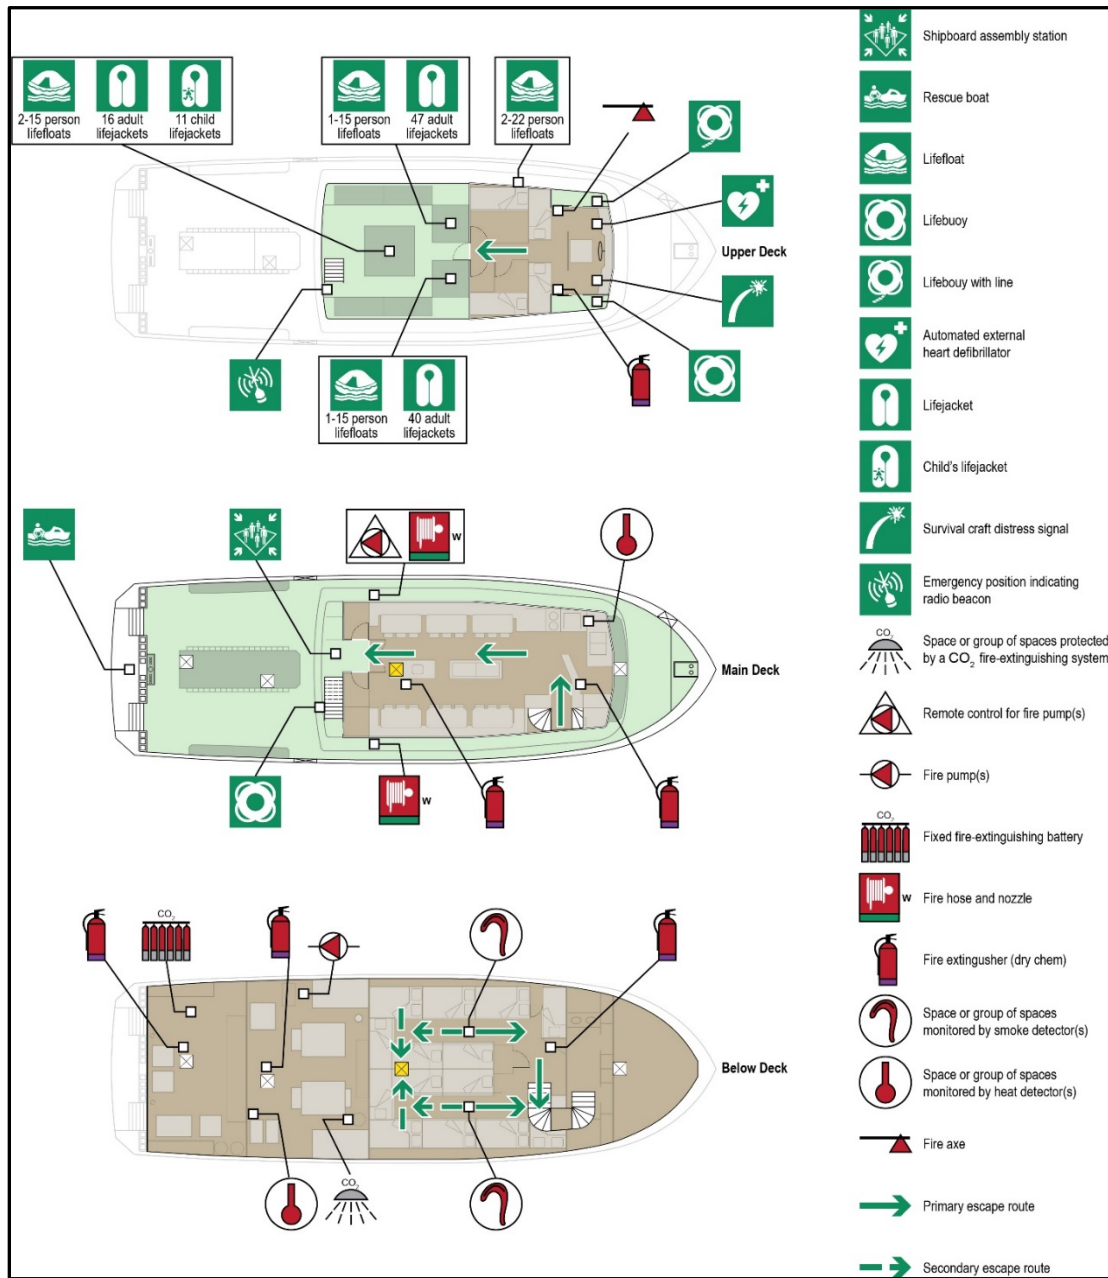
Figure 8: Fire, lifesaving appliance and evacuation plan for the *Conception*.

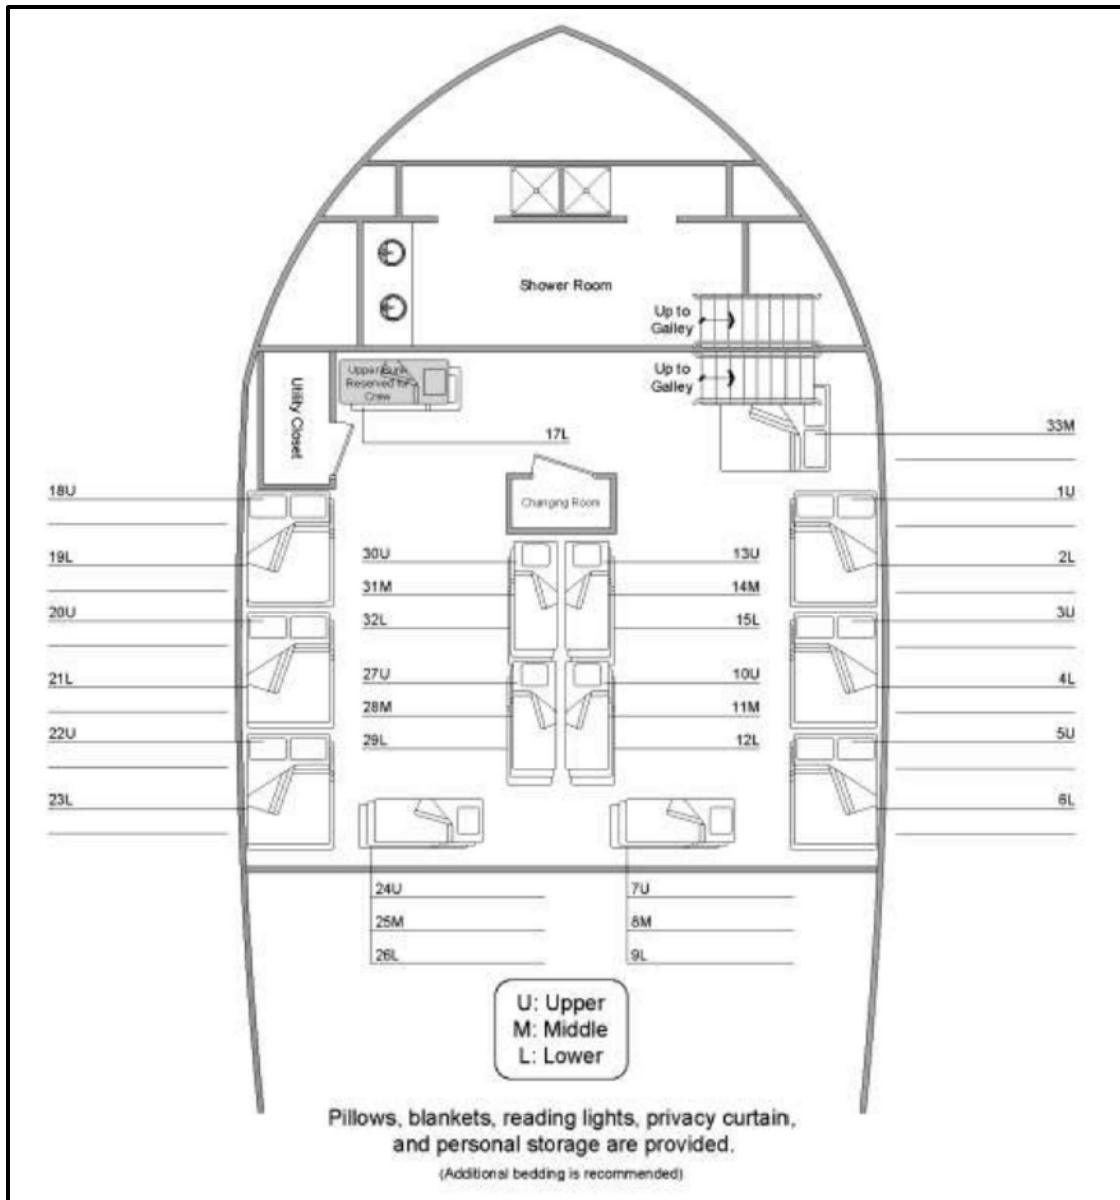
1 two-high double bunks. At the inner (centerline) side of each aisle there were two sets of three-  
2 high single bunks. Two sets of three-high single bunks were arranged athwartship along the aft  
3 bulkhead, with one two-high bunk along the forward bulkhead on the portside (the top being  
4 reserved for a crew member) and one double bunk underneath the forward stairway on the  
5 starboard side. Each of the bunks had a privacy curtain that could be pulled fully across the aisle-  
6 accessible side of the bunks. The privacy curtains were normally closed by passengers when they  
7 were occupying the bunks. It was also common to keep them closed by passengers when not  
8 occupied.

**Figure 11: *Conception* bunkroom arrangement. (Source: Truth Aquatics)**
