Memorandum

Date: 7 July 2022

Subject: Memorandum Addressing Cause of Ground Movement
Edwardsville, Illinois
Geosyntec Memorandum: TXG0258-0700-MM-001 (Rev. 1)

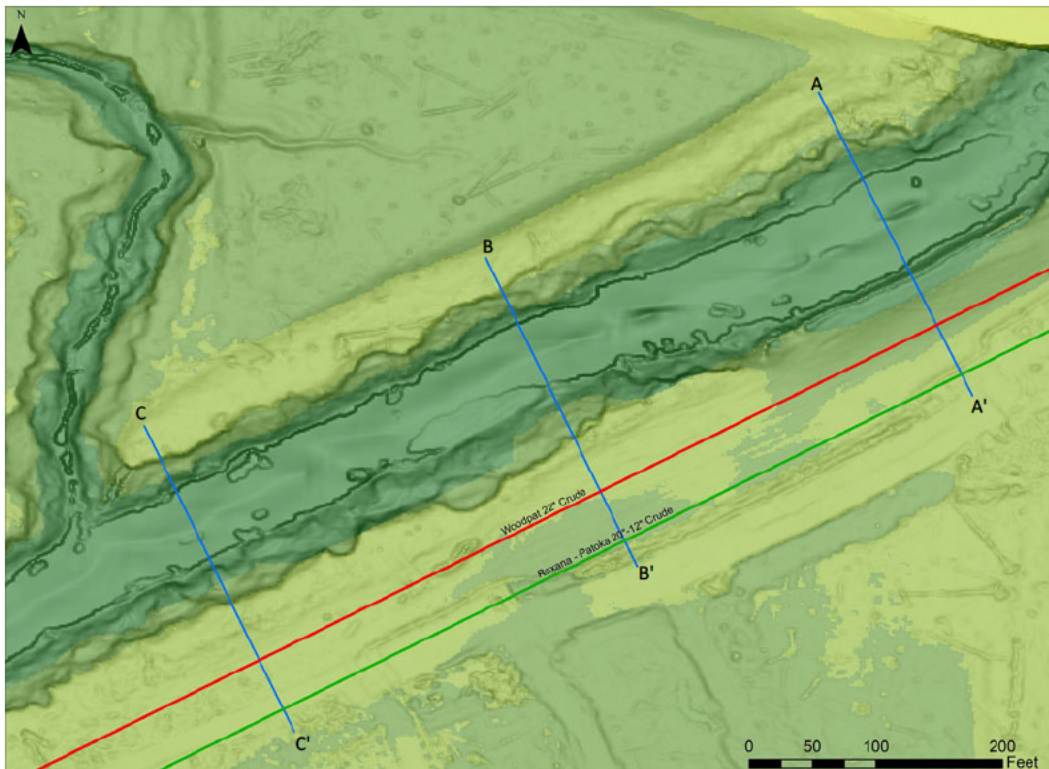
Figure 6 - Site Plan with Bathymetric and Ground Contours Obtained April 2022 (from DoC Mapping LLC)

The creek bathymetry and bank topography collected by DoC Mapping LLC after the 11 March 2022 ground movement is shown in Figure 6. These contours, along with the cross sections in Figure 8, illustrate topographically the impact of scour and ground movement on the left bank relative to the forested upstream and downstream streambanks. The instabilities along the left bank are coincident with deeper creek bed depths (i.e., resulting from bed scour), lateral bank position, and altered bank slope inclination. As shown in Figure 8, in the area of the ground instability, the creek bed depth is about five feet deeper and the bank is recessed laterally about 15 feet, compared to the upstream and downstream streambanks.
