NATIONAL TRANSPORTATION SAFETY BOARD

Systems Group Chairman's Factual Report

DCA-15-IA-089

Operator: Gojet Airlines
Location: Chicago O'Hare International Airport (ORD), Chicago, Illinois
Date: March 14, 2015
Time: 1521 central daylight time
Airplane: CRJ 700, registration N157GJ

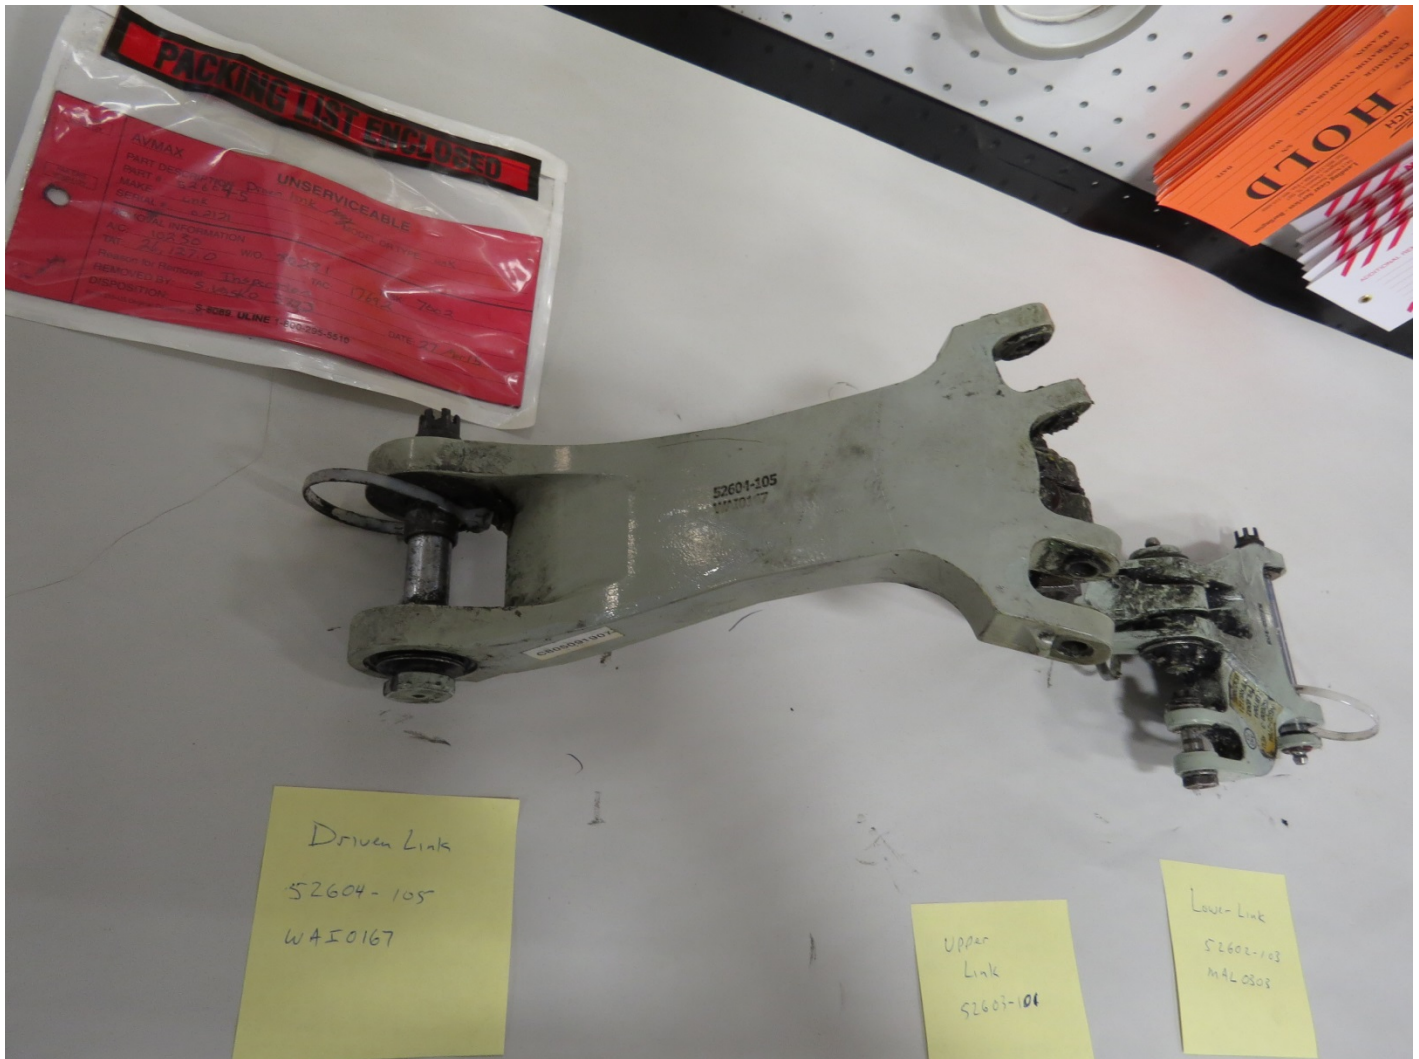
Figure 2
Driven Link

There was a sticker on the part that read, “C805091907”. According to Bombardier, this sticker notes the disposition of an assembly discrepancy found during manufacture. The discrepancy was that a pin would not fit through one of the holes, and the corrective action was to remove excess chrome plating from the pin and to lightly sand the inside of the hole.

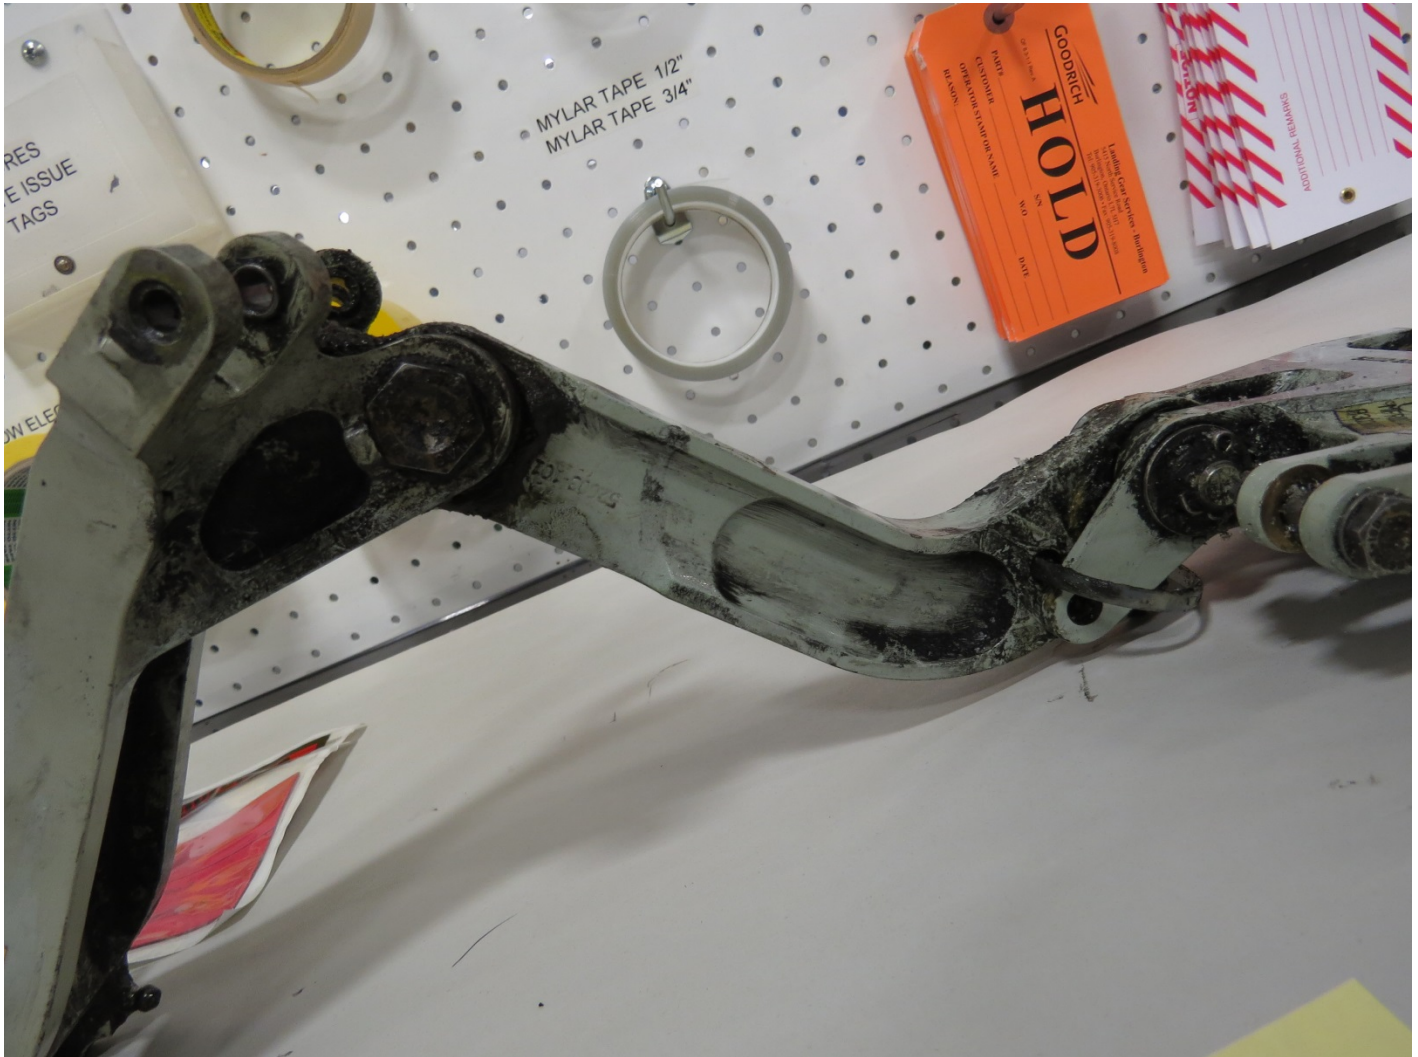
Figure 3
Upper Link

A contact area was noted between the grease nipple area of the upper link and the lower link (see figure 4). This area was identified for further investigation in the UTAS M&P laboratory.

The spherical bearing between the upper link and lower link was noted to potentially have excessive movement (play), and was identified for further investigation in the UTAS M&P laboratory.

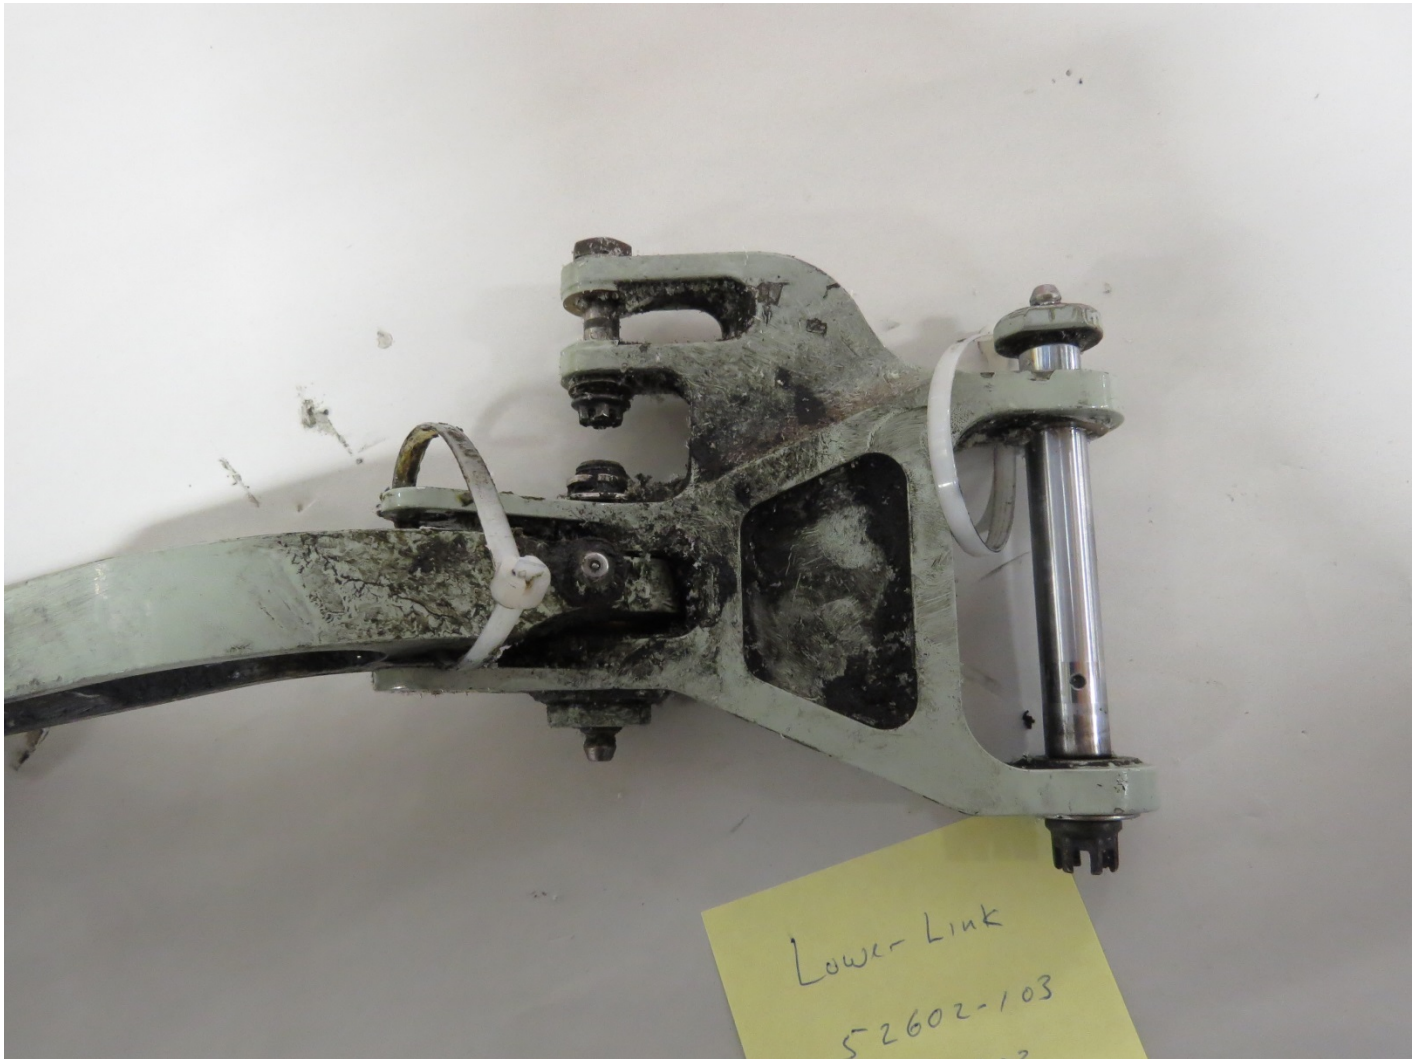
Figure 5
Lower Link

There was a contact area noted between the lower link and the grease nipple area of the upper link. There was an area of missing paint noted in the area of the drive link rod end attachment to the lower link (see figure 6).

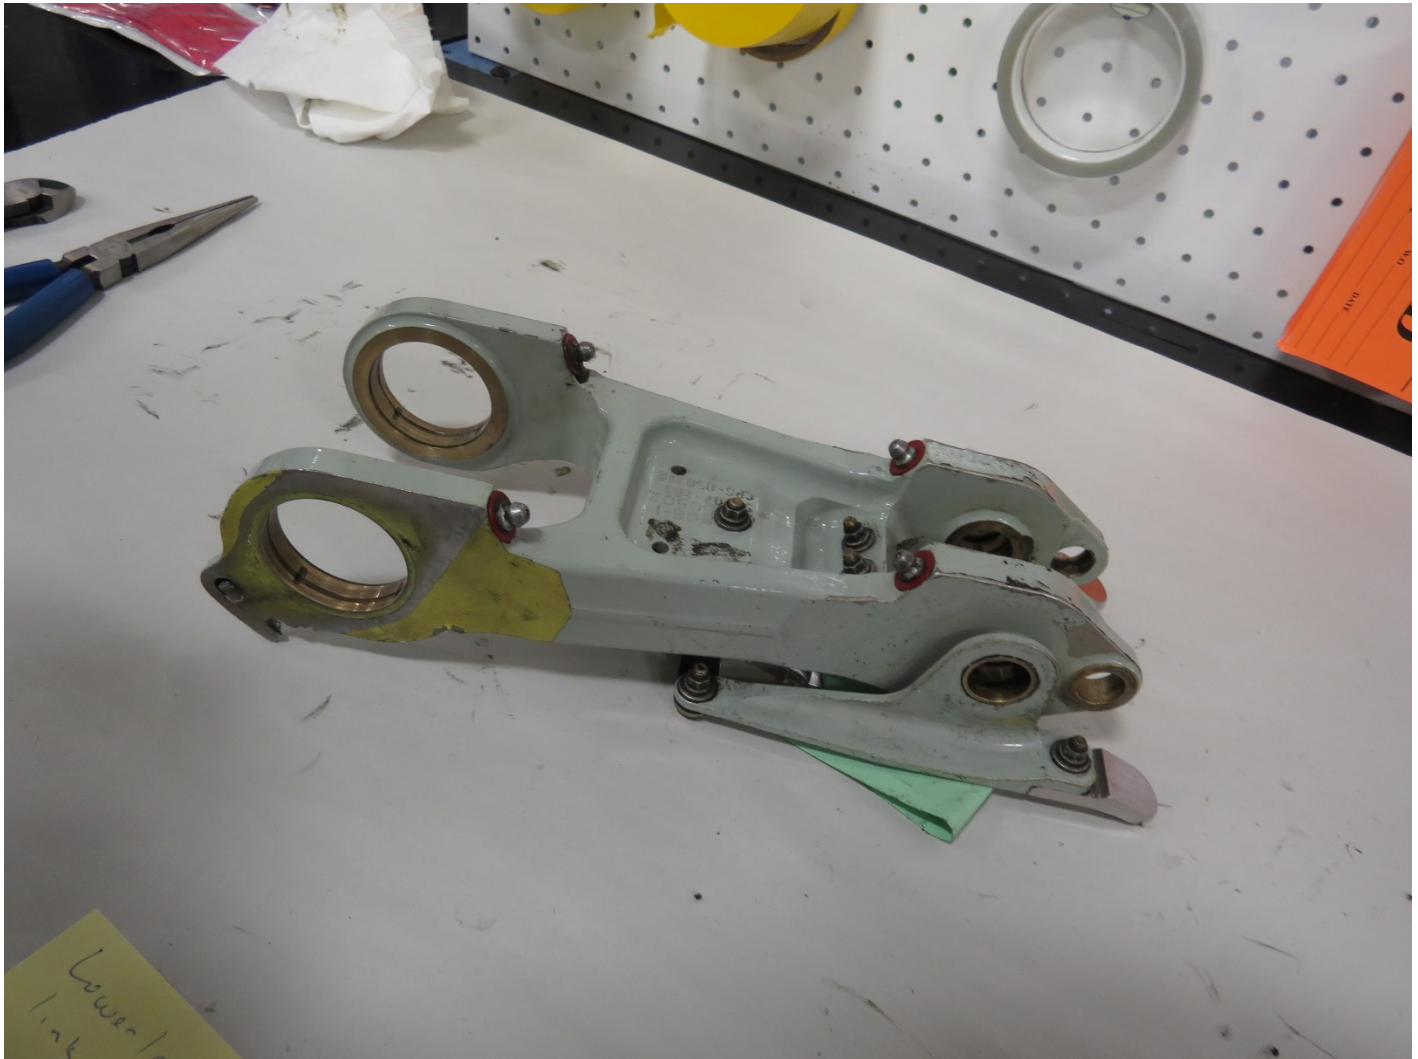
Figure 7
Lower Lock Link Assembly

The upper bolt hole on the attachment lug between the lower lock link and the drive arm was noted to have a broken out area where the material from the bolt hole extending to the edge of the lug was missing. The anti-rotation bolt from this hole was found to be deformed and was still present in the drive arm assembly (see figures 8 and 9).

There was a linear shaped depression and round divot noted in the same arm as the attachment lug with the broken and missing material. The depression started approximately 1.5 inches away from the broken materials and extended for approximately 1 inch.

Variations in primer paint density were noted throughout the portion of the lower lock link assembly that was not painted with top coat paint. These variations ranged from areas where the primer paint was completely absent to areas where the primer paint appeared to be scuffed. The areas of missing/scuffed primer paint matched those areas of

The lower lock link assembly was identified for further examination in the UTAS M&P laboratory to characterize the fracture surfaces, examine the bolt holes, and to characterize the linear depression and divot.

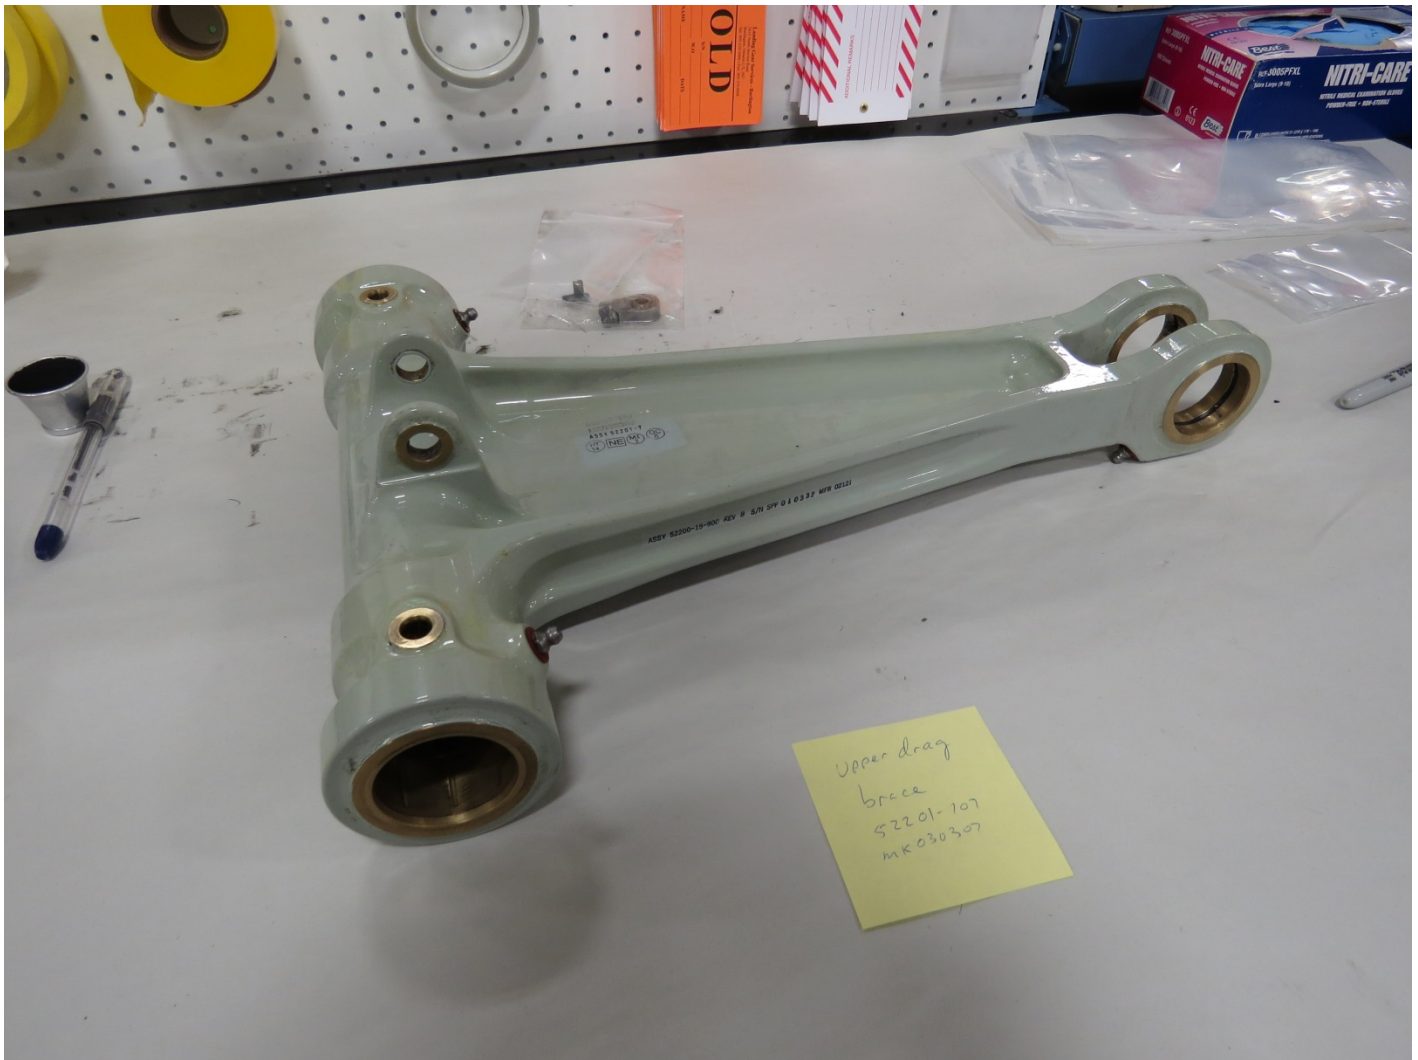
Figure 14
Upper Drag Brace

There were minor paint nicks in several locations around the part. There were nicks noted at the base of each attach lug where the upper drag brace mates with the lower link.

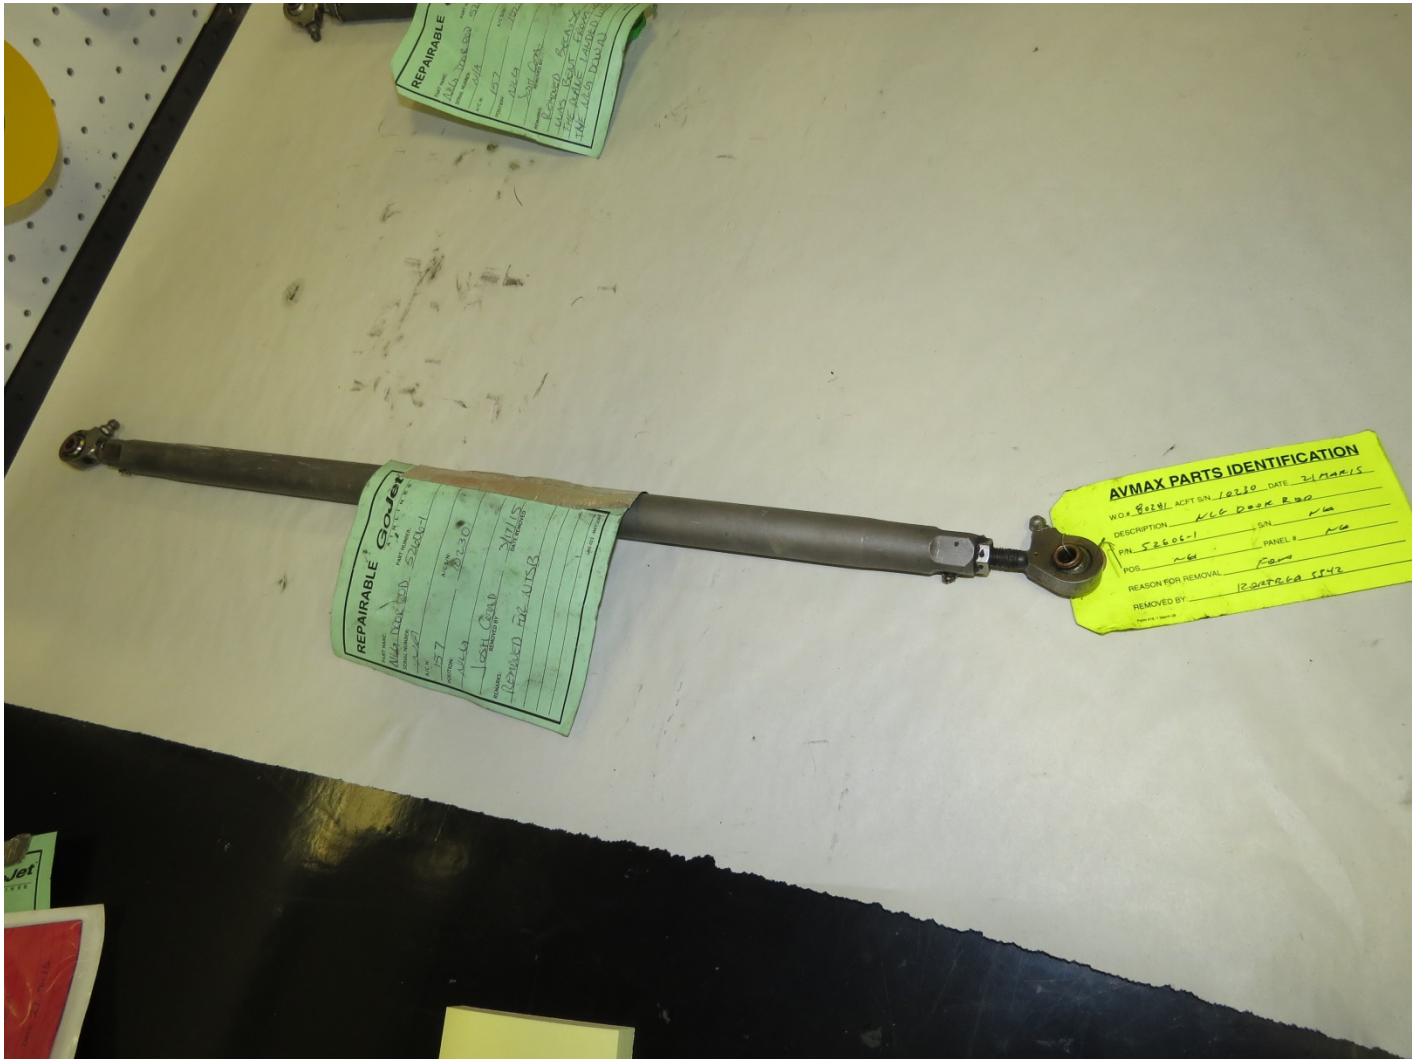
Figure 20
Door Rod (with yellow tag)

The rod was received with a yellow tag attached to one rod end. This rod end was able to rotate freely using hand pressure. The lock nut safety wire was noted to be intact.

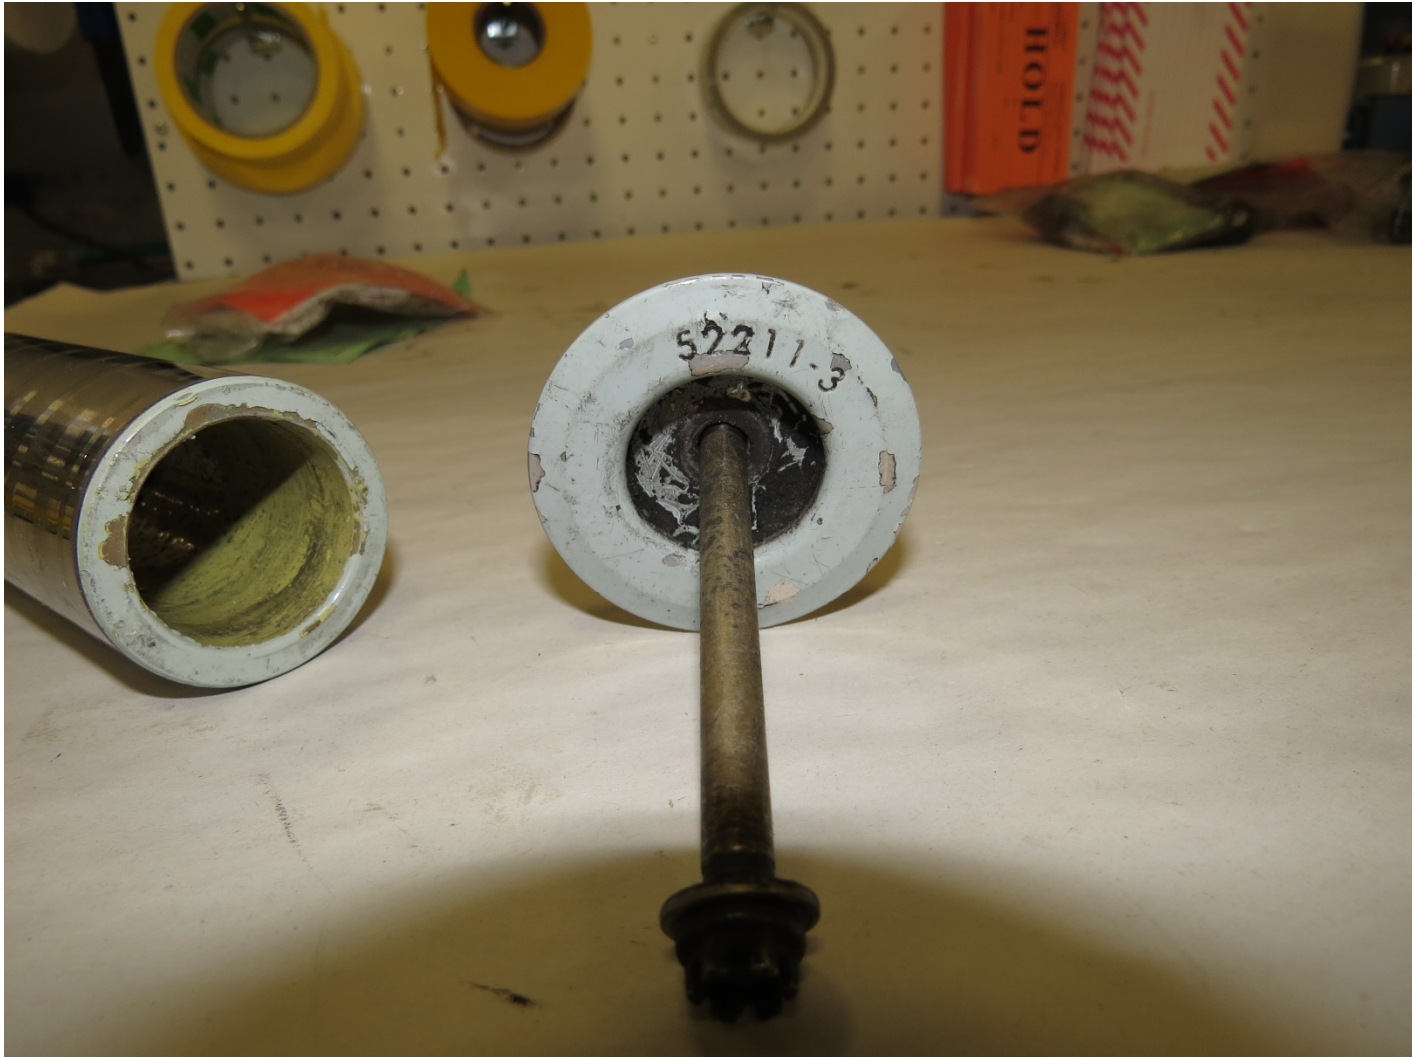
Figure 23
Drag Strut Cap

that there should be two washers on the nut side of the cap when assembled.

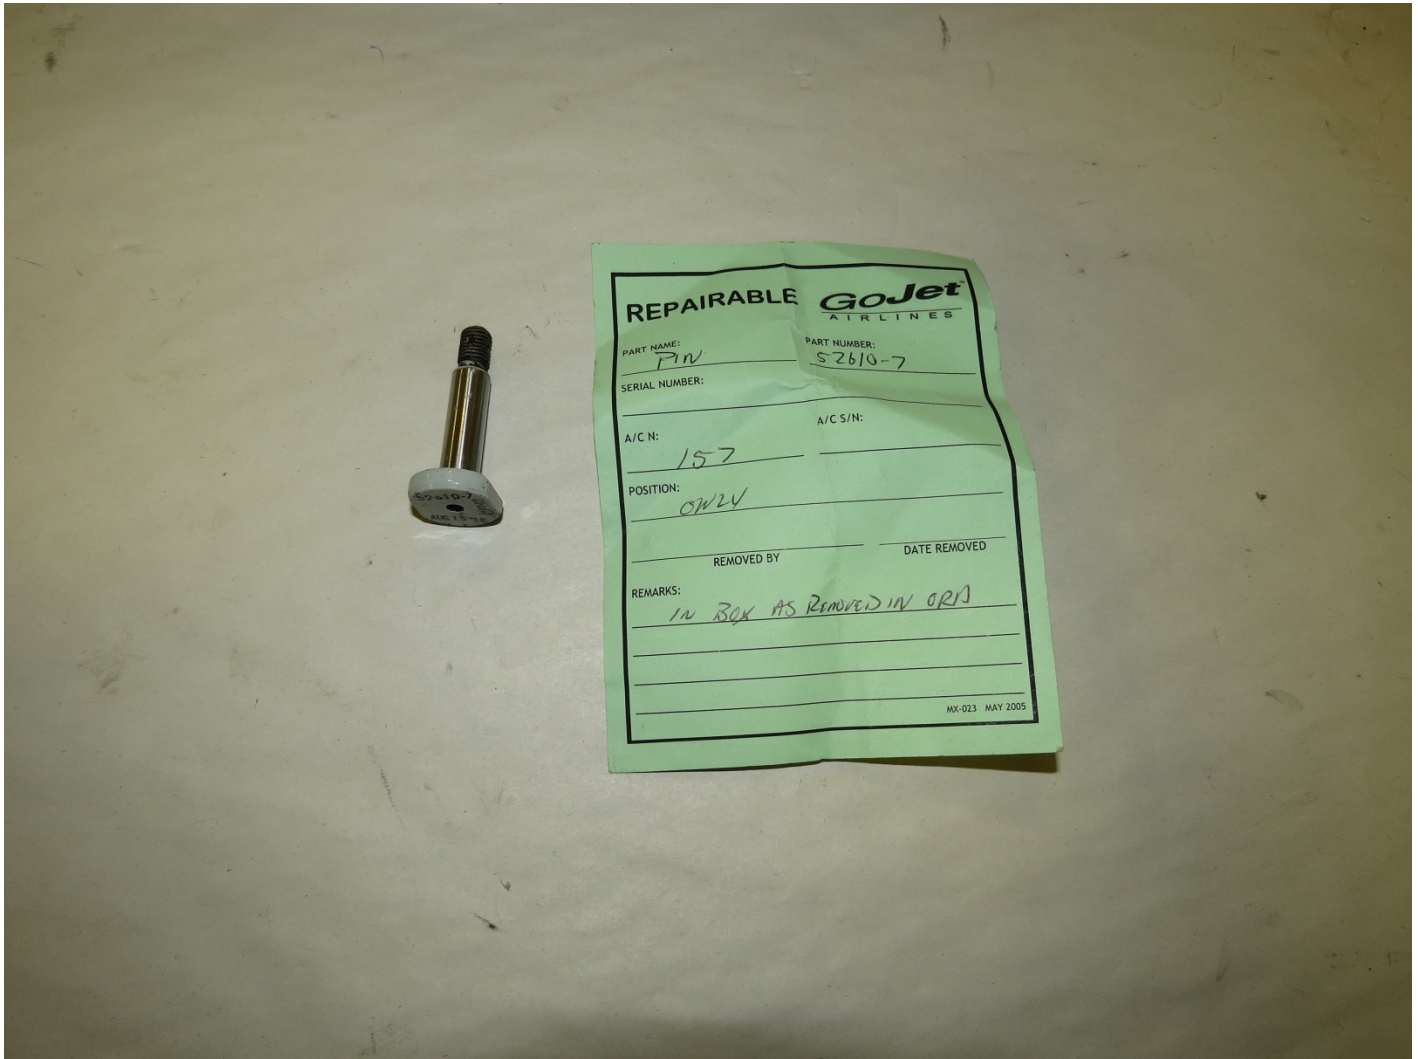
Figure 25
Pin

The head of the pin contained the notations of, “CFN2” and “Aug 15 ‘14”. No nut was included with this pin.

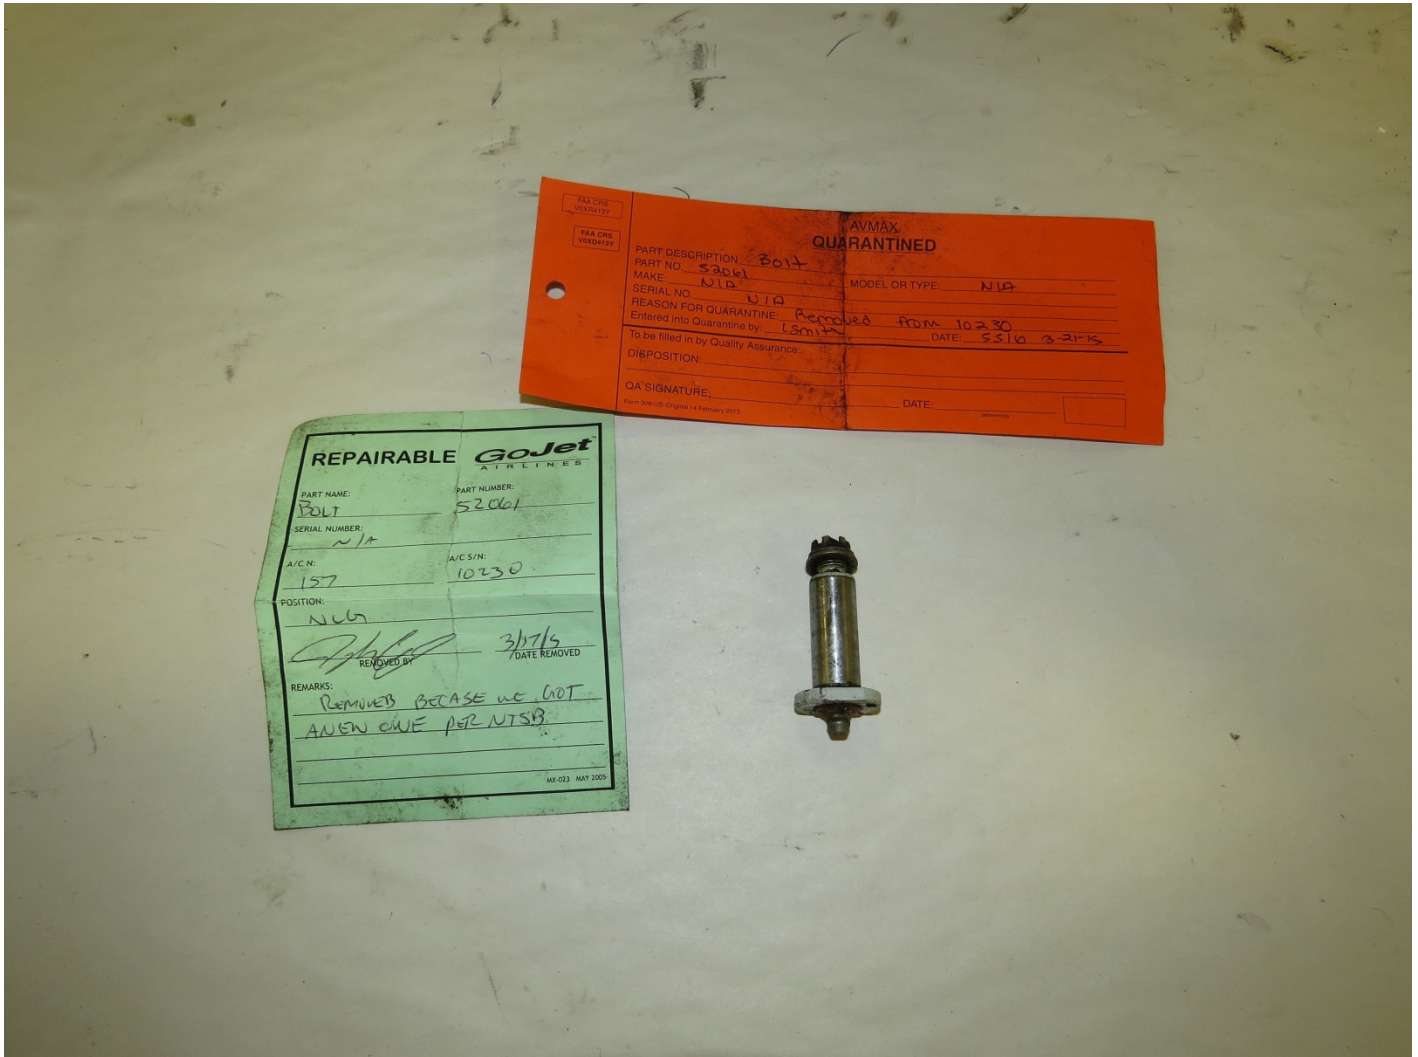
Figure 26
Bolt

The bolt face had areas of chipped paint, and there was a nut included with the bolt.

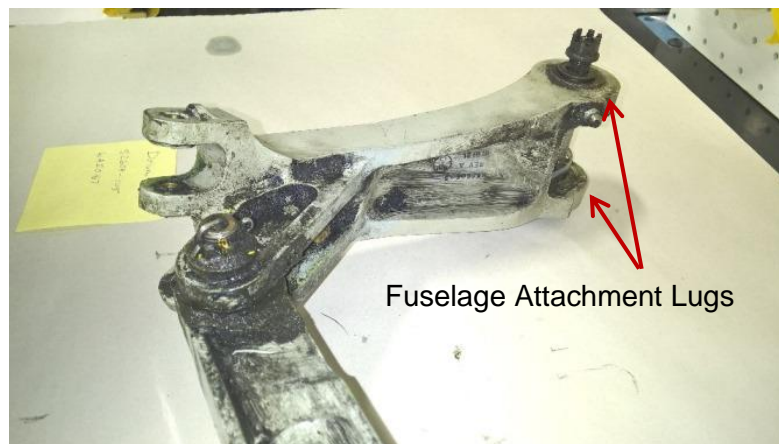
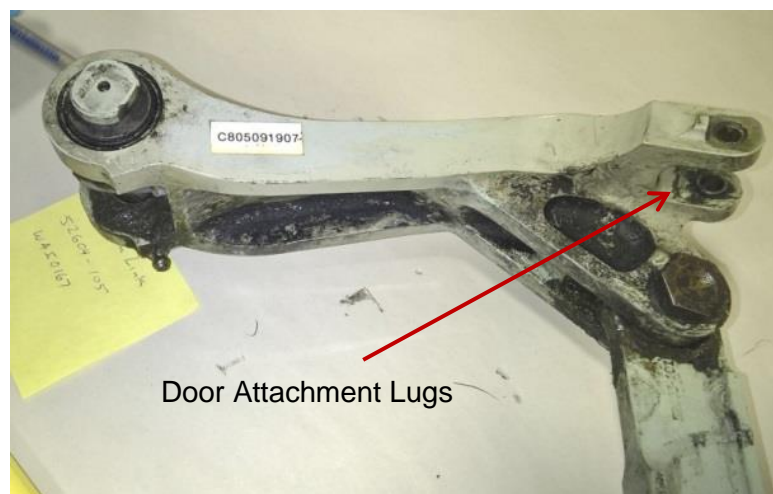
Visual inspection of the part displayed in figures 2 and 3 did not reveal any outward mechanical damage, distortion, or discoloration. Examination of the attachment lug holes displayed ample black grease with no obvious elongation or mechanical damage.

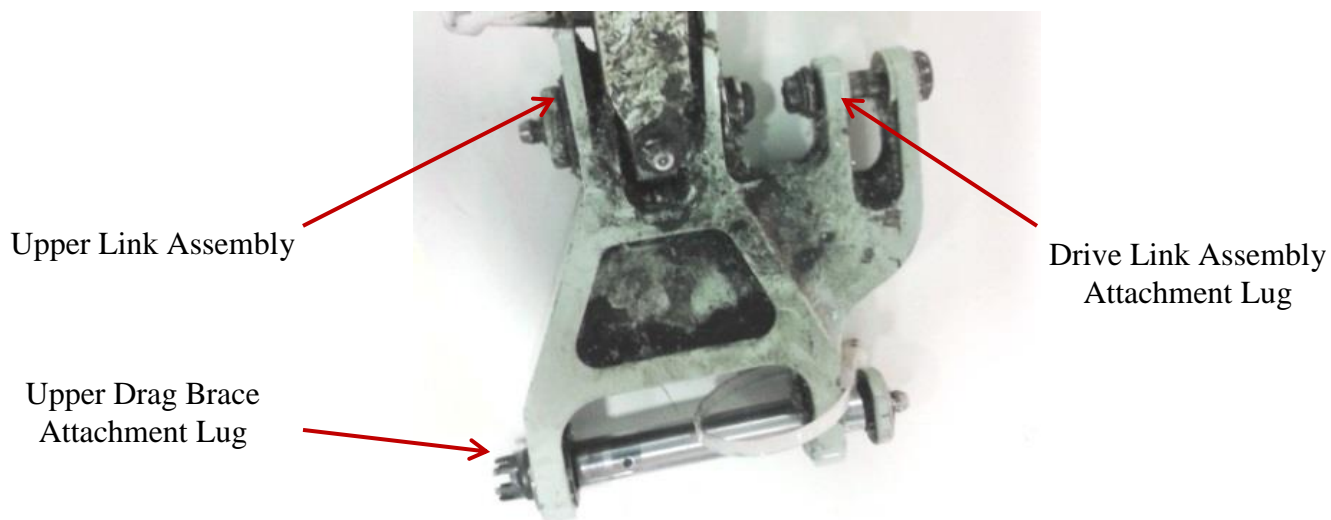
Figure 8
“As Received” Lower Link Assembly

Figure 8 displays the “as received” surface of the Lower Link Assembly. The chrome plated bolts and mating lug surfaces were covered with black colored grease, with unrestricted movement to the attached assemblies.

Two other contact damage areas, highlighted in figure 10, were found on the flat surface adjacent to the base of the lugs that connects to the drive link assembly. The damaged areas coincide with the location the end of the rod end nuts on the end of the drive link assembly indicating that the upper linkage had traversed over center during retraction. The contact damage found on the two regions suggests that the upper and lower link assemblies would have had to articulate beyond the expected retract design path.

Since the exposed base metal regions were free of discoloration and corrosion, it’s likely that this occurred within the same timeframe as the damage to the adjacent links.

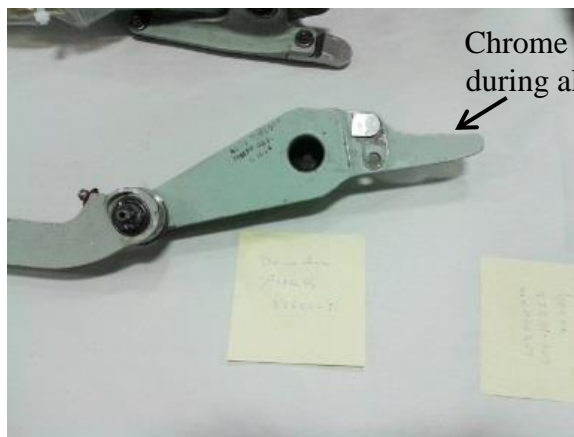
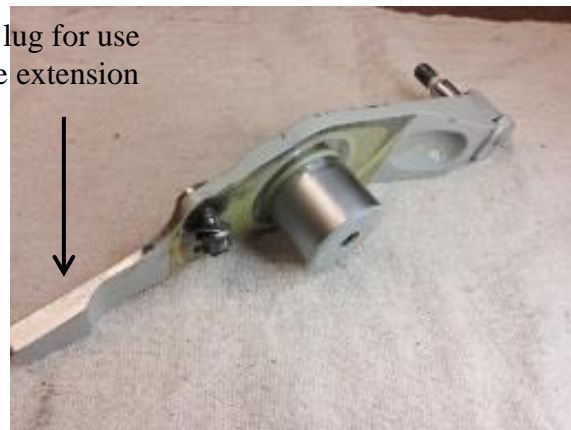
Figures 19 and 20 are photos of the as-received drive arm assembly. One of the two “D” headed pin used to secure the Drive Arm was found completely bent, as displayed in figure 21. The primed surface adjacent to the lower pin hole displayed scrapes to the base metal indicating relative motion between the two components prior to separation as highlighted on figure 22.

- One of the two MS21042L4 nuts on the lower 'D' headed pins securing and providing anti-rotation between the Drive Arm Assembly to the Lower Lock Link Assembly had lost pre-load and backed off. This conclusion is based on the evidence that the end of the protruding threads on the sheared pin did not show any physical damage from the threads interacting with the nut.
- Accepting the absence of the nut on the 'D' headed pin, the Drive Arm Assembly is provided a side to side rotational movement as well as creating a gap with the Lower Lock Link Assembly during the extension and retraction of the gear as displayed in figure 36. Evidence of the side to side movement between the components was found by way of rub marks in the primed surfaces adjacent to the sheared bolt hole and other surfaces between the two parts.

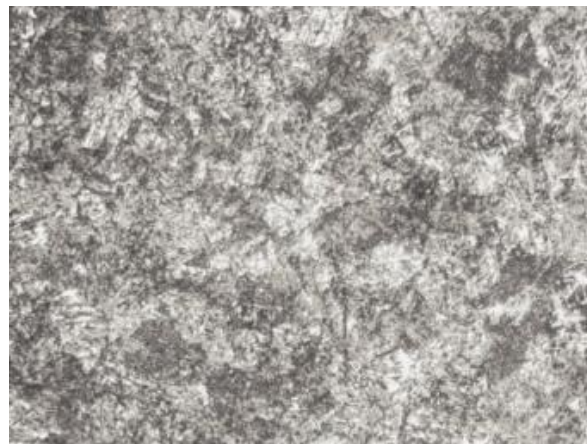
Figure 25

To examine the microstructure of the Drive Arm material, a specimen was excised from the part, mounted, polished, and etched using 3% Nital Etch Reagent. Metallographic inspection showed the expected tempered martensite as shown in figure 25 at 200X.

Tempered Martensite Microstructure

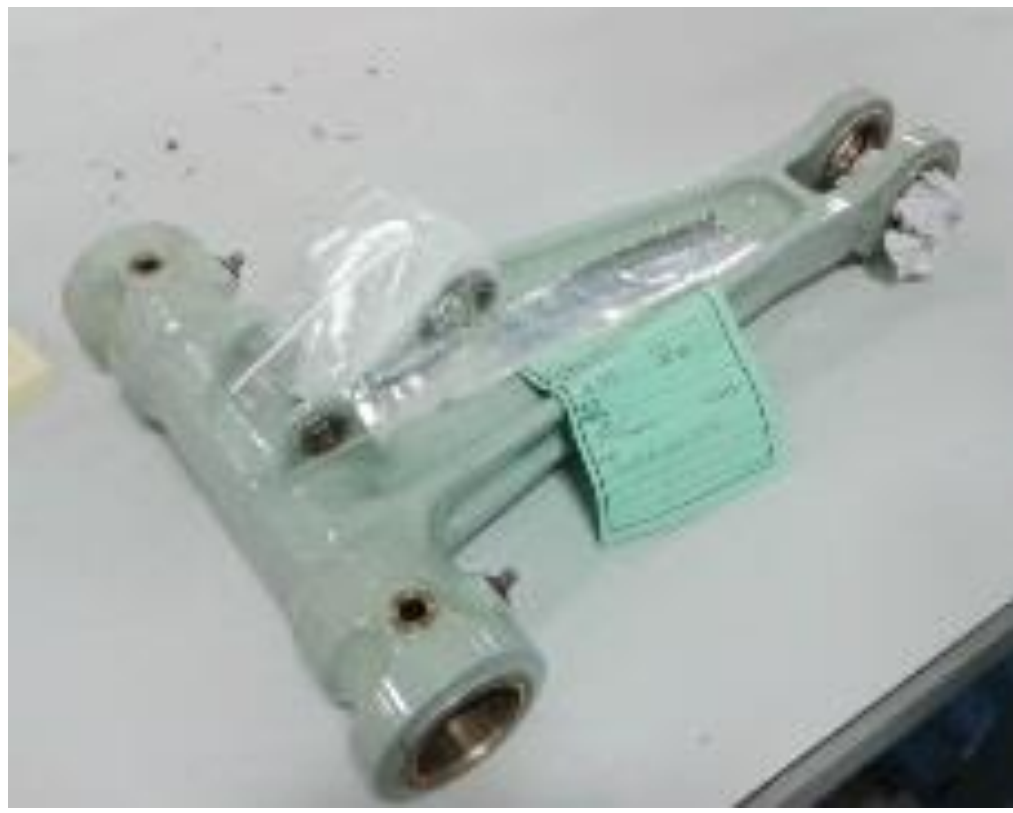
Figure 35
 As-Received Upper Drag Brace

The upper drag brace was received in a cleaned condition as displayed in figure 35. With the exception of the expected minor chips to the paint of a service component, no outward mechanical damage, discoloration, or distortion was found on the part.

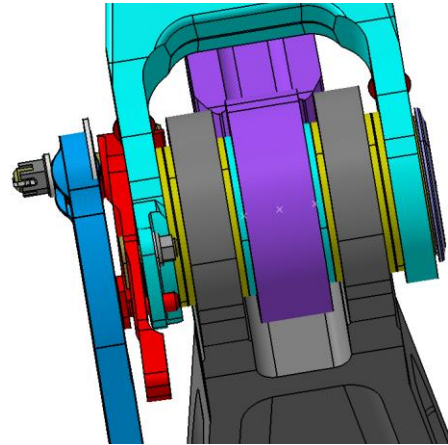
Figure 36

The opening and closing of the landing gear doors is choreographed through the Driven Link, Lower Link, and Upper Link Assemblies, articulated by the Drive Link Assembly attached to the Drive Arm Assembly. The absence of the nut and the gap between the adjacent components causes the loads to be transferred to the upper 'D' headed bolt, in turn causing the aluminum lug to fail in tensile overload, as highlighted on figure 37.
