Stretch Limousine Run-Off-Road Crash
Near Schoharie, New York
October 6, 2018

NTSB/HAR-20/03
PB2020-101008

Highway Accident Report

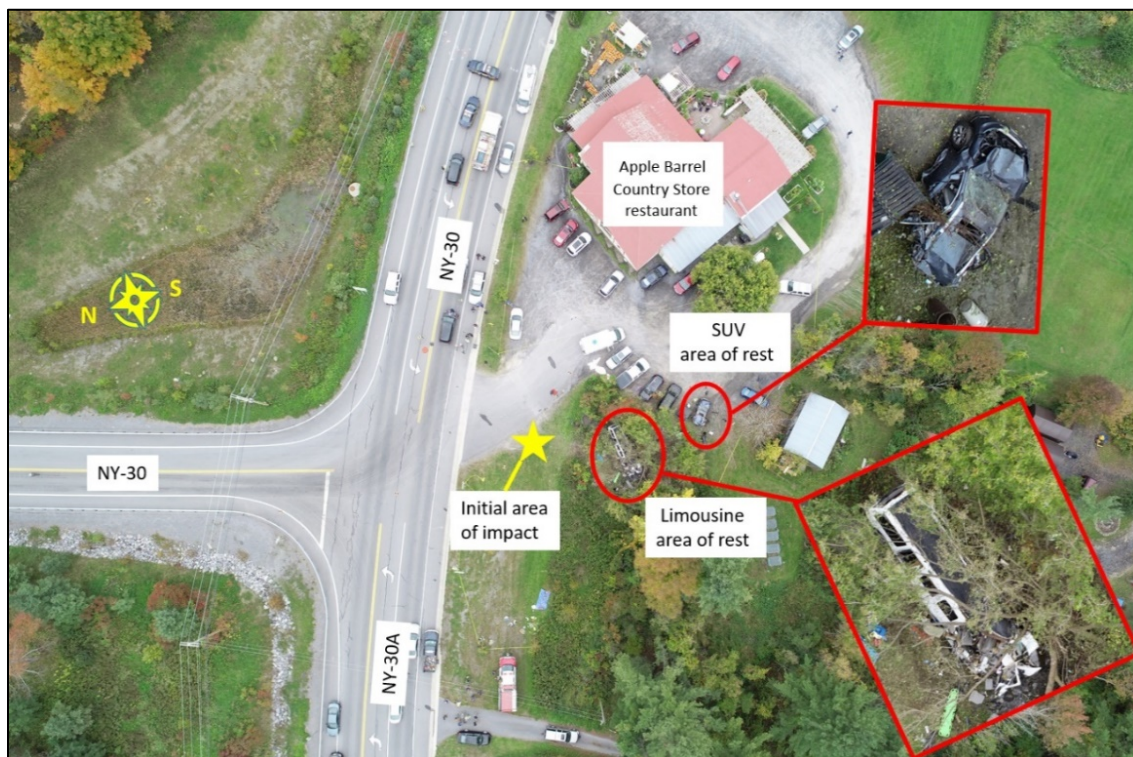
As the limousine neared the bottom of the grade, it approached the rear of a 2016 Jeep Patriot sport utility vehicle (SUV) in the same lane, which was stopped at the stop sign for NY-30 at the T-intersection with NY-30A. The two SUV occupants reported hearing the limousine—which they said sounded like a “jet engine”—and seeing it approach the SUV from behind at a high rate of speed. The limousine driver steered left to avoid the SUV, proceeded past the stop sign and through the intersection without slowing, and crossed the east- and westbound travel lanes of NY-30A (traffic on NY-30A did not have a stop sign for the intersection). The limousine entered the driveway of the parking lot of the Apple Barrel Country Store restaurant and struck an unoccupied 2015 Toyota Highlander SUV parked in a grassy field adjacent to the driveway. The limousine was traveling an estimated 101–118 mph when it collided with the Toyota SUV.³ The SUV was propelled in a southerly direction and struck two pedestrians who were standing near the SUV. The speed of the limousine was reduced to about 80 mph as it continued about 55 feet south, entered a ravine, and then struck an earthen embankment and several trees. At final rest, the limousine was in a streambed at the bottom of the ravine facing west with the driver’s side against the backslope of the ravine. The SUV came to rest facing south on the opposite side of the ravine (see figure 2).⁴

Figure 2. Aerial view of crash scene showing initial area of impact and vehicle areas of rest. (Source: New York State Police with National Transportation Safety Board annotations)

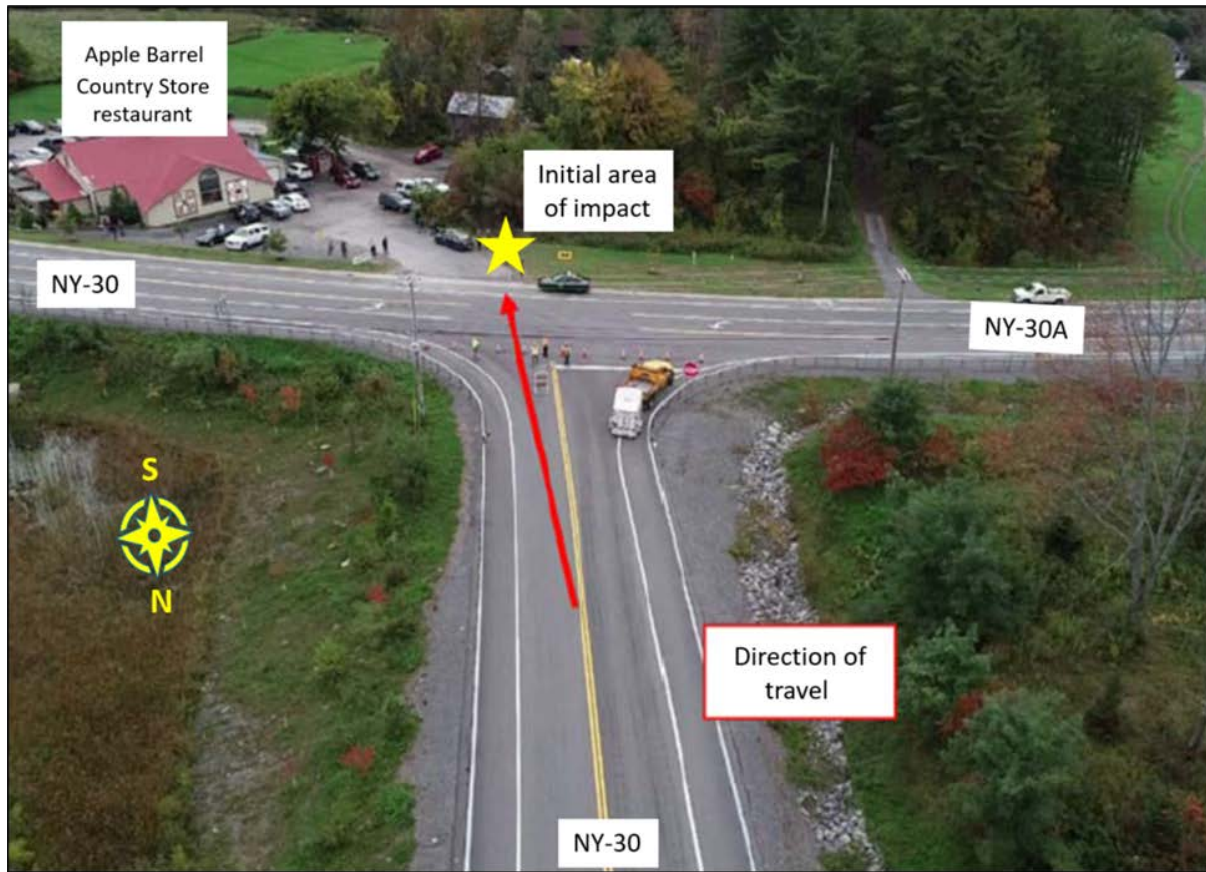
Figure 4. Southbound view of crash scene, showing limousine's direction of travel and area of initial impact. (Source: NYSP)

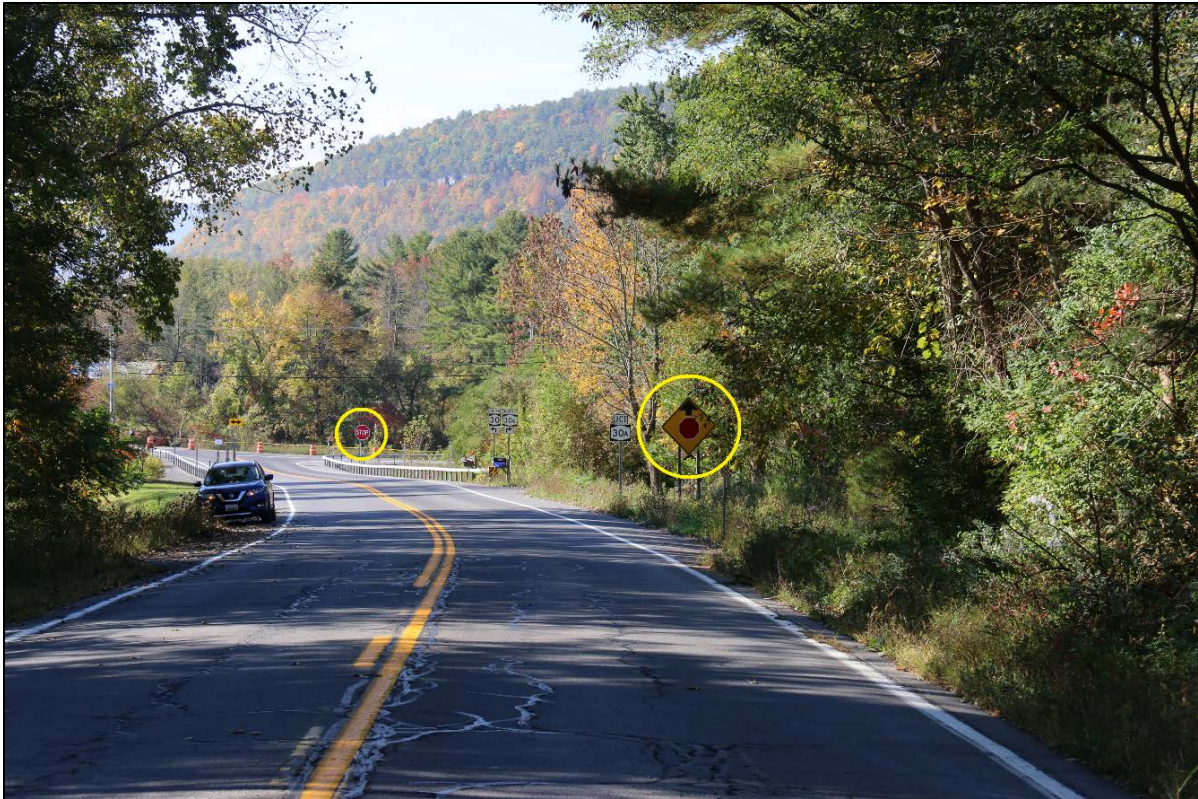
The stop ahead warning sign and intersection stop sign on NY-30 southbound came into the southbound driver's view simultaneously about 1,125 feet before the intersection stop sign. The available sight distance on the approach to the intersection with NY-30A exceeded the minimum standards for stopping sight distance outlined in the American Association of State Highway and Transportation Officials (AASHTO) *Policy on Geometric Design of Highways and Streets*. (See figure 5.)

Figure 5. Southbound approach view of NY-30/NY-30A intersection about 660 feet before intersection. (Stop ahead warning sign and intersection stop sign are circled in yellow.)

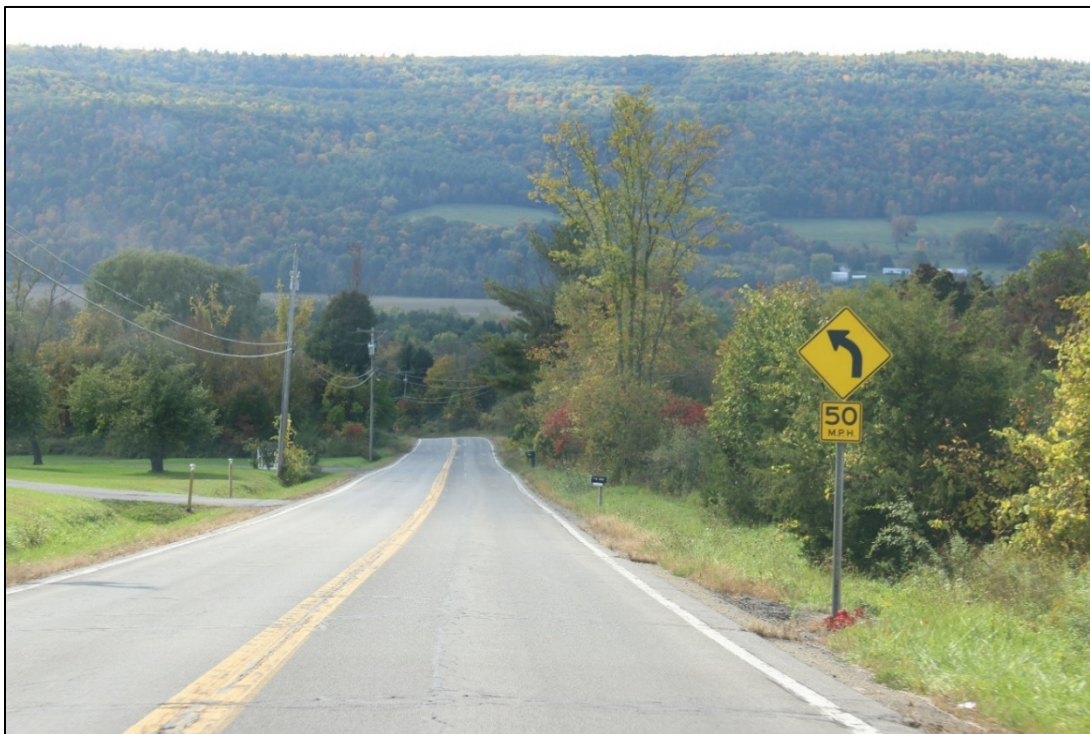
The final 1.81-mile descending grade consists of four discernable curves—one rightward curve and three leftward curves with long tangent sections separating them.¹⁰ Vertical alignment involves 13 changes in grade that range from less than 1 percent to 11.35 percent (see table 1). The total change in elevation during the 1.81-mile descent is about 573 feet. Figure 7 shows an example of the downhill grade (9.64 percent) about 0.56 miles north of the intersection.

Figure 7. Southbound view of downhill grade on NY-30 about 0.56 miles north of the crash location.

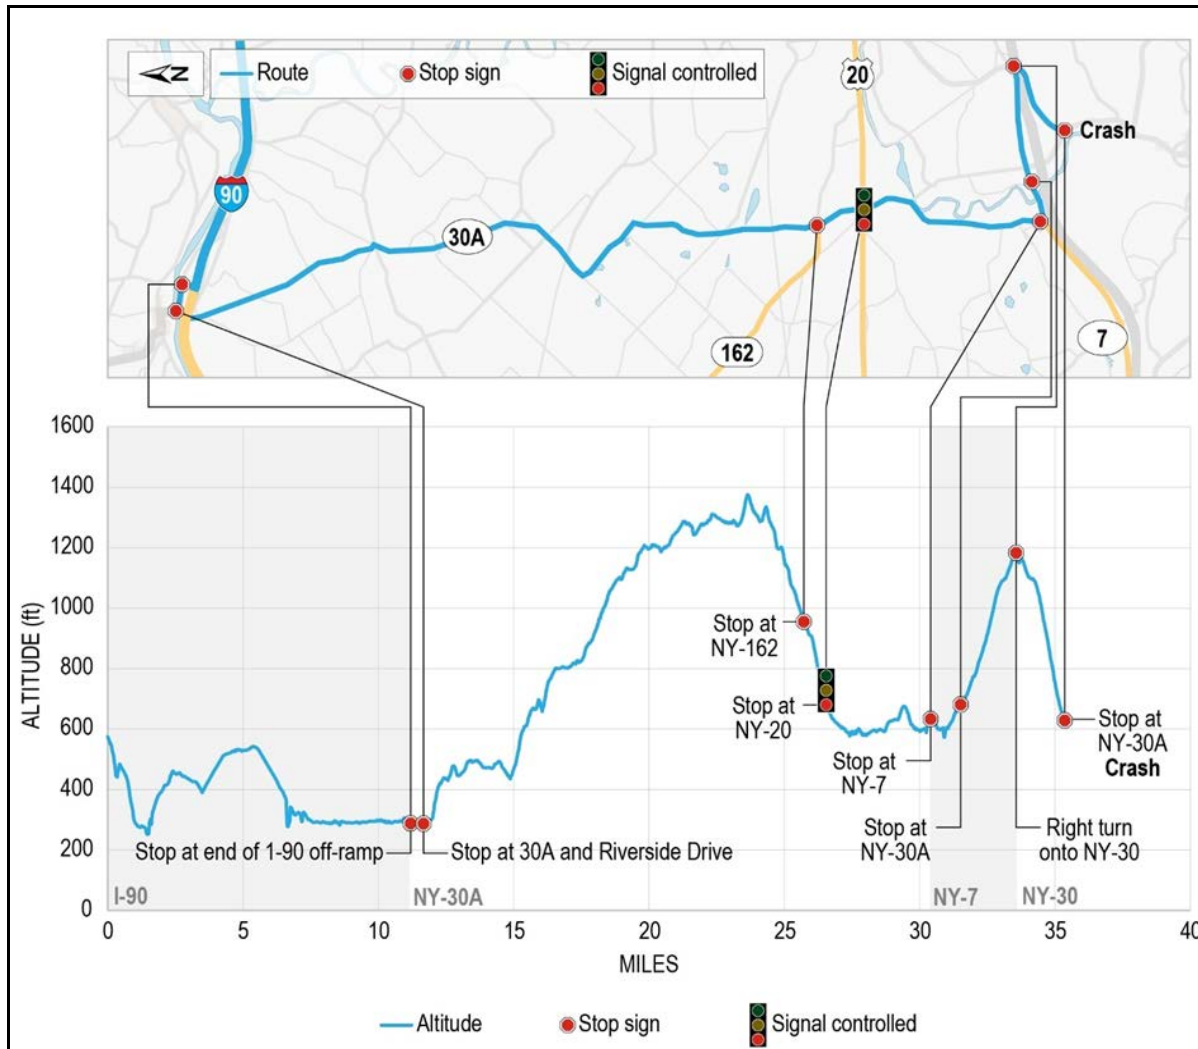
changes in vertical grade, although the overall grade was ascending.¹¹ Figure 8 depicts the vertical profile of the trip along the route.¹² These data were used to examine the brake system's performance under different operating and loading characteristics (see section 1.5.6).

Figure 8. Highway profile graph showing altitude measurements taken along limousine's charter trip from Amsterdam, New York, to crash location.

¹⁰³ The 35.4-mile trip from the passenger pick-up location to the crash site consisted of rolling terrain with frequent changes in vertical grade. One descending grade earlier in the trip covered 2.3 miles with an elevation decrease of more than 700 feet (refer to figure 8).

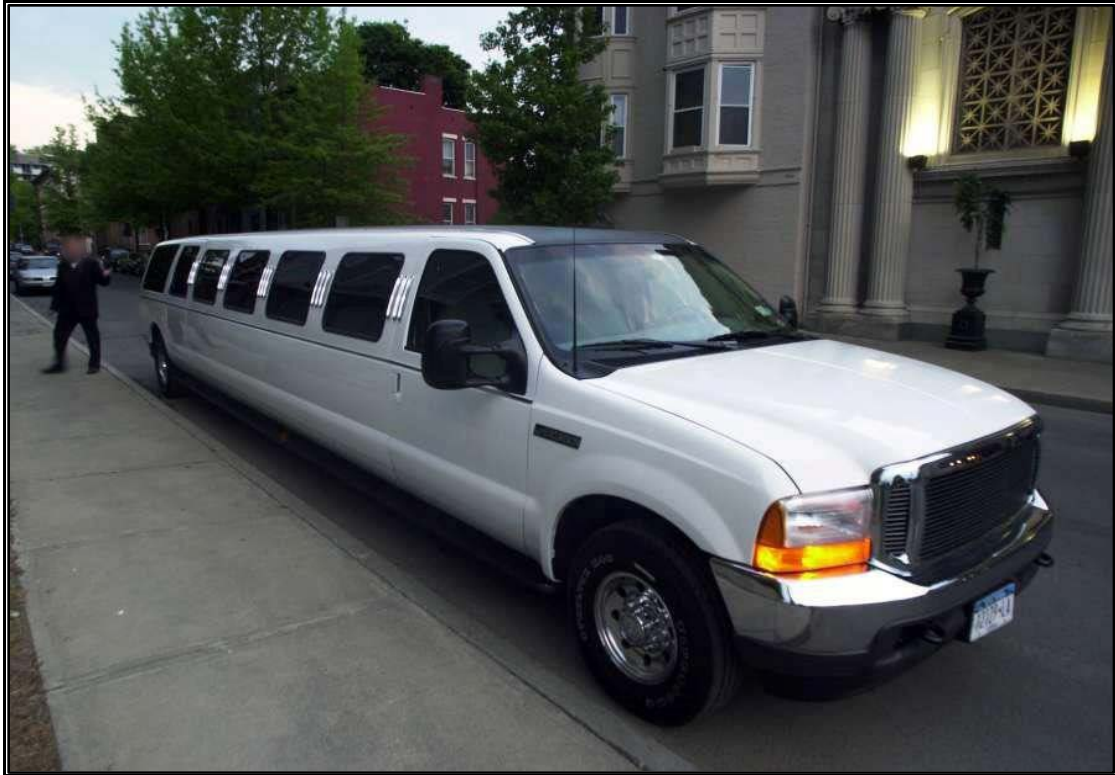
The alteration in 2001 entailed cutting the SUV's factory frame and welding an additional 144 inches of frame rail to extend the factory frame rail. The alteration increased the vehicle's wheelbase to 281.1 inches (23.4 feet) and its overall length to 370.7 inches (30.9 feet). (See figures 13 and 14.)

Figure 13. Precrash photograph of crash limousine. (Source: Times Union newspaper [James Goolsby photographer])

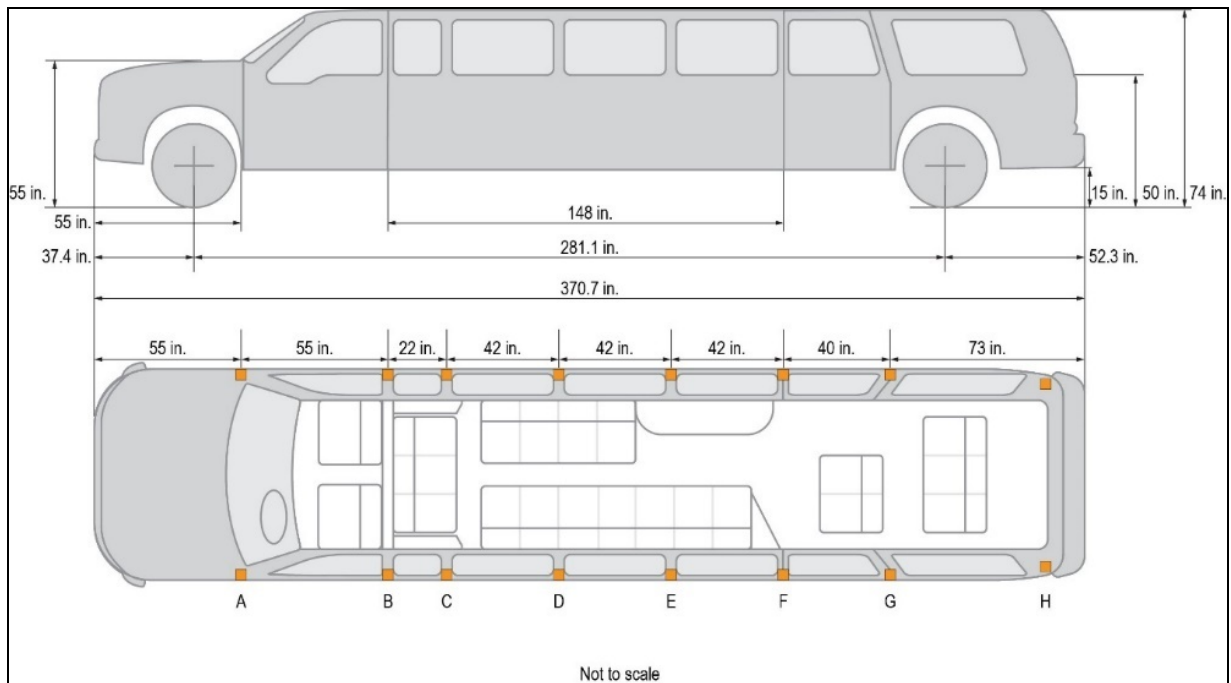
Figure 14. Diagram of limousine exterior and interior. Letters A–H denote positions of structural pillars from front to rear. Pillars C–F were added during alteration from SUV to limousine.

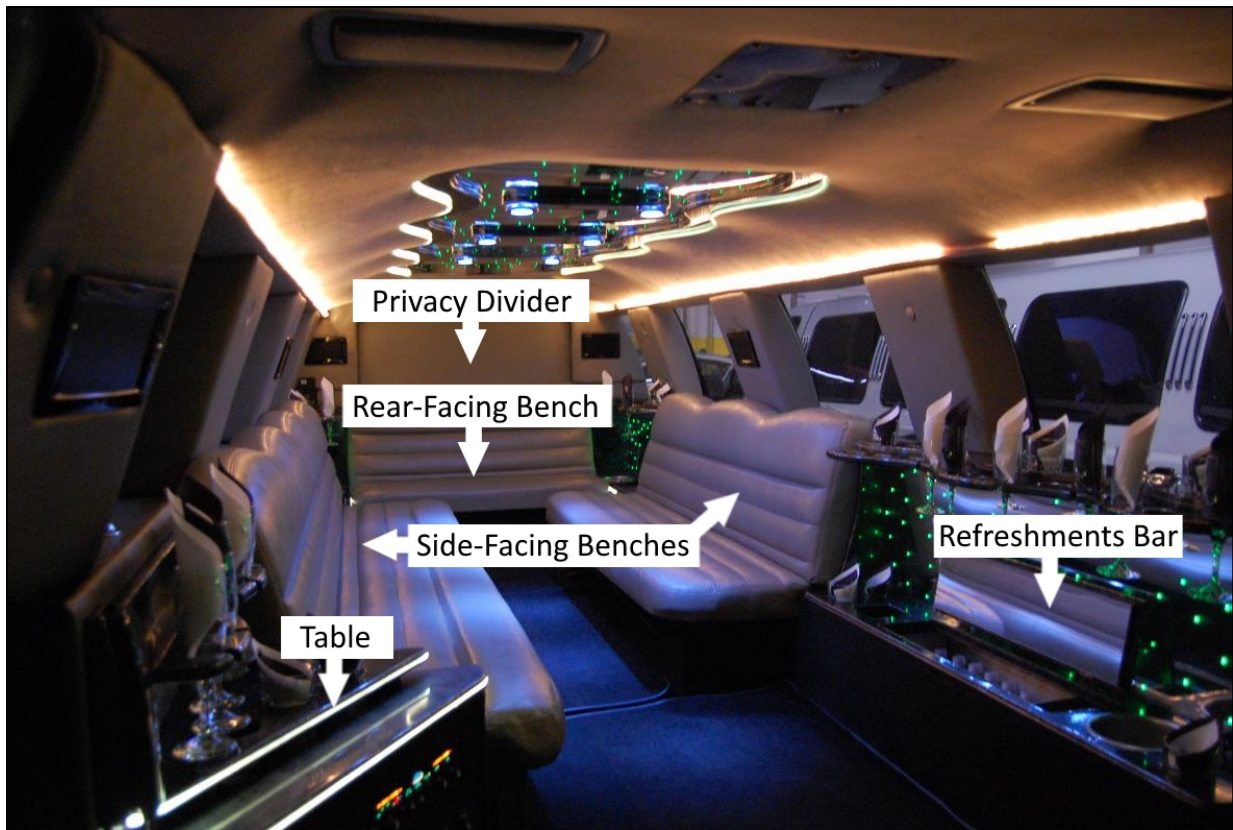
Figure 15. Photograph of limousine's interior, looking from rear of passenger compartment toward driver's compartment. (Source: Advantage Transportation Group, 2010)

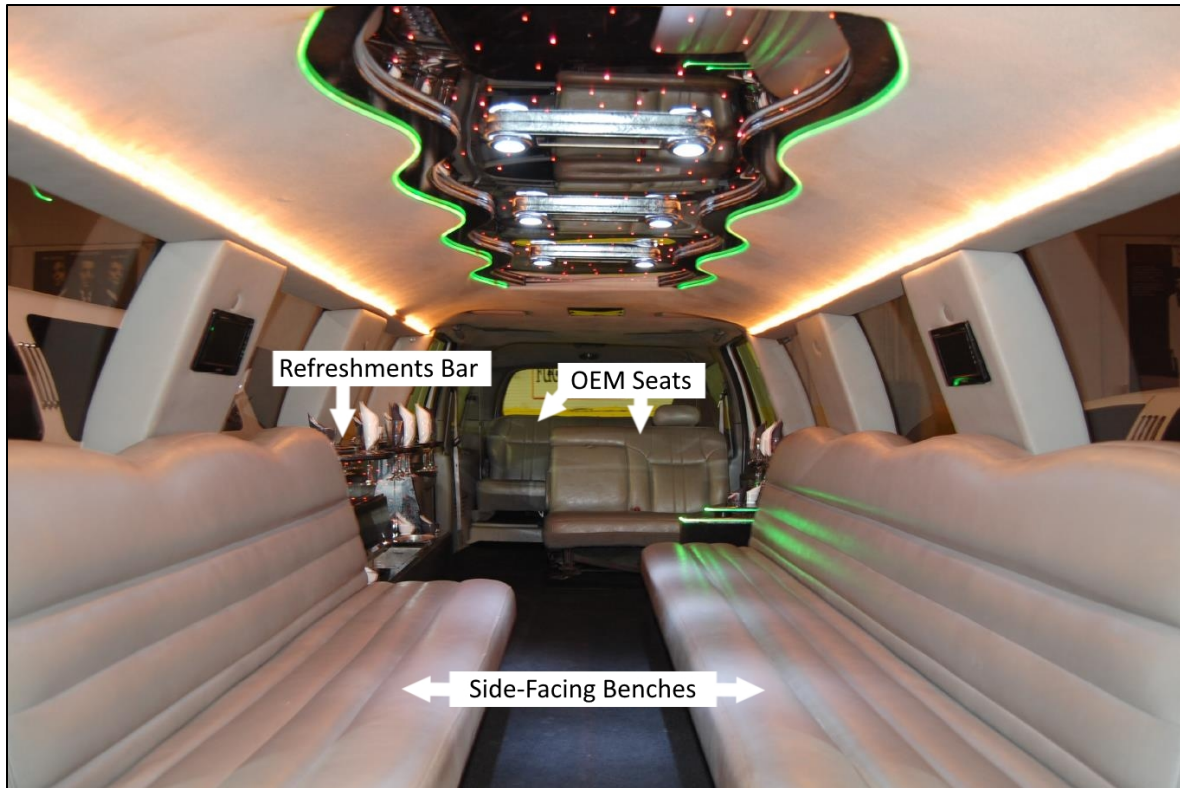
Figure 16. Photograph of limousine's interior, looking from front of vehicle toward rear of passenger compartment. (Source: Advantage Transportation Group, 2010)
