Multivehicle Work Zone Crash on Interstate 95
Cranbury, New Jersey
June 7, 2014

Accident Report

NTSB/HAR-15/02
PB2015-105186

**National
Transportation
Safety Board**

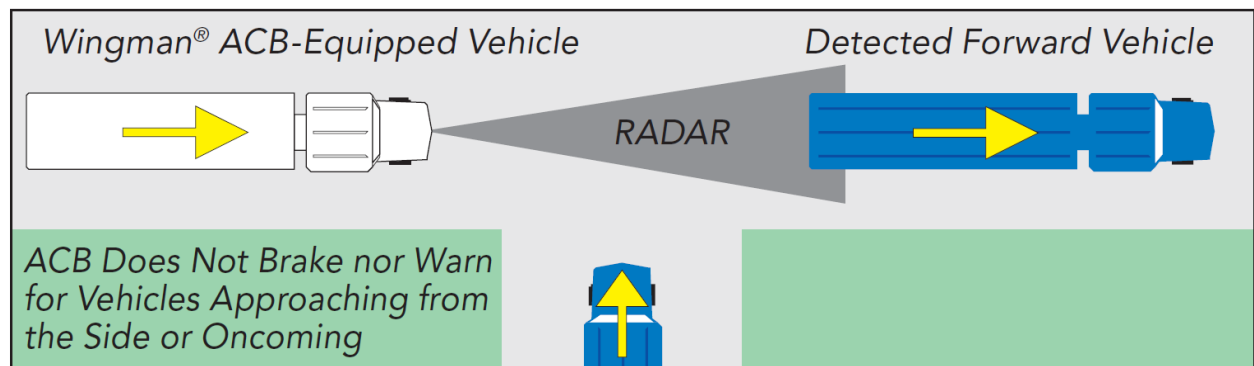
Figure 5. Bendix Wingman ACB system detecting a vehicle ahead. (Image source: Bendix system operator's manual [Bendix 2010].)

When the system is activated, interventions by either the Wingman ACB or the ESP can include automatic throttle reduction and application of up to one-third of the vehicle's potential braking power.²¹ The system will not react to non-metallic or limited metallic objects (such as pedestrians and animals). Reflective objects, such as crash barriers, guardrails, work zone barricades, and tunnel entrances, may affect the radar sensor's ability to detect another vehicle. Entering a curve will reduce the system's alert times. Once the driver intervenes with more powerful braking or other evasive maneuvers, system alerts and interventions are suppressed.

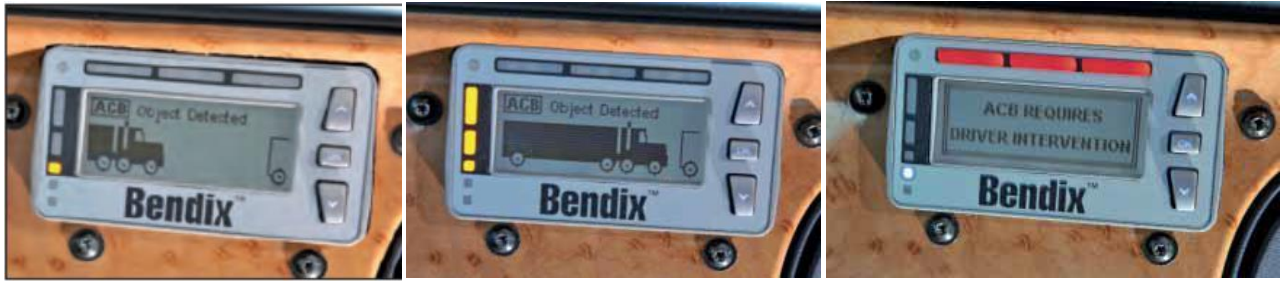
Figure 6. In-cab displays of Bendix Wingman ACB system alerts showing a following distance alert, a stationary object alert, and an impact alert. (Image source: Bendix system operator’s manual [Bendix 2010].)

Following distance alerts provide progressive audible and visual warnings whenever the distance between the equipped vehicle and a tracked vehicle ahead is less than the set distance and decreasing. If the following distance continues to decrease, the driver will hear more rapid audible alerts and see increasingly prominent yellow indicator lights along the left side of the Bendix display unit. Depending on system settings, the following distance alert may include a message to the driver saying “distance alert” or a similar warning phrase. In addition, when the distance interval reaches a critical point, a red light will illuminate on the instrument cluster. Once the audible alert is given, the driver must increase the distance between the vehicles for the audible alert to stop. With variations dependent on vehicle speeds and alignments, as well as system settings, the following distance alerts can have different frequencies and durations, ranging from fractions of a second to continuous.

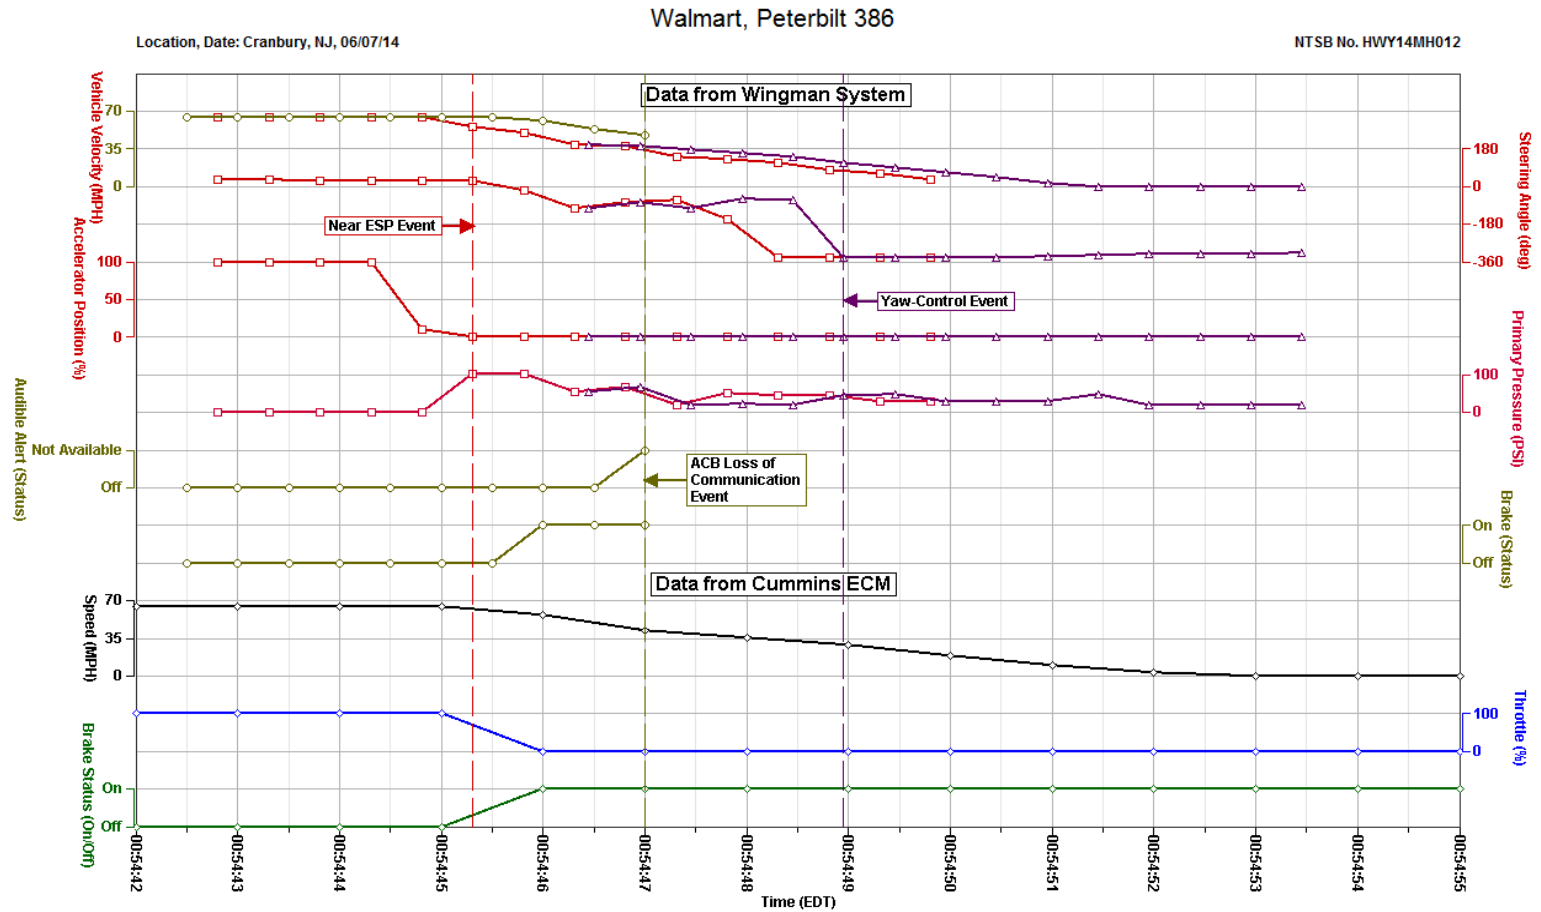
Appendix B. Walmart Transportation Truck ESP and ECM Data

⁶ The electronic control module and the active braking system were consistent in indicating cruising speeds for the Walmart Transportation truck of 64–65 mph. The active braking system has a more frequent sample rate and a record of impact time based on loss of radar control; therefore, the impact speed was taken from that system's data. The simulation analysis discussed in the Analysis portion of the report overlapped with the 47–53 mph speed. Due to uncertainties involved in estimating vehicle speeds when wheel slip is present, the actual collision speed may have differed slightly from the recorded speeds. The speed range data acquired from different electronic systems are shown in appendix B.
