Highway Investigation Report HIR-23-01

Multivehicle Crash in Icy Conditions on Interstate 35 West

Fort Worth, Texas
February 11, 2021

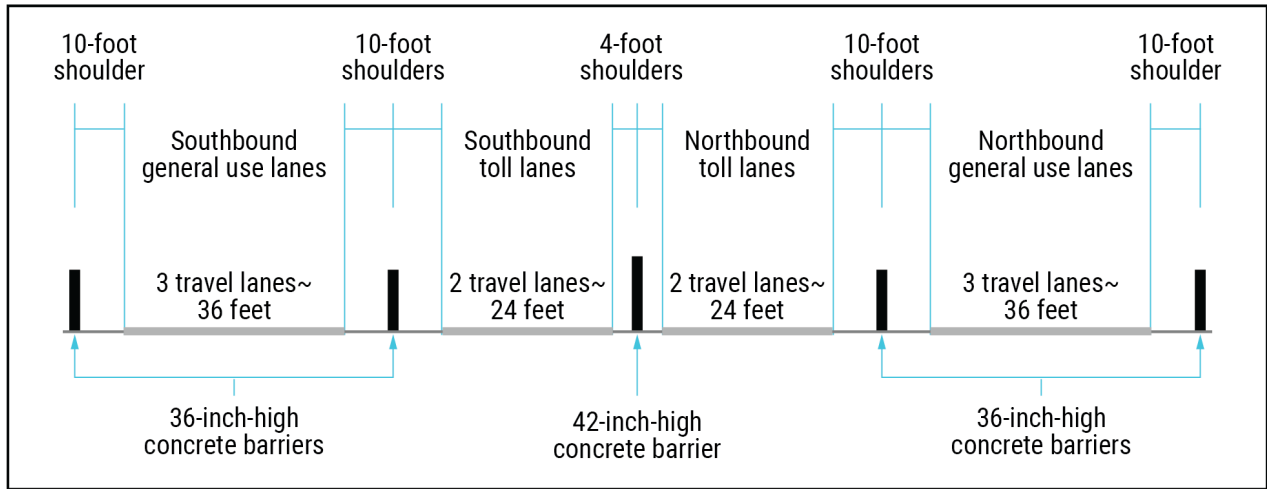
At the crash location, the southbound direction of the I-35W tollway consisted of two lanes that totaled about 24 feet wide (each lane was 12 feet wide), bordered by a left paved shoulder that was about 4 feet wide and a right paved shoulder that was about 10 feet wide. At the edge of the left and right shoulders were, respectively, a 42-inch-high and a 36-inch-high concrete barrier.¹² In the area of the crash, the concrete barriers along both sides of the travel lanes were continuous and not configured with any spacings or gaps allowing for vehicle or pedestrian passage, making the toll lanes a constrained right of way. (See figures 2 and 3.)

Figure 2. Configuration of north- and southbound travel lanes in crash area.
