HIR-23-10

Grade Crossing Collision Between Commuter Train and Box Truck

Clarendon Hills, Illinois
May 11, 2022

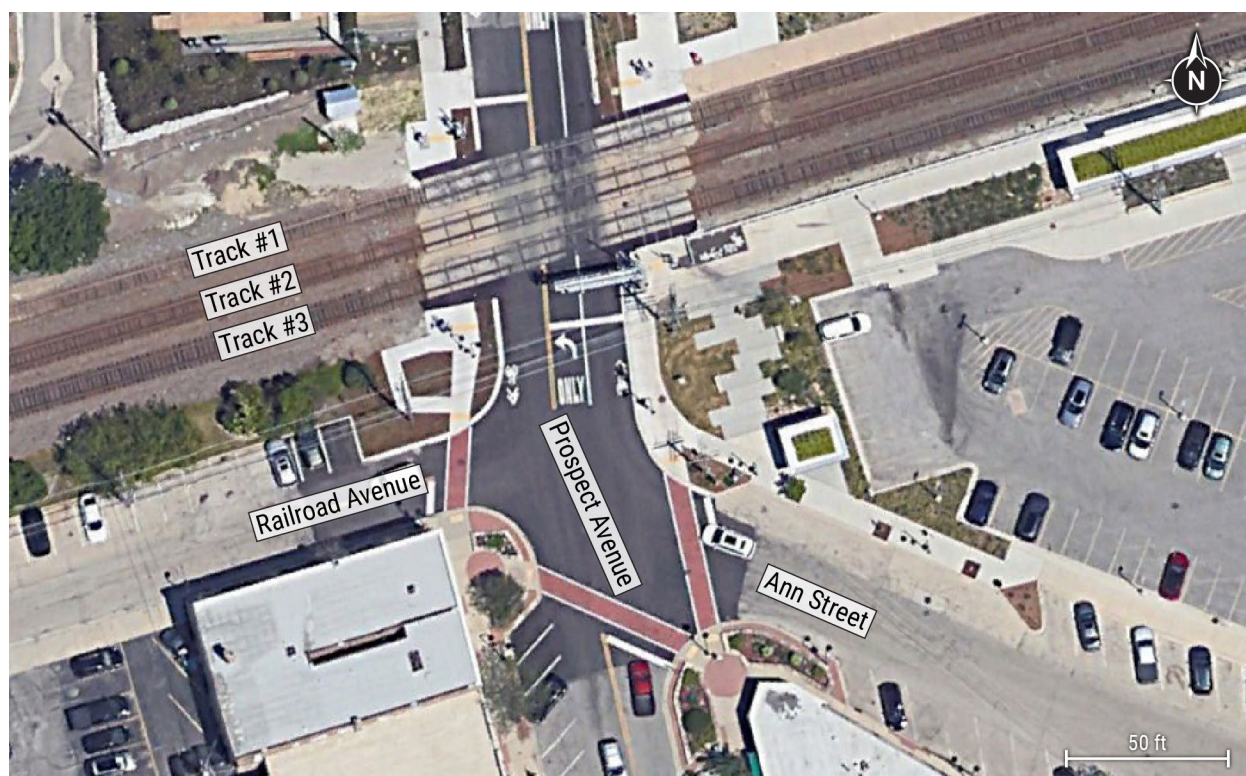
Figure 3. Overhead view of the Prospect Avenue grade crossing with side streets and track numbers annotated. (Source: Google Maps [image from 2023], annotations by NTSB)

At the grade crossing, Prospect Avenue consisted of one northbound dedicated left-turn lane, one northbound through lane, and one southbound travel lane. The grade crossing consisted of three BNSF Railway (BNSF) tracks and the three lanes of Prospect Avenue (Figure 3). The roadway grade leading up to the south end of the grade crossing was approximately a 6% upward grade.
