Hazardous Materials Investigation Report HZIR-23-01

BNSF Railway Company Derailment and Pool Fire Involving DOT-117J Tank Cars

Oklaunion, Texas
January 8, 2022

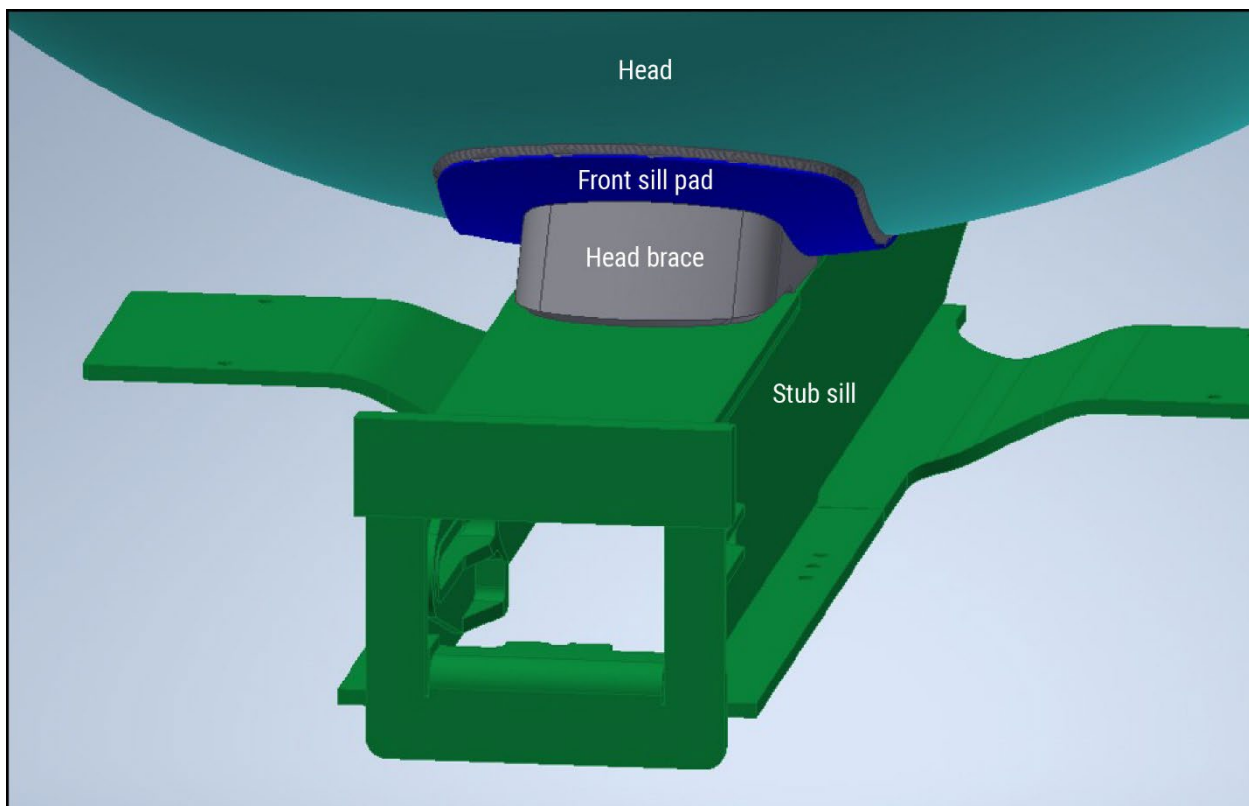
Tank cars include structural elements that support and protect the tank. One of these elements, the stub sill, is the part of the underframe below the tank itself and above the trucks (which house the tank cars' wheelsets). Stub sills are attached to tanks using sill pads to reduce stress on the tank shell during normal operations.¹⁴ At each end of a tank car, where the head of the tank curves away from the stub sill, a head brace fills in the space between the curved section of the sill pad—often called a front sill pad to distinguish it from sill pads that may be installed nearer the center of the tank. (See figure 2.)

Figure 2. Illustration of several tank car underframe components from a 3D computer model. (Courtesy of Trinity Industries with NTSB annotations.)

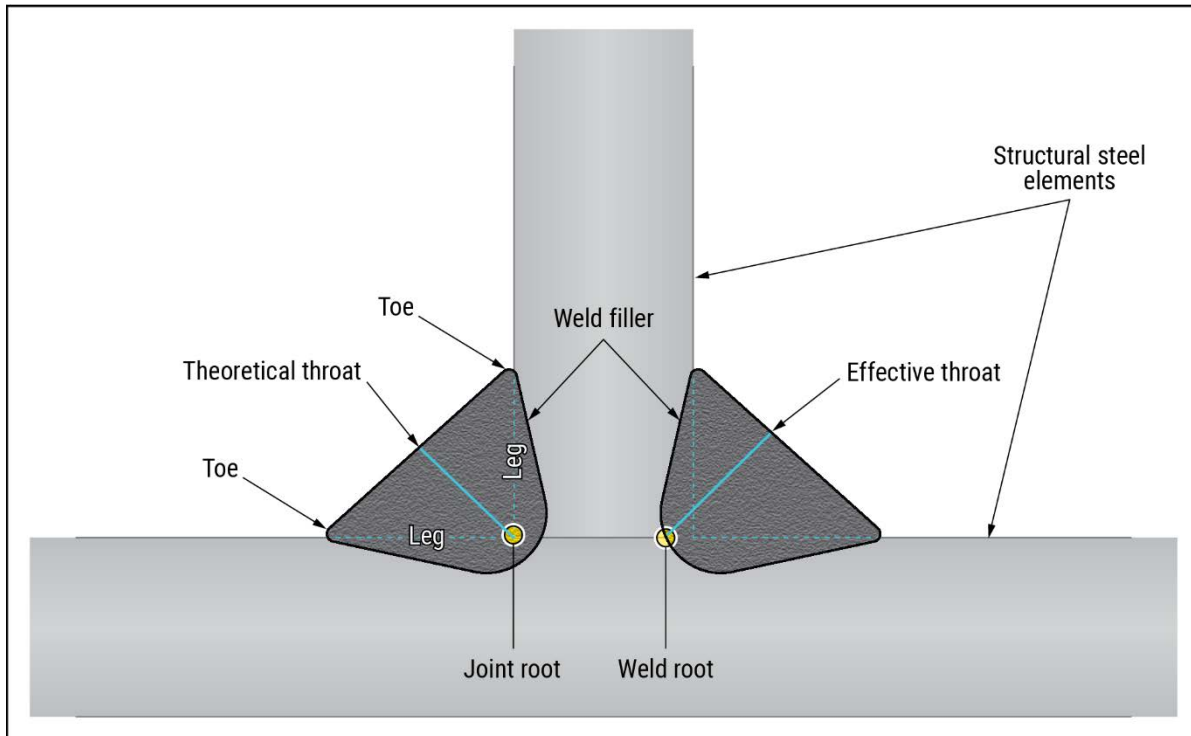
In general, weld strength is a function of weld shape and size. The welds that secure tank car structural elements to pads and pads to tanks include fillet welds, which join two pieces of metal, often at a right angle as in a T-joint. Design specifications use measurements between weld features to define fillet weld size. The point where the welded external surfaces intersect is the joint root. The distance the fillet weld extends along each surface from the joint root is a leg. The end of the leg farthest from the joint root is the toe. The theoretical throat is the shortest distance from the joint root to a line drawn between the toes of the weld.¹⁹ Effective measurements (such as effective throat) are performed from the weld root, which is the deepest point where the weld metal (or weld filler) intersects the joint surfaces; effective throat allows for a more accurate calculation of weld strength than does theoretical throat. (See figure 6.) Because a weld root is inaccessible without cutting a cross section of a weld, design specifications and inspection standards consistently use theoretical measurements.

Figure 6. Fillet weld cross-section diagram with theoretical measurements on the left and the effective throat on the right.
