Hazardous Materials Investigation Report HZIR-23-01

BNSF Railway Company Derailment and Pool Fire Involving DOT-117J Tank Cars

Oklaunion, Texas
January 8, 2022

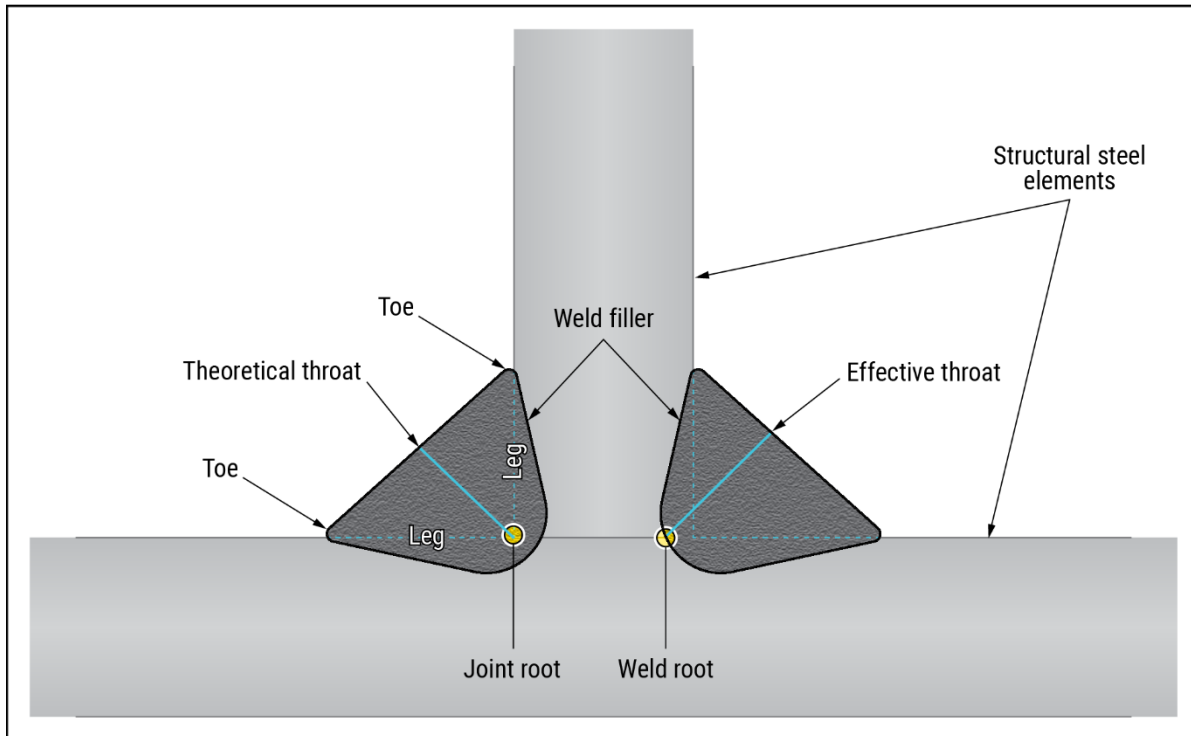
Figure 6. Fillet weld cross-section diagram with theoretical measurements on the left and the effective throat on the right.

In general, weld strength is a function of weld shape and size. The welds that secure tank car structural elements to pads and pads to tanks include fillet welds, which join two pieces of metal, often at a right angle as in a T-joint. Design specifications use measurements between weld features to define fillet weld size. The point where the welded external surfaces intersect is the joint root. The distance the fillet weld extends along each surface from the joint root is a leg. The end of the leg farthest from the joint root is the toe. The theoretical throat is the shortest distance from the joint root to a line drawn between the toes of the weld.¹⁹ Effective measurements (such as effective throat) are performed from the weld root, which is the deepest point where the weld metal (or weld filler) intersects the joint surfaces; effective throat allows for a more accurate calculation of weld strength than does theoretical throat. (See figure 6.) Because a weld root is inaccessible without cutting a cross section of a weld, design specifications and inspection standards consistently use theoretical measurements.

¹⁹ The *theoretical throat* does not extend all the way to the true surface of the weld if the weld is convex—that measurement is the *actual throat*, and it is not usually used in designs or when evaluating weld strengths, because additional material producing a convex bulge does not tend to contribute to weld strength.
