HAZARDOUS MATERIALS GROUP FACTUAL REPORT

**Derailment of Union Pacific Railroad Train UEBLTG 20
on April 24, 2019, with Subsequent Hazardous Materials Release**

Fort Worth, Texas

RRD19FR007

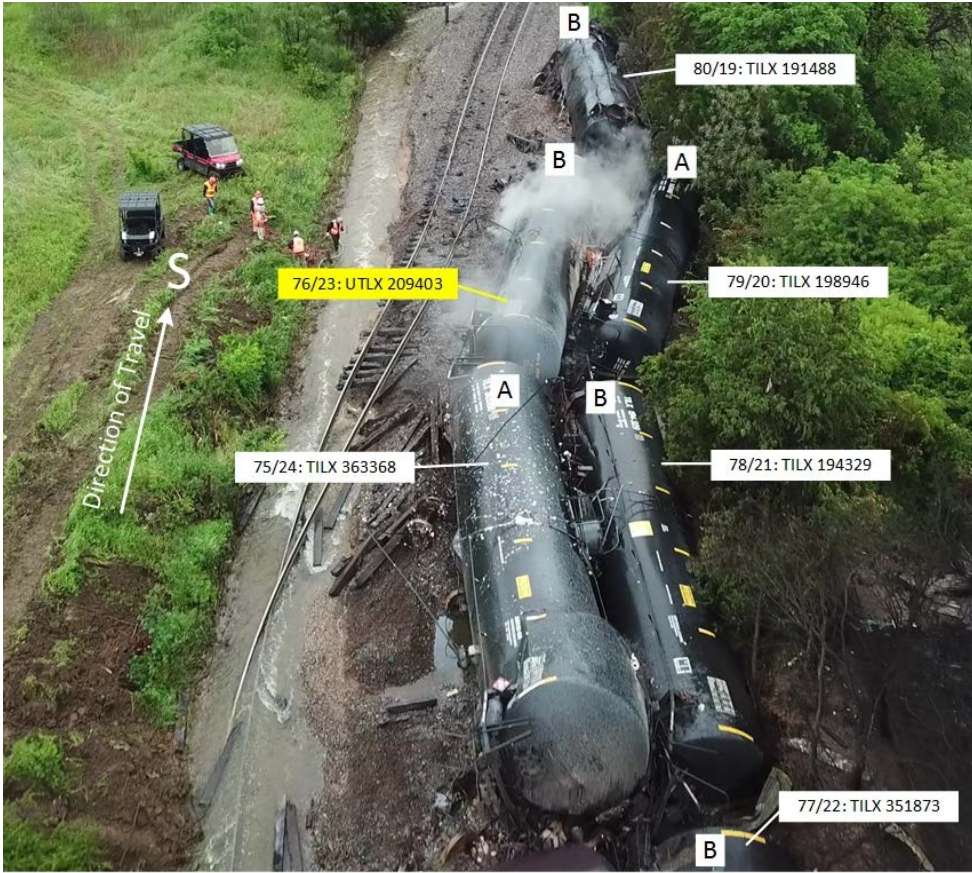
Figure 13. South end (head) of the derailment. Leading ends are labeled.

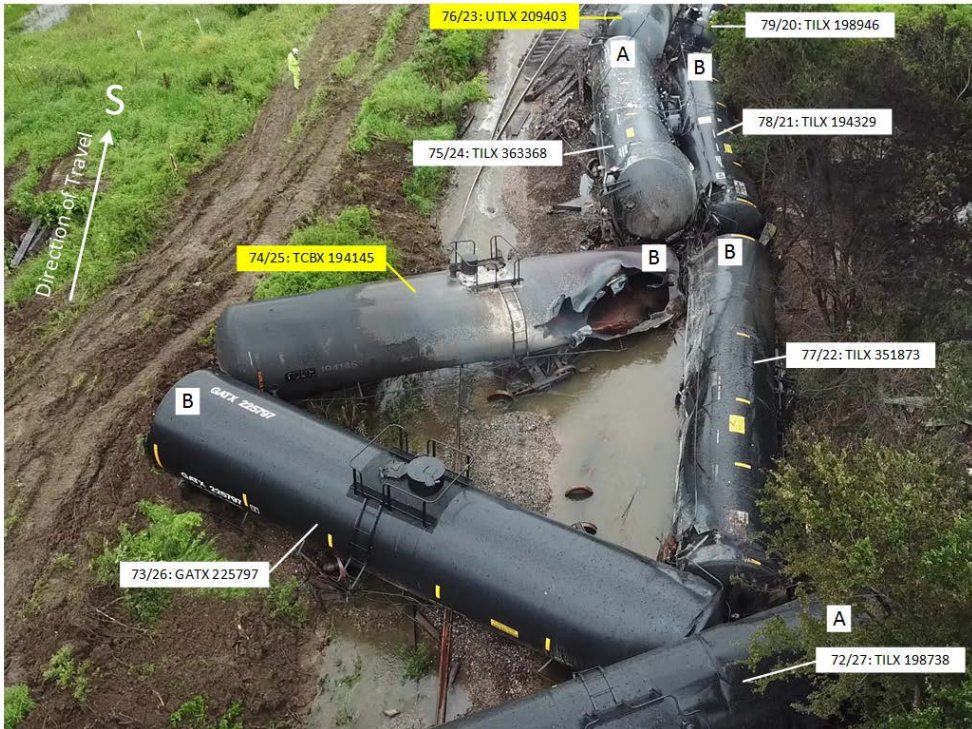
Figure 14. Middle of the derailment. Leading ends are labeled.

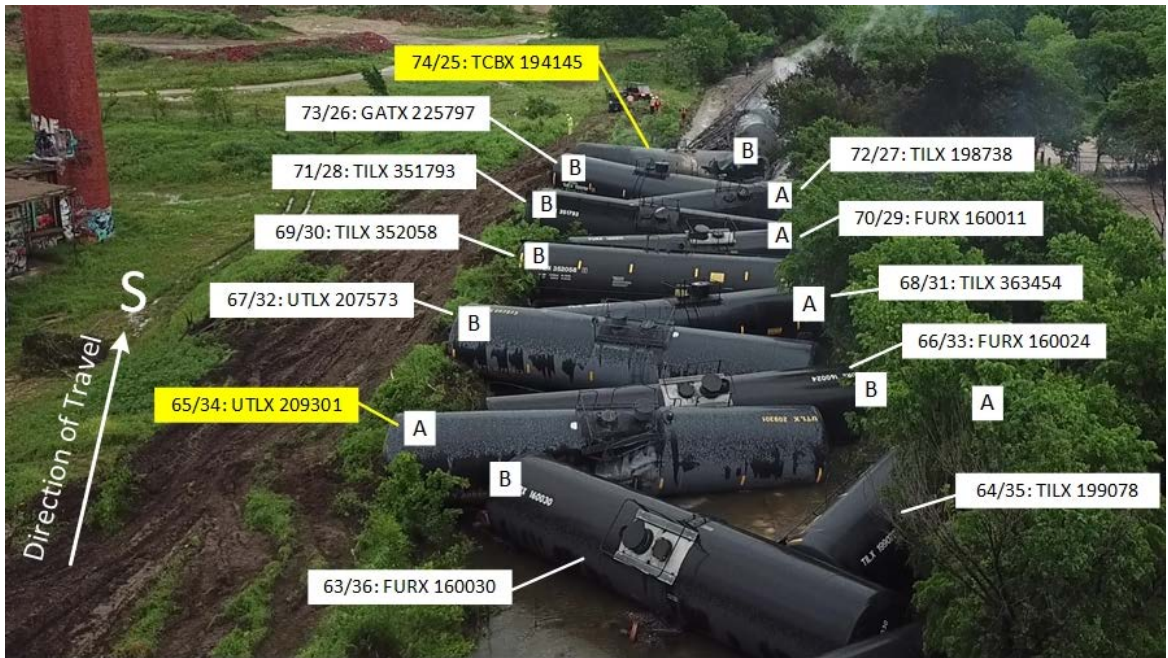
Figure 45. North end (rear) of the derailment. Leading ends are labeled.

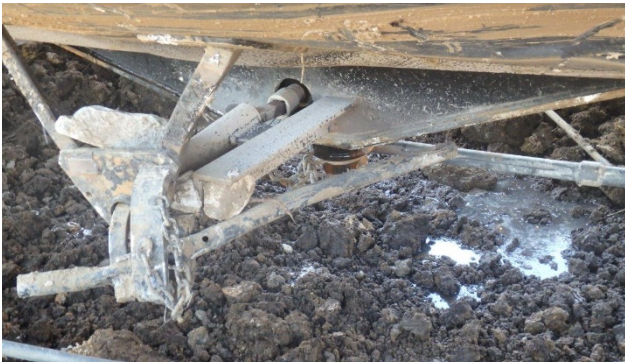
2(c) BOV operating handle and undamaged nozzle.

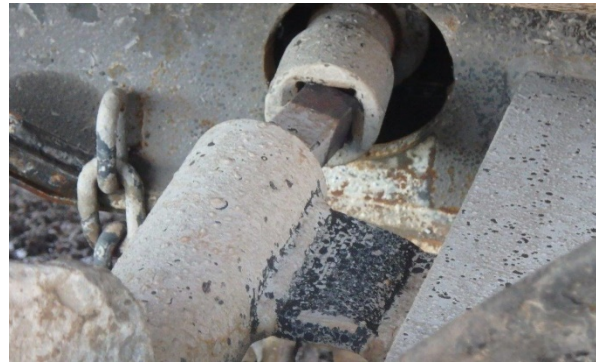
2(d) Bent BOV operating handle shaft and extension.

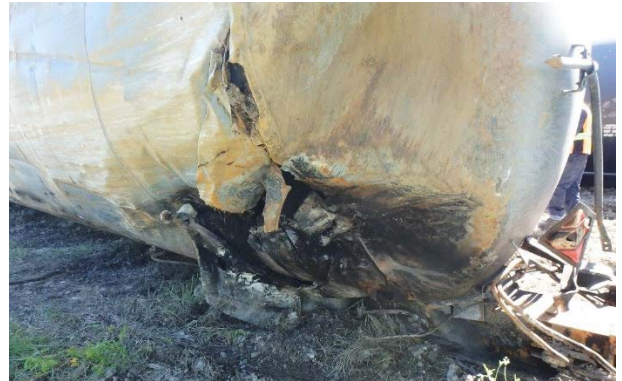
5(b) B-end head dent at 7 o'clock and breach to tank shell where the B-L bolster pad had been attached.

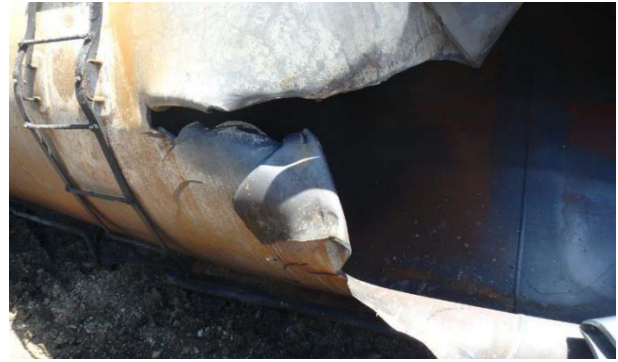
7(b) Inboard B-L shell tear detail.

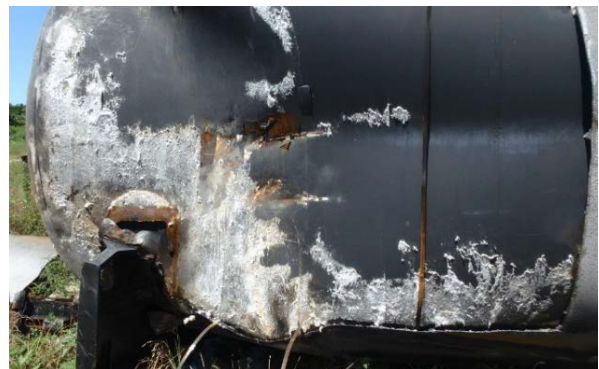
8(d) A-L shell after jacket removal showing non-penetrating gouge and dent left by the impacting stub sill. A-L bolster pad torn from the tank.

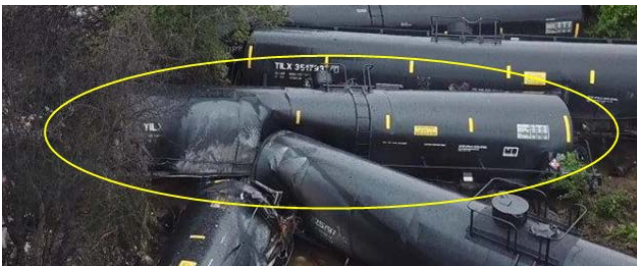
9(a) Resting position in the derailment scene with B-end of GATX 225797 in contact with the A-L shell.

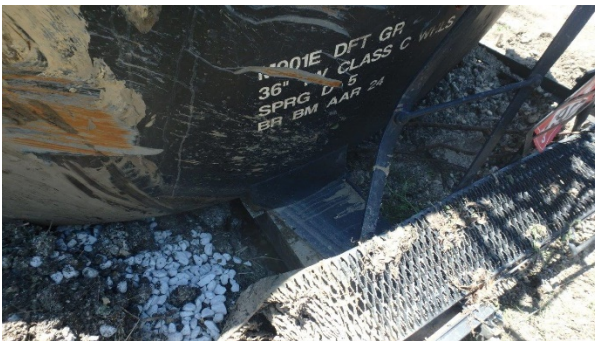
10(c) A-end head shield gouge about 6 o'clock.

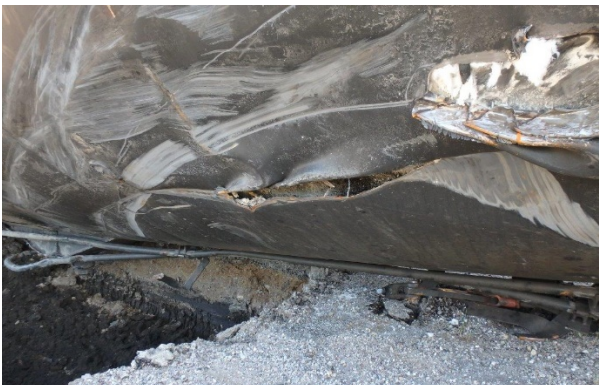
12(c) B-L longitudinal jacket tear below shell gouge.

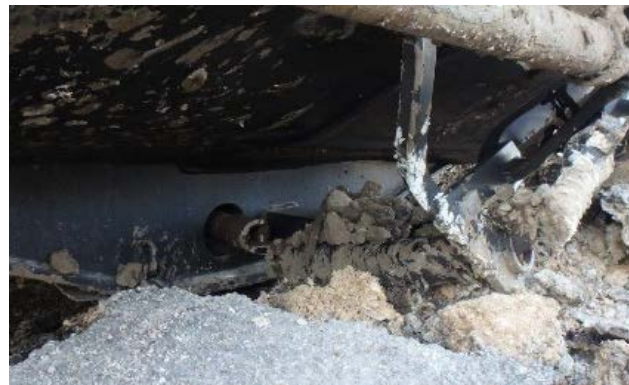
12(d) The BOV operating handle sleeve was bent away from the ball valve extension.

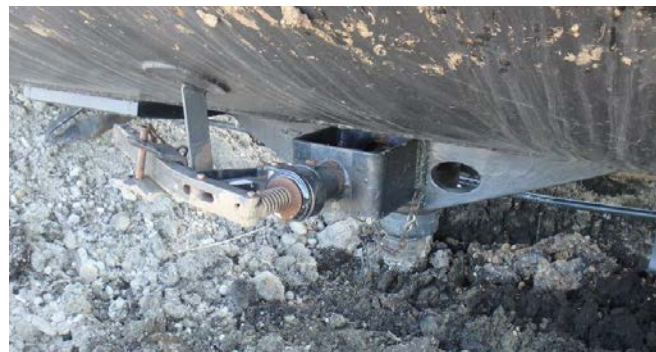
14(d) BOV operating handle and undamaged nozzle extension.

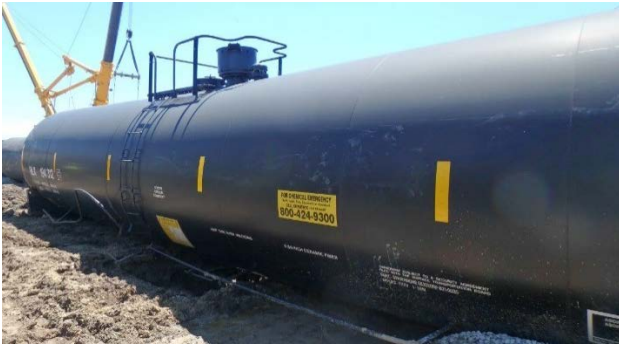
20(a) Left side showing no derailment damage.

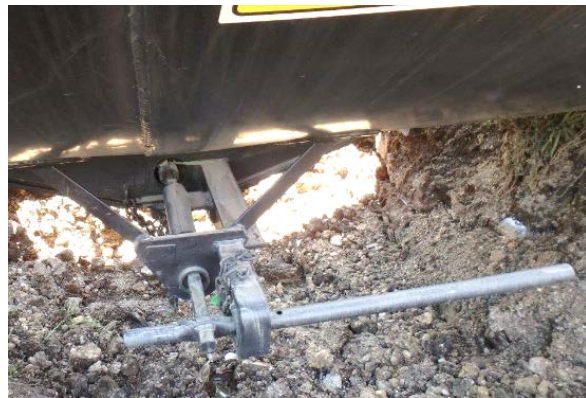
20(d) BOV operating handle and nozzle were not damaged.

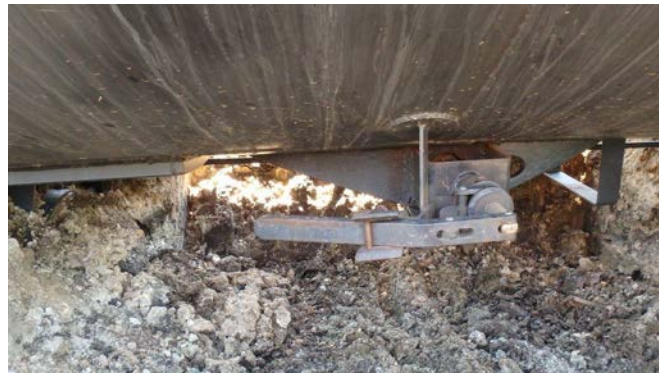
22(d) Undamaged BOV operating handle.
