# National Transportation Safety Board

HMD22LR001

## **HAZARDOUS MATERIALS**

Group Chair's Factual Report  
July 20, 2022

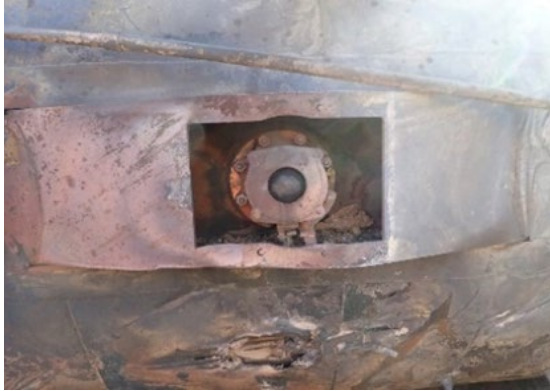
Figure 6. BOV nozzle sheared off. Valve body remained intact and closed at skid shear plane. TILX 731782. January 11, 2022. Courtesy Trinity Industries Leasing, Inc.

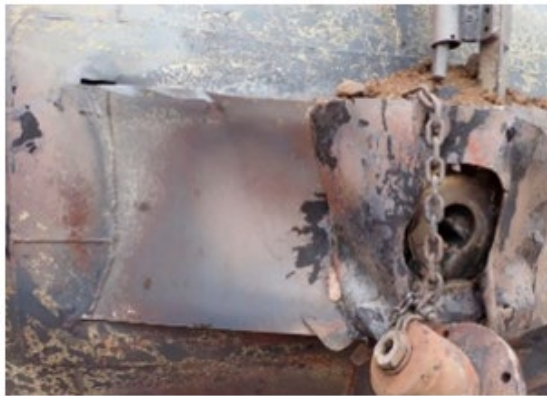
Figure 7. Center skid structure collapse with nozzle assembly sheared as seen hanging by the safety chain. Ball valve partially opened and BOV handle disengaged. CRDX 300056. January 26, 2022. Courtesy Trinity Industries Leasing, Inc.

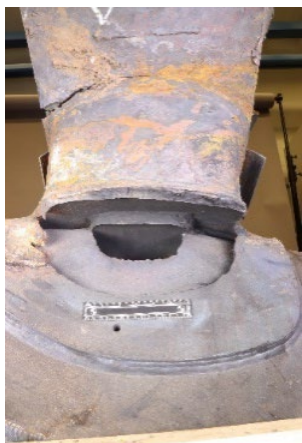
A-end stub sill head pad section with tank breach at the fractured A-3 stub sill “window weld” removed from the tank car and sent to the NTSB laboratory for examination (Control # HMD22LR-HAZ-002) (Figure 18). Figure 19 drawing of the head brace assembly shows welds in Section G-G, where the fracture occurred.

Figure 18. A-end stub sill/head pad/tank section removed for NTSB laboratory examination. TILX 731751. January 28, 2022.

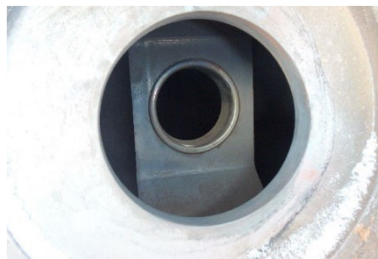
prevent the eduction pipe from shifting. Figure 21 shows proper placement of eduction pipe in the guide assembly.

Figure 21. Eduction pipe placement in guide assembly over BOV, TILX 731739. January 27, 2022.

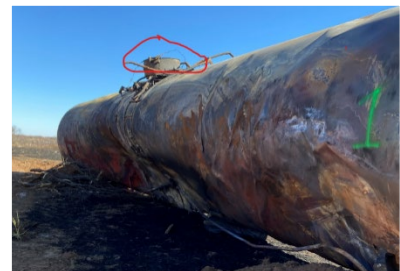
1(c) Protective housing cover torn off and crushed.

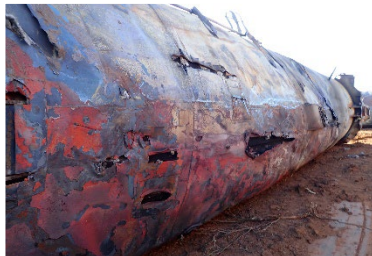
Consist order	<b>42</b>
Orientation in the consist	A
Heads	No damage.
Shell	Jacket thermal damage with several dents and tears (Figure 2a)
Bottom outlet valve	BOV skid protection structure collapsed in the center. BOV saddle missing, and bolts sheared/ smeared toward the B-L side. A dent in the BOV flange indicates impact from the A-R direction (Figure 2b). BOV stem bent.
Top fittings, PRD and Manway	Thermal damage to manway and top fittings (Figure 2c). 2 manway eyebolts bent. Protective housing damaged.
Stub sills	A-end draft sill torn
Breach/ Loss of Product	Thermal / 17,657 gallons

*2(a) Heavy thermal and mechanical jacket damage. Missing bottom outlet valve and saddle, and collapsed skid protection structure.*

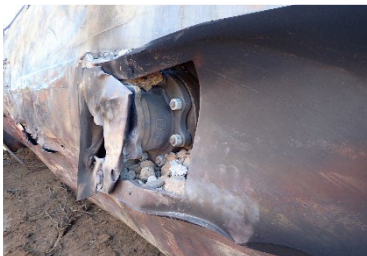
*2(b) Bottom outlet valve sheared off with ball intact.*

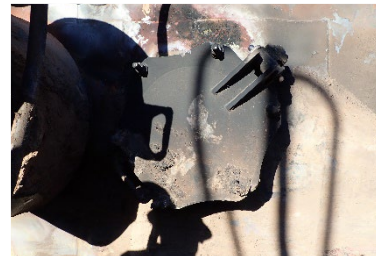
*2(c) Thermal damage to manway with visible carbon on lid.*

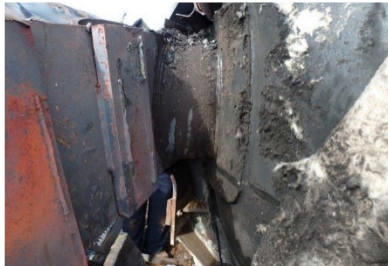
3(a) A-end head pad and head brace. No breach.

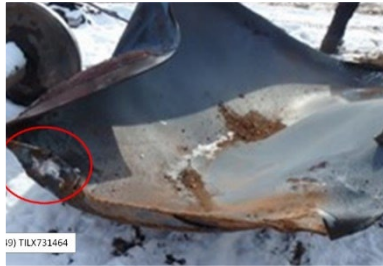
5(b). B-end head shield, impact mark (circled).

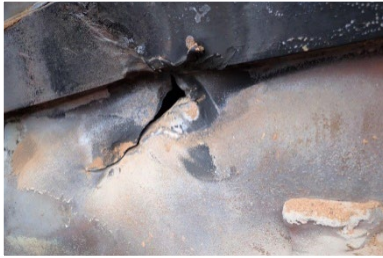
Consist order	<b>50</b>
Orientation in the consist	A
Heads	No damage
Shell	Bottom of tank punctured between the bottom reinforcing bats about 2 ft. beyond the A-end side of the BOV skid structure. Tank buckled inward at the puncture location (Figure 6a) Breach was a 2-inch angular hole along with a 6-inch long (through-wall) crack. A 2-inch gouge led to the hole from the A-end side of the tank.
Bottom outlet valve	Skid structure intact and ball valve closed (Figure 6b)
Top fittings, PRD and Manway	Manway thermally damaged.
Stub sills	No recorded damage
Breach/ Loss of Product	Mechanical and thermal / 15,465 gallons

6(a). Tank puncture A-end bottom center, 2 ft. beyond BOV skid structure.

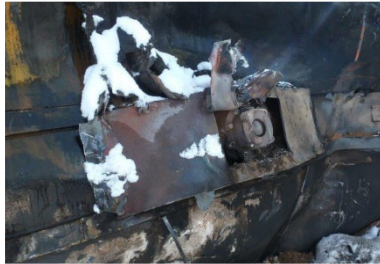
6(b). Buckled tank bottom and BOV skid structure.

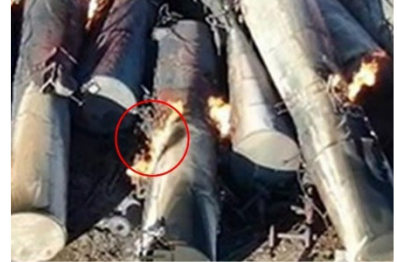
6(c). Flame in area of tank puncture, bottom center A-end side of BOV.

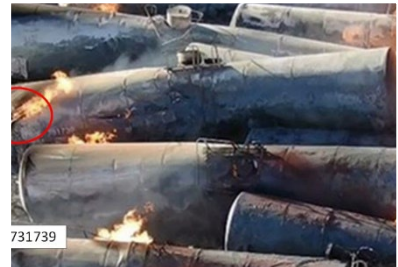
8(f). Flame at A-end head/shell tear.

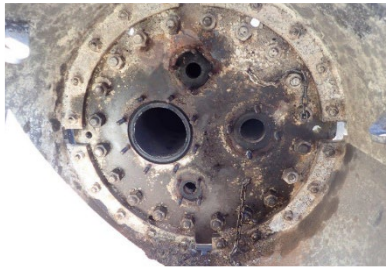
10(a). Top fittings flange after removal of fittings for bench testing.

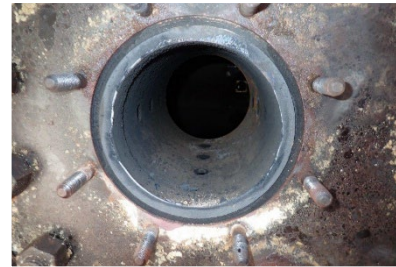
10(c). Carbon deposits on internal surface of PRD vapor space communication pipe.

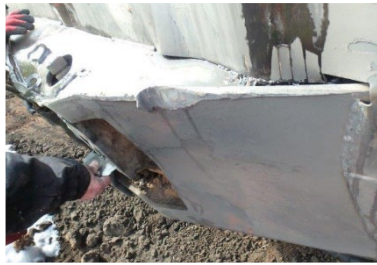
11(b). Skid protection structure impact mark, A-R side of skid structure.

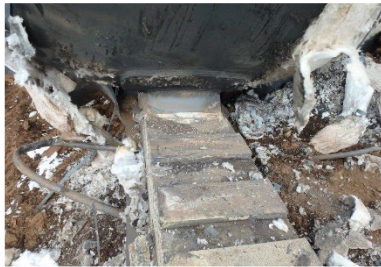
12(b). A-end head pad and head brace, no visible weld cracks.

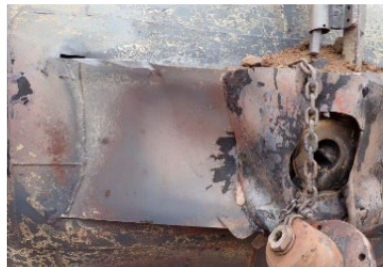
13(b). B-side skid protection structure. Impact marks on right side, dished in the middle. The separated BOV nozzle was hanging from the safety chain.

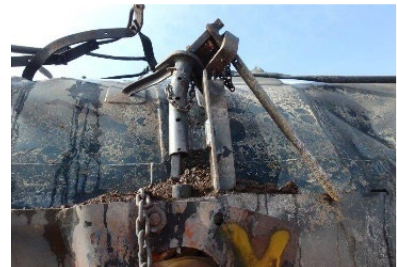
13(c). Bent and separated BOV operating handle extension.

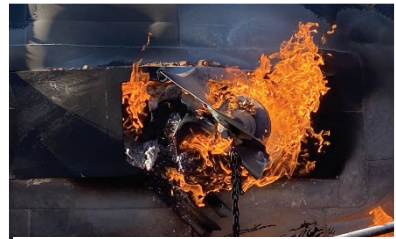
15(c). BOV active leak with fire due to burned out seats and gaskets.

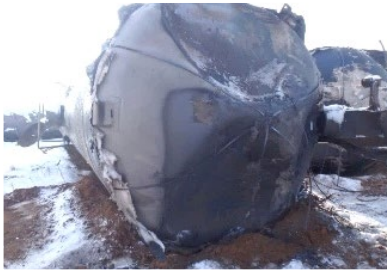
Consist order	<b>63</b>
Orientation in the consist	A
Heads	<p>A-end head shield and jacket were removed for inspection (Figure 16a). The head sustained three dents. The lower dent (directly above the stub sill) measured 60-in x 32 ¼-in x 8-in deep (Figure 16b). The upper right side of the head sustained a dent that measured 65-in x 80-in x 12-in deep. The upper left side of the head sustained a dent that measured 69-in x 70-in x 12-in deep.</p> <p>The A-end head pad fractured around the HAZ of the head brace attachment fillet weld. The head pad peeled away from the tank. The A-3 rectangular stub sill to head pad “window weld” appears to have penetrated the tank and the weld did not crack as the tank was pulled away from the stub sill. The tank fractured around the A-3 weld, opening a hole as the tank was deformed upward by a dent (Figures 16a-16h).</p>
Shell	Shell breach through A-end head. Jacket around the B-L side of the manway was scorched.

16(a). A-end head after head shield and jacket removal.

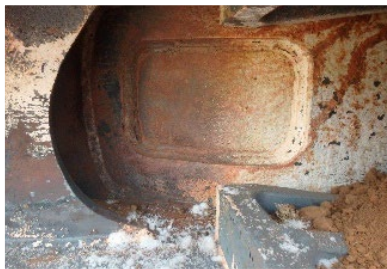
16(d). A-3 window weld, viewing the interior surface of the stub sill top plate.

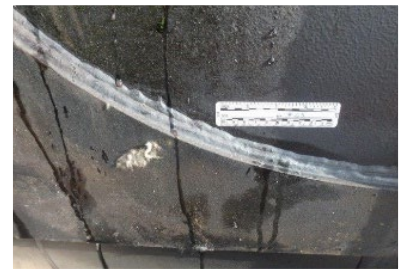
16(f). A-15 inboard sill pad weld.

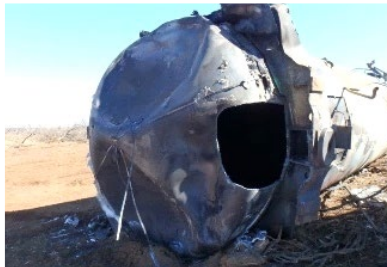
16(g). A-end head after stub sill/head pad/tank section was removed for laboratory examination.

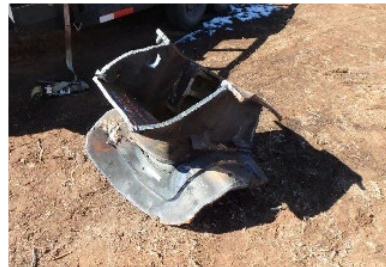
16(h). Evidence no. HMD22LR001-HAZ-002, stub sill/head pad/tank section.

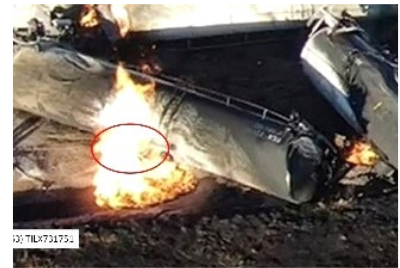
Bottom outlet valve	No damage.
Top fittings, PRD and Manway	Thermal damage to the top fittings and interior surface of the protective housing (figure 16i).
Stub sills	<p>The left and right A-end stub sill web was torn and peeled in both transverse directions. The left half of the head brace fillet weld to the top stub sill plate was fractured (Figure 16c).</p> <p>The inboard sill pad A-15 weld measured 10.5 mm thick (as measured by Vernon Walker, FRA). The left inboard sill pad leg fillet weld measured 6 mm, while the right leg fillet weld measured 8 mm. Weep holes near the stub sill tail piece indicated the pad was fitted flush with the tank in this area.</p>
Breach/ Loss of Product	Mechanical and thermal / 28,917 gallons

16(i). Flame from top fittings and manway area. The breached A-end head is to the right in this photograph with no flames visible in that area.

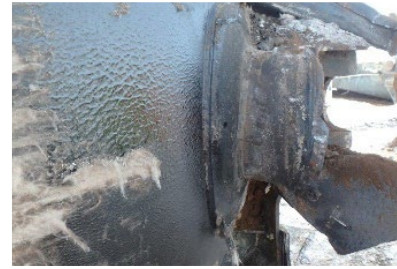
17(c). A-end head pad and head brace. The head pad A-1 and A-2 welds were not fractured.

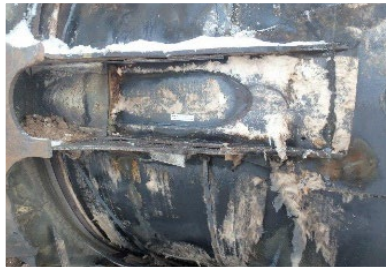
17(d). A-end inboard stub sill tail pieces. The measured A-7 fillet weld was adjacent to the white photo-tape.

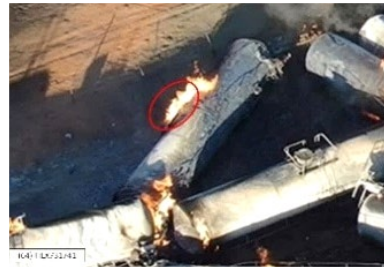
17(e). Flame in area of top fittings housing and manway.

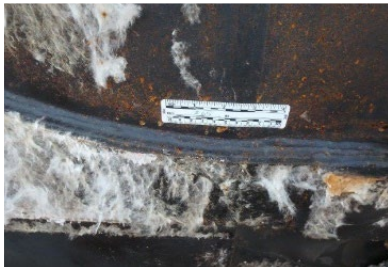
18(a) A-15 weld measurement location.

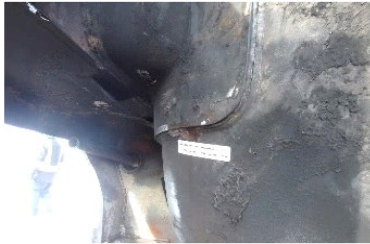
Consist order	<b>66</b>
Orientation in the consist	<b>B</b>
Heads	B-end head pad A-1 and A-2 fillet welds cracked, but head pad did not separate from the tank (Figure 19a). B-end head was punctured about 12-in above and to the right of the stub sill (Figure 19b). The puncture was an angular 4-inch-long tear within a shallow dent. There was a 1- to 2-inch-long gouge in the head material above this tear.
Shell	B-end head/ shell puncture - angular 4-inch tear with shallow dent
Bottom outlet valve	Eduction pipe and mounting flange were displaced from the sump and situated behind the ball valve 19(c)
Top fittings, PRD and Manway	PRD gasket was thermally damaged/ destroyed. Liquid valve gasket was thermally damaged. Manway area thermally damaged.
Stub sills and couplers	A-end coupler shank pushed upward. The top draft sill plate was torn and bent upward. Both A-end draft gear bottom carrier plates were deformed downward.

19(a). B-end head pad with cracked A-1 and A-2 fillet welds.

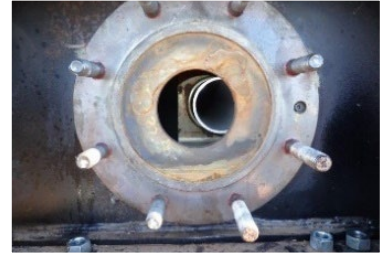
19(c). Displaced eduction pipe and flange as seen through BOV hole (investigators removed the bottom outlet valve from the flange).
