WPR23LA004

Group Chair's Factual Report - Attachment 2
Bell Alert Service Bulletin No. 206L-20-184

ALERT SERVICE BULLETIN

SUBJECT: SEGMENTED TAIL ROTOR DRIVESHAFTS 206-040-369-001/-101, 206-040-365-001/-117/-125 WITH BONDED ADAPTERS, PROOF LOAD TEST OF.

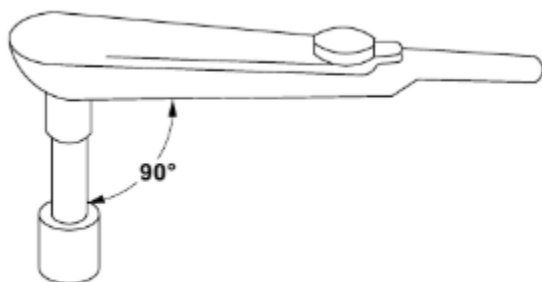
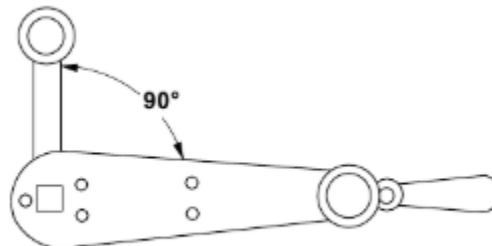
Applied and indicated torque values are the same.

Torque Wrench Concentric Type Attachments (Ref) BHT-ALL-SPM, Chapter 2

Use a ½-inch square drive dial-type torque wrench capable of measuring up to 150 foot-pounds (237 Newton-meters). Refer to BHT-ALL-SPM, Figures 2-1, 2-2, and 2-3 concentric and non-concentric type attachments. Examples of torque values when using concentric and nonconcentric attachments are shown in Figure 7.

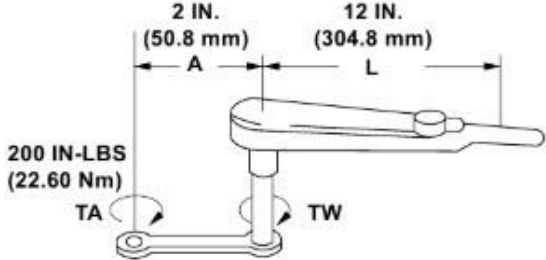
**Figure 7 – Example of Nonconcentric Type Attachments
(Ref) BHT-ALL-SPM, Chapter 2**

<p>FORMULA TO OBTAIN CORRECT INDICATED TORQUE VALUE WHEN USING NONCONCENTRIC ATTACHMENT</p> $TW = \frac{(TA) \times (L)}{(L) \pm (A)}$ <p> TW = INDICATED TORQUE VALUE ON TORQUE WRENCH TA = ACTUAL TORQUE VALUE APPLIED TO FASTENER L = LEVEL LENGTH A = ATTACHMENT LENGTH </p> <p>FORMULA</p>

<p> $TW = \frac{200 \times 12}{12 + 2} = \frac{2400}{14} = 171.4 \text{ IN-LBS (19.37 Nm)}$ </p> <p>RESULTS: FASTENER TORQUED 200 IN-LBS (22.60 Nm) WHEN WRENCH INDICATES 171.4 IN-LBS (19.37 Nm)</p> <p>EXAMPLE 1</p>
--	---
