**Highway Attachment -MSHP Crash Report**

**RRD22MR010**

MISSOURI UNIFORM CRASH REPORT

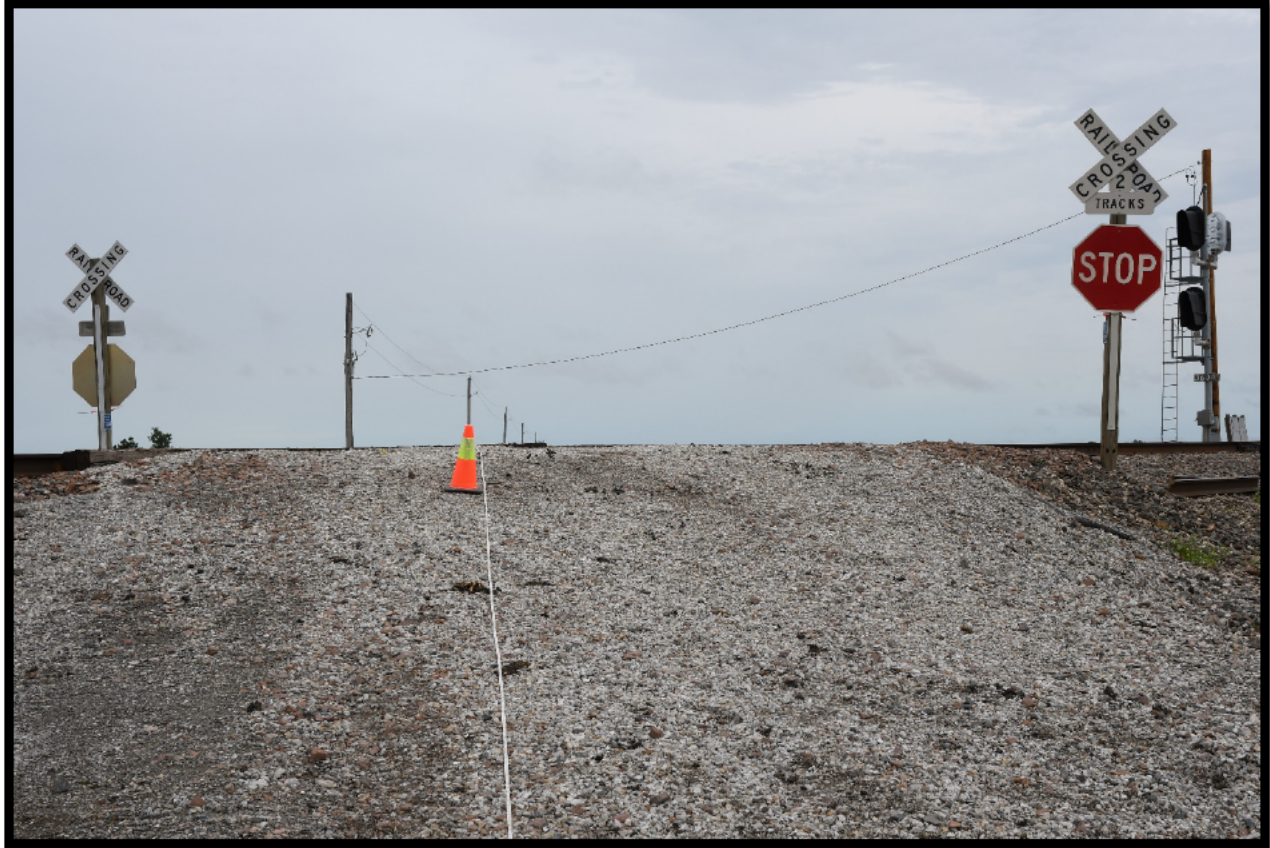
This crash occurred on Porche Prairie Avenue at Burlington Northern Santa Fe (BNSF) Railroad crossing number 005284Y. Porche Prairie Avenue was considered a north/south roadway, which traversed north and south in the area of the crash. At the crash location, Porche Prairie Avenue was a gravel roadway which measured approximately 17.4 feet in width and was designed for northbound and southbound travel. The roadway had no traffic control markings or lane lines. The crossing had only passive warning signs with cross bucks and a stop sign at each side of the crossing. The following photograph, DSC\_0002, depicts the cross bucks and stop sign, looking north from the northbound approach.

There were no shoulders and the roadway had farm fields on both sides. Porche Prairie Avenue was nearly level, south of the railroad crossing, until northbound motorists traveled an uphill grade which leveled off to cross a set of railroad tracks.

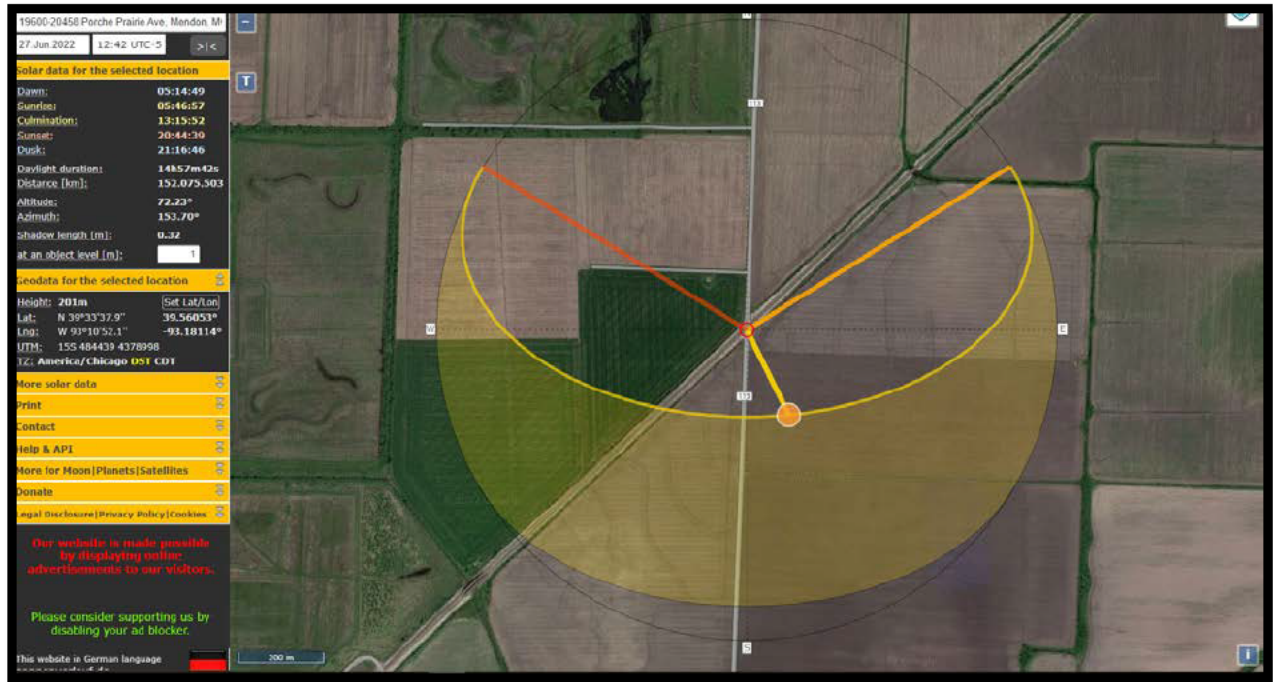
A check of the website [Suncalc.org](http://Suncalc.org) indicated on the day of the crash the sun rose at 0546 hours and set at 2044 hours. At the time of the crash, the sun was at an elevation of 72 degrees above the horizon and at an azimuth of 153 degrees. This would have placed the sun to the right and rear of Driver #1 and to the right of the Vehicle #2 Engineer. The sun report can be seen in the following image from [Suncalc.org](http://Suncalc.org).

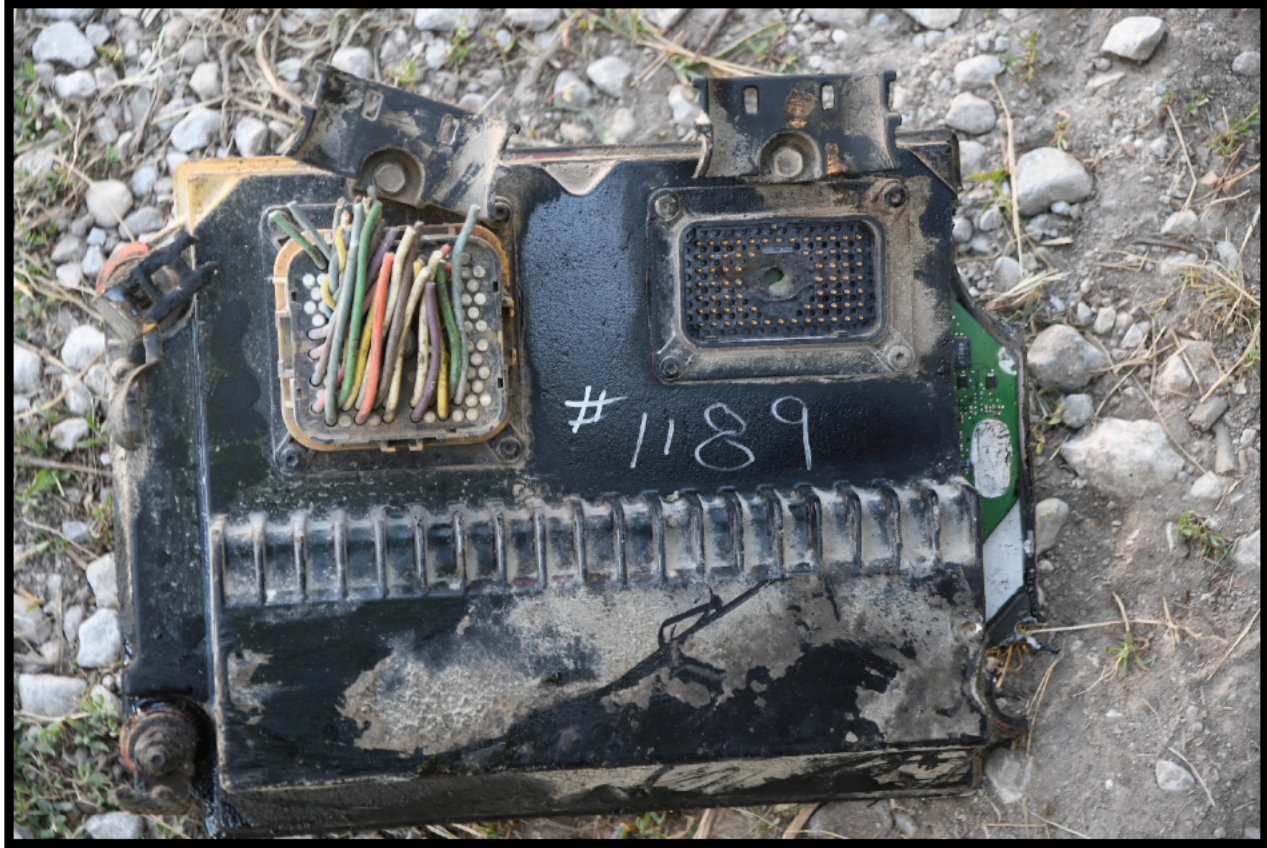
On June 28, at 1241 hours, I spoke with Phillip Davidson, an attorney representing the owner of Vehicle #1. He provided consent to remove the Vehicle #1 ECM and to release it to the NTSB to image the stored data at their laboratory in Washington DC. An audio recording of Mr. Davidson's consent is included on the digital media which contains this narrative. At 1745 hours, I removed the Vehicle #1 ECM module. I cleaned a portion of the cover and wrote my badge number, #1189, with a silver marker as a reference mark. I then released it into the custody of NTSB Investigator Payan. He provided me with a National Traffic Safety Board Evidence form and it is included in this report as an attachment. The condition of the ECM when I provided it to Investigator Payan can be seen in the following image, DSC\_0003.

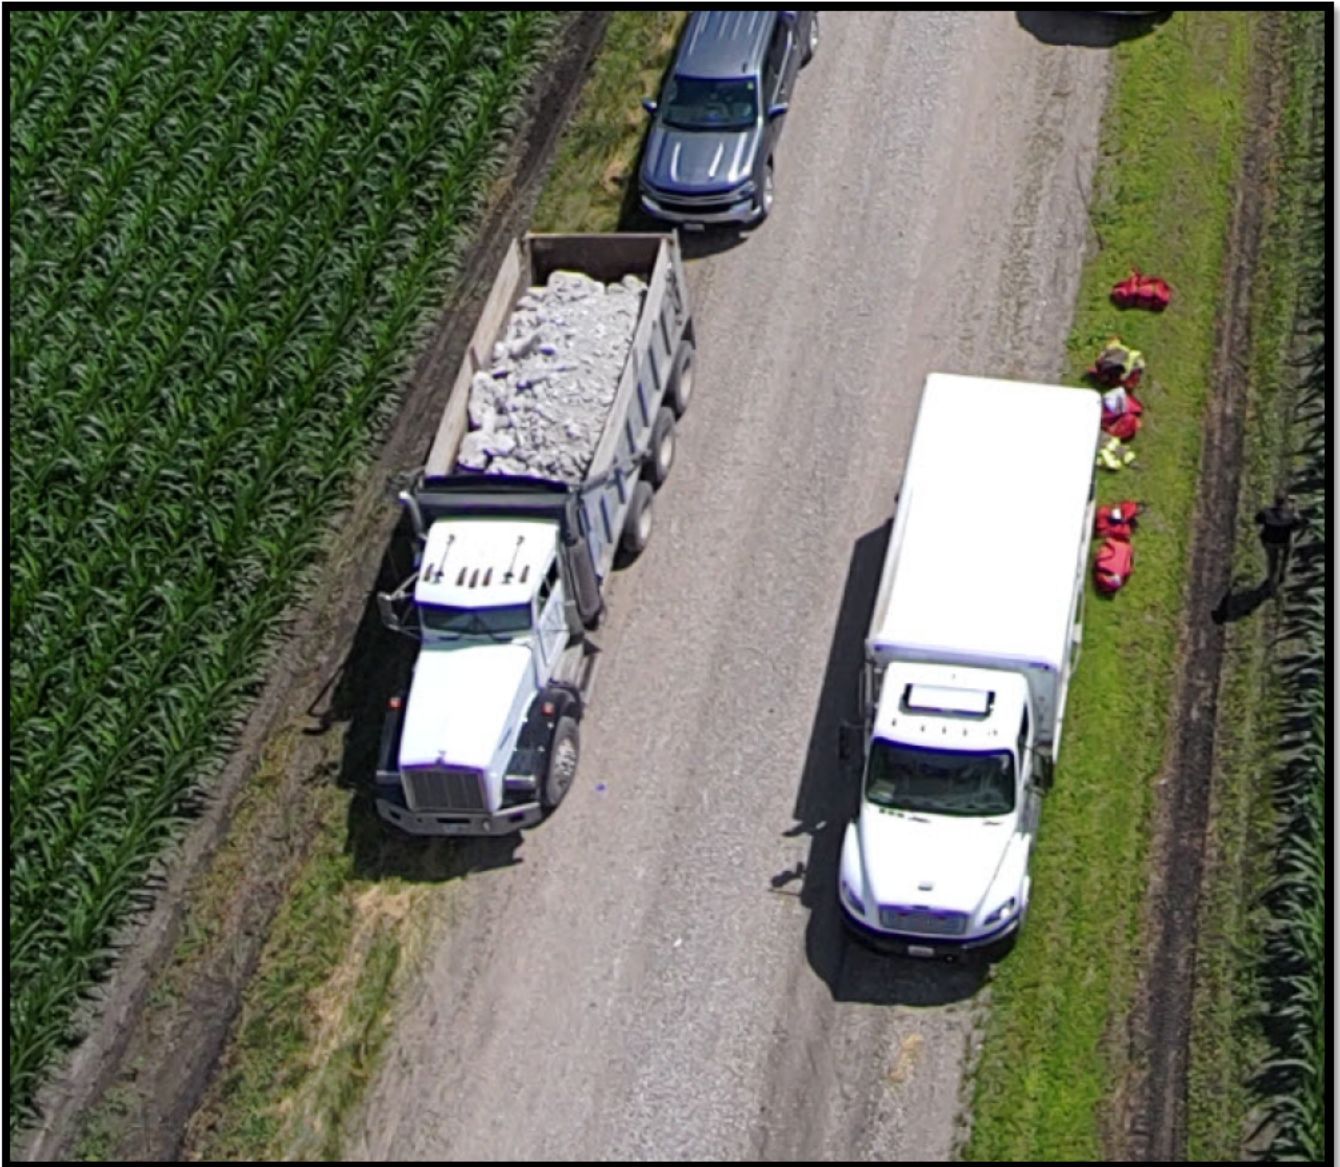
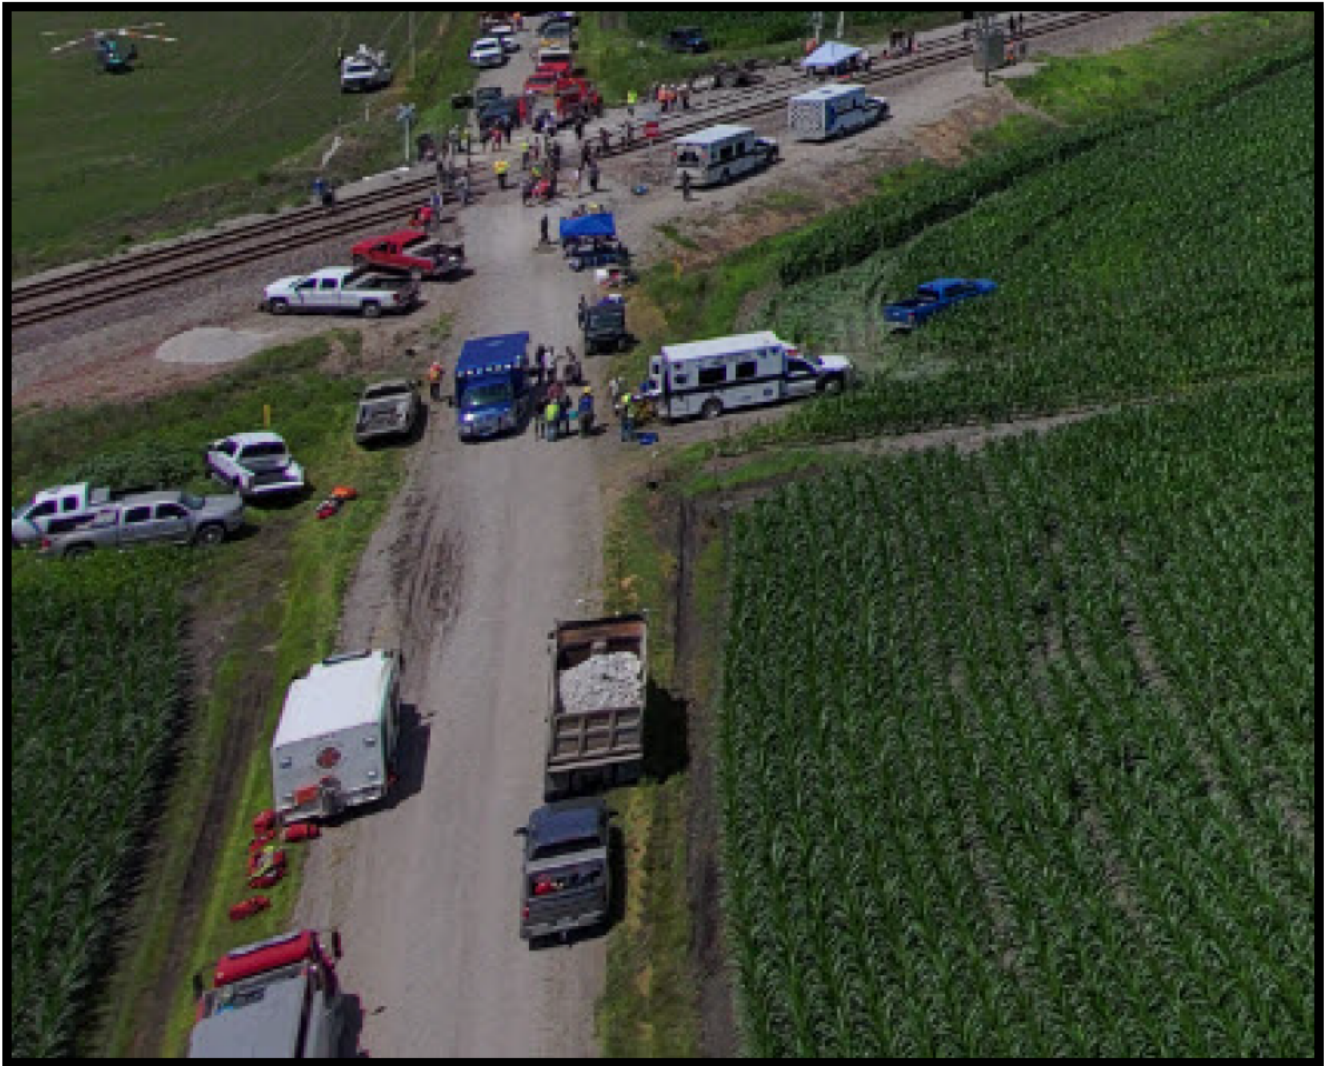
I asked Witness #1 about the vehicle he operated, the crossing, and his vehicle configuration. He stated he and Driver #1 both operated manual transmission dump trucks. He lifted his single pusher axle prior to the crossing because in the up position it still touched the roadway as he crossed the tracks. He stated it would have been difficult to cross the tracks with the pusher axle lowered and may have damaged the truck. He stated the type of rock on the grade was loose and caused the truck to bounce. He described the rock as spongy. I asked if and where he stopped prior to the crossing. He stated he did not stop on the grade as it was too difficult to get started again. He instead slowed to nearly a stop or stopped on the flat just prior to where his front wheels began up the embankment.

I informed him the speedometer and tachometer on Vehicle #1 were at approximately 5 miles per hour and about 1100 RPMs. He stated that was approximately the speed and RPMs he also crossed the tracks due to the crossing being so rough. He stated he needed to go slow since the pusher axle would touch as he entered the crossing. He did

not think he or Driver #1 could have safely crossed the tracks much faster than 5 miles per hour without damaging their trucks. The truck operated by Witness #1 can be seen parked at the crash scene on the day of the crash in the following screenshots from aerial images, S1001406 and S1001368.
