National Transportation Safety Board

MBTA Accident Brookline, MA

NTSB Accident Number: #RRD21FR013
Trolley Collision with Derailment

Human Performance / System Safety Group Factual Report

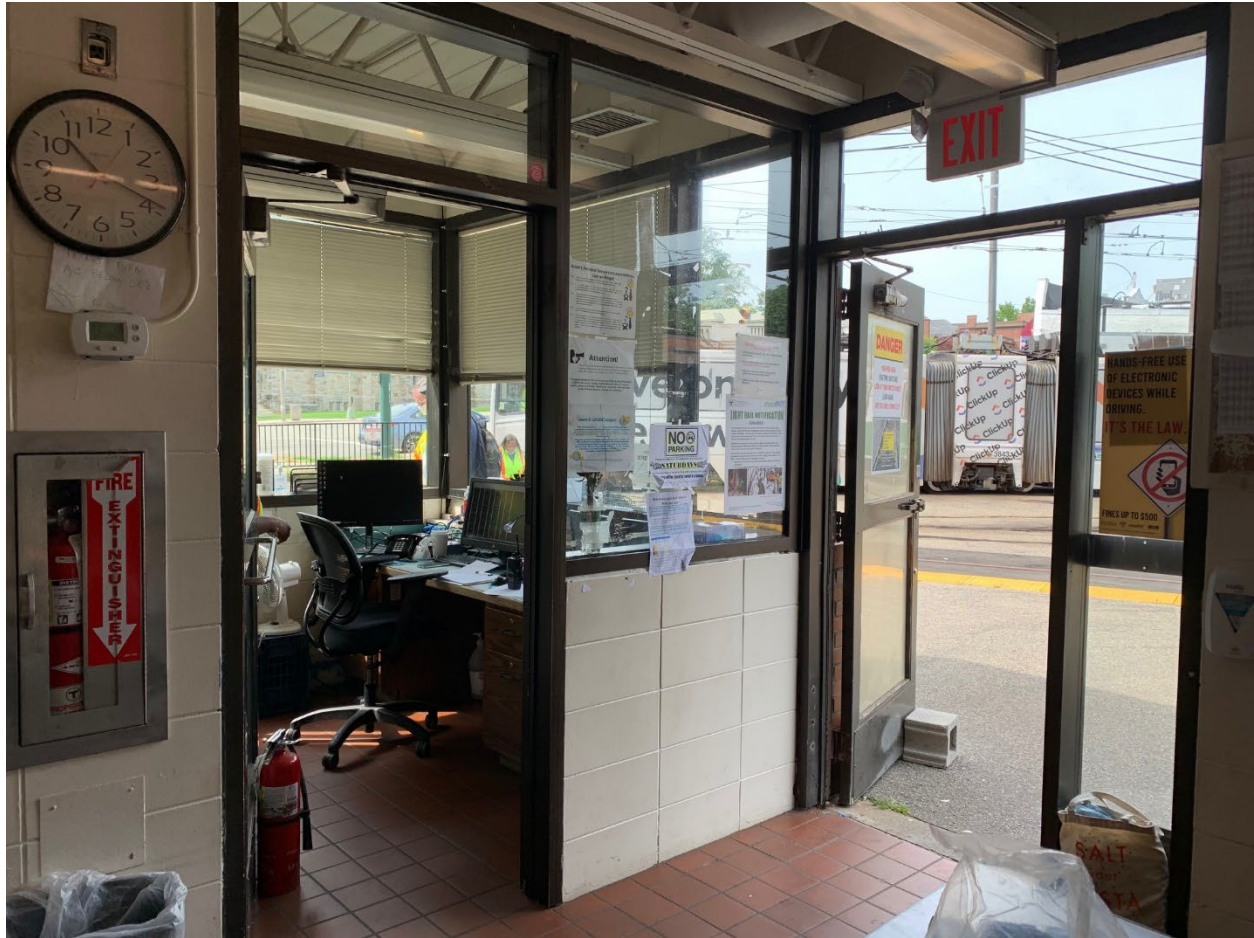
Photo 4: Inspector's booth from the Boston College station lobby at the starting point of the Green Line's B-Branch.

The office in the foreground is where the pullout Inspector manages car counts, crew assignments, and performs fitness for duty checks. He or she is also equipped with a vehicle tracking system, a radio, and telephones to communicate with their line Chief, the District Supervisors, and the OCC.

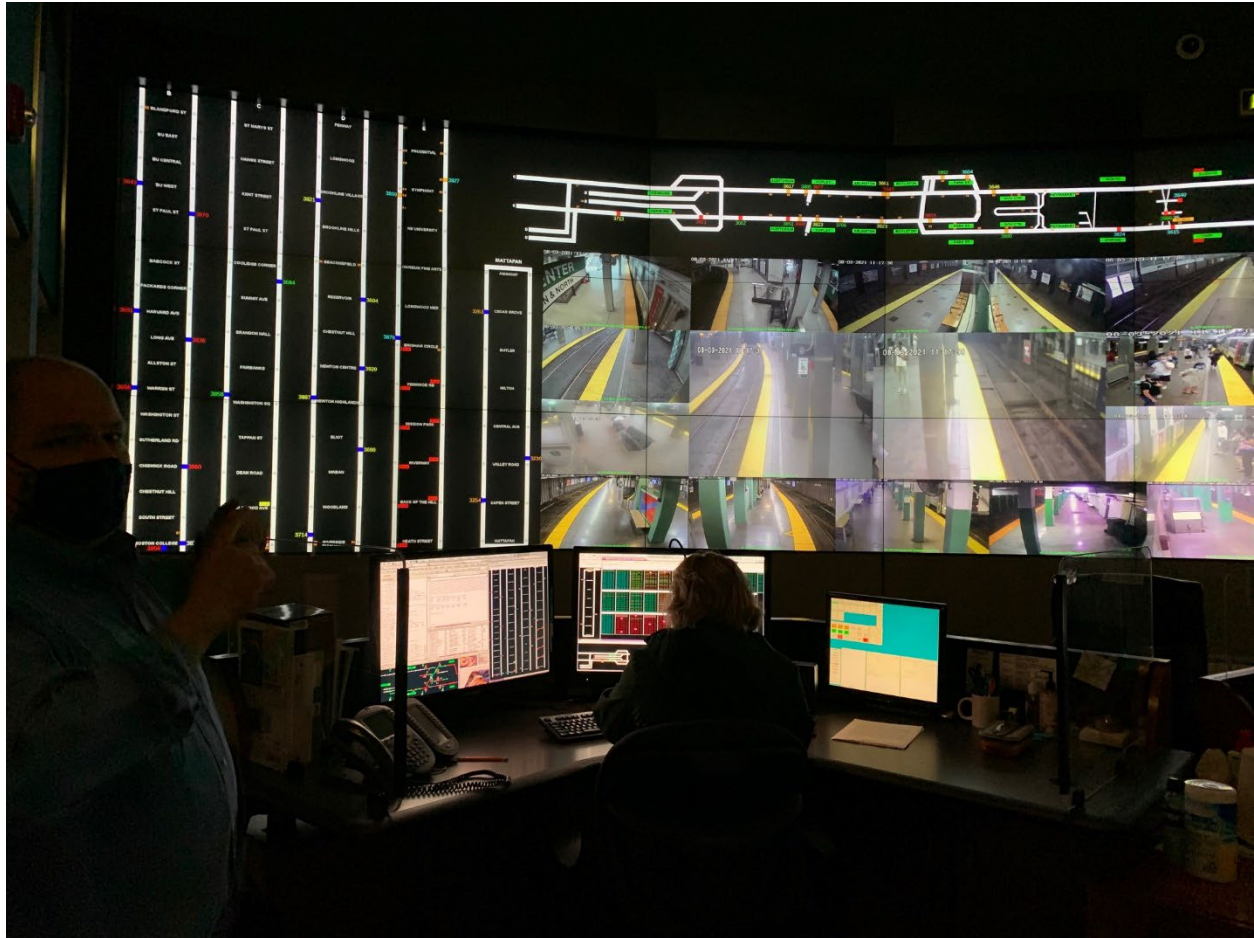
Photo 5: MBTA’s Operations Control Center (OCC).

The Green Line consoles are shown with a dispatcher in the foreground. Ahead of the dispatcher are three sections. To the left is the GPS data, outlining train locations on each of the five branches (B- Boston College, C- Cleveland Circle, D- Riverside, E- Heath Street and Mattapan-Ashmont High Speed Line). The lower right shows the dispatchers a series of live camera views of some of the Green Line’s busiest locations. The upper right shows a map of the AVI tracking system within the central subway (serving the B, C, D, and E branches). Two dispatchers work in tandem (the second dispatcher is to the right, out of view) 24/7 to manage the operations along the 5 branches and to respond to any situations that arise. Interim Deputy Division Chief of OCC & Training, William Hogan, is seen on the left giving the investigative group a briefing of the 7th floor control room at 45 High Street.
