National Transportation Safety Board

Investigator in Charge Factual Report

Operator: Pacific Gas & Electric
Location: San Francisco, CA
Incident Date: February 6, 2019
NTSB No.: PLD19MR001

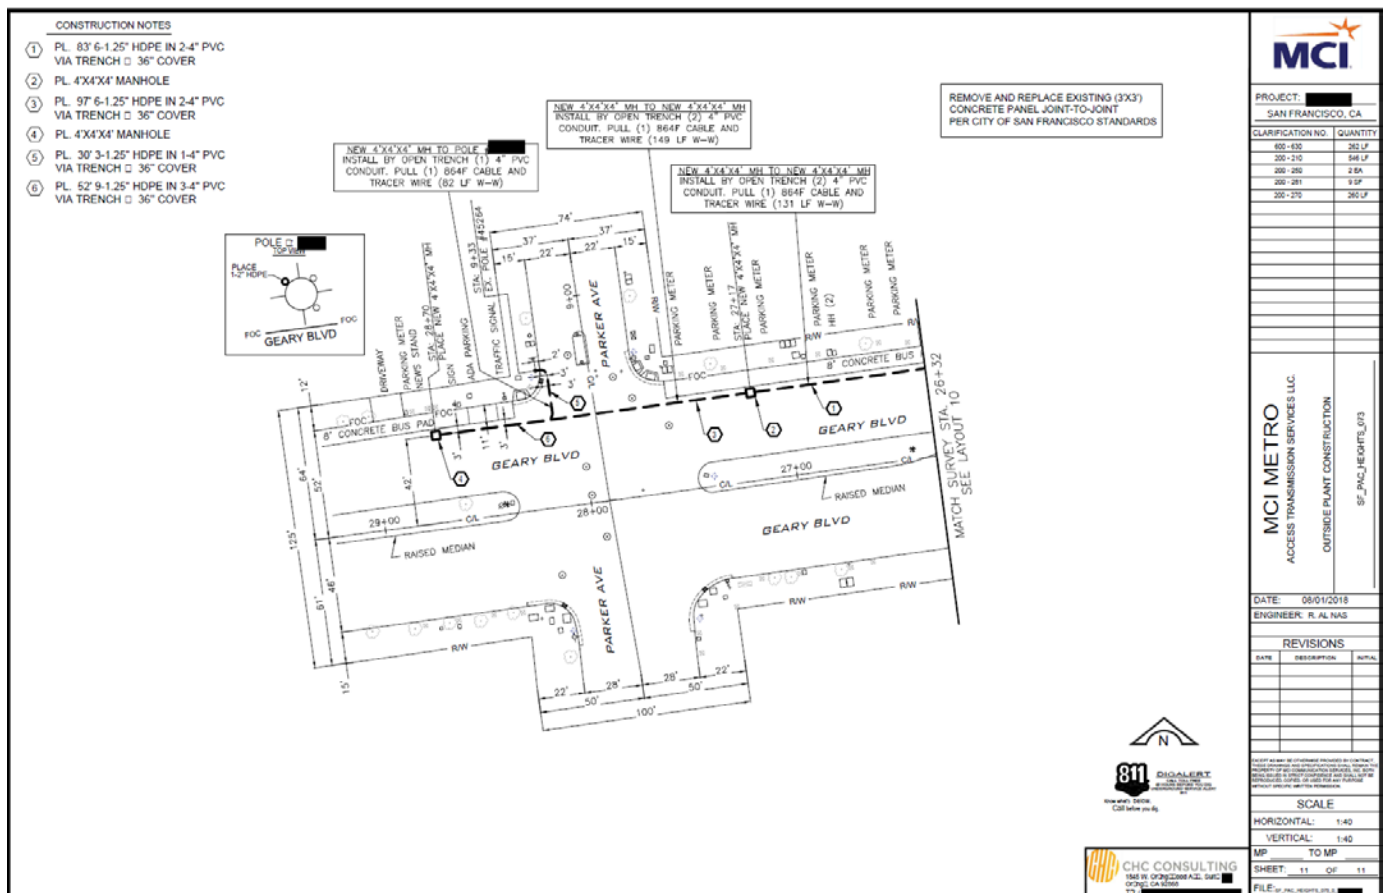
Excavation continued down Geary Boulevard in the direction of Parker Avenue by a combination of mechanical and manual means until the trench was sufficiently deep to lay conduit.²⁵ The spotter and operator then continued mechanical excavation about 50 feet to the east along Parker Avenue, while the other three employees remained near the newly installed hand-hole and installed conduit along Geary Boulevard.²⁶ The scope of work called for three lines of conduit to run from the handhole east until the intersection with Parker Avenue, where one of the three lines of conduit would run north along Parker Avenue 30 feet to a telecom pole and the other two lines would continue east along Geary Boulevard towards Spruce Street (Figure 6).

Figure 6. CAD plans for scope of work. Items 4, 5 & 6 were being executed on the day of the accident. Bold dashed line indicates the location of the conduit to be installed, and bold squares indicate the location of handholes to be installed.

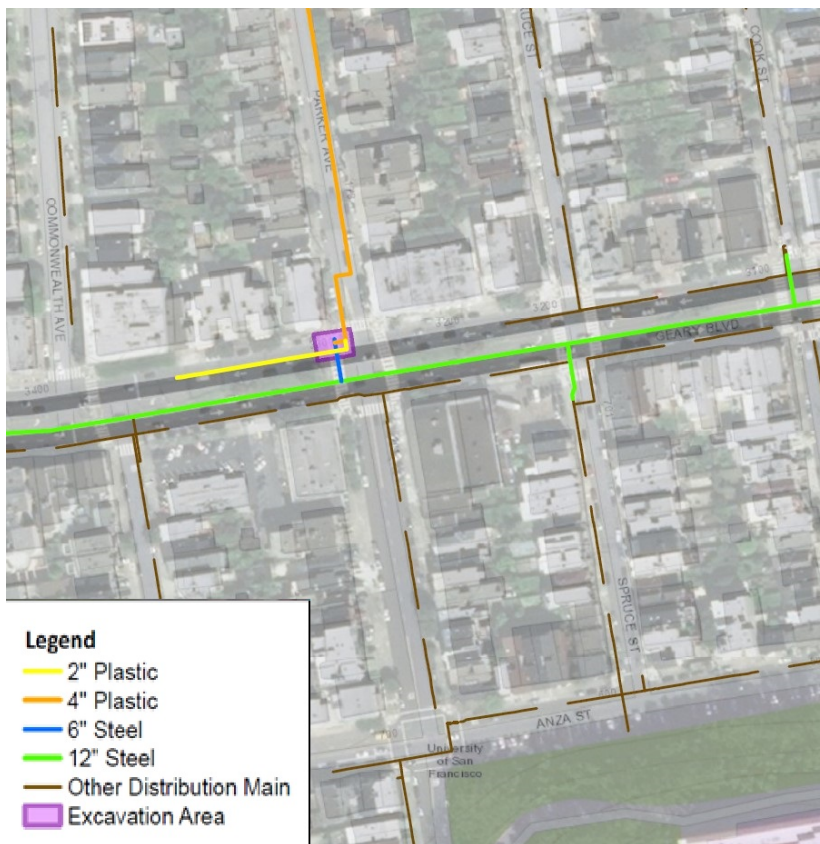
After the excavation of the 6-inch steel main was already underway, three PG&E locators used a Vivax vLoc-9800 and a Pipehorn 800-HL to locate the 12-inch steel main. All employees involved in the locate and mark of the 12-inch main were operator qualified with unexpired certificates of completion. The locators determined the 12-inch main was to the north of the current dig site, after experiencing difficulties with low readings due to restrictions with hook-on points.⁸⁹ See Figure 12 below for a basic drawing depicting how the various mains were connected in this area.

Figure 12. Basic map depicting general location of mains involved in the accident and emergency response. Diagram courtesy of Pacific Gas & Electric.

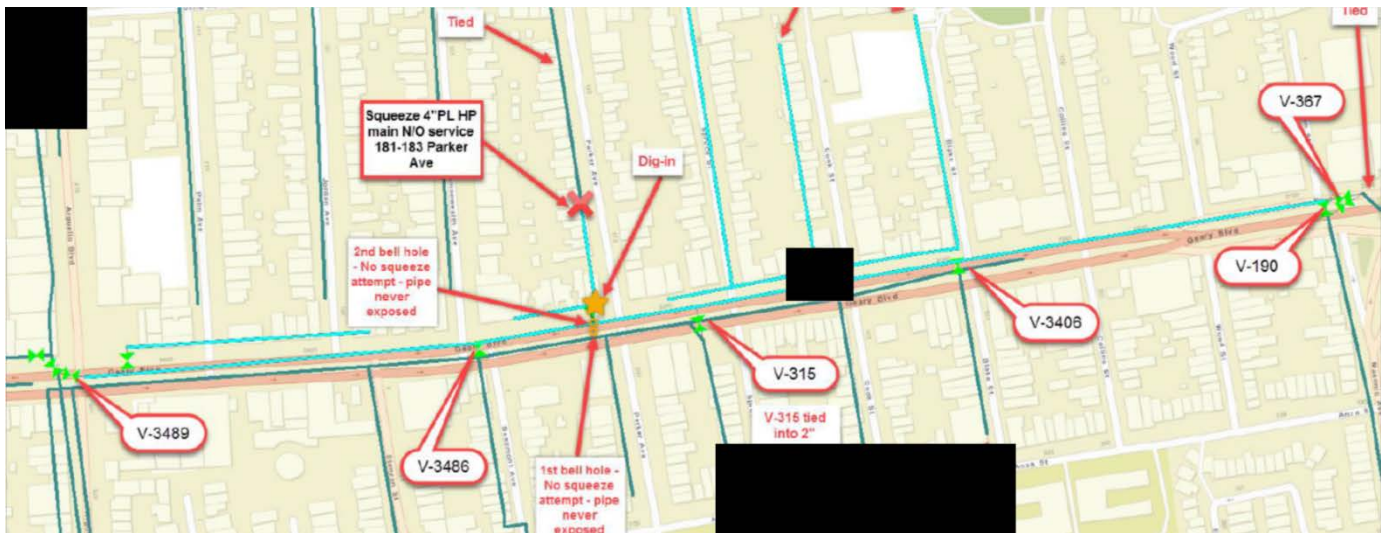
Figure 13. Final Valve Isolation Plan. Diagram courtesy of Pacific Gas & Electric.

The final VIP is shown above in Figure 13. Note the star labeled as “Dig-in” indicates the location where the line was damaged, all circles labeled as “V-#” indicate valves to be closed, “Tied” indicates an interconnect to another mainline, and “Dead-End” indicates the main ends at that point.

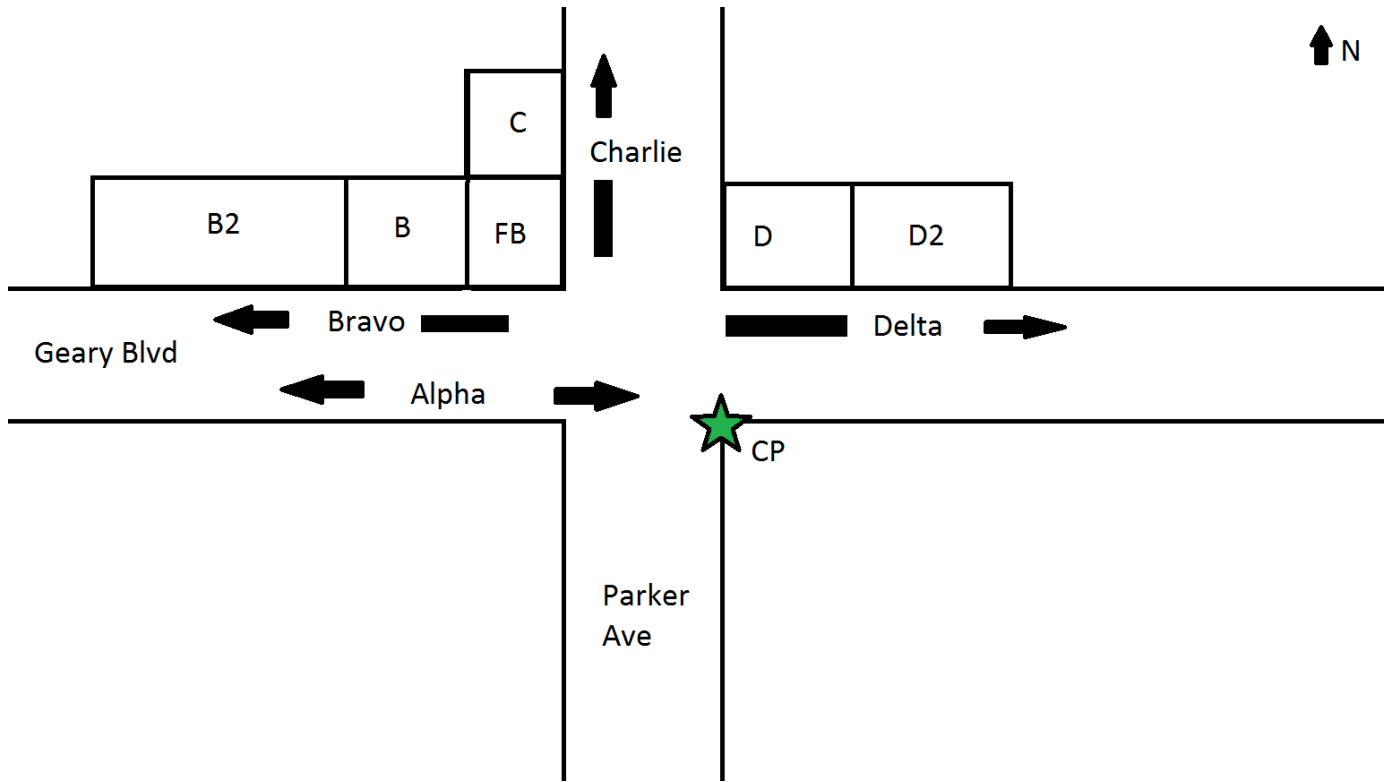
In Figure 15 below, B & B2 are buildings worked by the Bravo team. C is the building worked by the Charlie team. D & D2 are buildings worked by the Delta team. FB is the fire building, 3300 Geary Boulevard. CP indicates the location of the SFFD command post. Arrows indicate the covered areas by each team. Not pictured is additional staging, which was located on Spruce Street.¹⁰⁶

Figure 15. San Francisco Fire Department Response Teams.
