## Project 07-4063

### Examination and Testing of a Tapping Tee

# ***JANA LABORATORIES INC.***

**Report No.:** Project 07-4063 – Report

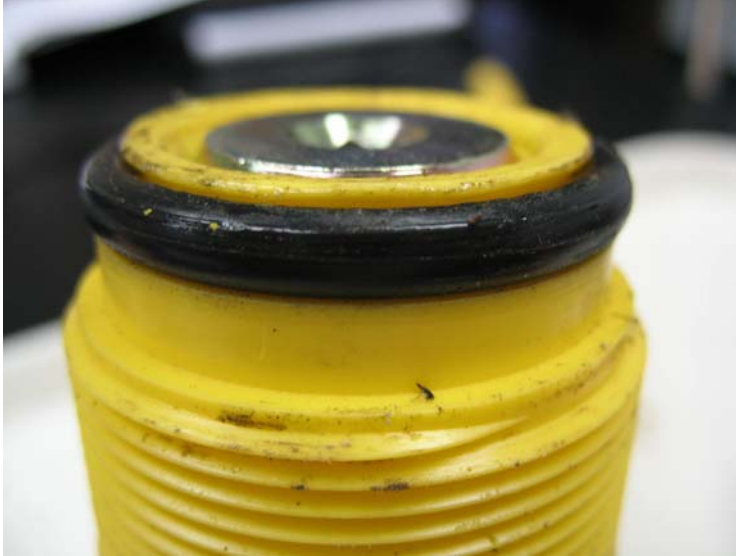
**Figure D2: O-ring and Cutter Position in Tower with Cap Removed**

- 2.2 Measure the height from top of the cutter to rim of the tower  
*0.014 inches*
- 2.3 Back-out the cutter  
*Torque to back-out cutter measured 12 in-lbf break-away and 5 in-lbf continuous. Cutter backed out smoothly with no cross-threading.*
- 2.4 Examine cutter for markings  
*No marks visible*
- 2.5 Photograph the cutter and the cutting end

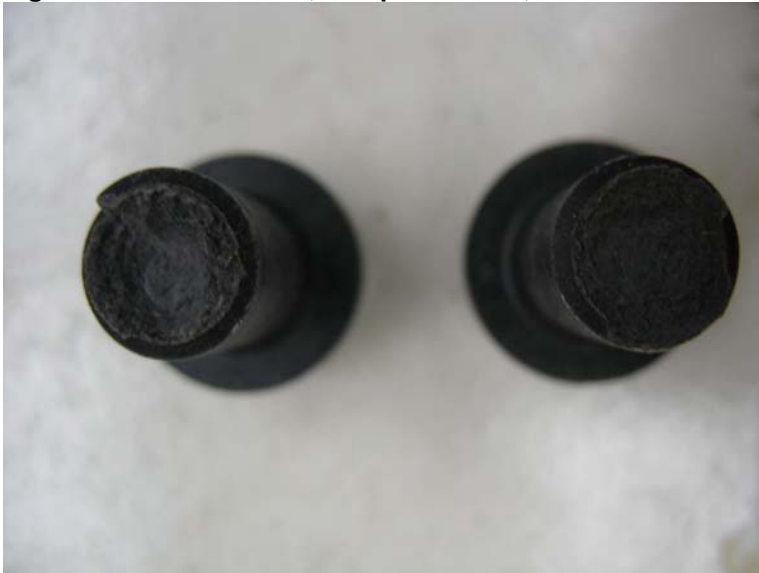
**Figure D8: Broken Bolts, Sample 07-1091, Fracture Surfaces**

- 3.10 Measure the length of threads on the broken bolt heads and the number of threads  
*No threads remaining on head end of broken bolts. Both bolts broke at the first thread.*

*Examine fracture surfaces by optical microscopy. Perform additional analysis of fracture surfaces by SEM/EDS or FTIR as appropriate to identify any contamination*

*Insofar as practical, determine the tensile breaking strength of intact and fractured bolts.*

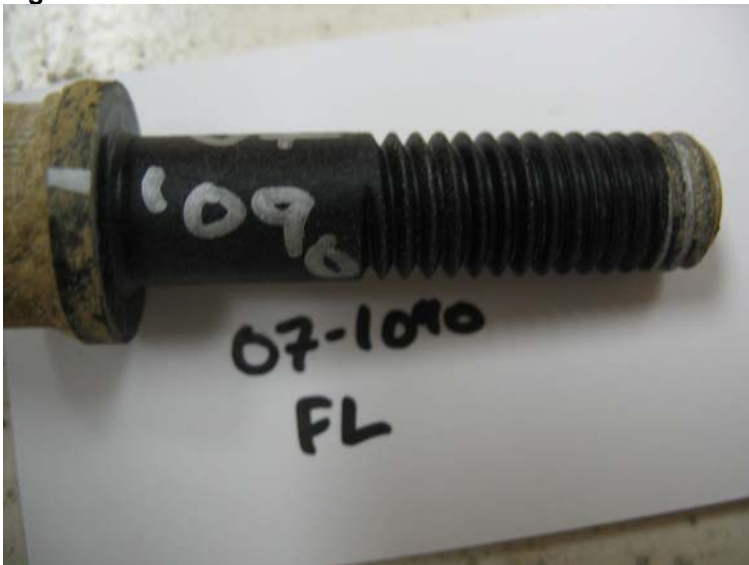
**Figure D10: Front Left Intact Bolt**

*Front left = 2.501 inches*

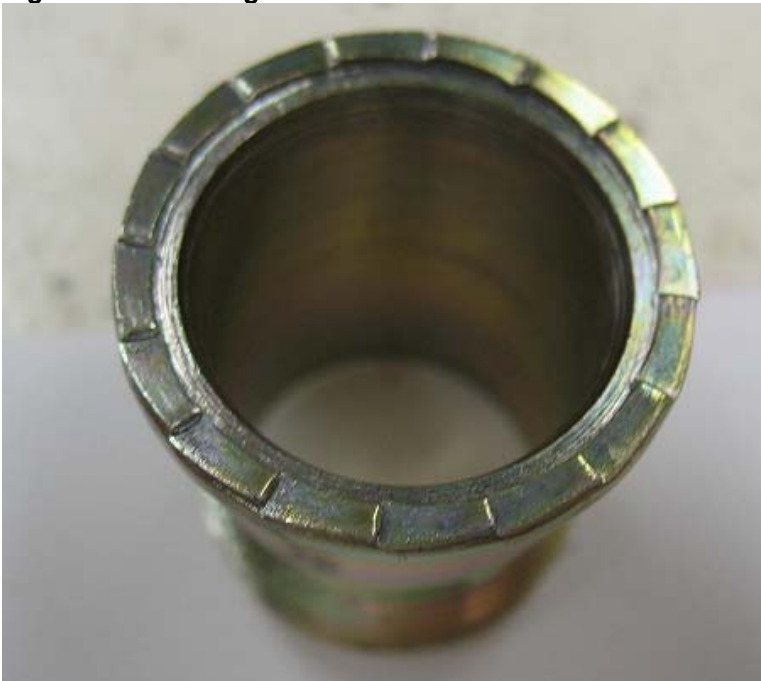
**Figure D14: Locking Sleeve Ratchet Surface**

5.9 Separate top saddle from pipe  
*Not applicable, as the saddle was not engaged with the pipe due to the non-engagement of the locking sleeve.*

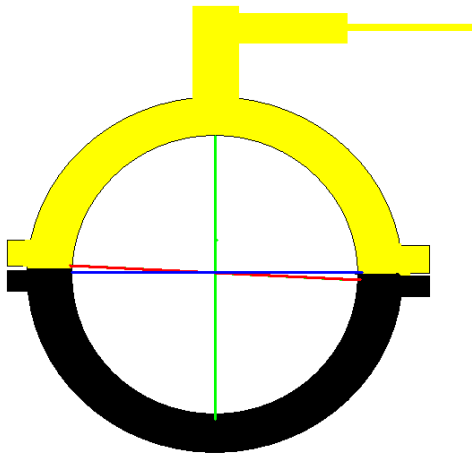
**Figure D20: Saddle Diameter Measurement Locations**

Figure D20 shows the three diameters that were measured with the saddles mated. Green is the diameter perpendicular to the flanges, while red and blue are the diameters measured the closest to parallel to the flanges without measuring at the gap between the flanges. These measurements were made at both ends of the saddle assembly with the saddles mated but not tightly clamped. They were repeated at one end with the saddles tightly clamped together.
