# National Transportation Safety Board

## Marine Accident Brief

### Container Damage and Loss aboard Deck Cargo Barge *Ho'omaka Hou*, Towed by *Hoku Loa*

<b>Accident type</b>	Hull/Machinery/Equipment Damage	<b>No.</b> DCA20FM022
<b>Vessel names</b>	<i>Hoku Loa</i> and <i>Ho'omaka Hou</i>	
<b>Location</b>	Pacific Ocean, 6.9 miles north-northwest of Hilo, Hawaii <sup>1</sup> 19°50.1' N, 155°02.69 W	
<b>Date</b>	June 22, 2020	
<b>Time</b>	0230 Hawaii-Aleutian time (coordinated universal time – 10 hours)	
<b>Injuries</b>	None	
<b>Property damage</b>	\$1.6 million est.	
<b>Environmental damage</b>	None reported	
<b>Weather</b>	Visibility 7 miles, overcast, winds southwest at 5 knots; seas northeast 6 feet, swell 1 foot, air temperature 72°F, water temperature 79°F, sunrise 0543.	
<b>Waterway information</b>	Open ocean off the northeast coast of the island of Hawaii, near Pepeekeo Point, at a depth of about 750 feet.	
<b>Persons on board</b>	6

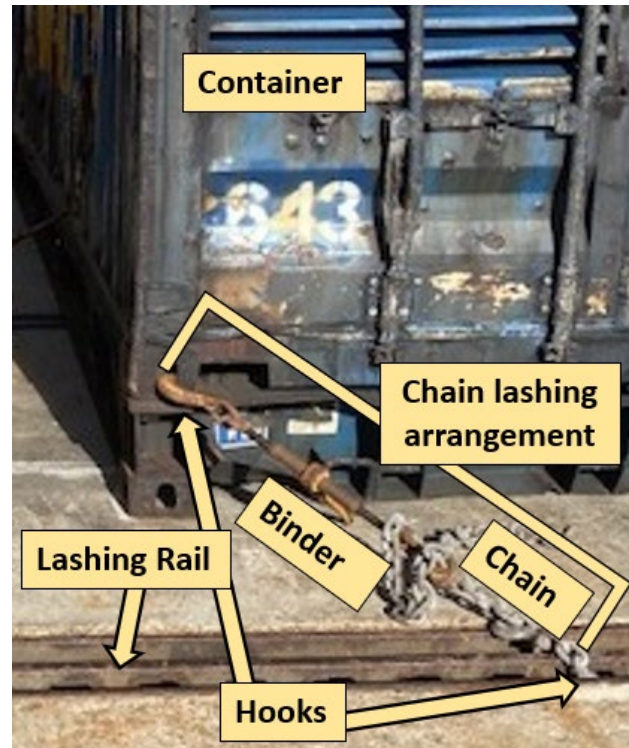
Container rows were generally secured in a similar fashion. The collapsed row of containers was secured to the deck of the barge using a lashing arrangement (loose fitting) consisting of 0.5-inch chain, ratchet binders, slip hooks, and grab hooks. The chains were secured to the deck with a hook on the steel lashing rails. The steel lashing rails ran fore and aft along the deck of the barge, were recessed in the concrete facing covering the deck, and were welded to the steel deck under the facing. The ratchet binders were used to tighten (tension) the complete chain lashing assembly.

A separate chain was hooked to the forward and after corner castings to the bottom of the first-, third-, and fifth-tier containers on the port outboard five-high stack of containers and to the forward and after corner castings of the first-, second-, and fourth-tier containers to the starboard outboard four-high stack of containers. The chains were also secured to the steel lashing rails by a hook.

A typical chain lashing securing arrangement similar to those used to secure collapsed row of containers. (Source: Coast Guard, annotated by NTSB)

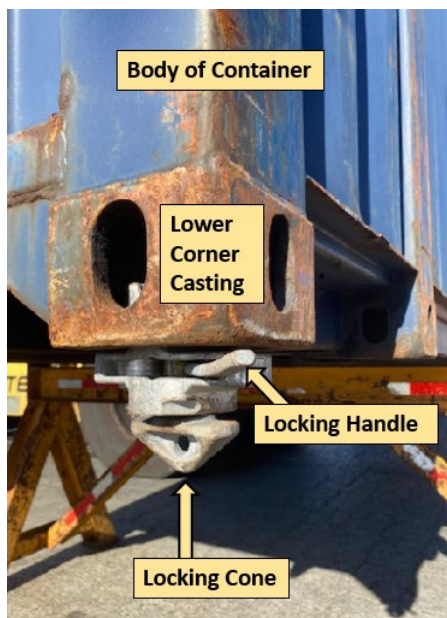
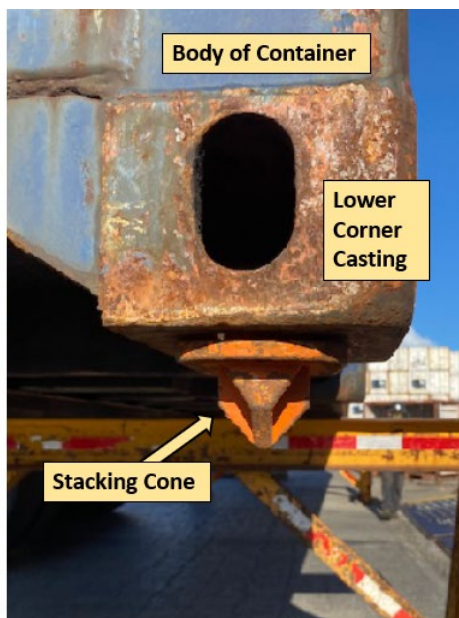
Locking cone (left) and stacking cone (right) similar to ones used on the *Ho'omaka Hou*. (Source: Coast Guard, annotated by NTSB)

In addition to chain lashing arrangements, barge team members used steel stacking cones in the four bottom corner castings of each container that was to be stacked on top of another container. Barge team members used locking cones at the bottom corner castings of the second-tier containers to the outboard port and starboard stacks of containers. Once the second-tier outboard
