# National Transportation Safety Board

## Marine Accident Brief

### Collision of Cargo Vessel *Nomadic Milde* and Bulk Carrier *Atlantic Venus*

<b>Accident type</b>	Collision	<b>No.</b> DCA20FM017
<b>Vessel name</b>	<i>Nomadic Milde</i> and <i>Atlantic Venus</i>	
<b>Location</b>	Lower Mississippi River, mile 114.5, South Kenner, Louisiana <sup>1</sup> 029°58.03' N, 090°16.60' W	
<b>Date</b>	May 8, 2020	
<b>Time</b>	1655 central daylight time (coordinated universal time – 5 hours)	
<b>Injuries</b>	None	
<b>Property damage</b>	\$16,854,348 million est.	
<b>Environmental damage</b>	13 gallons of lube oil est.	
<b>Weather</b>	Visibility 10 miles, overcast skies, winds northeast at 8 knots; thunderstorms in area, river surface conditions rippled, air temperature 73°F, water temperature 68°F, sunset 1943	
<b>Waterway information</b>	The Mississippi River at the Kenner Bend anchorage was about 54 feet deep and 0.6 miles wide. The current was estimated between 4 and 5 knots.

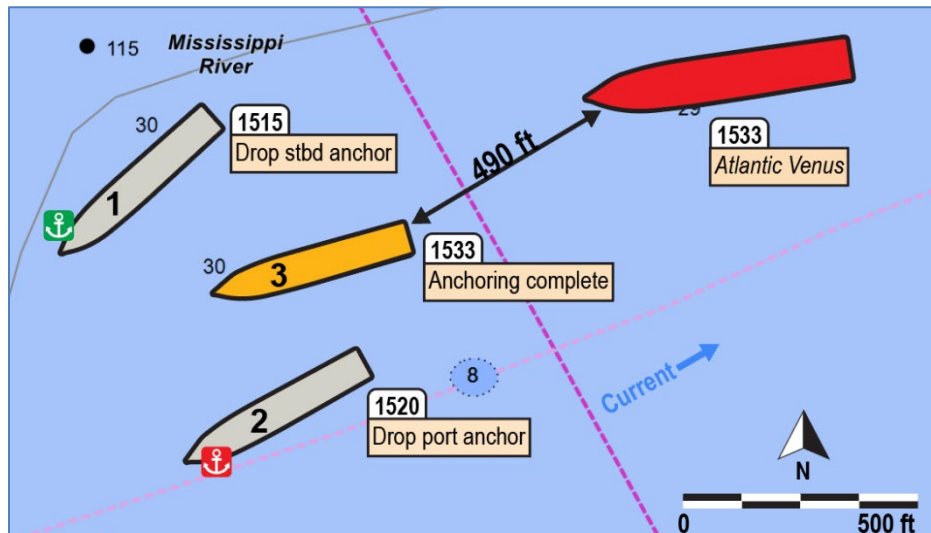
From 1533, when the pilot informed the master that the anchoring was complete, the *Nomadic Milde* continued to shift position and heading. The pilot departed the bridge at 1540 and left the ship on a launch at 1542.

*Nomadic Milde* positions from the vessel’s voyage data recorder (VDR). The green anchor icon indicates the starboard anchor drop position, and the red anchor icon indicates the port anchor drop position. Scale approximate. (Background source: NOAA ENC 6LA54M)
