Fire Aboard Small Passenger Vessel *Conception*
Platts Harbor, Channel Islands National Park,
Santa Cruz Island, 21.5 miles South-Southwest of
Santa Barbara, California
September 2, 2019

Marine Accident Report

NTSB/MAR-20/03
PB2020-101011

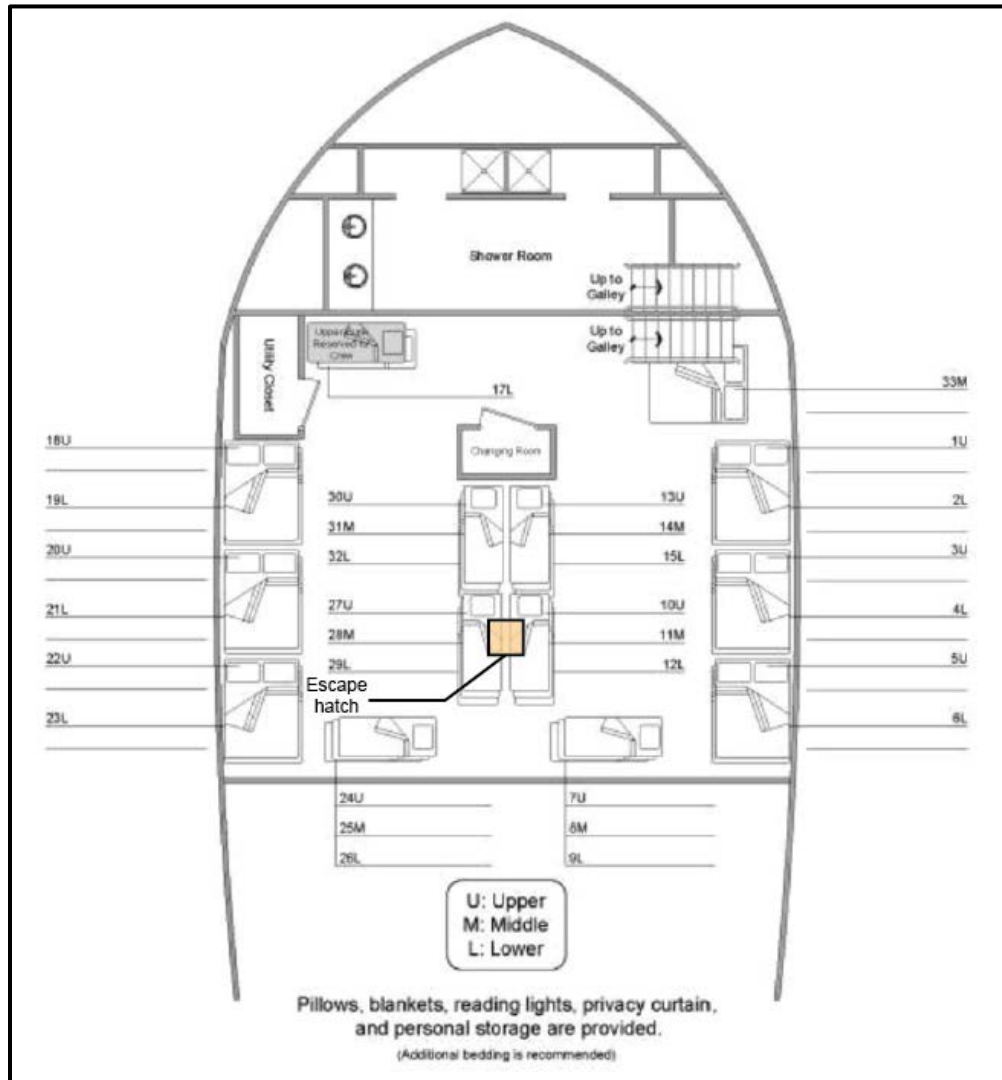
Figure 5. *Conception* bunkroom arrangement, with escape hatch location added by NTSB. (Source: Truth Aquatics; annotated by NTSB)

salon, and thus both escape routes from the bunkroom exited into the salon. The upper bunks nearest the emergency escape hatch had passengers assigned to them during the accident voyage.

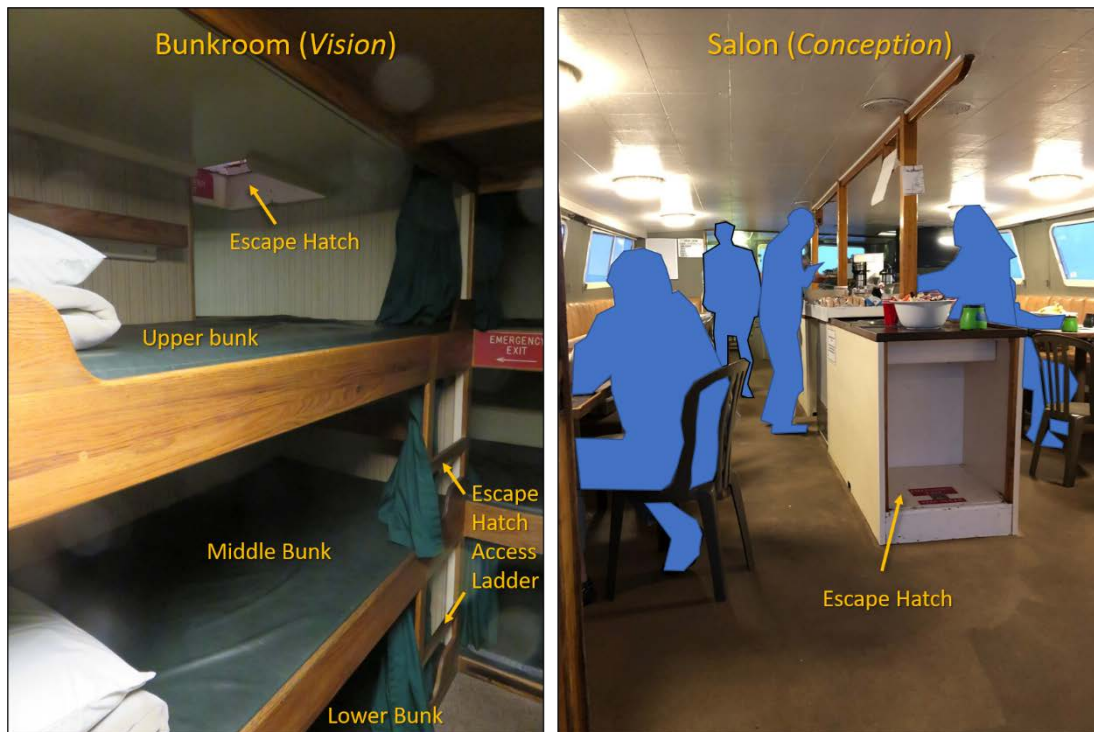
An escape hatch provided an alternate means of exiting the bunkroom (the stairway at the forward end was the primary means). The escape hatch, which consisted of a removable wooden panel that was about 22 inches by 22 inches in size, was located in the overhead between the aftmost centerline bunks.⁴ It could be reached from either aisle by climbing a wooden ladder installed on the side of each centerline aft set of bunks. The hatch exited into the aft end of the

Figure 6. Photo left is the escape hatch, viewed from the bunkroom, on the *Vision*, a Truth Aquatics dive vessel with arrangements nearly the same as the *Conception*. (Source: NTSB) Photo right, taken during a previous voyage, shows the escape hatch, viewed from aft in the salon, on the *Conception*. (Source: J. Palmer, annotated by NTSB)

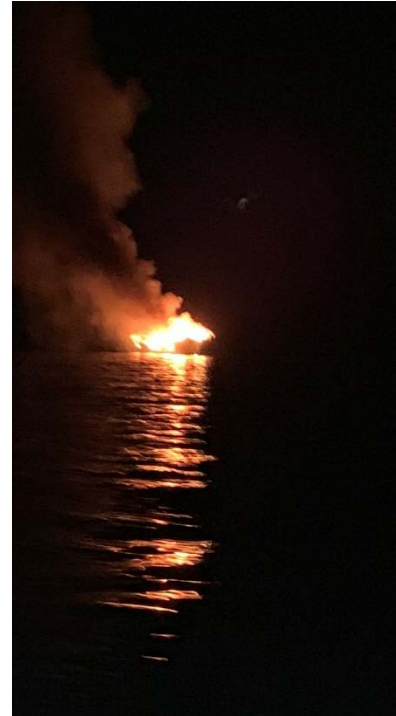
Figure 10. Cell phone photo of *Conception* on fire, taken from sportfishing boat *Grape Escape*. (Source: S. Hansen)

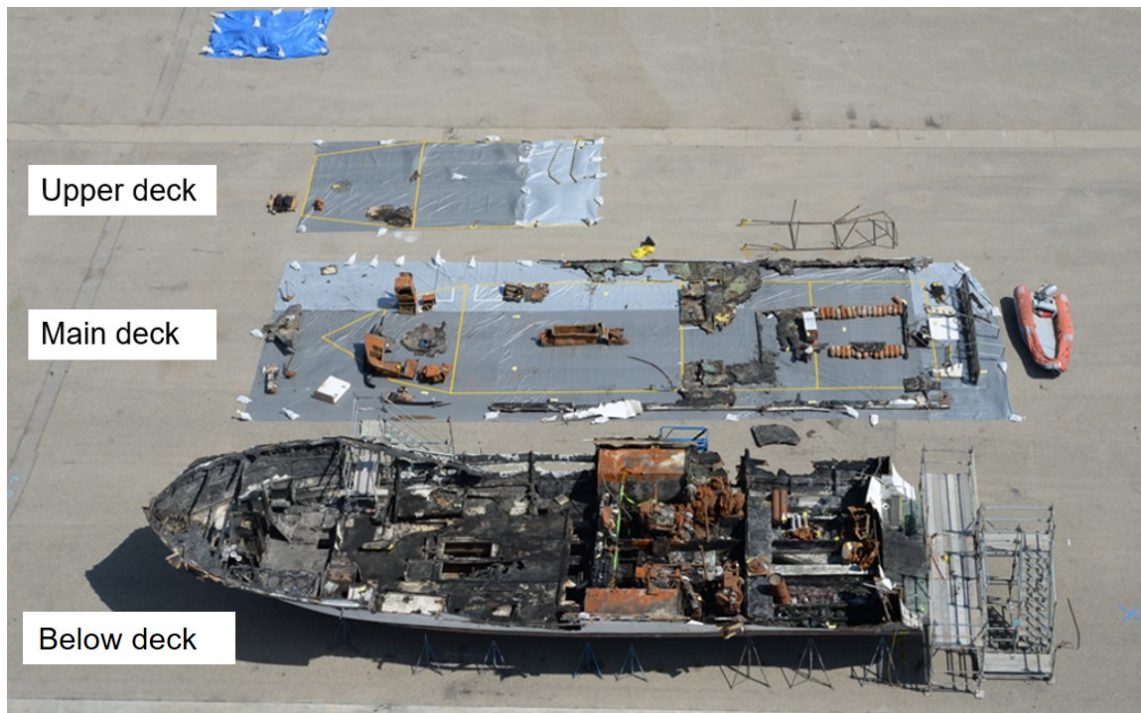
On September 25–27, the NTSB examined the wreckage and debris recovered from the seafloor and surface. The wreckage and debris were laid out by the ATF and FBI in a secure parking lot into three sections consisting of the main hull with the below deck spaces, the main deck, and the upper deck (figure 19). There were also bags full of items that had been floating in the water and/or collected from the seabed. The ATF and FBI, with Coast Guard assistance, placed the recovered items and portions of structure that could be identified in their corresponding places for each of the three sections of the wreckage representing the three decks. Identifiable engine room machinery and equipment, such as the generator and sewage tank, were placed back in their original position in the engine room within the hull. For the main deck and upper deck portions, an outline was made on tarpaulin underlays, and the items and structure were placed within the

outlines in the areas where they belonged. Very little structural material remained from the upper deck and the main deck.

Figure 19. *Conception* wreckage layout at Port Hueneme. (Source: FBI Evidence Response Team)

The hull of the *Conception*, where the below-deck compartments had been located, represented the bulk of the remaining structure. The transverse bulkheads were severely fire damaged, eliminating the separation of the below-deck compartments between the anchor room, shower room, bunkroom, engine room, and lazarette from forward to aft. The entire interior of the below-deck space was charred. Overall, the interior of the below-deck compartments had burned all the way down to the floor in the bunkroom and shower room and had consumed the floor, exposing the longitudinal frames, in both the engine room and lazarette ([figure 20](#)).

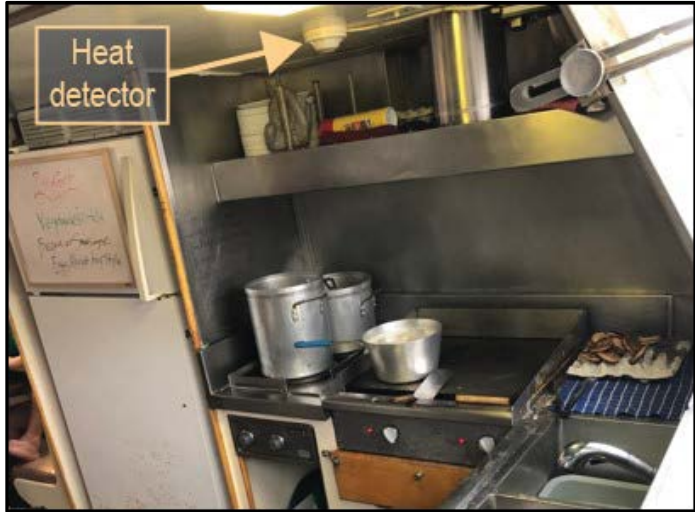
Neither Old T nor New T regulations required the salon and galley compartment to have smoke detectors installed. Heat detectors were installed in the engine room and galley. The smoke and heat detectors were not interconnected to other alarms or a central operating station in the wheelhouse. In the engine room, the heat detector, if activated, would initiate the carbon dioxide fixed fire-extinguishing system for the engine room. The galley detector was not connected to the range hood fan or any damper, nor was it required to be.

Figure 26. Photo of the galley of the *Conception* taken from the forward centerline window. (Source: NTSB eyewitness submission)

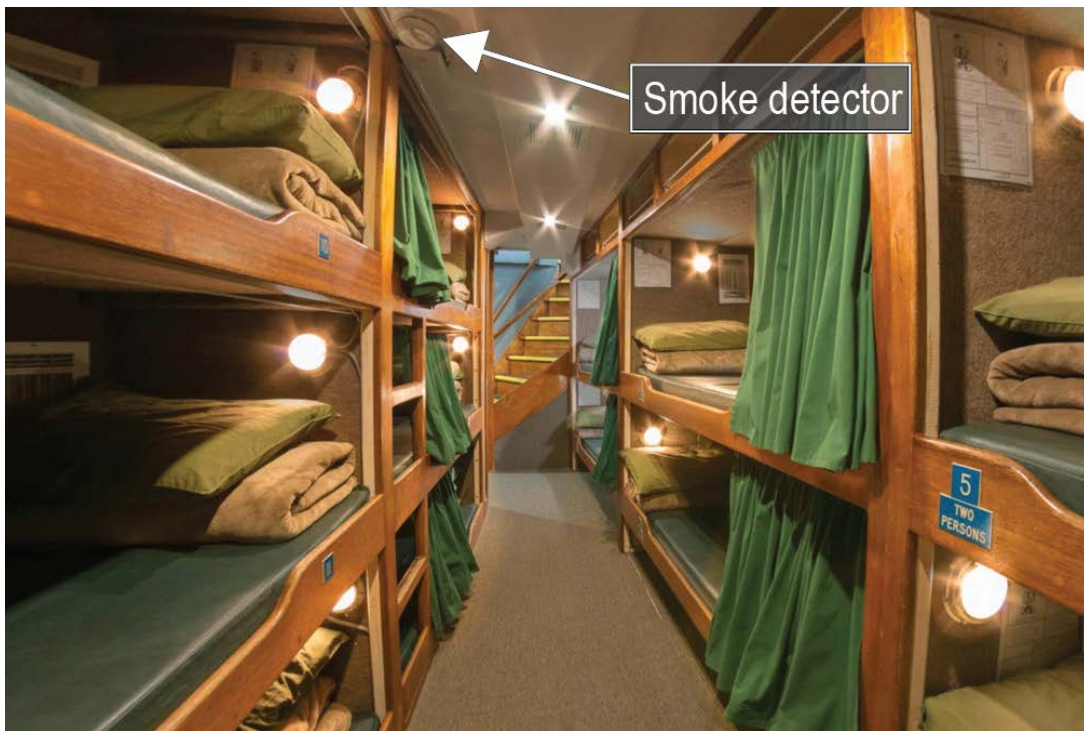
As required by 46 *CFR* 181.405(c), which applied retroactively to existing vessels with an overnight accommodation space, the bunkroom area contained two independent modular smoke detectors, installed in the overhead on the port and starboard aisles between the bunks. Investigators were informed by the vessel owner that the smoke detectors in the bunkroom were hardwired into the vessel’s electrical system, with a 9-volt battery backup. The smoke detectors were not interconnected to other alarms or a centralized system in the wheelhouse. Based on photos and video, the smoke detectors appeared to be common consumer-type smoke detectors, as specified in the regulations. The smoke detectors in the bunkroom were the only ones required to be on board. There were no additional smoke detectors installed on board.

Figure 27. Interior view of *Conception* bunkroom. (Source: Truth Aquatics; annotated by NTSB)

There were no requirements related to the testing and inspection of smoke detectors. The owner was aware that the bunkroom smoke detectors functioned properly less than a month before the accident voyage, when a contractor soldering on the air conditioning unit activated them. The owner told investigators that after the smoke detectors activated, the captain of the *Conception* “unplugged” them while the soldering was ongoing. When the work was completed, the smoke detectors were plugged back in, “fresh” batteries were added, and the detectors were tested. When asked whether there were routine inspections or testing of the smoke detectors on the *Conception*, the owner stated the captain was responsible for any inspections or testing.

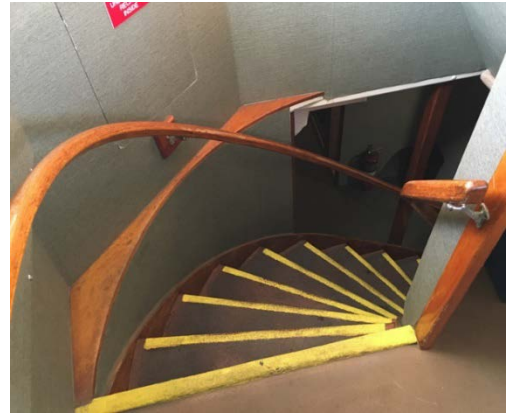
From the *Conception*'s bunkroom, there were two means of escape, both leading to the salon above: (1) the spiral stairs forward in the bunkroom ([figure 28](#)), and (2) the escape hatch installed centerline at the aft end of the bunkroom ([figure 29](#)). The hatch, marked with a two-inch plastic sign, was accessible from either aisle by climbing a wooden ladder, located in the corner where the aftermost middle and aft athwartship tiers of bunks were, onto the upper bunk; crawling to the centerline; and then pushing the plywood escape hatch up and out of the way. The hatch opened below the centerline countertop in the salon. Investigators measured the *Vision*'s escape hatch, which, according to the owner, was similar to the *Conception*'s escape hatch. The opening dimensions were approximately 22 inches by 22 inches through the main deck, with the aft-facing vertical opening having a clearance of about 35 inches from the main deck to the countertop above, or 28 inches from the top of the 7-inch main deck coaming. The two means of escape were at opposite ends of the bunkroom (so as to minimize the possibility of one incident blocking both escapes) and did not pass through a watertight door, thereby fulfilling the regulations applicable to the *Conception*. In the available documentation and inspection history of the vessel, no deficiencies or modifications were found related to the emergency escape hatch or the bunk ladders to the hatch.

Figure 28. Staircase from the main deck galley/salon leading down to the bunkroom on the *Conception*. (Source: NTSB eyewitness submission)

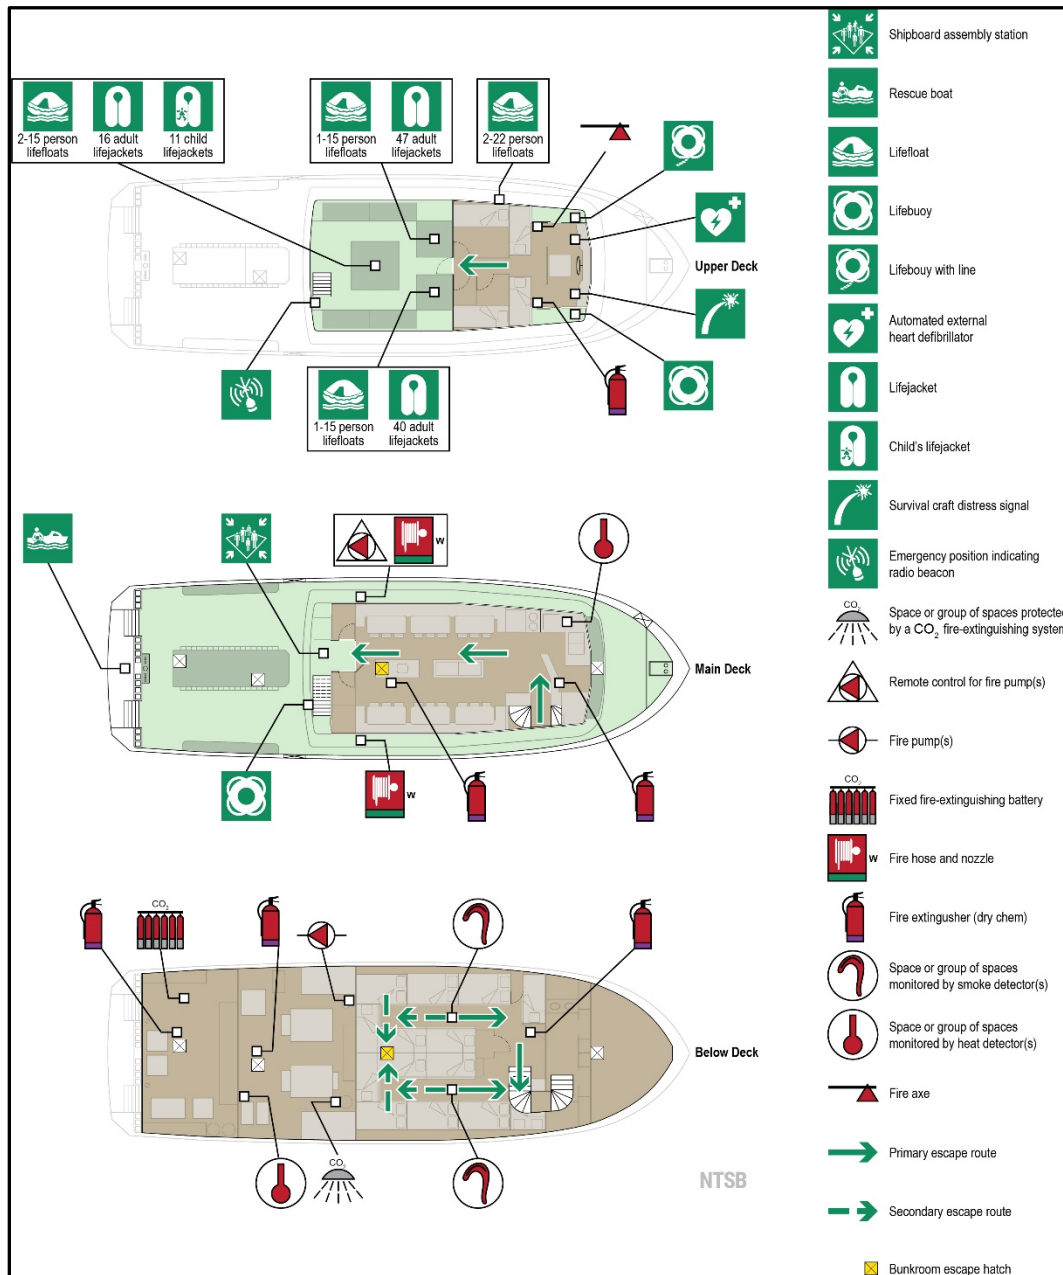
Three small restrooms, each with a single toilet and a small sink, were located just aft of the salon. Aft of the portside restroom door, a sign posted on the bulkhead identified the location as the muster area. Exterior walkways on either side of the salon and restrooms extended from the bow to the aft open deck. Fire hose stations were located on both port and starboard walkways adjacent to the restrooms (see [figure 30](#) for the location of all firefighting equipment and lifesaving appliances).

Figure 30. Locations of firefighting equipment, lifesaving appliances, and evacuation plan for the *Conception* at the time of the accident (compiled from the investigation and drawn by the NTSB).

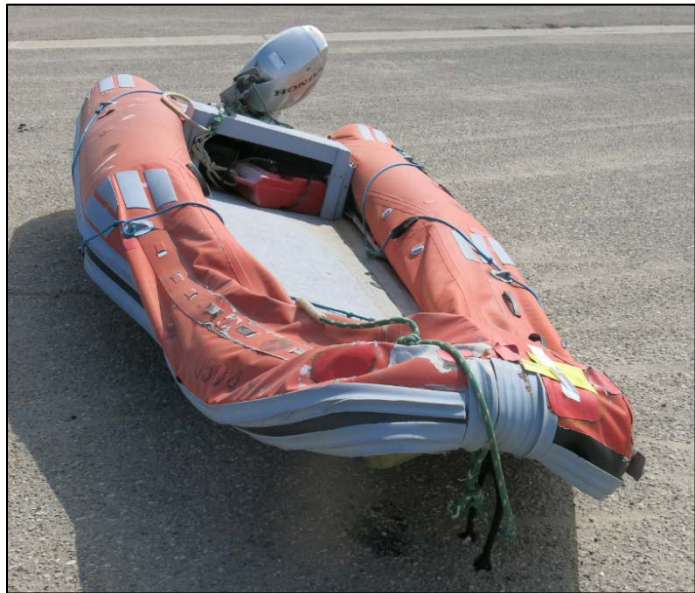
Figure 31. Postaccident photo of the *Conception* skiff.
