Adopted December 1, 2021

# Fire aboard Roll-on/Roll-off Vehicle Carrier *Höegh Xiamen*

Pier 20, Blount Island

June 4, 2020

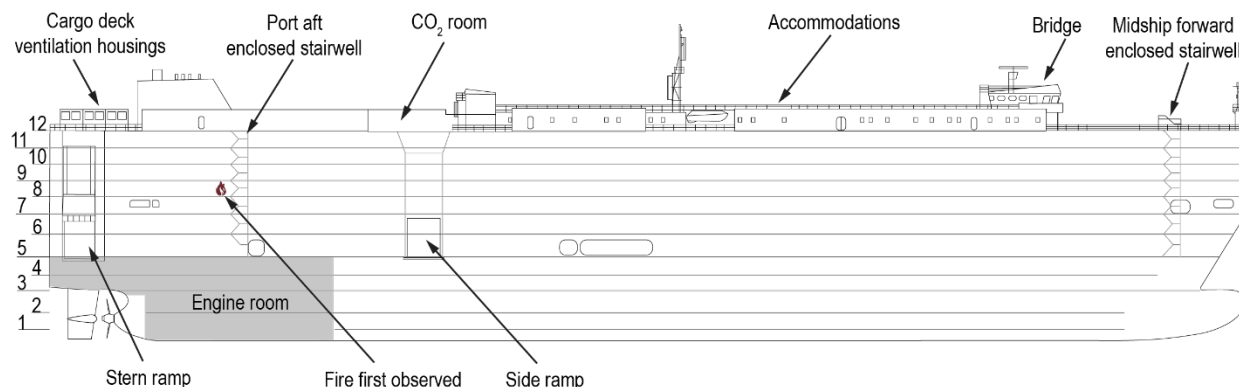
The chief mate sent an ordinary seaman and an able seafarer to decks 7 and 8 to investigate while he secured the cargo deck fans.<sup>4</sup> The chief mate also sent the vessel's electrician to close the remotely controlled ventilation dampers.<sup>5</sup> The chief mate stated that closing these dampers slowed but did not stop the smoke (the ventilation system's manually operated dampers remained open). At this time, he saw other crewmembers leaving their staterooms and donning firefighting equipment. About the same time, the chief engineer went to cargo deck 11 and began searching for smoke on the cargo decks, working his way to deck 7, by going down the port aft enclosed stairwell and checking each deck from the stairwell (the vessel had two stairwells: one located portside aft and one located on the centerline forward) (see figure 3).

**Figure 3.** *Höegh Xiamen* inboard profile. (Background source: Höegh Technical Management)

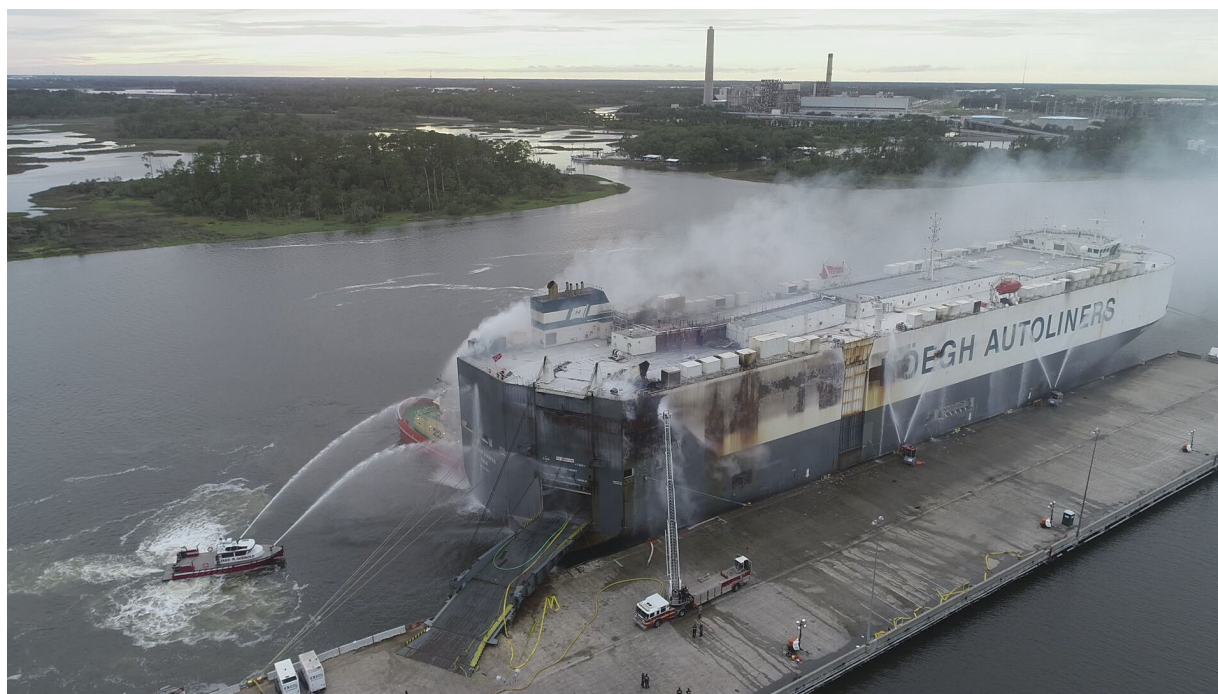
Following the explosion, the firefighters, assisted by the Coast Guard, transitioned to a defensive strategy where they focused on boundary-cooling to avoid flooding the higher decks and affecting the vessel's stability until personnel, including a naval architect, and equipment from the commercial salvor (Resolve Marine) identified in *Höegh Xiamen's* Coast Guard-approved non-tank vessel response plan arrived about 0130 on June 5 (see figure 6).<sup>8</sup> Personnel from Resolve Marine continued to arrive over the next week to assist with boundary-cooling while the Coast Guard and personnel from the Port of Jacksonville worked on security and oil spill containment. The fire continued to burn for 8 days, destroying the interior of cargo decks 7 through 11 and deck 12, including the accommodations.

**Figure 6.** Firefighters conducting exterior boundary-cooling on June 5, 2021, the day after the fire was discovered. (Source: JFRD)

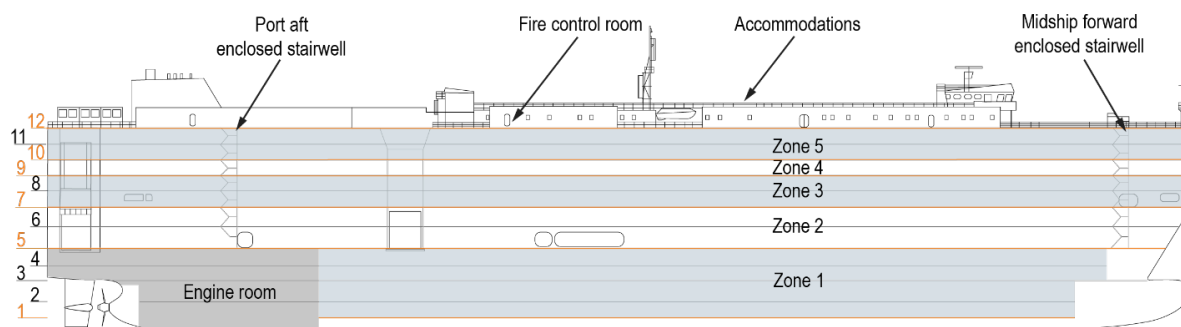
Of the vessel’s 11 decks used for cargo stowage, decks 3, 5, and 7 were stronger and intended to carry high and heavy rolling units, as well as static cargo, while the rest of the decks were intended to carry cars and other light-wheeled cargo. The cargo decks were open along the entire length of the vessel (bow to stern) but were divided vertically by retractable ramps between decks into five horizontal gastight fire zones: decks 1–4 comprised zone 1; decks 5 and 6 comprised zone 2; decks 7 and 8 comprised zone 3; deck 9 comprised zone 4; and decks 10 and 11 comprised zone 5 (see figure 8).

**Figure 8.** *Höegh Xiamen* fire zones. The vessel’s gastight decks, which separate fire zones, are highlighted orange. (Background source: Höegh)

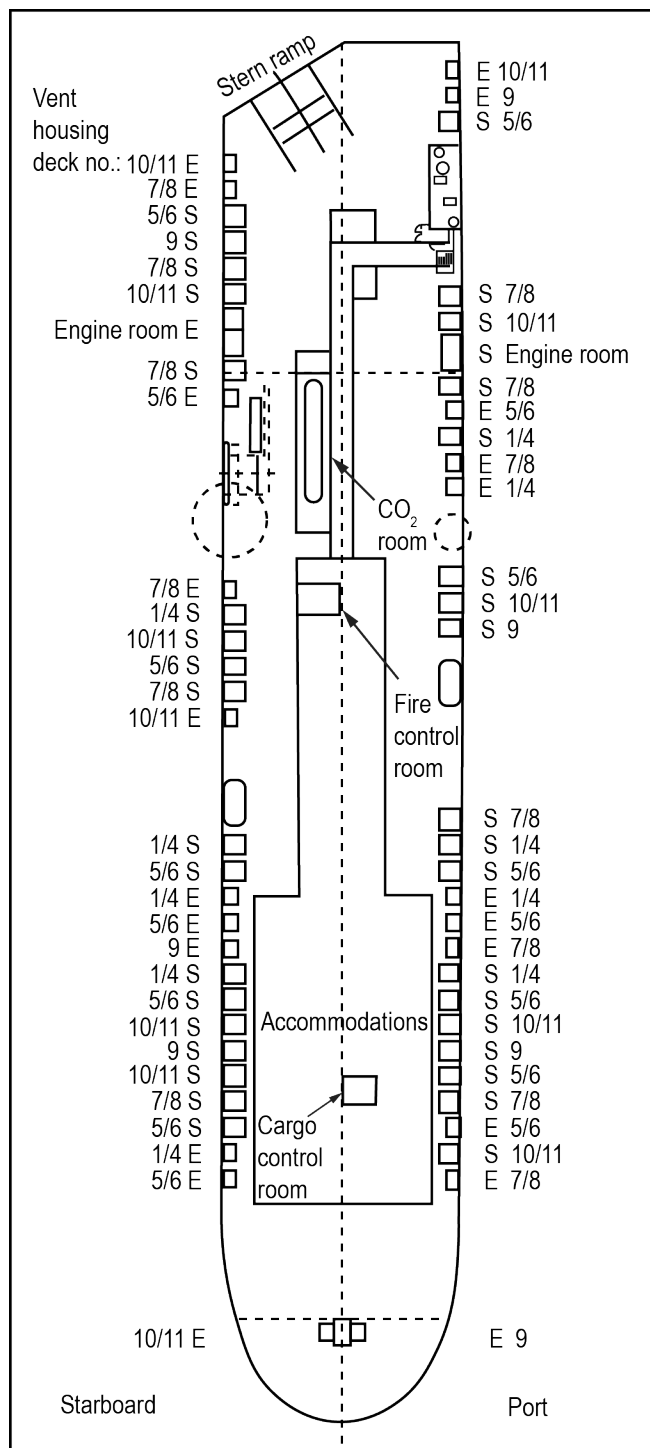
Fresh air was drawn into and expelled from the cargo holds through a system of closable dampers, fans, and large ventilation shafts, known as trunks (see figure 9). The vessel's cargo deck supply and exhaust ventilation trunks were located along both sides of the vessel and ran from each cargo deck to deck 12. The supply and exhaust trunks provided fresh air through vent grilles to ventilate the cargo decks during vehicle loading. The trunks were independent of each other. However, since decks within the same fire zone were not gastight from each other, for fire zones that encompassed two decks (such as decks 7 and 8), the ventilation was mixed in the cargo area, and, therefore, the independent trunk served both decks (figure 10 shows a portion of the portside aft ventilation trunks). The exhaust and supply fans for these ventilation trunks were also located on deck 12 along the periphery of the ship from bow to stern in ventilation housings.

**Figure 9.** Diagram of deck 12 showing ventilation housings. Each exhaust is marked with an "E," and each supply is marked with an "S."

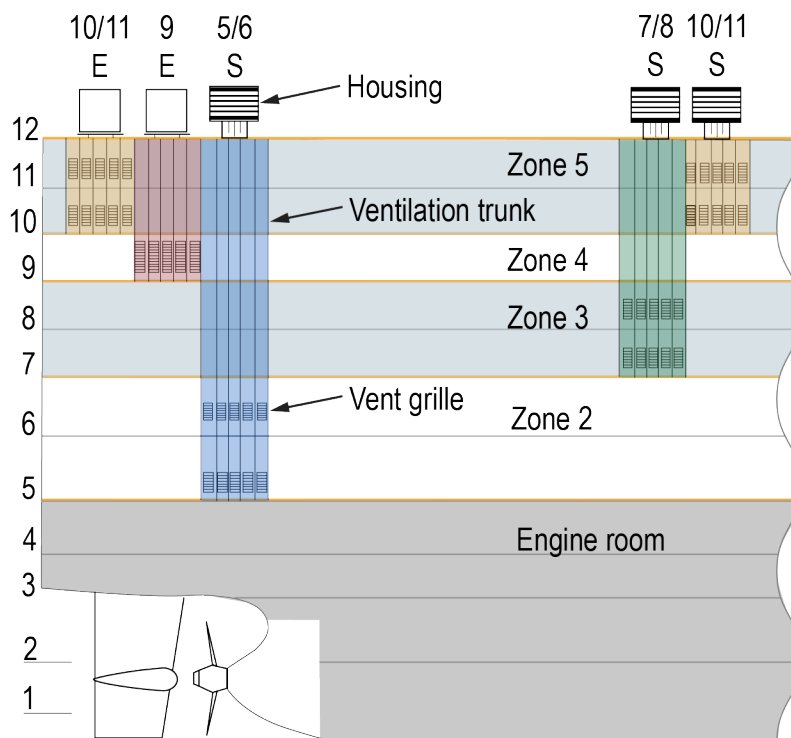
**Figure 10.** Arrangement of portside aft cargo ventilation trunks on deck 12. Each exhaust is marked with an "E," and each supply is marked with an "S." This only represents a portion of the exhaust and supply ventilation trunks.

Each supply and exhaust trunk was fitted with a fire damper that could be closed (in conjunction with stopping the supply fans) to cut off the air to a fire zone in case of fire. The dampers were gravity sealed. The Fire Control and Safety Plan listed 58 manual dampers for cargo spaces. The plan did not list remotely controlled dampers, but crewmembers reported that modifications had been made to the ship since the plan's creation in 2010, and some remotely controlled dampers were replaced with manually operated dampers. The plan was not updated with the manually operated dampers. The remotely controlled dampers could be secured from the cargo office, while the manually operated dampers required a crewmember

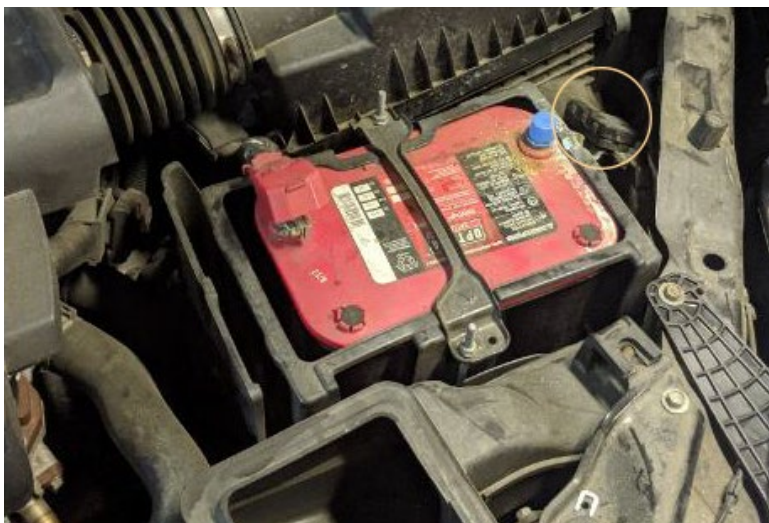
Grimaldi instructed SSA to create a "battery brigade" of ILA longshoremen who would be solely responsible for following behind vehicles as they were loaded and parked in order to disconnect the batteries. The brigade was required to disconnect the negative cable from the battery, tuck the cable away from the battery terminal, and cover the battery post with the battery cap (see figure 12). Once the cable was disconnected and the hood was shut, the brigade would mark the unit with grease marker to identify the vehicle as having a disconnected battery. Before loading, on May 22, 2020, the Grimaldi port captain emailed the company's written procedure to SSA and instructed, "Please note that I can't stress enough the importance of battery disconnect. Please ensure to have battery caps and adequate mechanics ordered to keep up with production."

**Figure 12.** Excerpt from Grimaldi battery disconnect procedure showing a vehicle battery secured with a blue plastic negative terminal cap and disconnected cable (*circled*) tucked inside. (Source: Grimaldi)
