**Accident Investigation Report -
Pedestrian Bridge Collapse at Florida
International University**

**UniversityCity Prosperity Project
Miami, Florida**

Prepared by:
Munilla Construction Management (MCM)
6201 SW 70th Street
Second Floor
Miami, FL 33143

Date:
September 20, 2019

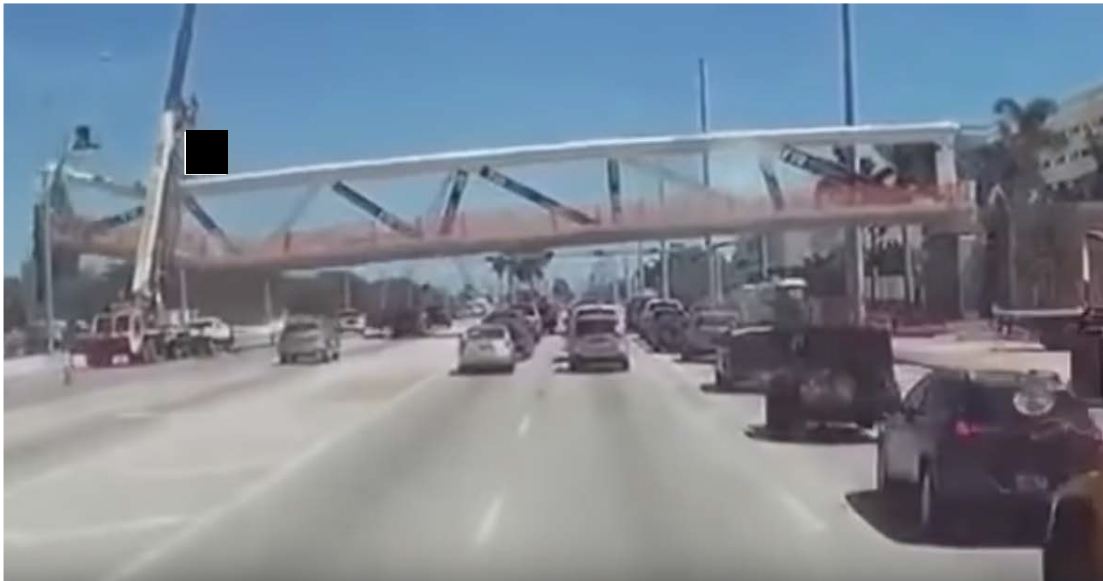
Dashboard video camera footage of the collapse is publicly available. One such video is taken from a moving vehicle traveling east toward the Bridge. The north end of the Main Span is situated on the left side of the frame. It is apparent from the video that the failure precipitating the collapse initiated on the north end of the Main Span (Figure 7). Figure 8 shows the aerial views of the collapsed Main Span.

Figure 7. Frame from dashboard video of Bridge collapse.²⁸

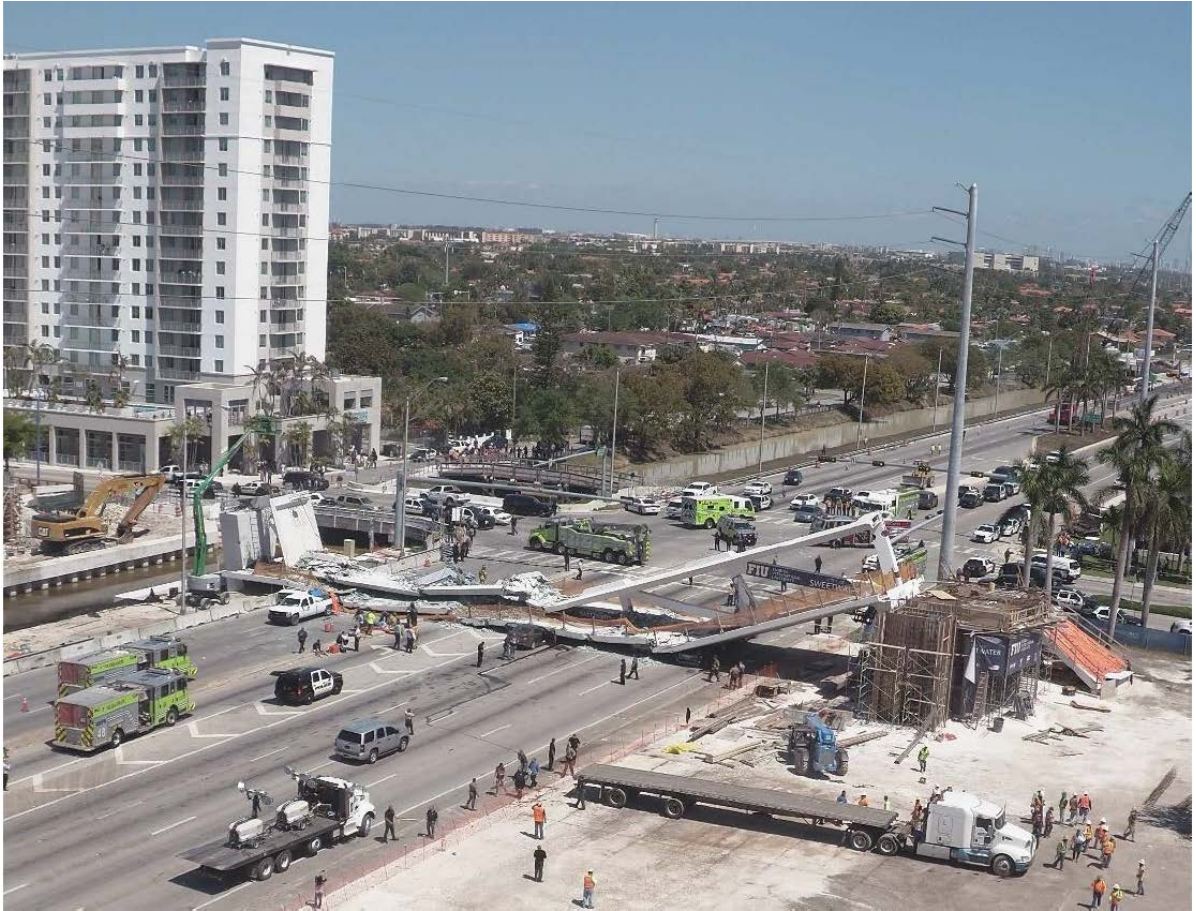
Figure 8. Aerial photo of collapsed Main Span and rescue efforts.²⁹

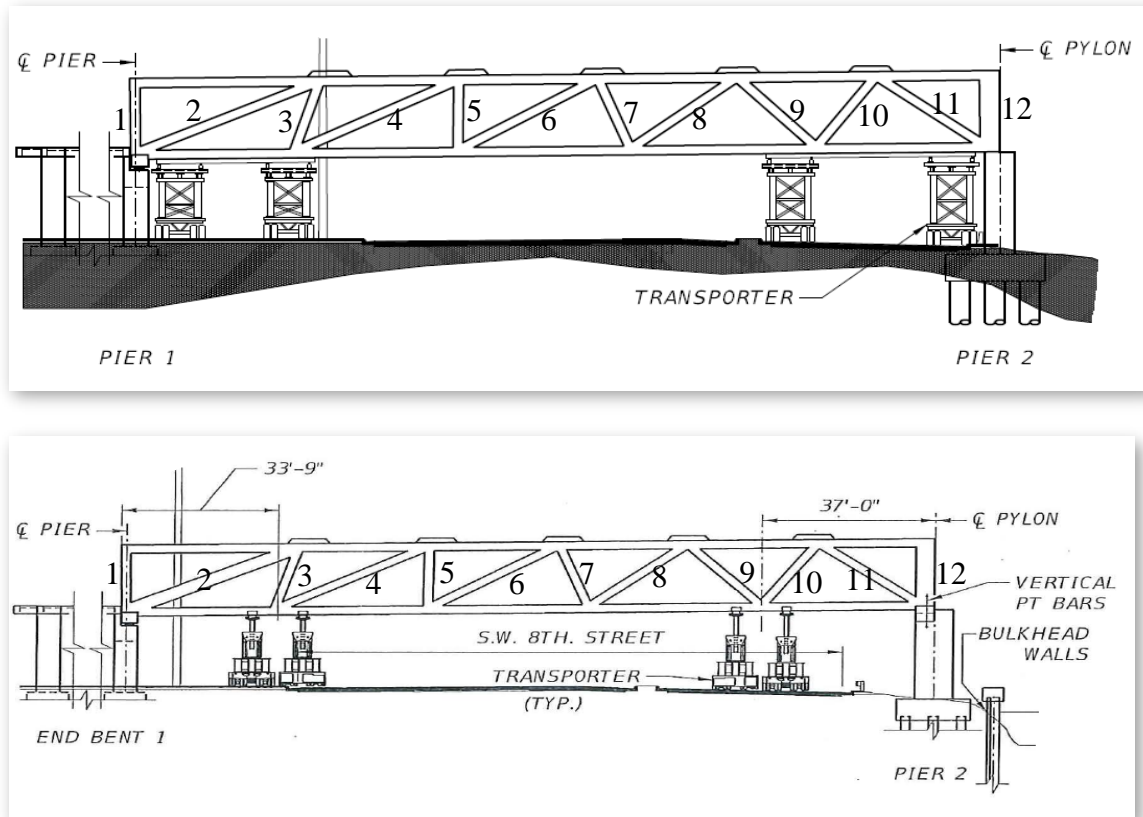
For the intended move of the Main Span, FIGG's initial design proposal had SPMTs providing support near the ends of the Main Span and at the first panel points (*i.e.*, the intersection of Members 3-4 and 9-10). But, as shown in Figure 12, FIGG's later RFC drawings in B-109 instead showed SPMTs providing support on either side of these first interior panel points. This change resulted in approximately 35 feet of the Main Span on both the north and the south sides (37' and 33'-9", respectively) to be unsupported (cantilevered past the SPMT support) during transport. This changed the distribution of force in the Web Truss Members, with the most significant change being the creation of tensile forces in Members 2 and 11.

Figure 12. Placement of SPMT support: Proposal (upper) and RFC (lower).⁶⁵

This addition meant that the large compression and shear forces created from the temporary PT in Members 2 and 11 compounded the already large compression and shear forces that existed in these elements both before and after the move. Critically, FIGG did not update its calculations (i.e., interface shear friction capacity) to check this worst-case loading combination of high compression and shear from self-weight and PT at Members 2 and 11.⁶⁶ It is this combination of compressive forces in Member 11 and resulting shear at Node 11/12, combined with FIGG's failure to accurately verify the structural integrity of the Bridge at these locations, that led to the cracking and final collapse, as discussed in more detail in Sections 5 and 6.⁶⁷ FDOT failed to

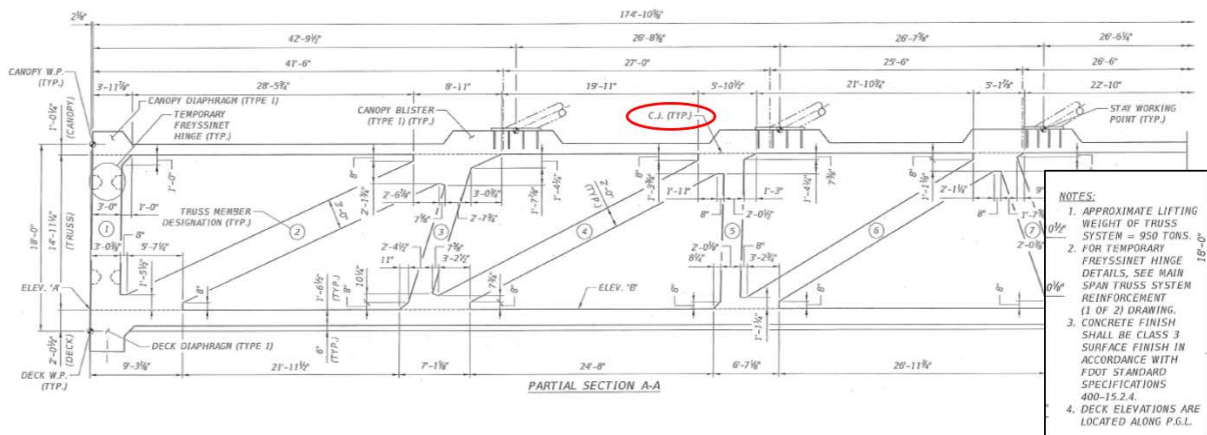
The locations at which Truss Web Members meet the Deck and Canopy are referred to as “construction joints” (“CJ” or “cold joints”). As shown in Figure 13 below, which includes excerpts from Sheet B-37 of FIGG’s plans with the construction joint callout indicated, depicts these interface surfaces for the Main Span with horizontal dashed lines. Only one instance is specifically identified, however, and the callout reads, “C.J. (TYP).” These abbreviations inform the user of the drawing that all instances of these dashed lines represent construction joints.

Figure 13. Main Span Truss elevation with construction joints and notes from RFC Sheet B-37.⁶⁸

Based on this B-37 note, and the details of construction stage 2 shown on Sheet B-109, FIGG anticipated and allowed the placement of the Deck concrete to be completed prior to the placement of the Truss Web Member concrete and expected that the Canopy concrete would be placed after the Truss Web Member concrete (thereby creating construction joints). However, FIGG did not provide any instructions regarding surface roughening amplitude at these construction joints, despite the fact that Eddy Leon of FIGG stated in his NTSB interview that intentional roughening is usually called out on the plans when it is intended in the design.⁶⁹

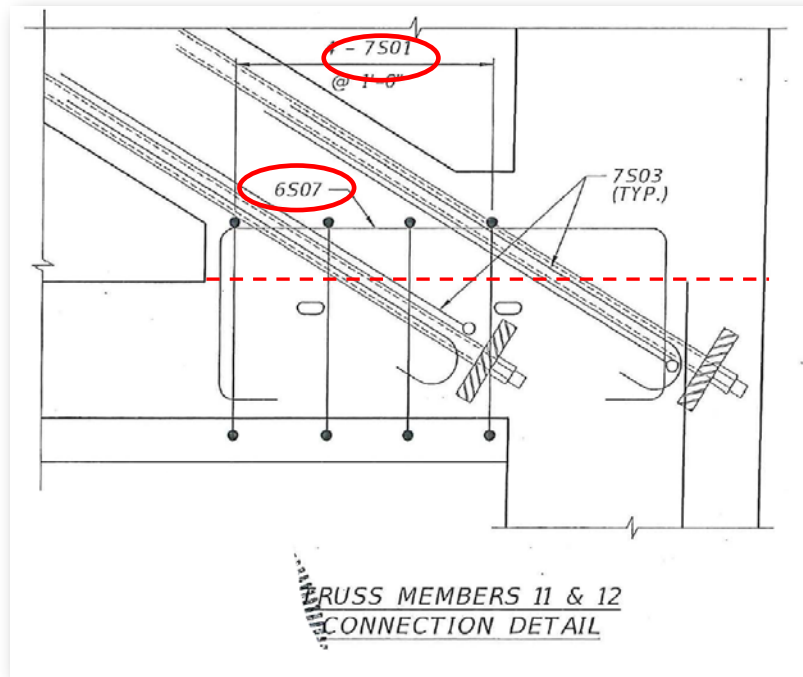
The mild steel reinforcement in the Truss nodes for Members 11 and 12 located at the Deck elevation are shown in Figure 15 and Figure 16. Bars 7S01 are hat-shaped bars placed transverse to the Bridge length, and Bars 6S07 are approximately u-shaped bars placed parallel to the axis of the Bridge. The leading numeral in the bar designations indicate the size of the bar. The drawing excerpt in Figure 16 shows that the 6S07 bars were not to be placed within the bends at the tops of 7S01 bars but were to be located more centrally in the nodes.

In summary, the 7S01 bars crossing the construction joint at Node 11/12 were not designed to be embedded in concrete deep enough to allow development of their full strength. Therefore, shear strength calculations at Node 11/12 that involve any contribution from 7S01 bars should have considered a reduced capacity of these bars. Accurate estimation of shear capacity at Node 11/12 is essential for explaining the cause of the observed cracking and failure in and around construction joint at Node 11/12. These calculations are discussed in Section 5.

Figure 15. Reinforcement in Node 11/12, Deck construction joint indicated with red dashed line.⁷⁴

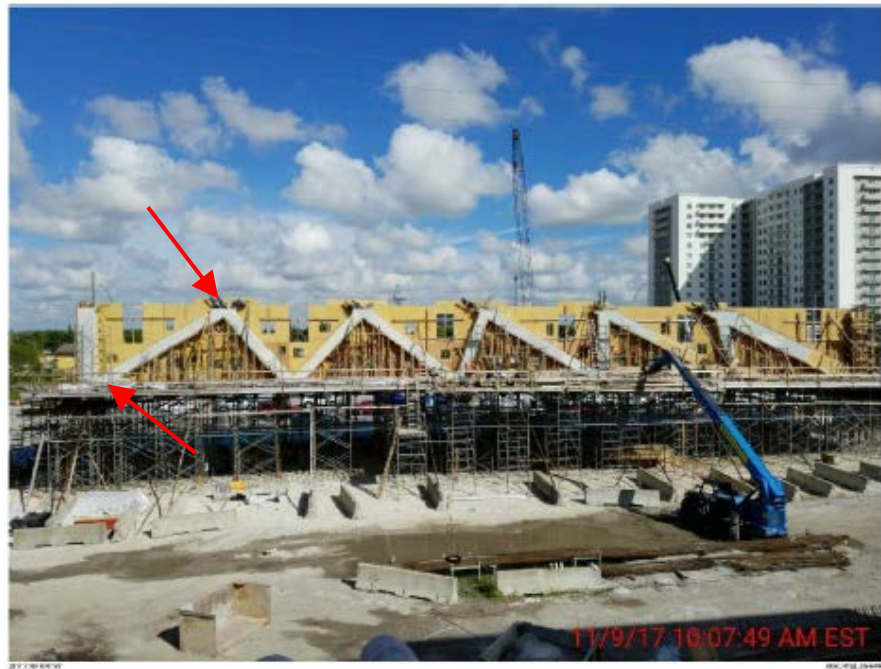
Figure 23. November 9, 2017: Truss form removal, location of construction joints indicated with red arrows.⁸²

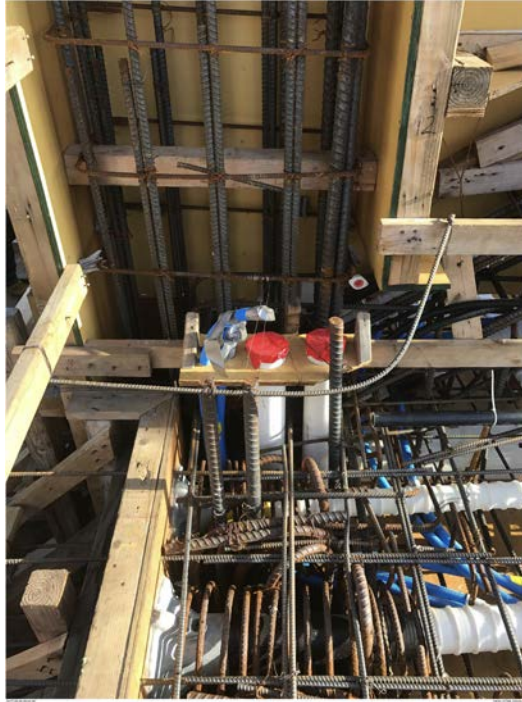
Figure 30 shows the interface between vertical Member 12 and the Deck prior to Deck concrete placement. Figure 31 shows the forms for the Truss Web Members after the Deck concrete had been placed, with the location of a construction joint shown in the bottom left of the image. And Figure 32 and Figure 33 show the remains of the interface between Node 11/12 and the Bridge Deck after the collapse.

Figure 30. Deck and Web forms and reinforcement prior to pour of Deck concrete (Member 12).¹⁰¹

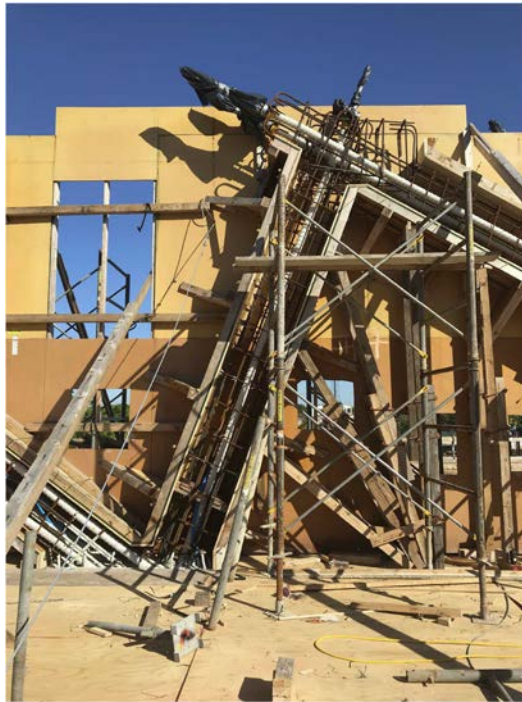
Figure 31. Superstructure forms showing one Web-to-Deck construction joint.¹⁰²

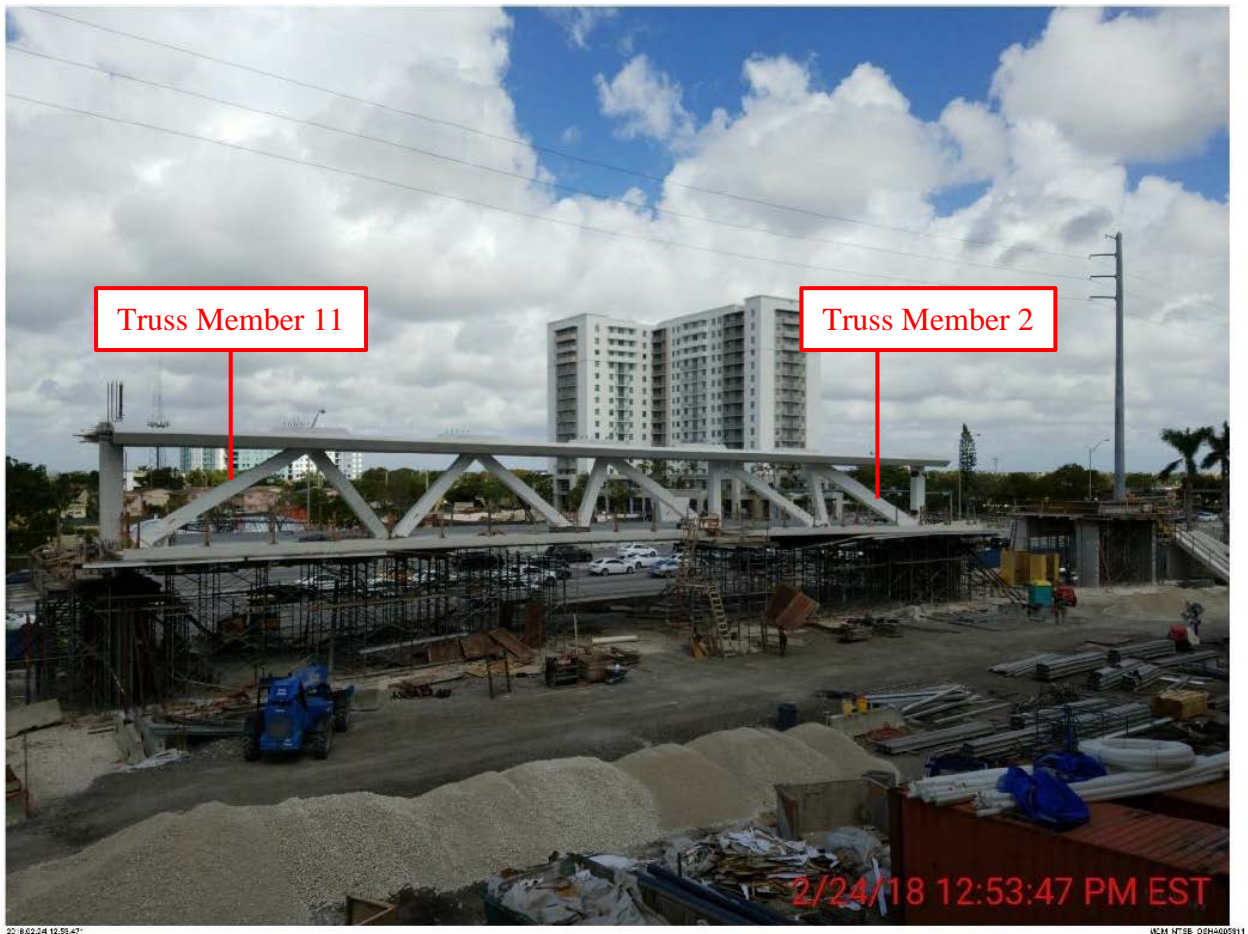
On February 6, 2018, after the Main Span Deck PT tendons had been stressed and grouted and Web Truss PT bars in Member 2 and 11 had been stressed but not yet grouted, BPA, MCM, and Corradino noticed minor cracking around several Diagonal Members of the Main Span, specifically Truss Members 3 (south end) and 10 (north end).¹⁰⁷ Truss Members 2 and 11 were the furthest outboard Diagonal Truss Members at each end of the Main Span (Figure 34).

Figure 34. Photograph of Main Span taken on February 24, 2018.¹¹³

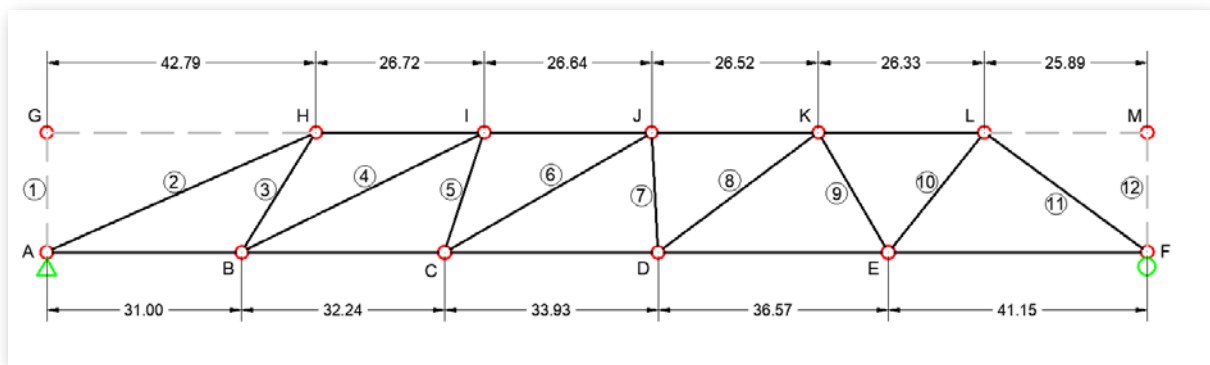
In its Simply-Supported condition, the Main Span’s member loads could be reasonably approximated as an ideal truss,¹⁸⁸ which allows the magnitudes of the forces in the end diagonals to be computed with reasonable accuracy using hand calculations. Under ideal truss assumptions, Truss Web Members 1 and 12, as well as the end Canopy segments, would be “zero force members,” meaning they would not carry any significant axial force. Figure 45 shows the configuration of the Truss under ideal assumptions.

In this case, most of the Bridge’s weight reaches the end supports (nodes A and F in Figure 45) by passing through end Diagonal Members 2 and 11. Only the weights of end vertical Members 1 and 12 and half of the end Deck and Canopy segments would reach the supports without first passing through the end Diagonals Members. Therefore, of the 1900-kip (950 ton) weight of the Main Span, all but 360 kips (180 tons) must pass through Diagonal Members 2 and 11 as compressive force. If the remaining 1,540 kips is evenly distributed between the north and south supports, the nominal dead load axial forces in Diagonal Members 2 and 11 would be approximately 1,890 kips and 1,450 kips, respectively, excluding the effects of PT. Adding the prescribed 560 kips of PT in each of these Diagonals, as set forth in FIGG’s design plans,¹⁸⁹ increases the nominal axial compressions to 2,450 kips and 2,010 kips, respectively.

Figure 45. Idealized Main Span Truss.

The axial force in Diagonal Member 11 can be resolved into vertical and horizontal components. The horizontal force is the critical component here because it contributes to interface shear in the Truss-to-Deck connection. The nominal horizontal component of the diagonal axial force is 1,710 kips for Diagonal Member 11. This horizontal force must be resisted by shear friction at Node 11/12. As discussed later, the value of 1,710 kips for interface shear at Node 11/12 arrived at by simple hand calculation greatly exceeds the value of 571 kips that FIGG extracted from its LUSAS finite element model (*see* Section 6.2.1). A hand analysis should have thus revealed to FIGG that it had greatly underestimated the shear force at this critical connection.

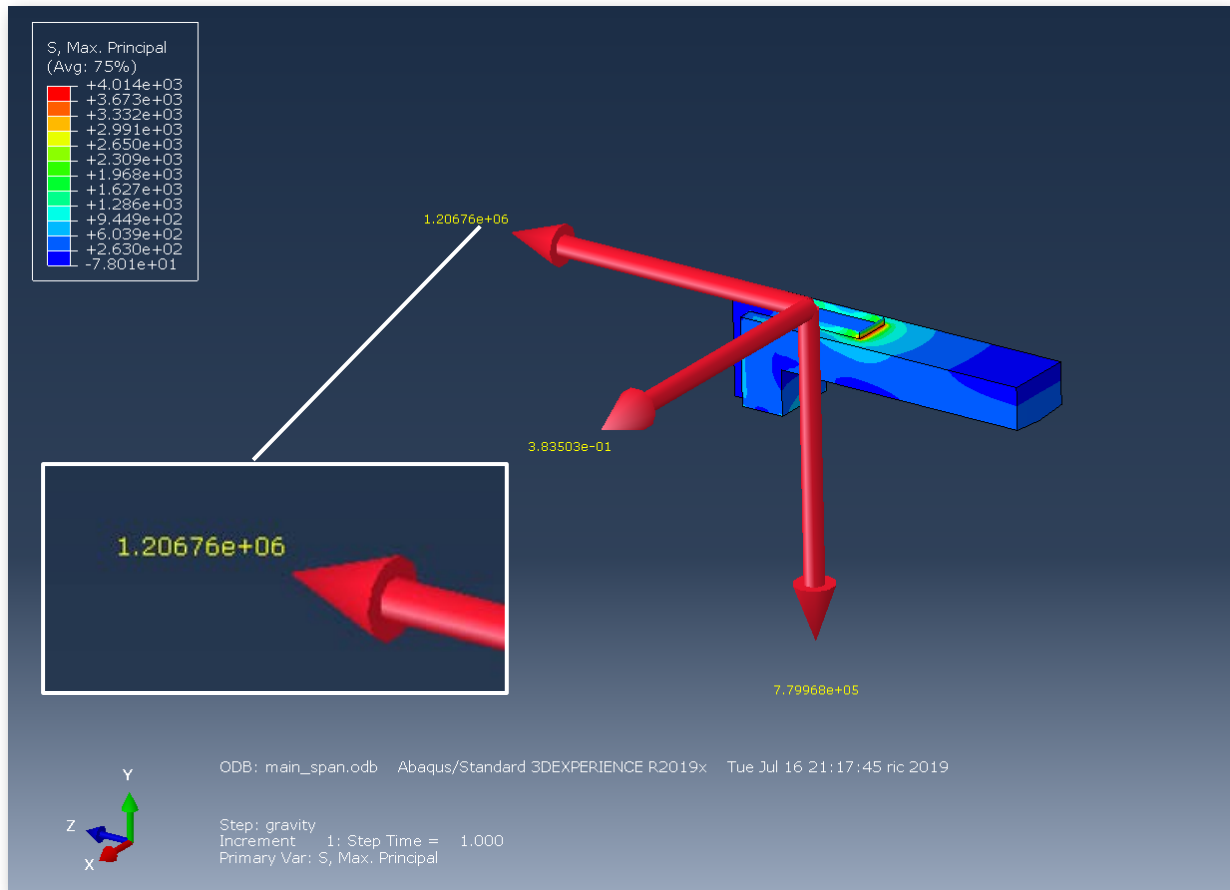
Figure 48. Node 11/12 interface shear force extraction from ABAQUS (DL only).

Figure 47 shows a rendering of the ABAQUS model with color contours of principal stress, and Figure 48 shows the directly-extracted interface shear force (reported in pounds) just above the Deck at the bases of Members 11 and 12 for nominal dead load (“DL”) with no PT. This nominal DL interface shear value from ABAQUS combined with the effect of PT from hand calculations resulted in a total nominal interface shear value of 1,686 kips, which corresponds with 1,710 kips and 1,738 kips from hand calculations and SAP2000 analysis, respectively.

Interface shear at Node 11/12 from all three models are within 3% of each other, demonstrating the utility and accuracy of each model in this analysis.

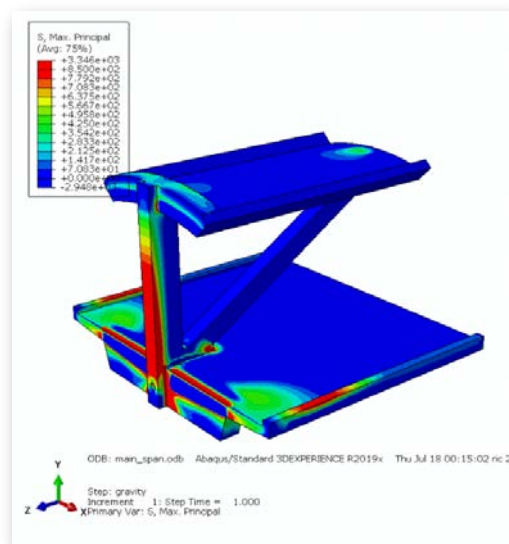
Figure 50. Principal stresses from refined ABAQUS model.

Figure 50 shows the resulting contours of principal stress. Any color warmer than blue indicates the presence of some tensile stress. Red colors indicate principal tensile stresses over 850 psi, which corresponds to the approximate threshold for concrete cracking in the Superstructure.

According to this analysis, cracking was anticipated on the north side of Member 12, at the south corner of Node 11/12, and on the north face of the Type II Diaphragm. These results are validated by the observations of cracks prior to collapse, as shown in Figure 51 and Figure 52. The extent of the flexural cracks on the north face of Member 11, however, raises questions about the adequacy of the design of this Member that will be addressed in Section 6.

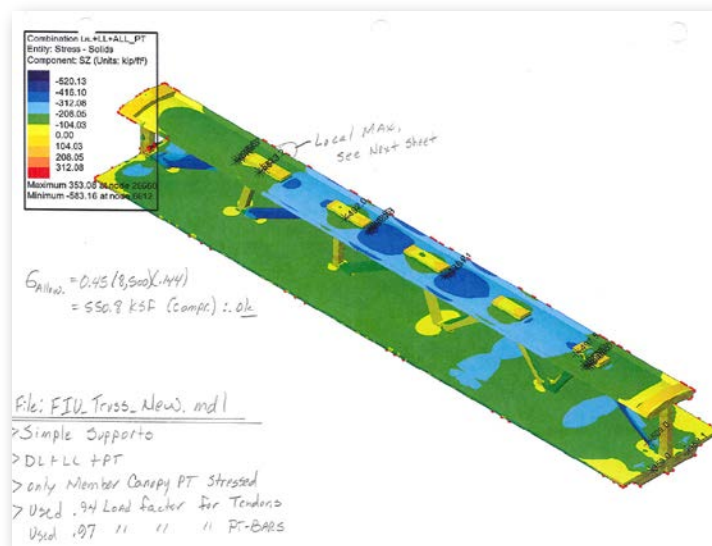
Figure 61. Hand-annotated LUSAS model screenshot.²¹⁵

Figure 61 shows the longitudinal normal stress contours for the Simply-Supported Main Span, indicating that dead, live, and PT loads were applied to the model. However, there is no indication that the construction loads specified in FIU’s Design Criteria Section 4.10 were included in FIGG’s design calculations, which would have increased the design loads and resulting stresses.

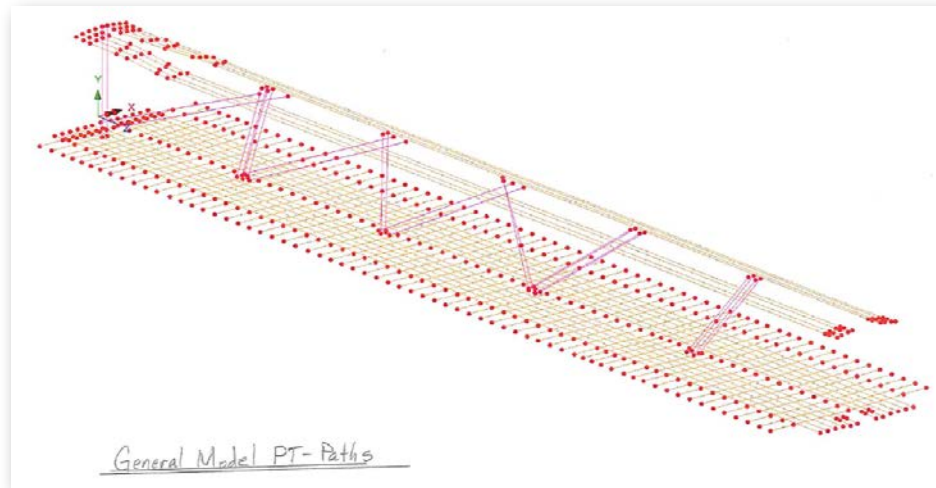
Figure 62. LUSAS screenshot showing PT paths for Simply-Supported Main Span.²¹⁶

Further, Figure 62 shows the locations of PT tendons modeled in the Simply-Supported Main Span. However, PT bars are notably shown in Diagonal Member 2 on the south end of the span, but not in Diagonal Member 11 on the north end of the span. Figure 62 also shows PT bars located in vertical Member 1 and Diagonal Member 4, contrary to RFC drawing Sheet B-38 and the installation in the field. In other words, this arrangement of PT bars does not represent the condition of the Main Span prior to its collapse on March 15, 2018 and is thus unreliable.

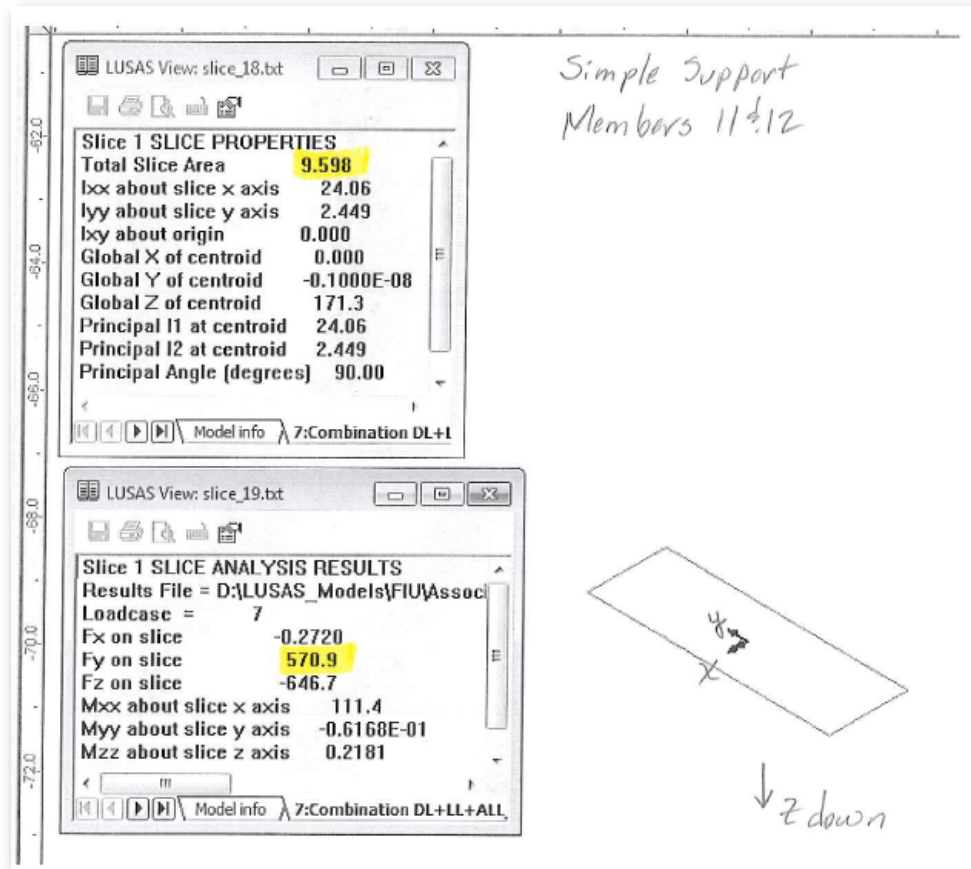
Figure 63. LUSAS screenshot of Node 11/12 interface for the Simply-Supported Model.²¹⁷

The Design Calculation submittals also include screenshots of planar slices through the models at nodal interfaces at the Deck level, which report the internal normal and shear forces on these planes. FIGG’s screenshot for the interface at Node 11/12 is shown in Figure 63. The load case producing the forces is not completely visible in the screenshots, but based on the screenshot showing longitudinal normal stress contours in Figure 61, it appears to correspond to the load case called, “DL+LL+ALL_PT.”

The value, F_y , in Figure 63 is the total horizontal shear forces occurring at the slices for the given load case and combination, acting in a direction parallel to the length of the Bridge. These horizontal shear forces tend to cause sliding between the Truss Web Members and the Deck, unless the structure has adequate capacity to resist this movement. The value, F_z , is the internal force acting perpendicular (normal) to the slices, and the value, F_x , is the horizontal shear force oriented in a direction perpendicular to the length of the Bridge. All forces in these figures are reported in kips.

In the Simply-Supported condition, nearly all of the weight of the Main Span Truss must pass through the 1/2 and 11/12 interfaces. Summing the vertical forces at these two locations (1,235 and 646.7 kips) yields a reasonable total force of 1,881.7 kips, or 941 tons. This is close to the 950-ton lifting weight given by FIGG on RFC drawing Sheet B-37. However, the distribution of the force between the two interfaces is disproportionate: 66% of the vertical force is passing through Node 1/2, and the remaining 34% is passing through Node 11/12. While the Truss Web Members are not symmetrically configured, there is not enough asymmetry to produce such a large disparity in vertical force distribution. In contrast, the vertical components of DL in end diagonals in FIGG’s LARSA model “Superstructure_Model_9.28.2016_MF.lar” are 761 kips (53%) and 674 kips (47%), for Members 2 and 11, respectively. The disparity in the LUSAS output conflicts with FIGG’s other analysis model and is likely an indication of an error in the LUSAS model.

Further, axial force in Diagonal Members 2 and 11 would transmit most, but not all, of the weight of the Superstructure to the Substructure Piers. The orientation of the force resultants at Node 1/2 and Node 11/12 would be approximately equal to the orientations of Diagonal Members 2 and 11. And because Diagonal Members 2 and 11 are both oriented at shallow angles to the Deck, the horizontal components of force should be larger than the vertical components. However, the opposite is reflected in FIGG's LUSAS screenshots for the interface shears, again indicating an error in these models.

Finally, aside from a small amount of transverse shear in Members 1 and 12, nearly all the horizontal shear acting on these interfaces is coming from axial force in Diagonal Members 2 and 11. The magnitude of the reported horizontal shear should be related approximately to the axial force in the diagonal by trigonometry. For example, the horizontal shear force reported by FIGG in Figure 63 is 570.9 kips. Considering that Diagonal Member 11 forms a 33-degree angle with the surface of the Deck, the axial force in Diagonal Member 11 would be interpreted to be around $(570.9)/\cosine(33 \text{ degrees})$, or 681 kips. This is very different from the 1,285 and 1,253 kips axial force represented in the LARSA 4D models for DL (see Section 6.1.2). The LARSA 4D results reported in the calculation submittal also did not include any additional axial force applied through PT bars in Diagonal Member 11.

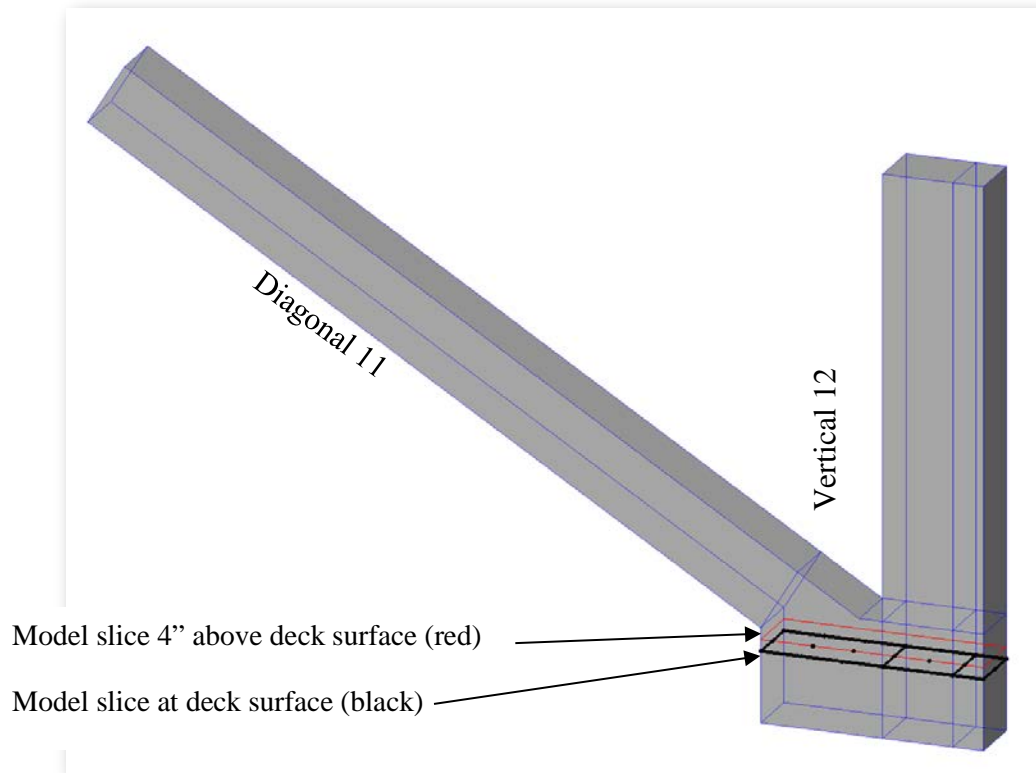
Figure 64. Example LUSAS Model Extract Showing Node 11/12 Slice Locations.

Ultimately, our review revealed a nuance of FEA that led FIGG to underestimate the nodal interface shears. Specifically, FIGG's Design Calculation submittals showed that FIGG's query of the interface shear forces was exactly at the Deck elevation. This is problematic because taking a slice through the model a small distance above the Deck surface, but still below the bottom of the incoming diagonal, yields an interface shear force significantly larger than if the slice is at the Deck, where interpolation and averaging effects of the numerical model artificially distribute the nodal forces into the Deck elements. As a result, this placement results in a calculated shear force much smaller than the actual shear force. The difference between these two model slice locations for Node 11/12 is illustrated in Figure 64.

Figure 64 includes the 10-1/2 inches of Member 12 thickness that projects north beyond the Bridge Deck, but FIGG did not include this area in its query of interface shear forces.²¹⁹ For model FIGG280209.mdl (October 5, 2016), the DL interface shears for slices at the Deck and four inches above the Deck are 635 and 852 kips, respectively (considering the same slice area as FIGG’s Design Calculation submittals). Similar differences were obtained for the other models. Slicing the volume at the exact interface between the Nodes and the Deck caused FIGG to systematically underestimate the interface shears at the Truss Nodes. This underestimation of interface shears would have been discoverable by FIGG if it had compared their LUSAS results to simple hand calculations.

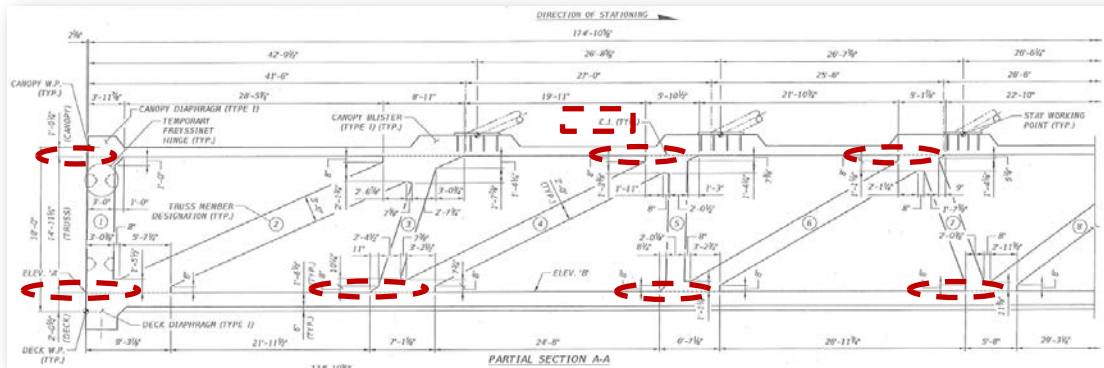
Figure 67. Example of Diagonals to Deck/Canopy construction joints. The construction joint call outs and locations are outlined in red.²⁵³

related to calculations of shear capacity and loads at Node 11/12 of the Main Span during various stages of construction. Louis Berger failed to note that FIGG did not specify the ¼-inch amplitude for surface roughness in its design drawings for Web Truss to Deck construction joints and did not recognize its significant adverse effect on shear strength at Node 11/12.

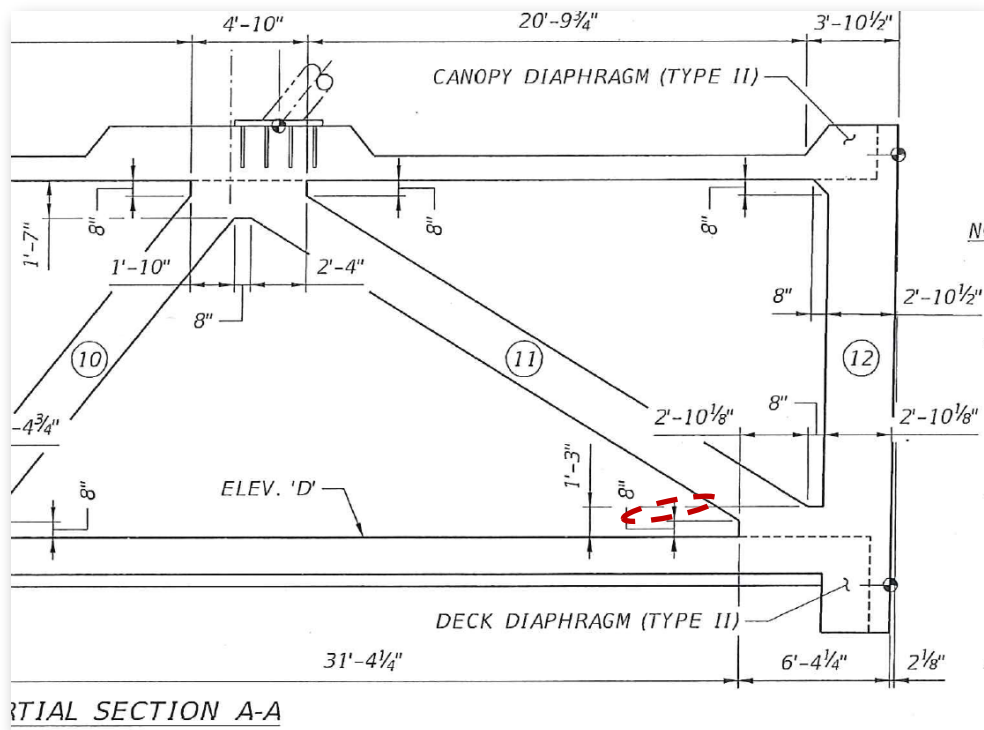
- Louis Berger’s IPR of the main members was limited to the Diagonals and the verticals under axial load and bending moment and did not include the design for shear capacity across the discontinuities near the member ends. (Figure 68) Therefore, Louis Berger was unable to identify Member 11 design as non-compliant with AASHTO LRFD Bridge Design Specifications.

Figure 68. Shear capacity check at discontinuity at base of Member 11, as outlined in red.²⁵⁴

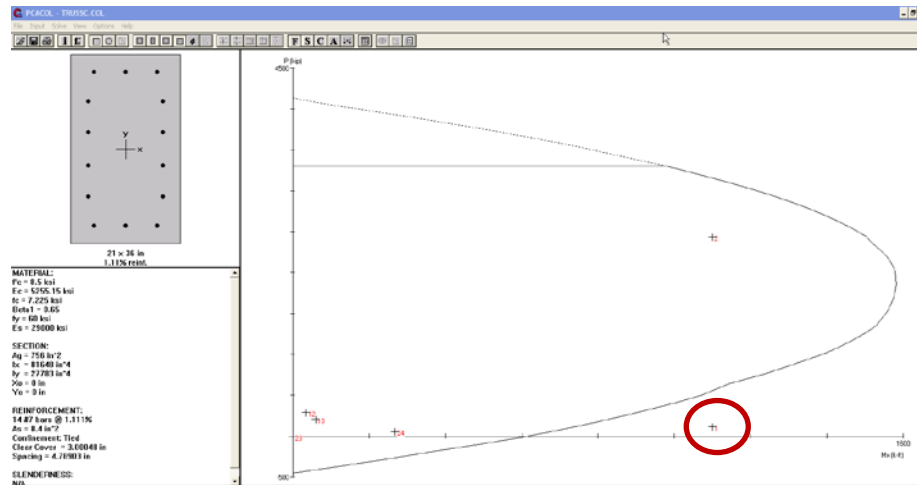
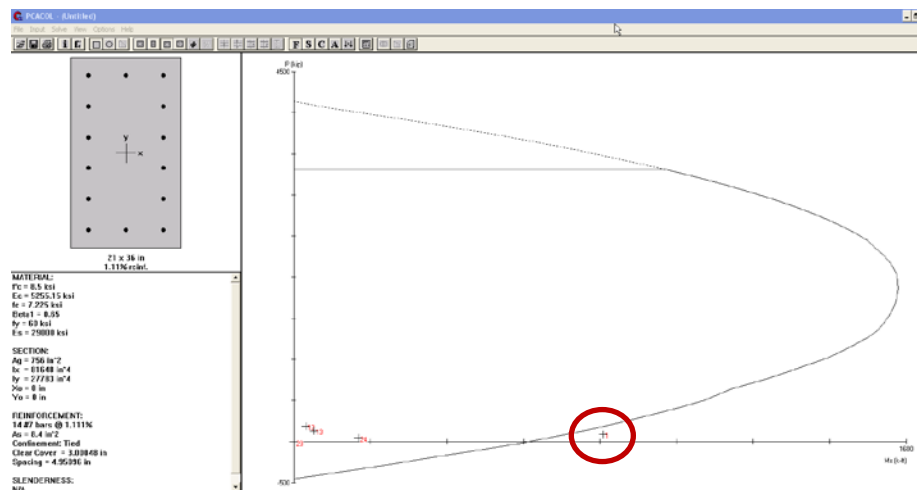
- Louis Berger’s calculations appear to show that Truss Members 1 and 24 did not meet the required Design Criteria.²⁵⁶ Figure 69 shows loading points outside of Louis Berger’s axial force and bending moment interaction diagrams. However, the documents that Louis Berger provided did not include communications related to any discussion and/or resolution with FIGG on this issue, even though documents reviewed by us show that reinforcement in these members was increased after the 90% submittal.

Figure 69. Louis Berger column superstructure interaction diagrams.²⁵⁷ Cross marks circled in red indicate non-conforming loading conditions.
